MEASUREMENT OF ROD SEAL LUBRICATION FOR STIRLING ENGINE APPLICATION

Allan I. Krauter
Shaker Research Corporation

July 1980

Prepared for
NATIONAL AERONAUTICS AND SPACE ADMINISTRATION
Lewis Research Center
Under Contract DEN 3-22

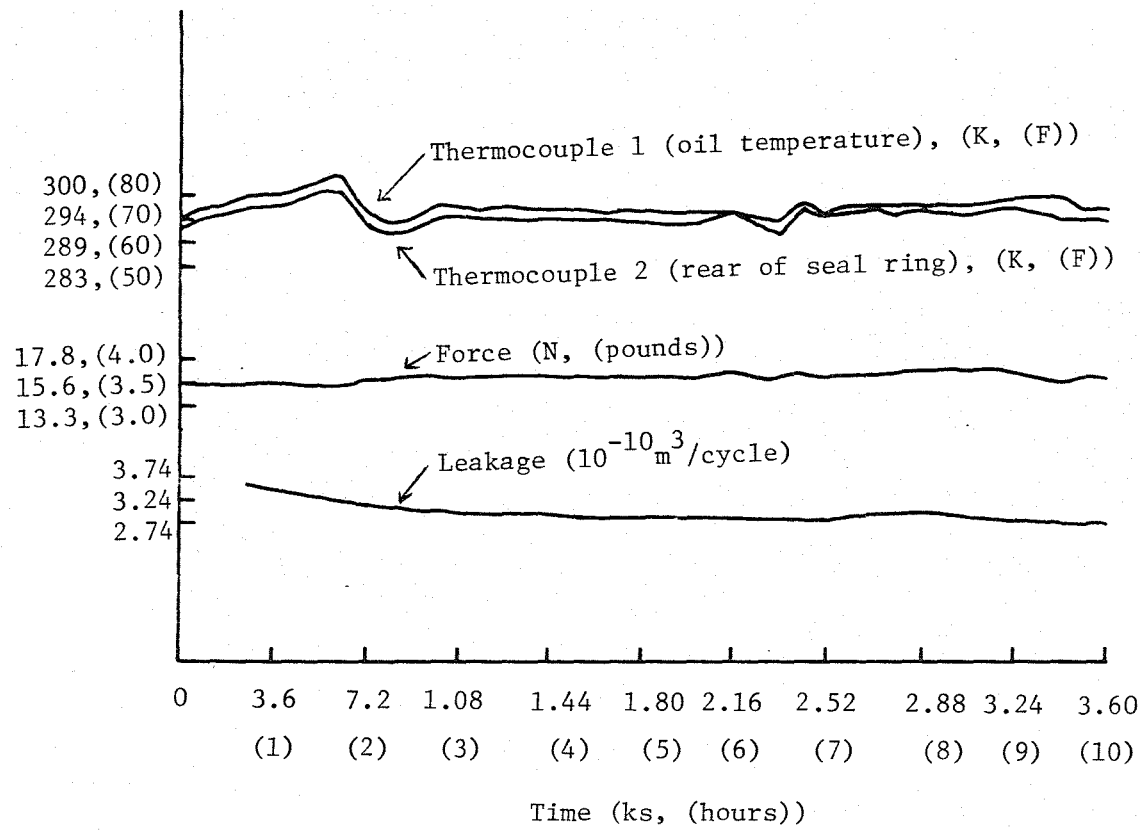
Figure 7 Results of the Ten Hour Test

Results from the ten hour test are given in Figure 7. The figure shows, plotted vs time, two temperatures, the peak force, and the oil leakage rate. The first thermocouple (T.C. 1) is that above the seal -- it protrudes slightly into the oil film. The second thermocouple is just behind the seal in the aluminum test seal holder. The leakage rate is shown on a per cycle basis -- it was computed on the basis of total oil leaked after start of the test divided by total cycles since start of the test. As a result, the leakage figures become more of a test average as more cycles are included in the running total.

A few points regarding the test and the figure are of interest. The thermocouples show a rising temperature trend for the first two hours. The rather abrupt decrease at that time was due to the start of water cooling. Also, the force can be seen to be very constant throughout the test. This occurred even though the test was stopped (approximately once per hour) to check oil leakage and to add oil.

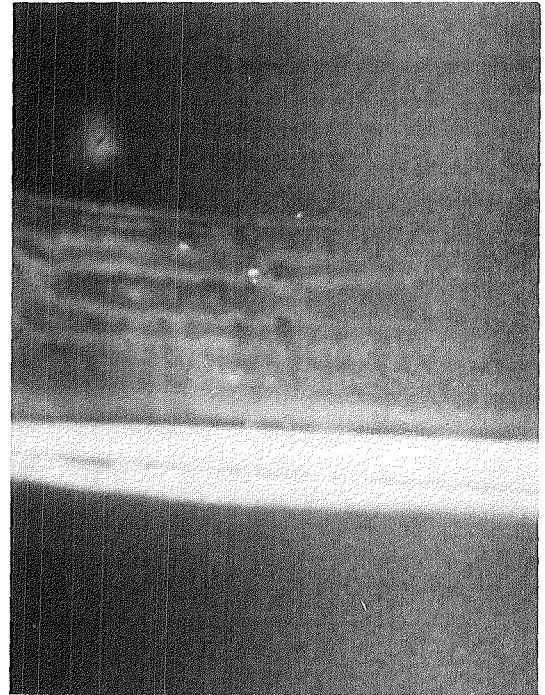
Another set of photographs is given in Figure 9. The only condition that differs between this set and those of Figure 8 is the seal type -- for Figure 9 the soft (70 durometer) rather than the hard (90 durometer) seal was used. Consequently, Figure 9 is for Test Matrix number 2.

Irregularities in the fringe pattern also occur for the softer seal. In contrast to the irregularities in Figure 8, those in Figure 9 are bright dots. These bright dots may have been caused by broken small

GREEN FILTER (0.550 μm)
16 EXPOSURES

ORANGE FILTER (0.600 μm)
10 EXPOSURES

air bubbles in the seal coating. These bubbles, when broken during polishing or during seal operation, could form small holes which could cause significant reflection of light. As in the hard seal case, these irregularities form handy reference points for measurements.

It is suspected that the majority of the difference for the two photograph sets in circumferential fringe regularity is caused by the optical coating. This coating, although carefully applied with an airbrush, varied somewhat from seal-to-seal. This variation was minimized, but not eliminated, by the polishing procedure described in the previous section. A less significant cause for the fringe irregularities in Figure 9 may be the durometer of the seal. The softer seal is the more likely to degrade both during the smoothing (sanding) operation prior to coating and during the polishing procedure itself.

The analysis employs Figure 9, in which a fringe overlap seems to exist for the dark fringe just ahead (toward the leading edge) of the center of the contact zone. Verification that this is a fringe overlap point can be obtained by comparing a measurement from a bright spot (irregularity) to the fringe in each photograph. Assuming that $i = 1$ and referring to Figure 4 and Appendix A, one finds that, at the fringe overlap point, the absolute oil film thickness is about $2.2 \mu\text{m}$ ($83 \mu\text{in.}$). Following the process used for the hard seal, one can measure the distance in each
