NASA Technical Memorandum 81885

FLIGHT PERFORMANCE OF THE TCV B-737
AIRPLANE AT MONTREAL/DORVAL INTERNATIONAL
AIRPORT, MONTREAL, CANADA, USING
TRSB/MLS GUIDANCE

William F. White and Leonard V. Clark

SEPTEMBER 1980

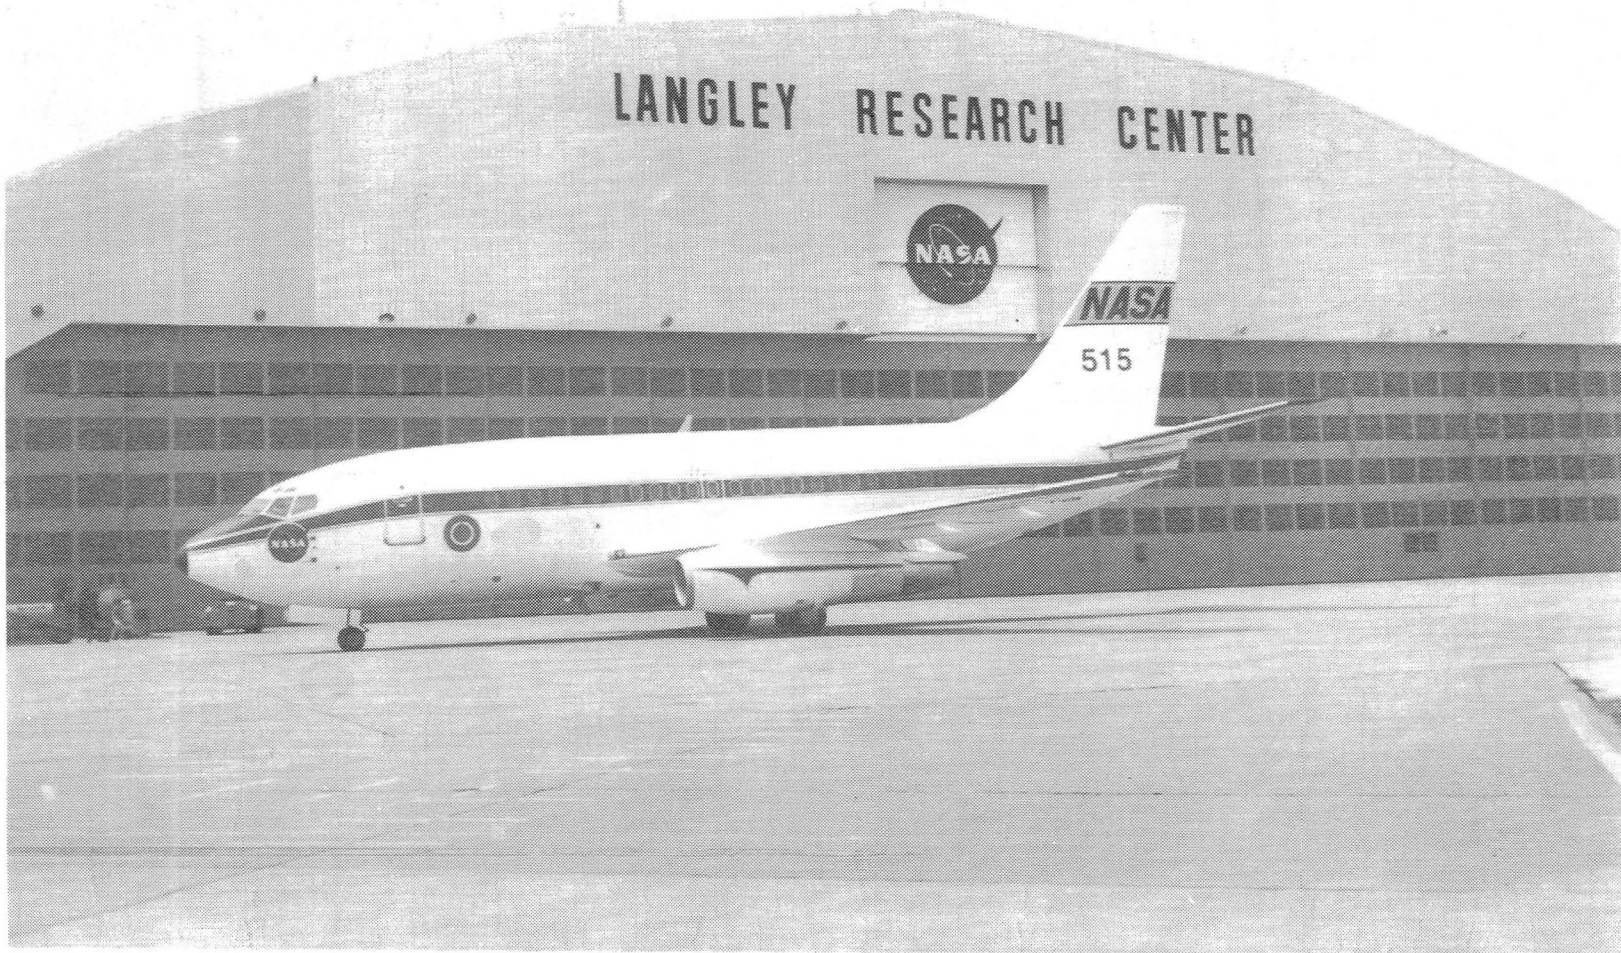
Figure 1. - NASA TCV B-737 Research Aircraft.

The TCV Program operates a Boeing 737-100 airplane (figure 1) to conduct flight research aspects of the program. The airplane is equipped with a special research flight deck, located about 6m (20 ft) aft of the standard flight deck. An extensive array of electronic equipment and data recording systems is installed throughout the former passenger cabin (figure 2).

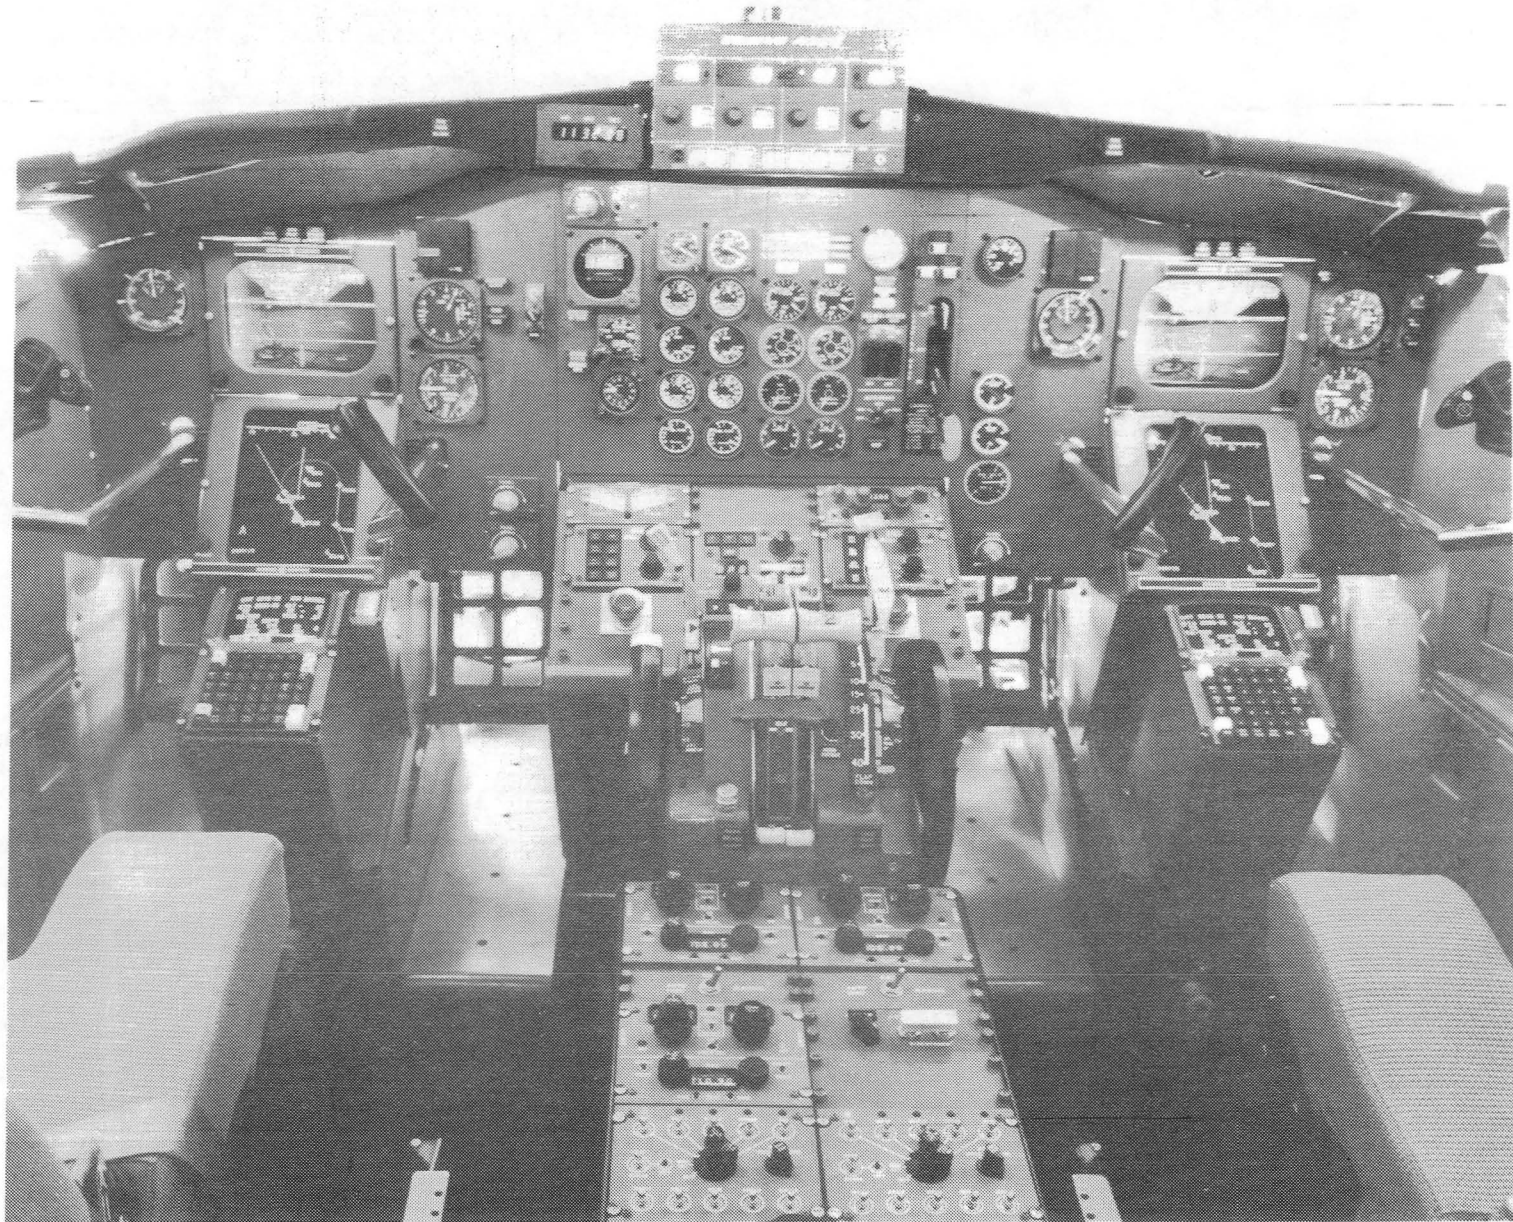
Figure 3. - Aft Flight Deck Display Arrangement.

The aft flight deck (figure 3) includes three monochromatic Cathode Ray Tube (CRT) displays that are available to each research pilot. The lower display is the Navigation Control and Display Unit (NCDU) which allows each pilot to control and monitor the airplane's navigation computer. The computer can access airway, Standard Instrument Departure (SID), Standard Terminal Arrival Route (STAR), and runway data for the geographic area of interest.

The center display is an Electronic Horizontal Situation Indicator (EHSI) that provides each pilot with a pictorial navigation display of the airplane's position relative to desired guidance path, flight plan waypoints, and selectable local points of interest such as airfields, obstructions and radio navigation aids.

The top display is an Electronic Attitude Director Indicator (EADI) that provides the pilots with a display of the airplane's pitch and roll attitude for instrument flight. Other symbols for flight path acceleration, flight path angle (actual and commanded), lateral and vertical guidance, and speed error are integrated into the EADI display format. A forward-looking television image (from a TV camera located in the airplane's nose) can be presented on the EADI in registration with the symbols. A computer-generated runway drawing, showing the true

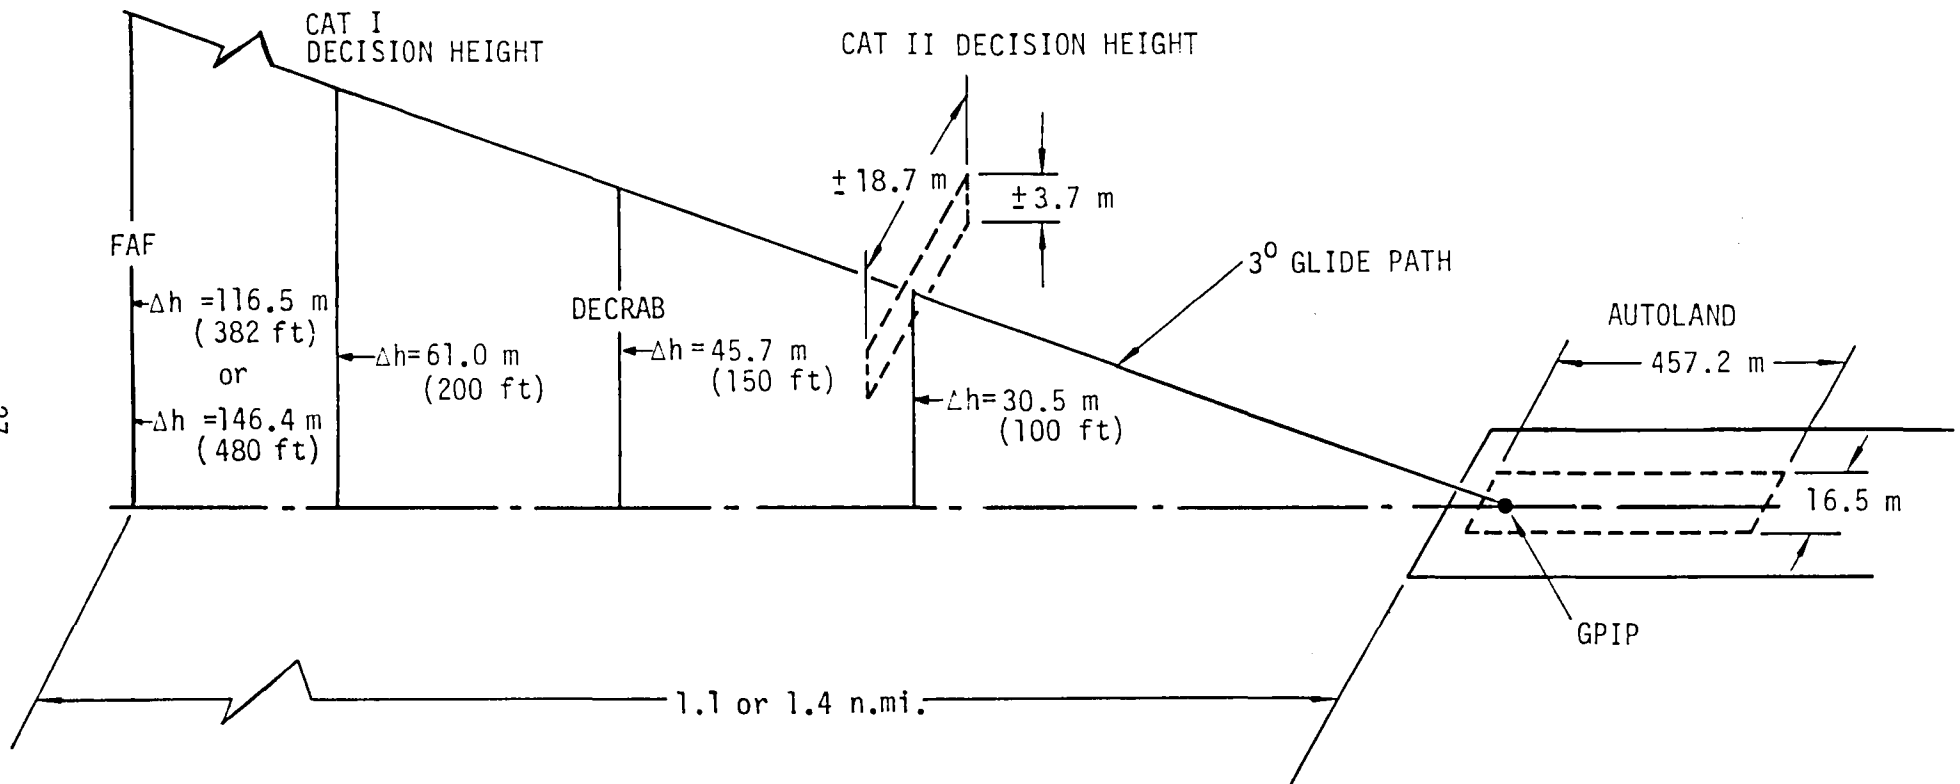
Figure 14. - Montreal/Dorval International Approach and Landing Profile Showing FAA Criteria (2d) for Automatic Systems (see references 6, 7, and 8).

Figure 14 schematically depicts the FAA certification criteria for approaches and automatic landings using ILS guidance, taken from references 6, 7, and 8. Some additional points used for data analysis are also shown. The flight performance data from table I are compared with the certification criteria in figures 15 through 19 and figure 21 in order to provide some quantitative aspects of the TCV B-737 approach and landing performance utilizing MLS guidance in lieu of conventional ILS guidance.

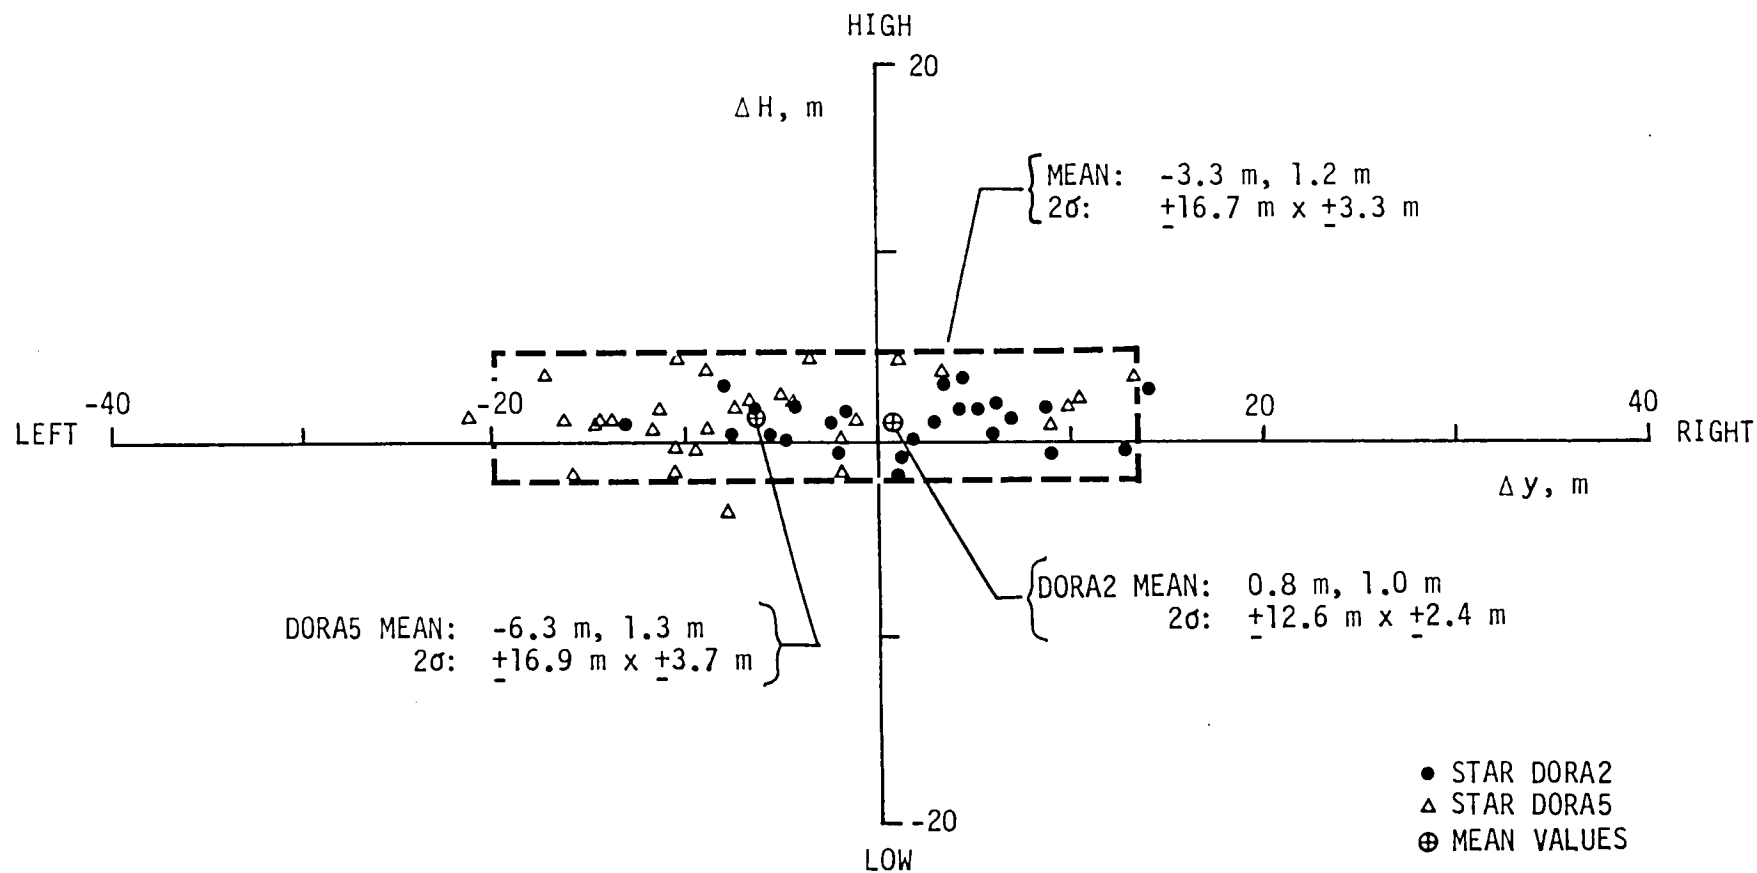
Figure 16. - Summary of TRSB - Derived Errors at the Final Approach Fix for Montreal/Dorval International Automatic MLS Approaches.

Final Approach Fix Delivery Errors. Figures 15 and 16 present the autopilot guidance errors at the final approach fix as determined from the navigation and flight control computers, respectively. At this point the cross track flight technical error is represented by XTK (figure 15), since localizer mode engage has either not yet occurred, or has only just occurred such that the aircraft has not yet had time to react to a change in control laws. The vertical flight technical error is given by ΔH (figure 16), since the glide path tracking mode of the autoland system was engaged earlier during the turn to final.

A second comment involves the previously-mentioned failure to account for the AZ antenna offset in the RNAV computations. Figure 16 indicates that for the DORA2 path, the mean delivery error at the FAF was only 0.8m whereas the RNAV system guidance error mean was -6.7m at that point. Most of that discrepancy (5.6m) is due to the AZ antenna offset from centerline.

A final point concerns the difference of 1.9m in altitude error between figures 15 and 16. The aircraft actually tracks a computed glide path rather than flying the 3° EL beam. All MLS position measurements are translated to the aircraft center of gravity, and the computed glide path may be adjusted so that flare initiation occurs at a known main wheel height above the runway. In this case the GPIIP calculated for the autoland system was inadvertently set to be 44.8m different from the RNAV path GPIIP, which resulted in the RNAV glide path being 2.3m below the path being tracked by the autoland system.

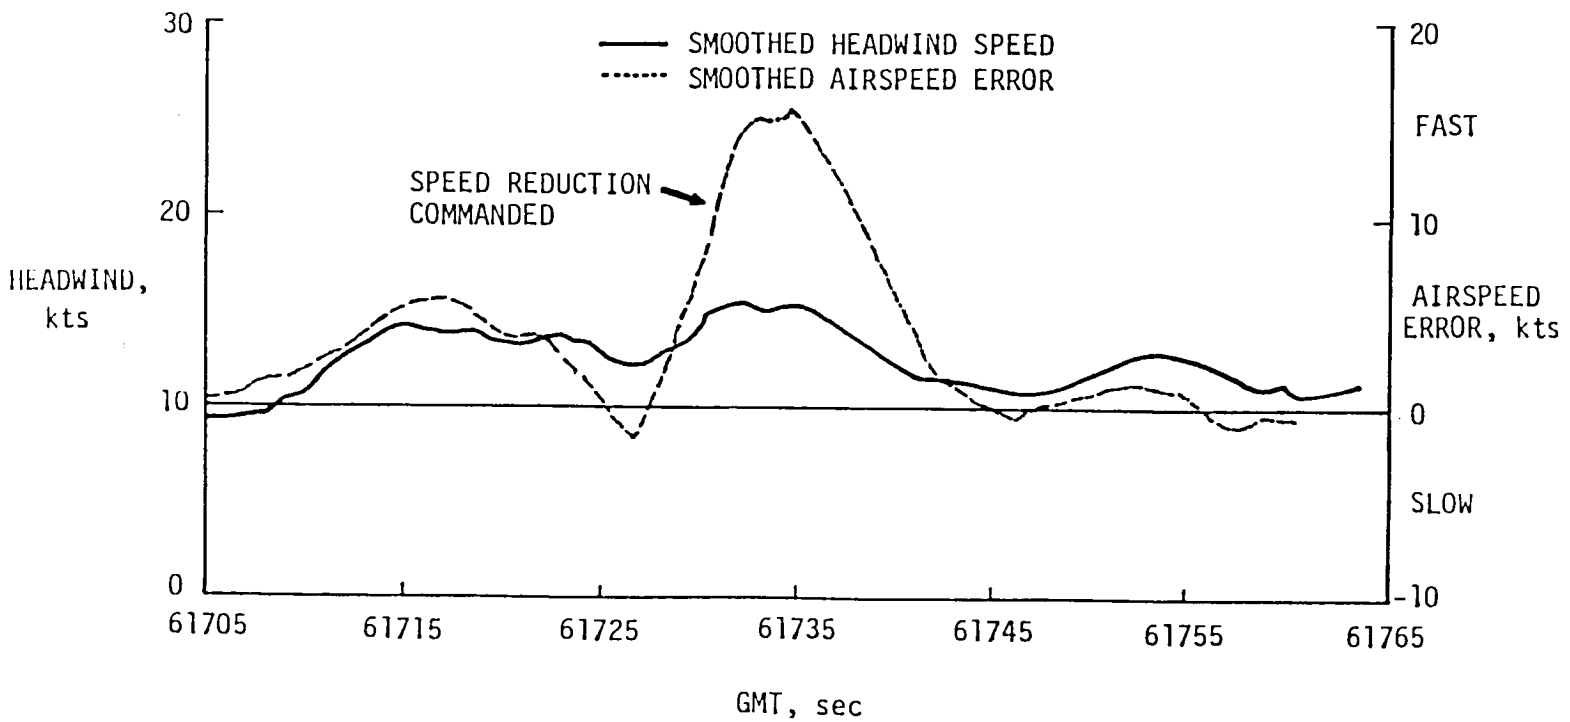
Figure 20. - Analysis of large glidepath errors on Flight/Run No. 229A-5.

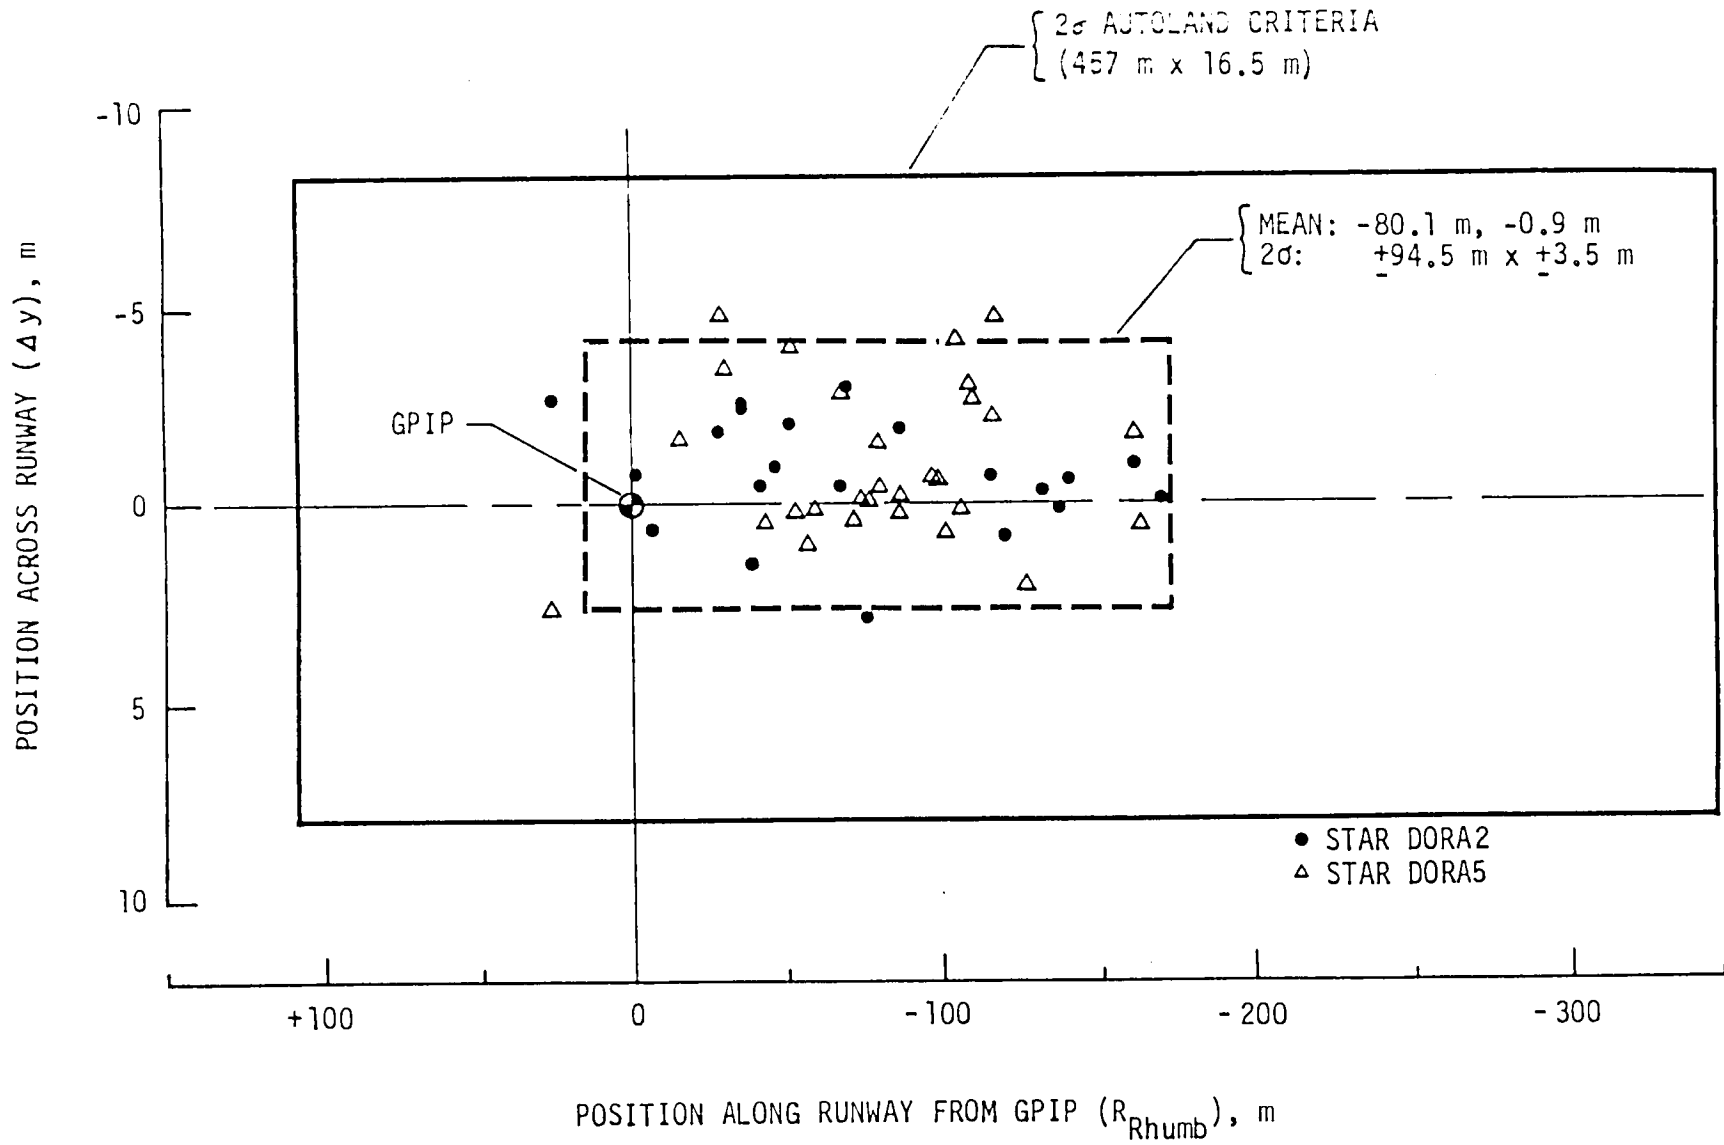
Figure 21. - Summary of TRSB - Derived Touchdown Performance of TCV B-737 for Automatic Landings at Montreal/Dorval International Airport.

Figure 21 presents a summary of the touchdown performance data for the TCV B-737 automatic landings. These data are compared with the FAA criteria for autoland systems (reference 8). In the figure the longitudinal location of the specified touchdown footprint is arbitrarily located with respect to the GPIP. Figure 21 does not include all of the touchdown data since the lateral error was not available for some of the runs. The longitudinal dispersion shown in the figure therefore differs slightly with the value in table I, which includes all of the landings. For all landings, the mean touchdown point was 80.1m past the GPIP with a dispersion of 93m, 2σ . This represents a large reduction in dispersion over that experienced in previous MLS demonstrations (references 2-4) due to the use of the new variable τ flare control law. The mean value of wind speed at flare initiation was 15 knots. The mean wind direction was 270 degrees, almost a direct headwind for landings on runway 28 (true runway heading of 267.7°).
