NASA Technical Memorandum 81435

ASSESSMENT OF POTENTIAL EXPOSURE
TO FRIABLE INSULATION MATERIALS
CONTAINING ASBESTOS

Walter S. Kim and David E. Kuivinen
Lewis Research Center
Cleveland, Ohio

April 1980

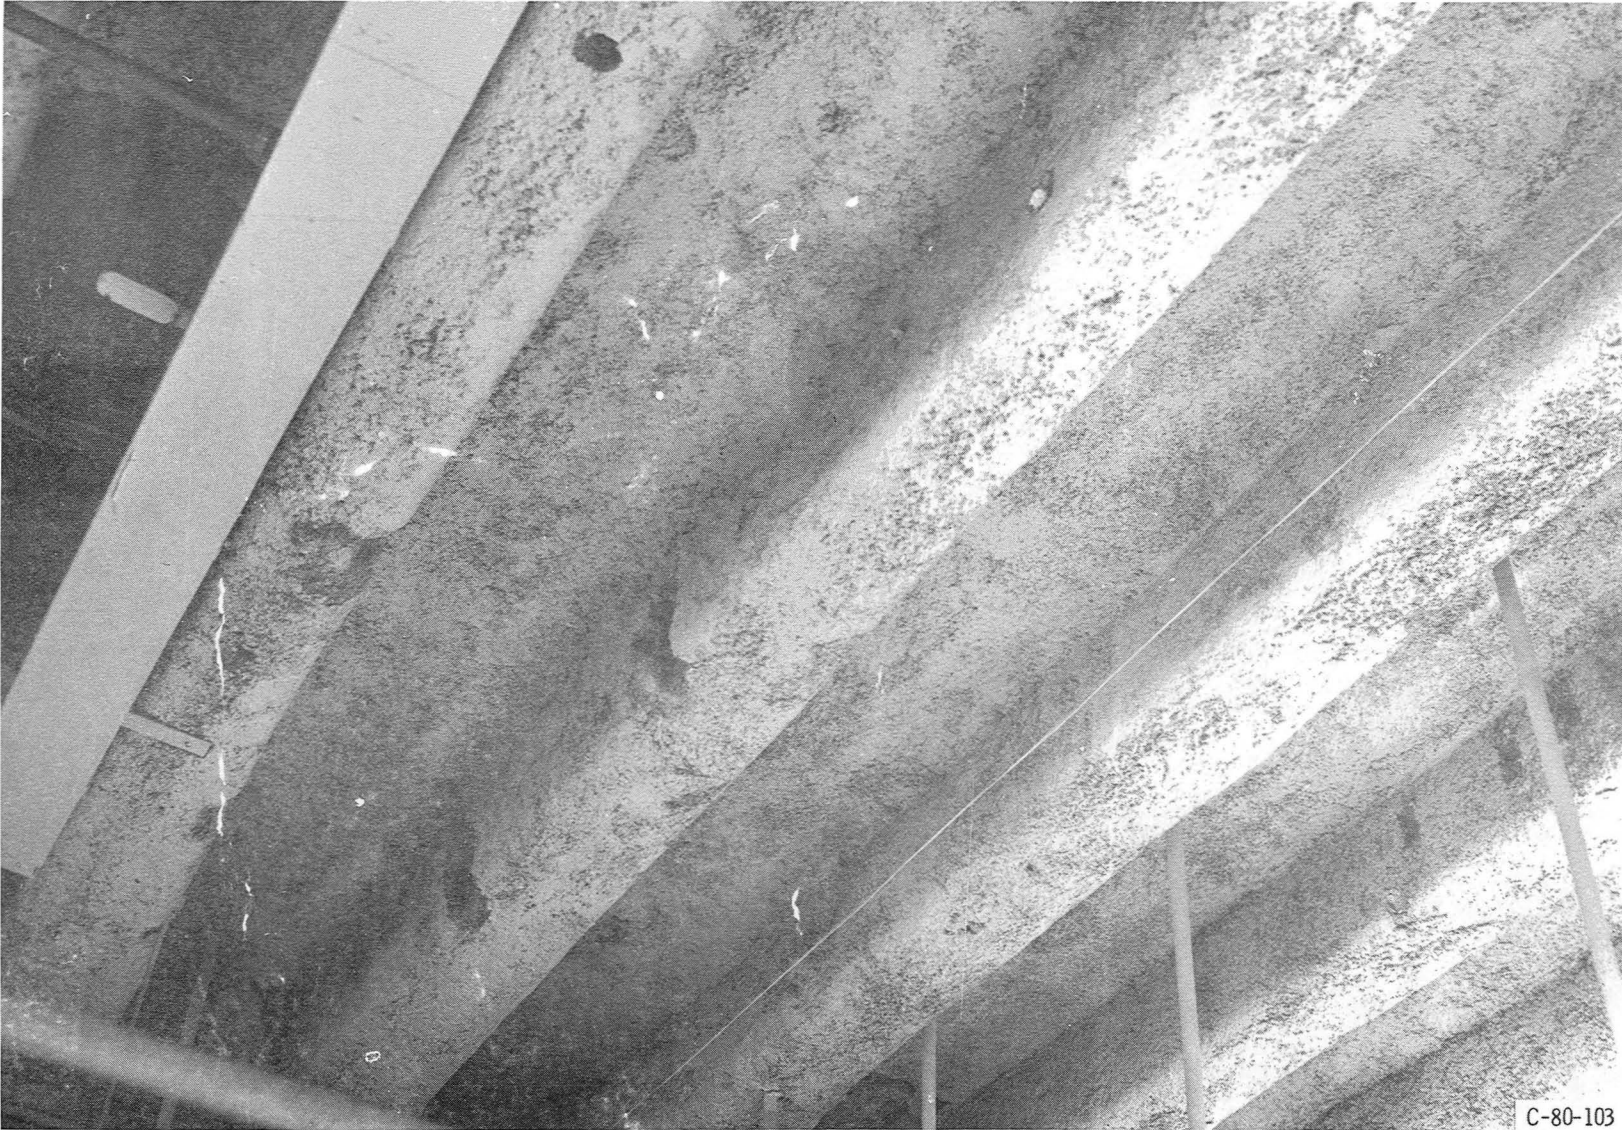
C-80-103

Figure 1. - Spray-applied ceiling insulation.

Fibrous insulation. - Figures 1 to 3 illustrate typical fibrous friable insulation materials which may contain asbestos fibers. The rough surfaces were painted years ago. Figure 2 shows the deterioration and damage of the material. Figure 3 illustrates a pipe covering with damaged and exposed surface. Where the friable insulation is located in view, the surface is normally tamped-finished. Untamped material is found in areas of limited access such as boiler rooms and basements.

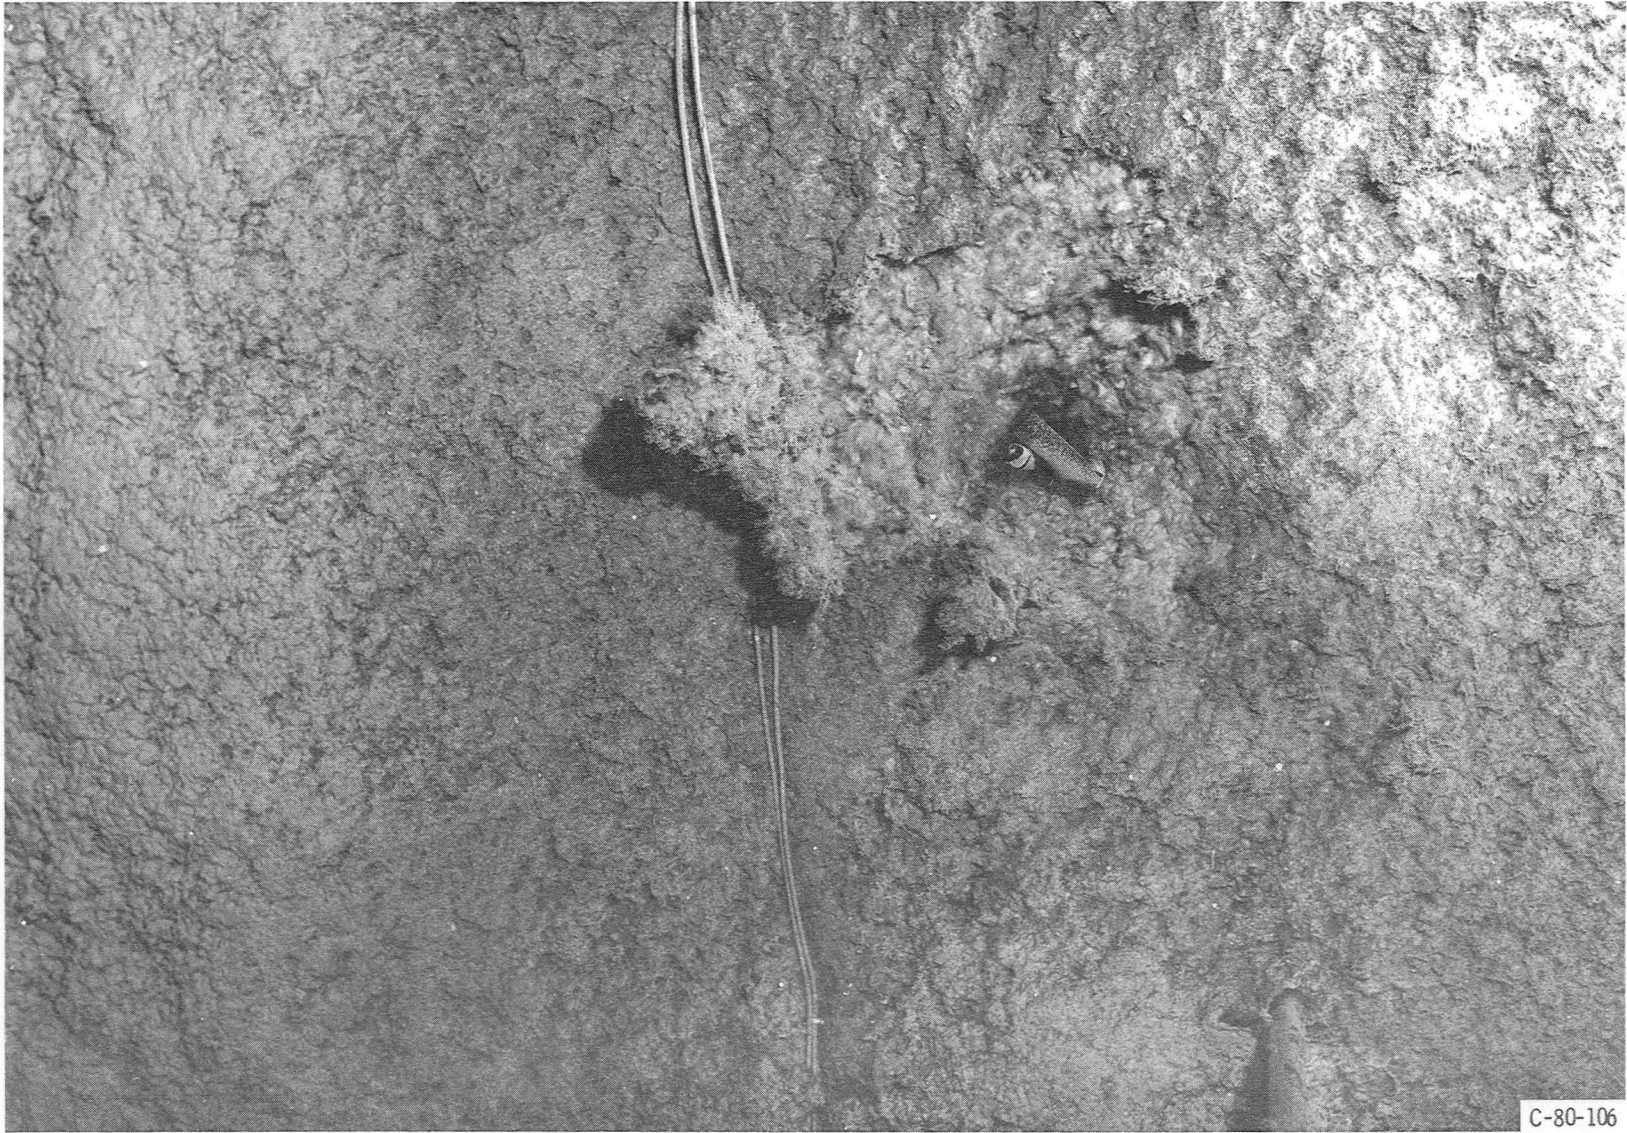
Figure 2. - Damaged ceiling insulation.
