NASA CR-159782
PWA-5526-31

THIN FILM TEMPERATURE SENSOR

United Technologies Corporation
Pratt & Whitney Aircraft
Commercial Products Division

NATIONAL AERONAUTICS AND SPACE ADMINISTRATION

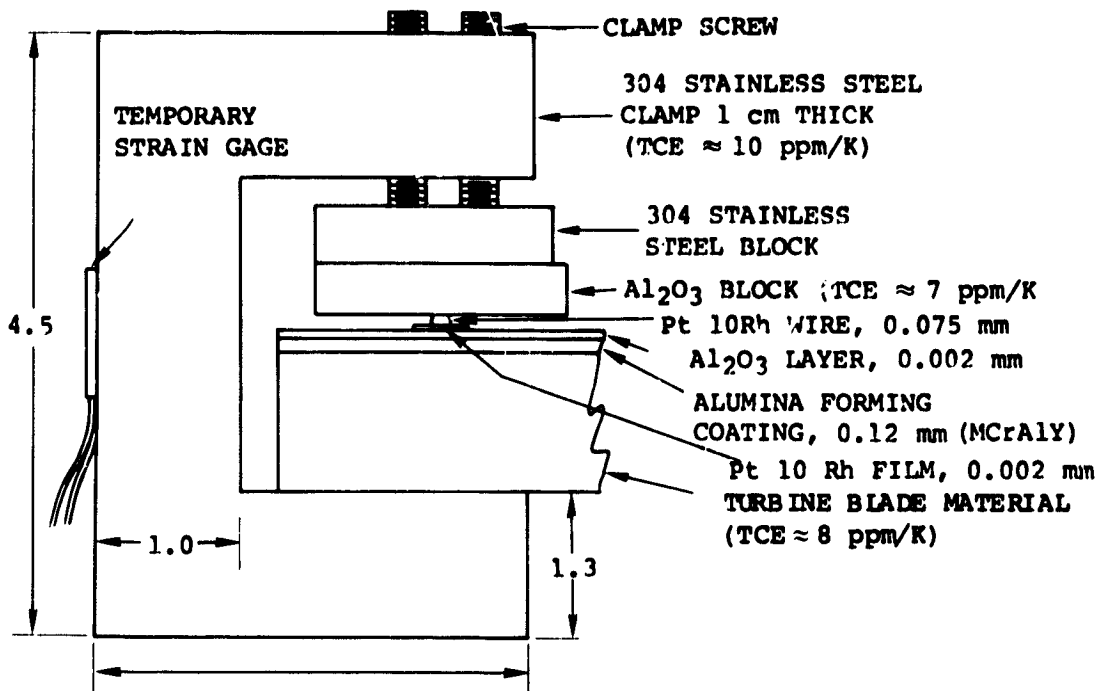
Figure 4 Diffusion Bonding Apparatus - All Dimensions are in centimeters (not to scale).

In Figure 4, the wire is clamped against the thin film with a force sufficient to result in about 50 percent deformation of the wire without fracture of the supporting insulating oxide. During application of the clamping force, the electrical resistance of the leadwire to ground (substrate) must be continuously monitored, using a low voltage ohmmeter. The clamping force must be reduced if a sudden decrease in electrical resistance is observed. It was found that if the leadwire resistance to ground decreases to a few ohms (indicating fracture of the insulating layer), the low resistance is permanent and cannot be repaired by further heat treatment up to 75 hours at 1300 K.

*TCE = TEMPERATURE COEFFICIENT OF EXPANSION

A clamp instrumented with a strain gage (Figure 4) was calibrated and used to determine a typical clamping force. The force measured for a typical bonding run was about 530 N (120 lbs) applied to two platinum-10 percent rhodium lead wires. The calculated stress in each 0.075 mm x 1 cm area was therefore about 350,000 kN/m², which is approximately the yield strength of annealed platinum-10 percent rhodium. No change in lead wire resistance to ground was noted at this clamping pressure. The resistance remained above 20 megohms (the limit of instrument).

To distribute the clamping force over several lead wires, a strip of stainless steel was placed under the clamp screws. A hard, dense smooth strip of Al₂O₃ was placed between the lead wires and the stainless steel strip to eliminate wire sticking and possible metallurgical reactions with the stainless steel.

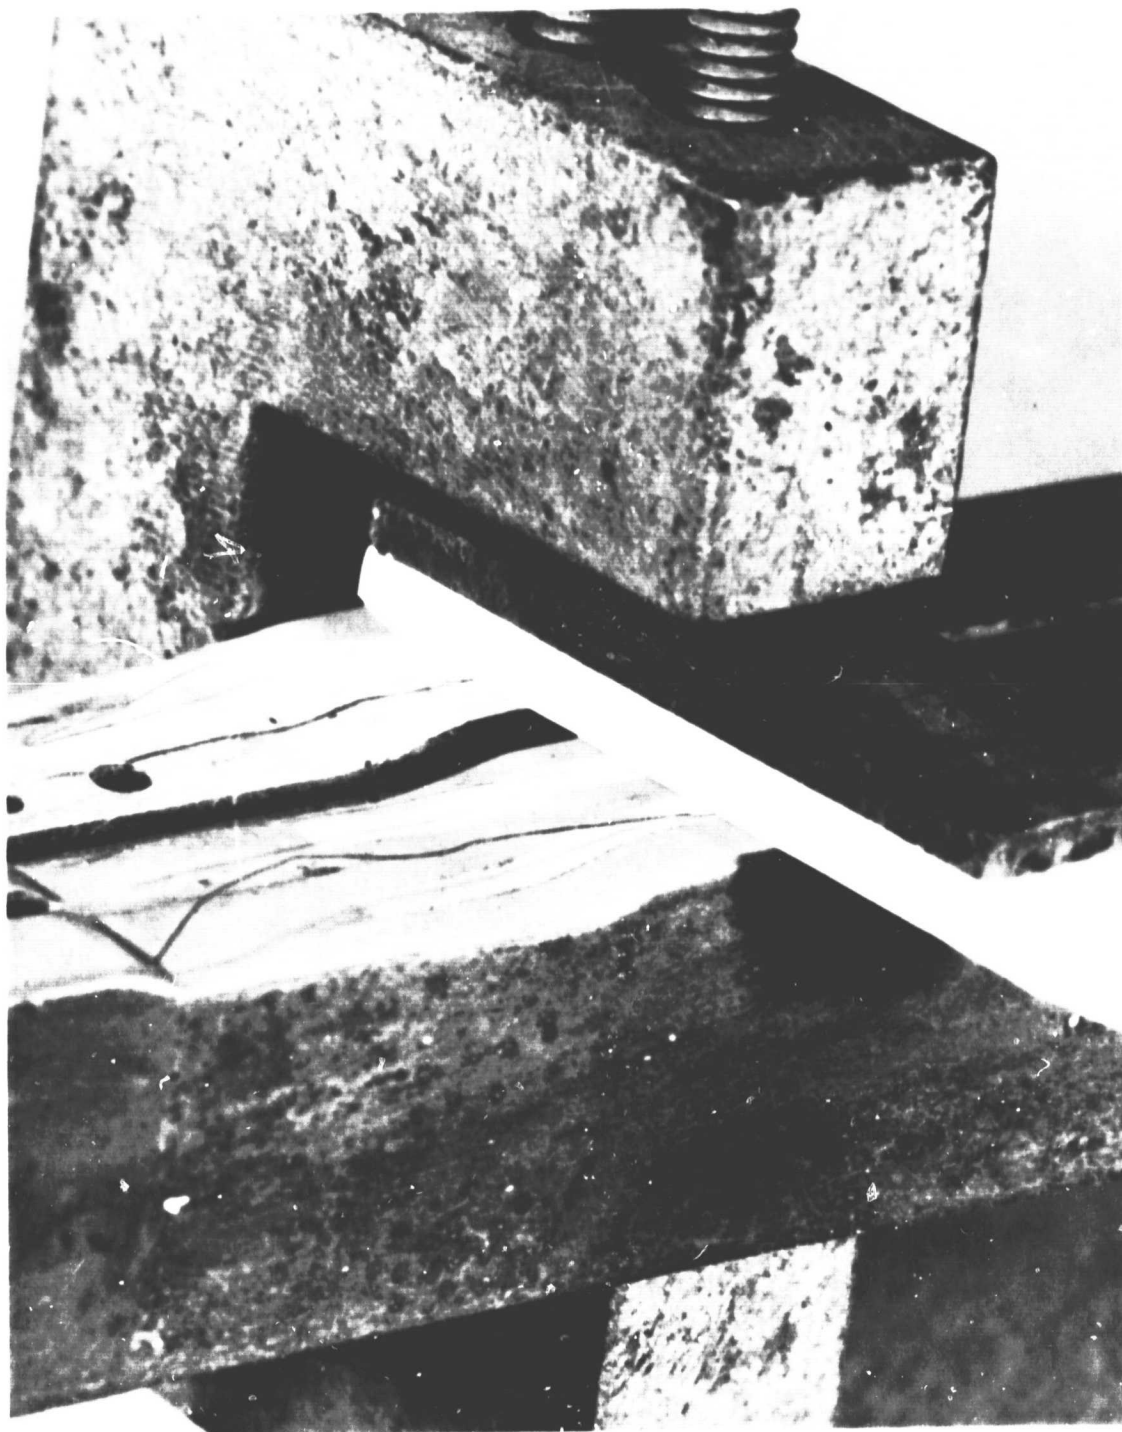
Figure 5 Lead Wires (0.075 mm diameter) - The lead wires are shown clamped to the thin films on the simulated blade in preparation for diffusion bonding.

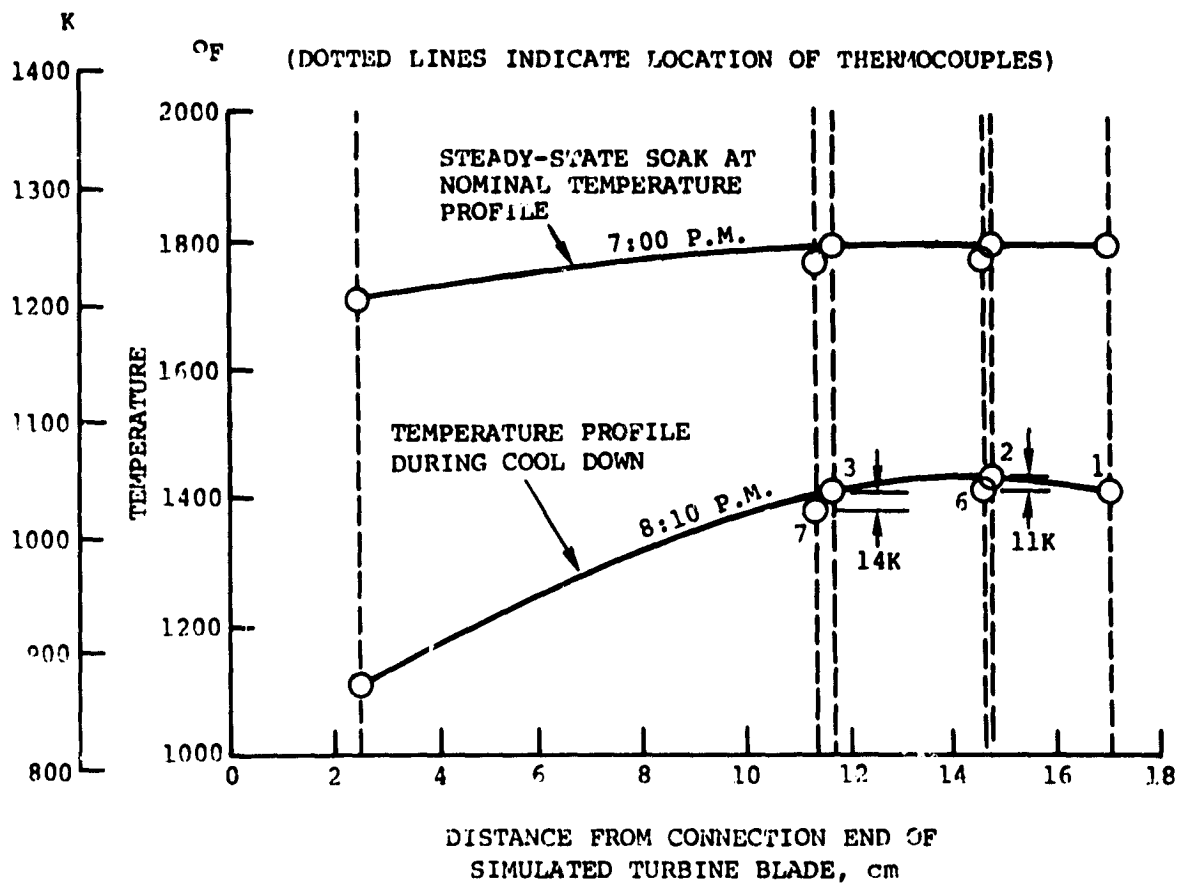
Figure 15 Indicated Temperature versus Distance from Lead Wire End of Simulated Turbine Blade at Two Different Times During Oven Test - Dotted lines indicate the location of thermocouples.

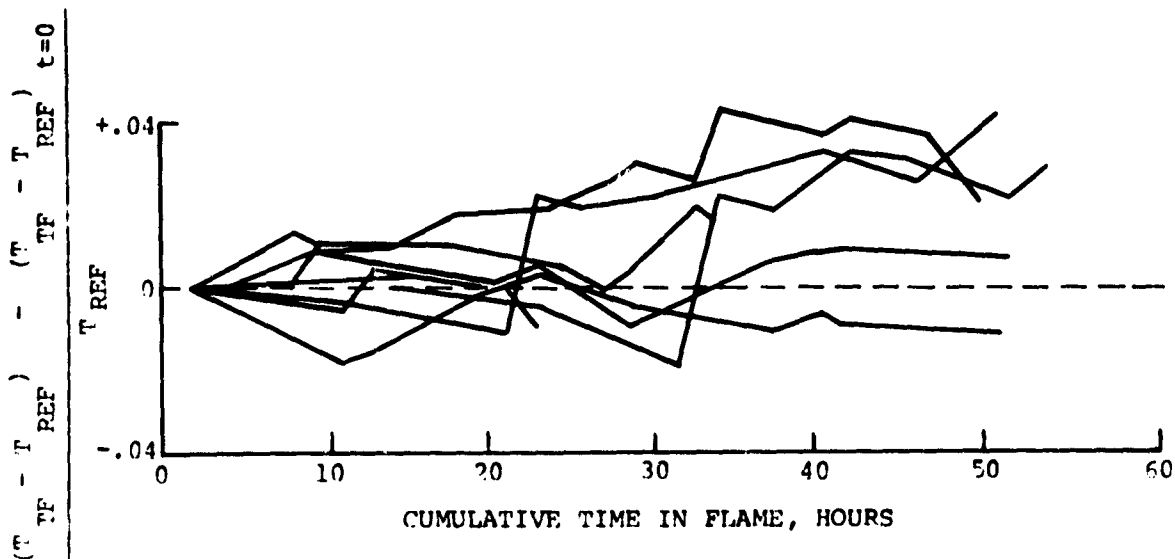
Figure 17 is a plot of the change in error, or drift, with time of the eight thin film thermocouples. The drift has been normalized to a value of zero at a starting time of near zero. The drift in indicated temperature is generally downward at a rate of less than 0.1 percent per hour. In only two cases did the cumulative drift exceed + 1 percent during the first ten hours. In no case did the cumulative drift exceed 2 percent during the first 20 hours or 4 percent during the first 50 hours.

Figure 17 Relative Drift in Calibration of Eight Thin Film Temperature Sensor Systems on Simulated Blades During 1250 K Exhaust Gas Flow Tests (T_{TF} is thin film thermocouple temperature and T_{REF} is the adjacent reference wire thermocouple temperature)
