NASA Technical Memorandum 78972

FRETTING WEAR OF IRON, NICKEL,
AND TITANIUM UNDER VARIED
ENVIRONMENTAL CONDITIONS

by Robert C. Bill
Propulsion Laboratory
AVRADCOM Research and Technology Laboratories
Lewis Research Center
Cleveland, Ohio

TECHNICAL PAPER to be presented at the
International Conference Wear of Materials
cosponsored by ASME, ASLE, ASM, ASTM -62, SAE, SME,
Amer. Chem. Soc., AIME, and APS
Dearborn, Michigan, April 16-18, 1979

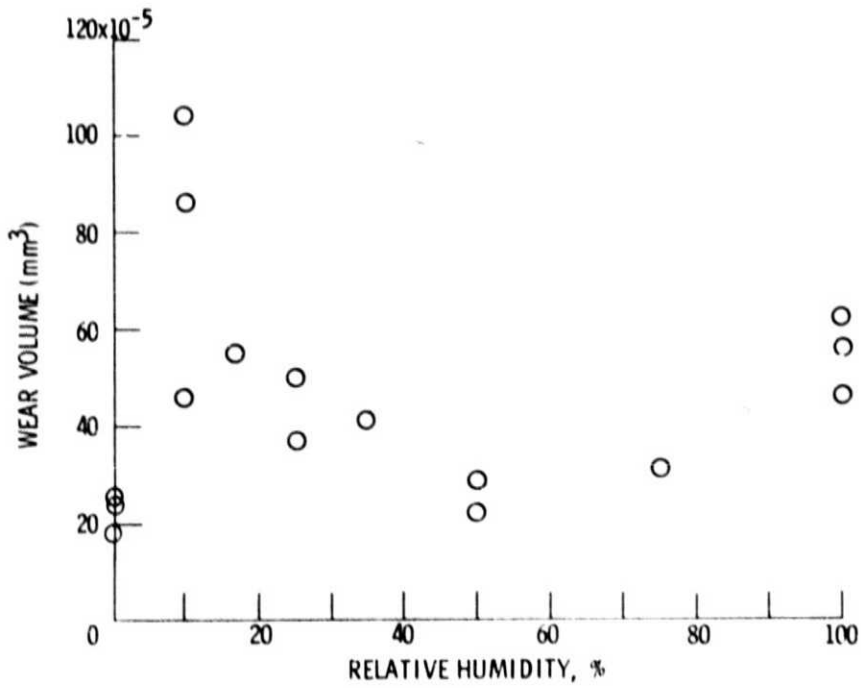
Figure 2. - Fretting wear volume as a function of relative humidity for 99.9% iron.

As may be seen in figure 2, the effect of relative humidity level on the fretting wear of high purity iron is a complex one. A sharp increase in wear occurs as the humidity is increased from dry air conditions to about 10 percent relative humidity. Further increases in humidity result in a gradual re-

duction in fretting wear, with a minimum somewhere between 50 and 70 percent relative humidity, and a slight increase in wear as saturated air conditions are approached. These results compare trend-wise with those of Feng and Uhlig on mild steel (9) over the intermediate humidity range. Feng and Uhlig did not conduct tests, other than those in dry air, at humidity levels lower than 20 percent relative humidity, because of rusting of the mild steel they did not conduct tests in saturated air.

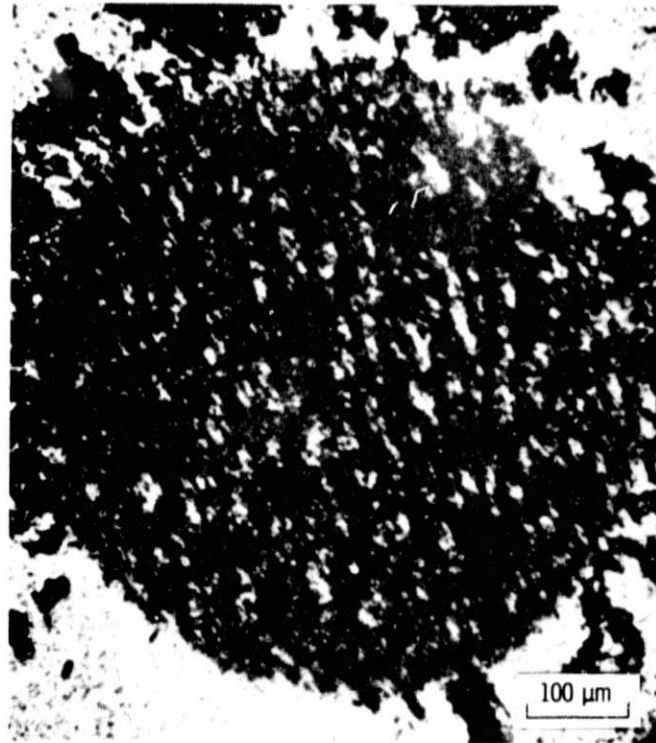
(a) DRY AIR.

(b) 10 PERCENT RELATIVE HUMIDITY.

Figure 3. - Fretting wear scars on high purity iron after 3×10^5 fretting cycles in air under indicated humidity conditions.

(c) 35 PERCENT RELATIVE HUMIDITY.

(d) SATURATED AIR.

Optical micrographs shown in figure 3 indicate a striking effect of relative humidity on the distribution of fretting wear debris and nature of the fretting contact. Under dry air condition virtually all of the debris was retained in the contact area in the form of dark, oxidized material, as may be seen in figure 3(a). Fretting under conditions of 10 percent relative humidity resulted in dispersal of fretting debris from the contact area (fig. 3(b)), with exposure of metallic contact regions; the debris was reddish brown in color. Further increases in relative humidity did not bring about changes in the distribution of wear debris and nature of the fretting contact, until saturated air conditions were approached. After fretting in saturated air, the wear scar was virtually free of oxidized debris, all of the debris having been extruded from the contact area. The material comprising the contact area had a smeared metallic appearance.

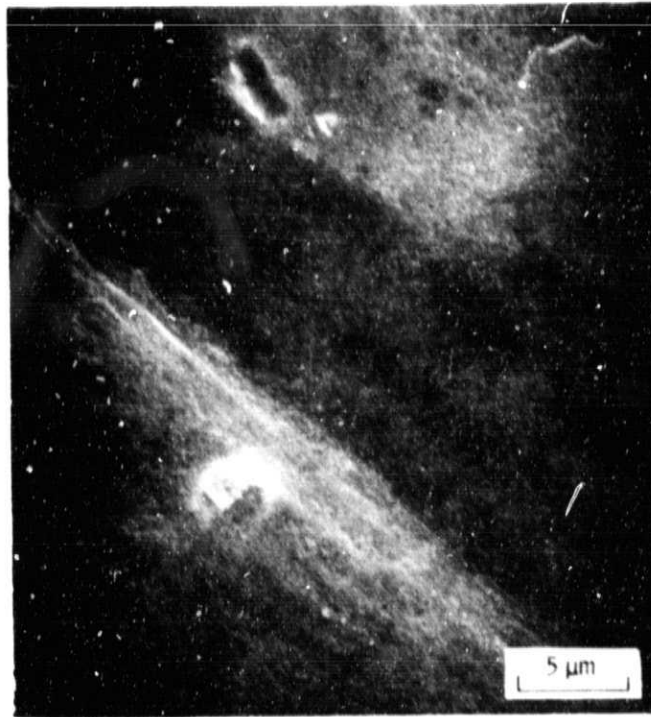
(a) OVERVIEW.

(b) CENTRAL REGION.

Figure 5. - Fretting wear scars on high purity iron after 3×10^5 cycles in saturated air.

dry air conditions leads to repeated working of particulates, promoting the very fine crystallite size observed. The long term presence of debris on the wear surface also affords some surface protection by inhibiting metal to metal contact. There is certainly no direct evidence that different oxides are formed under dry air and saturated air fretting conditions. Additional effects attributable to increased moisture content might include accelerated corrosive wear of the iron, and enhanced surface plasticity under wear conditions (13). The latter effect, known as the Rehbinder effect, is consistent with the fretted surface shown in figure 5.

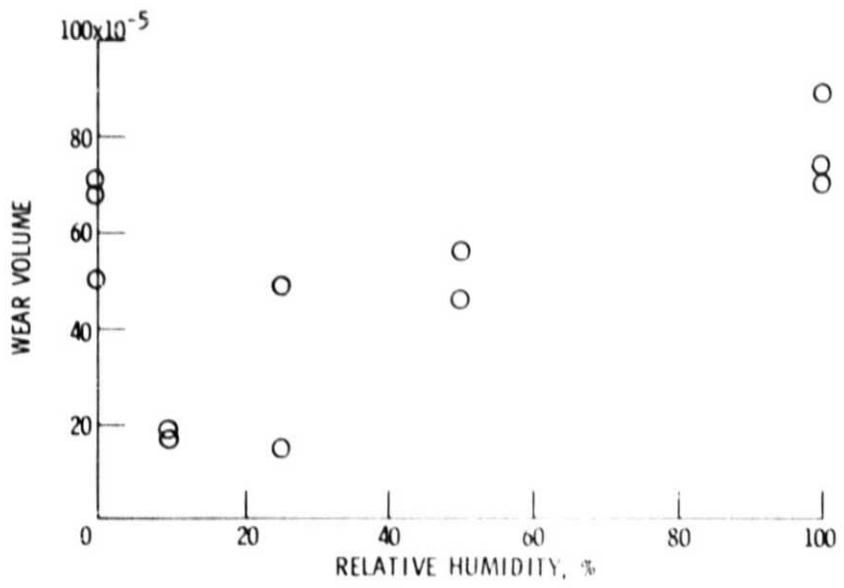
Figure 11. - Fretting wear volume as a function of relative humidity for high purity nickel.

A minimum is observed at about 10 percent relative humidity in the fretting wear volume versus humidity curve for nickel, shown in figure 11. Slightly more fretting wear was observed under saturated air conditions than under dry air conditions. The wear scar on nickel after fretting in dry air was covered with dark oxidized debris, with only occasional spots showing evidence of metal to metal contact (fig. 12(a)), the situation resembling that observed on iron after fretting in 10 percent relative humidity air. Increasing the humidity resulted in a highly metallic appearing contact area, with extensive plastic working in evidence (fig. 12(b)), as was the case for iron under high humidity conditions.

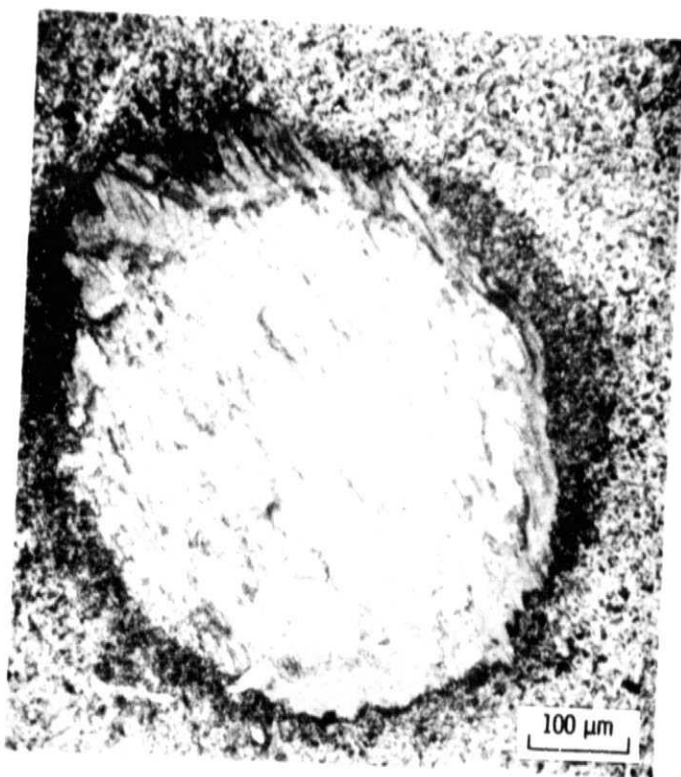
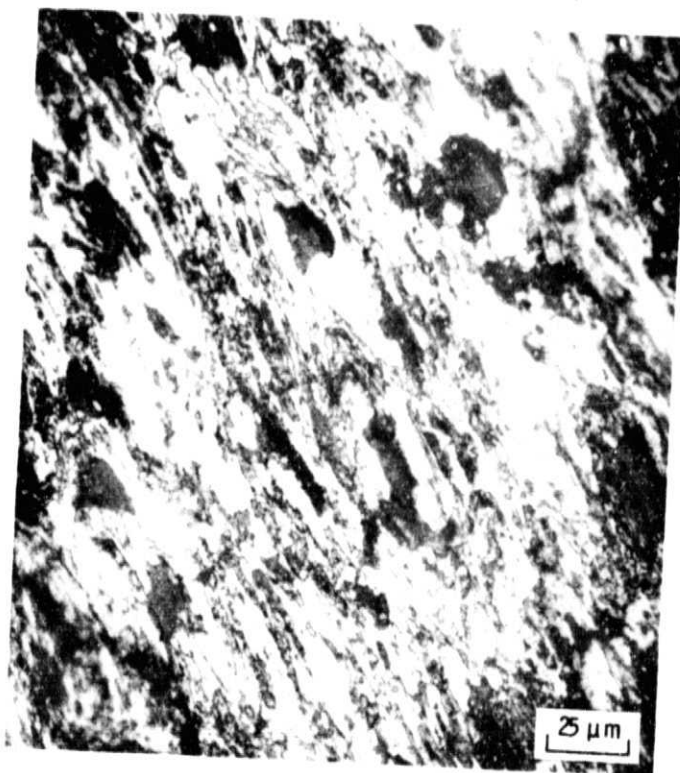
(a) DRY NITROGEN, OVERVIEW.

(b) UPPER LEFT QUADRANT OF (a).

Figure 15. - Fretting wear scars on high purity nickel after 3×10^5 fretting cycles in dry nitrogen and saturated nitrogen.

(c) SATURATED NITROGEN, OVERVIEW.

(d) CENTRAL REGION OF (c).

The micrographs of figures 15 and 16 show the fretted surfaces resulting from experiments in nitrogen for nickel and titanium respectively. Comparing the two figures it is interesting to note that no loose debris was observed after fretting nickel in either dry or saturated nitrogen, whereas prodigious amounts of black debris were seen for titanium in

both environments. Also, the extensively worked metallic appearance of the wear scar on nickel after fretting in saturated nitrogen (this type of wear scar was seen on iron as well) is very similar to that seen on iron and nickel after fretting in saturated air.

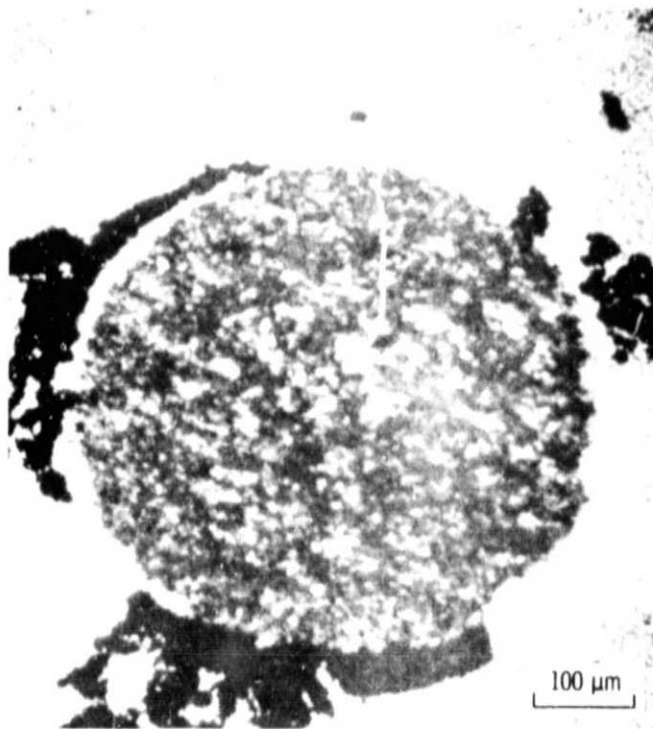
(a) DRY NITROGEN, OVERVIEW.

(b) CENTRAL REGION OF (a).

Figure 16. - Fretting wear scars on high purity titanium after 3×10^5 fretting cycles in dry nitrogen and saturated nitrogen.

(c) SATURATED NITROGEN, OVERVIEW.

(d) CENTRAL REGION OF (c).
