NASA TM-78876

THE ROLE OF THERMAL SHOCK IN CYCLIC OXIDATION

by Carl E. Lowell and Daniel L. Deadmore  
Lewis Research Center  
Cleveland, Ohio 44135

TECHNICAL PAPER to be presented at the  
One hundred fifty-third Meeting of the Electrochemical Society  
Seattle, Washington, May 21-26, 1978

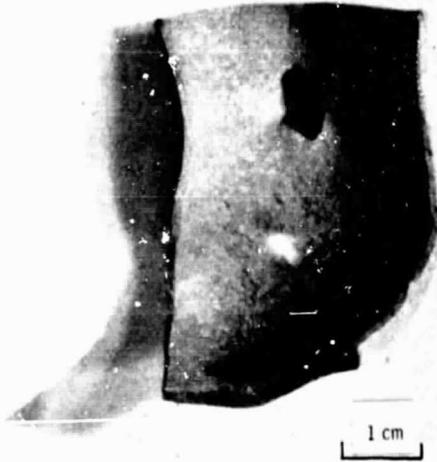
(b) DUCTILE ALLOY HOSKINS 875.

Figure 4. - Deformation modes of thermal shock after 80 one hour cycles.

One thing that was apparent in the fast cooling tests was that the alloy coupons became more and more distorted as the tests progressed. Examples of such distortion are shown in figure 4. The wrought alloys HOS-875, TD-Ni, IN-702, and IN-601, all plastically deformed extensively, while cast B-1900+Hf had considerably less, but measurable plastic deformation. These alloys all tended to elongate and assume a dogbone shape, although the HOS-875, the weakest alloy, also curled (fig. 4(b)). In contrast, the alloy with very limited ductility (TD-NiCrAl) had little plastic deformation, and cracked extensively (fig. 4(a)).

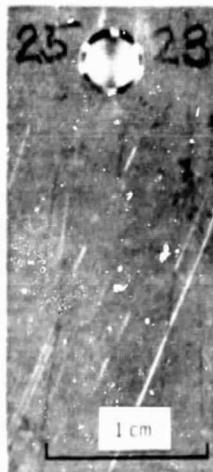
(a) AS MACHINED.

(b) 40 ONE MINUTE CYCLES  
WATER QUENCHED.

Figure 5. - Metal flow from thermal shock IN-601.

It was assumed that the cause of the deformation was the rapid cooling and not oxidation. To test this assumption, a coupon of IN-601 was put into a 1100<sup>o</sup> C furnace just long enough to reach temperature (~1 minute), removed, and plunged into water. After a few such thermal cycles, thermal growth was noted. By the end of 40 cycles, the change was quite obvious as can be seen in figure 5.

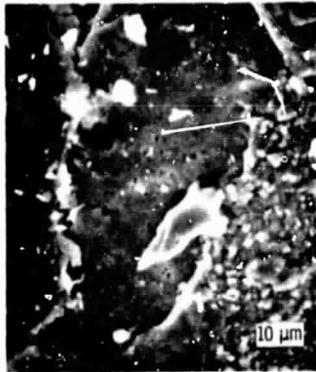
(a) IN-702 AIR COOLED.

Figure 6. - Effect of cooling rate on oxide surface structure of a ductile alloy.

A comparison of the slow cooled oxide surface morphologies with those of rapidly cooled oxides was made using scanning electron microscopy. Of particular interest were the surfaces on IN-702, IN-601, and B-1900+Hf. Figure 6 shows the comparison for IN-702. The oxide morphology of the air cooled sample is typical of the type of spalling which normally occurs on cooling. It results from CTE mismatch induced compressive stresses in the oxide exceeding the strength of the oxide. When this happens, large flakes of oxide part from the scale, often explosively. In the case of the rapidly cooled sample, the oxide appears to have failed by cracking, but there is no evidence of the loss of large oxide flakes of oxides. Furthermore, the crack pattern is nearly a regular array much as one might expect from a biaxial tensile failure.
