NASA TM -78826

**EVALUATION OF COMMERCIALY-AVAILABLE
SPACECRAFT-TYPE HEAT PIPES**

by W. B. Kaufman and L. K. Tower
Lewis Research Center
Cleveland, Ohio 44135

TECHNICAL PAPER to be presented at the
Third International Heat Pipes Conference
sponsored by the American Institute of
Aeronautics and Astronautics
Palo Alto, California, May 22-24, 1978

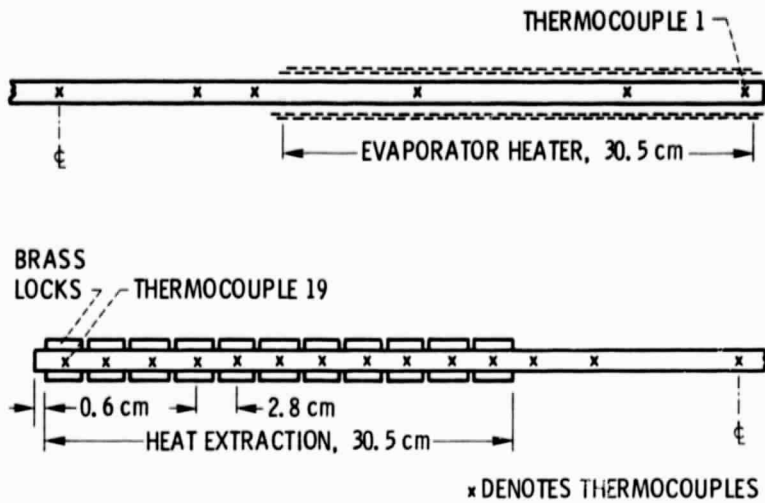
Figure 4. - Thermocouple locations:

Temperatures are measured by 19 iron, constantan thermocouples, three in the evaporator, five in the adiabatic section, and on top between each condenser block pair. Couples in the condenser and adiabatic sections are spotwelded on stainless pipes, and are glued down on aluminum pipes by thermally conducting epoxy cement. The thermocouple installation on the evaporator is described elsewhere.⁵ Figure 4 shows the locations of the thermocouples on the pipes. An additional thermocouple in the evaporator is connected to an overtemperature sensor, set to shut the heater off at about 75° C.

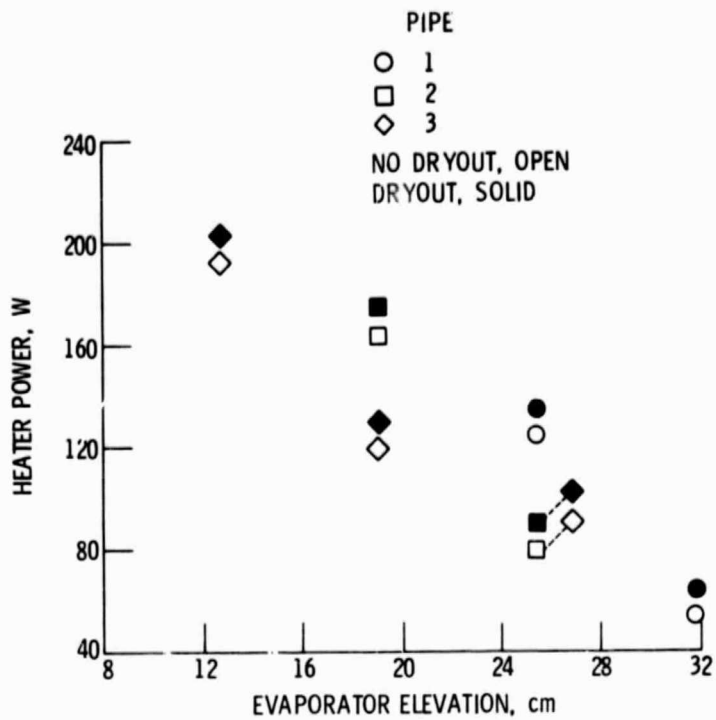
Figure 6. - Maximum heater power without dryout for methanol pipes of group A. Adiabatic temperature above 50° C.

Methanol pipes. Figure 6 shows the maximum heater power before dryout against evaporator elevation for the methanol pipes of group A. Below an evaporator elevation of 1.27 cm a sufficiently low coolant temperature could not be obtained to hold the adiabatic temperature near 50° C because of the high power being transported. The heat capacity of this group of pipes at no evaporator elevation can be projected linearly to be about 290 watts. A variable conductance pipe of similar internal design but twice the length, tested in a similar

facility, gave results that extrapolate to about 230 watts.

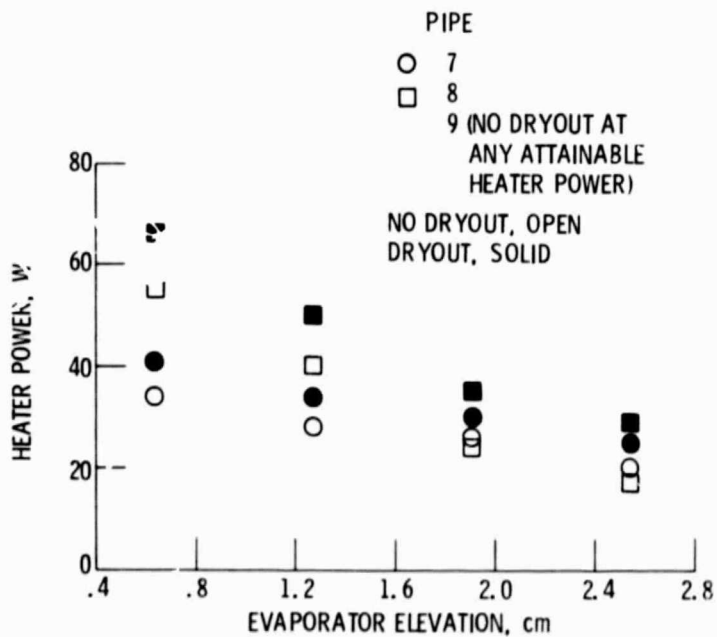
Figure 7. - Maximum heater power without dryout for methanol pipes of group C. Adiabatic temperature above 50° C.

Figure 7 shows maximum heater powers for dryout against evaporator elevation for pipes of group C. Two pipes, 7 and 8, performed at a very low level which was substantiated by repetition on other occasions. Pipe 9, on the other hand, could not be dried out with 300 watts at 2.5 cm or with 279 watts at 3.8 cm. After the latter determination, pipe 9 was left unattended with 95 watts at 0.63 cm over a lunch period and was found subsequently in the process of drying out. Possibly gas inducted into the arteries of group C caused the low or erratic performance observed. The behavior of pipe 9 suggests that pipes of group C design may offer very high performance if problems due to the presence or generation of gas can be ameliorated.

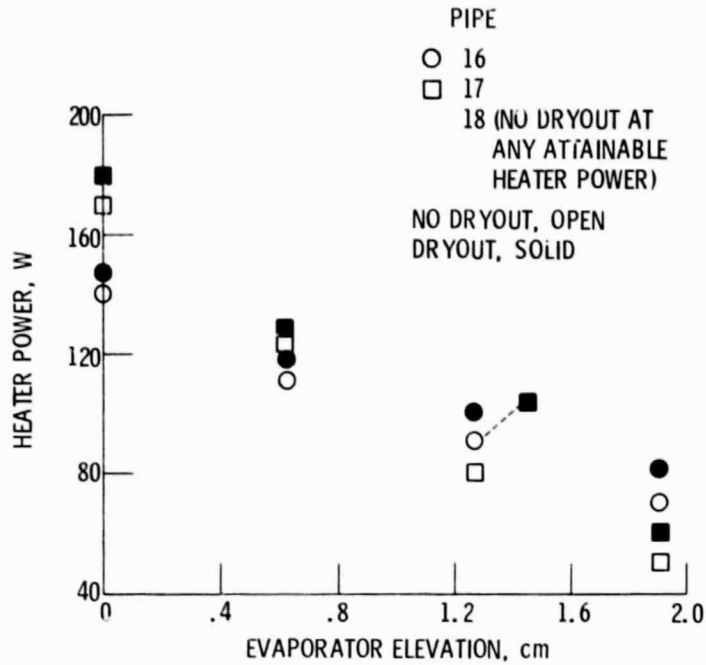
Figure 10. - Maximum heater power without dryout for ammonia pipes of group F. Adiabatic temperature, 50° C.

Ammonia pipes. Figures 8, 9, 10, and 11 show maximum heater power before dryout against evaporator elevation for the ammonia heat pipes of groups D, E, F, and G, respectively. Most of the performance data for ammonia were obtained between about 12 000 and 15 500 hours. Except as noted the data were again taken at nominal adiabatic section temperatures of about 50° C.

Two of the pipes of group F exhibited very similar heat transport capacities over the range of elevations. Pipe 18, however, could not be dried out at any power attainable with the heater. Heat transport capacity otherwise resembled that of group E.

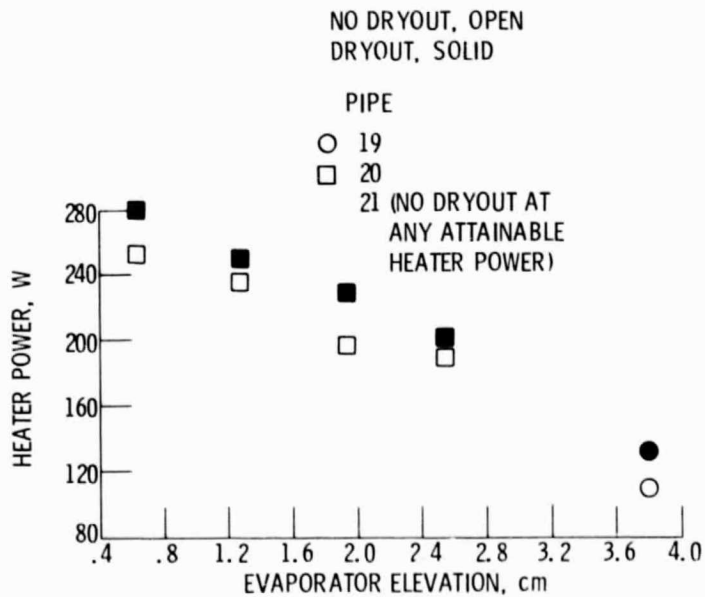
Figure 11. - Maximum heater power without dryout for ammonia pipes of group G. Adiabatic temperature above 50° C.

Most heat transport data for the pipes of group G could not be taken at the desired adiabatic section temperature of 50° C used for the other pipes. The temperature of the controlled bath could not be lowered sufficiently to maintain 50° C at the dryout power. This may have been due to increased thermal resistance between the heat pipe vapor and the coolant passages in the heat extractor. However, group G exhibited higher transport capacity than any other group of ammonia pipes.

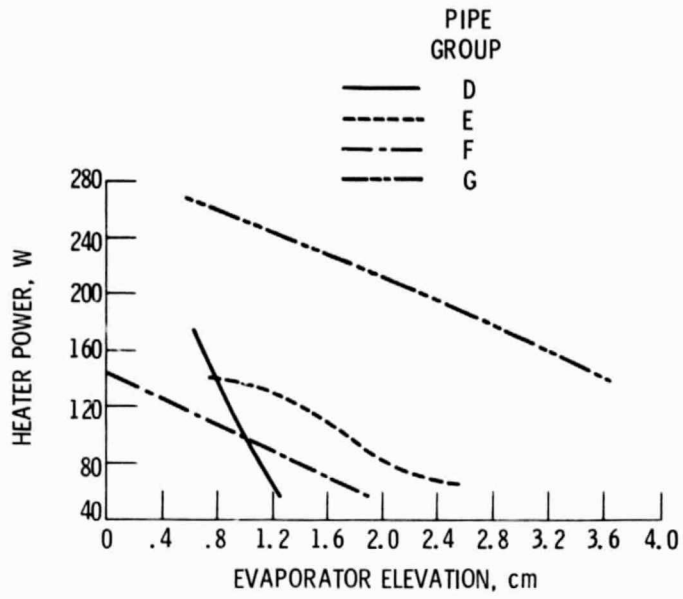
Figure 12. - Envelopes of maximum heater power without dryout for ammonia pipes of groups D, E, F, and G.

Group D promises performance similar to group G at low elevation and therefore at zero "g". This can be seen on figure 12 where the envelopes of no dryout for the ammonia pipes, from figures 8,

9, 10, and 11 are shown. An interesting feature is that all the aluminum-walled pipes, groups D, E, and F, are clustered together, with the stainless pipes of group G by themselves. However, the pipes of group E and the pipes of group G have the same internal configuration (fig. 1).
