Development of a Self Contained Heat Rejection Module

Phase II and III Final Report

REPORT NO. T211-RP-032

17 August 1976

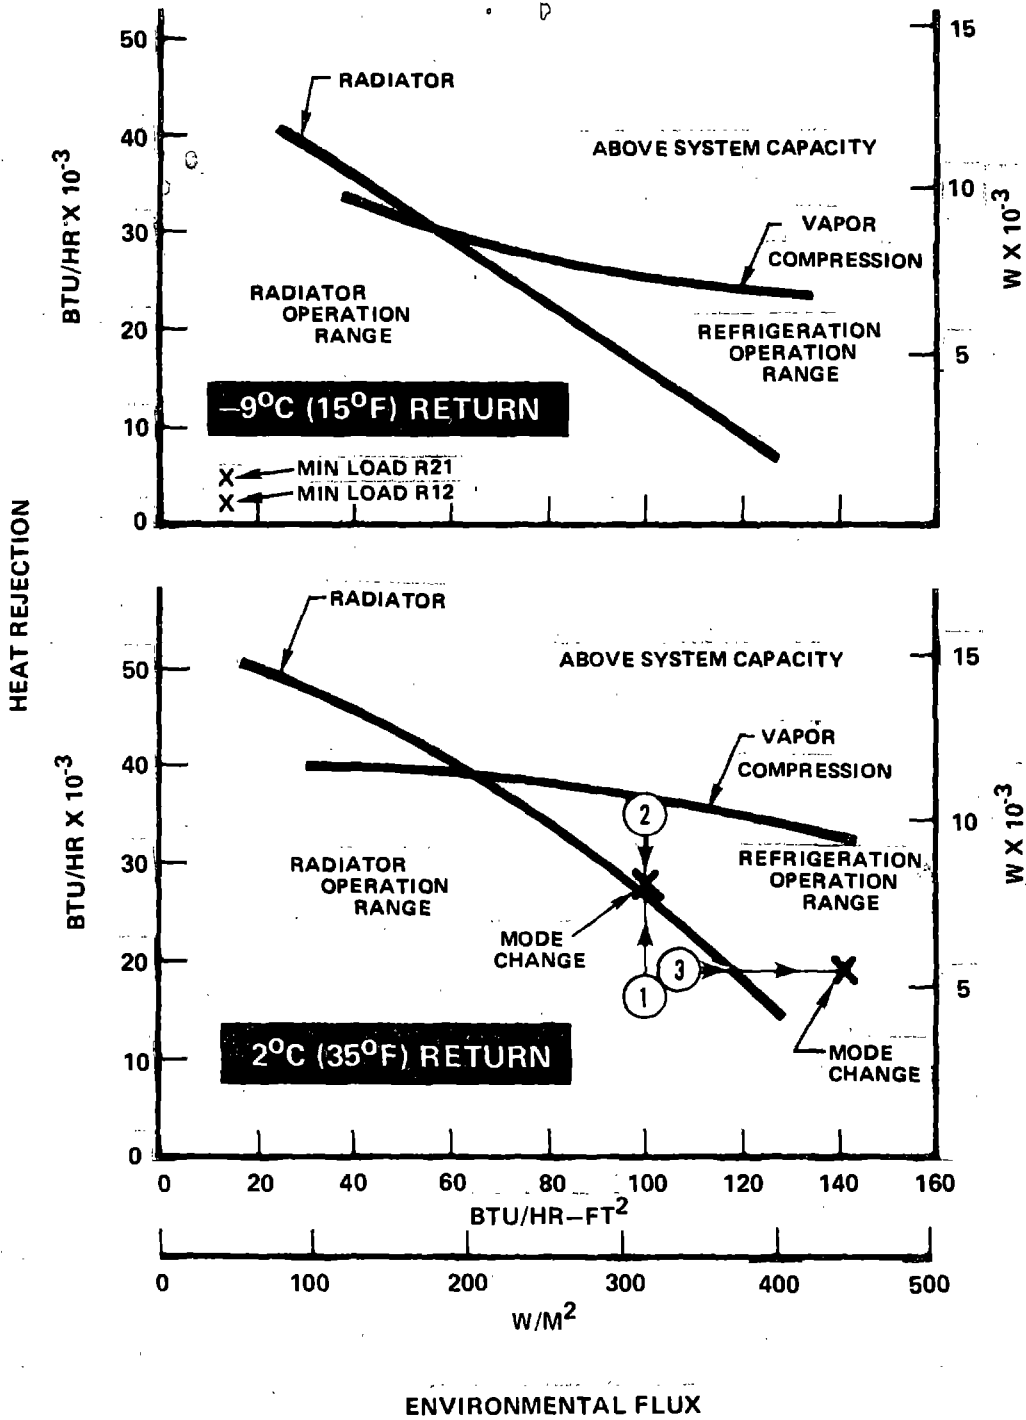
FIGURE 13 MAXIMUM SYSTEM HEAT REJECTION MAPS

The maximum system heat rejection at R-12 return temperatures of approximately 35° and 15°F is shown in Figure 13 as a function of environmental flux. The radiator operation line defines the maximum heat rejection which can be achieved over the environment range by the system operating in the radiator mode and continuously returning 35°F R-12 to the contact heat exchanger. At a given point on the line, should the heat load (R-12 delivery temperature) or the environmental flux be increased this would cause the R-12 return temperature to exceed the desired 35°F return. Obviously, should a higher return temperature be allowed, higher heat rejections could be obtained. Thus, the system capacity described in this Figure represents the maximum heat rejection only for the given return temperature (35°F). The refrigeration operational line of similar nature is also shown in Figure 13. As can be seen in the figure the refrigeration heat rejection changes less with increases in heat flux than does the radiator. This is due to the characteristics of the closed cycle vapor compression system. As the environmental flux increases there is a subsequent increase in the condensing temperature in the radiator panels. The higher radiator panel temperature results in higher emissive power (σT^4) which offsets, in part, the increase in absorbed heat flux as environmental flux is increased. The constant return temperature is achieved by evaporating the liquid at a 35°F saturation pressure for R-12 by means of the constant pressure expansion valve. The increase in panel temperature with environmental flux does not occur in radiator operation and heat rejection falls off more rapidly. The intersection of the two operation lines form ranges of operation for the system. Below and to the left of the radiator operation line radiator operation can meet the heat rejection

and return temperature requirements. Although the refrigeration system could be used in this range for heat loads below the refrigeration operation line it would logically not be used because of the much higher power consumption. The region on the plot above and to the right of the radiator operation line but below the refrigeration line defines the region of operation in which the refrigeration system would logically be used. In this region the desired return temperature of 35°F can only be achieved by use of vapor compression. Heat rejections above both of the lines cannot be achieved with this system size and a 35°F return. The 15°F return temperature was evaluated during the second week. The results of this testing are also shown in Figure 13. Ranges of operation in both modes were well defined and the system operated satisfactorily in both modes. Also shown in Figure 13 is the low load data taken in the fully deployed position. It should be noted that these points are based on the first three panels only since the flow stopped in panel 4 at the outset of the low load test points. These were the only two low load points taken due to the ruptured flex hose terminating the test. The R-21 simulation test was based on no temperature falling below -210°F, the freezing point of R-21. The R-12 test was based on -252°F, the freezing point of R-12. As can be seen there is considerable heat load range even with the panels deployed. More heat load range could be obtained by retracting the panels until only one surface of panel 4 is exposed.

Figure 14 shows data from -10°F R-12 return temperature tests of the first week similar to that given in Figure 13 for 35° and 15°F. While the radiator operation curve was defined sufficiently, only one point on the refrigeration curve was obtained. At environments above 80 BTU/hr-ft² the compressor discharge overheated (> 300°F) and testing at these conditions was terminated. Since refrigeration system operation in the radiator operation range is not logical, no further refrigeration testing was conducted at the -5°F return temperature. With this system and compressor there is no refrigeration operation range for the -10°F return temperature. As a result of these tests the 15°F return was selected for evaluating in the second week.
