NASA CR-2711

CARBIDE COATED FIBERS IN GRAPHITE-ALUMINUM COMPOSITES

Progress Report No. 4: January 1 - June 30, 1975

Prepared by
LOS ALAMOS SCIENTIFIC LABORATORY
Los Alamos, N.M. 87544
for Langley Research Center

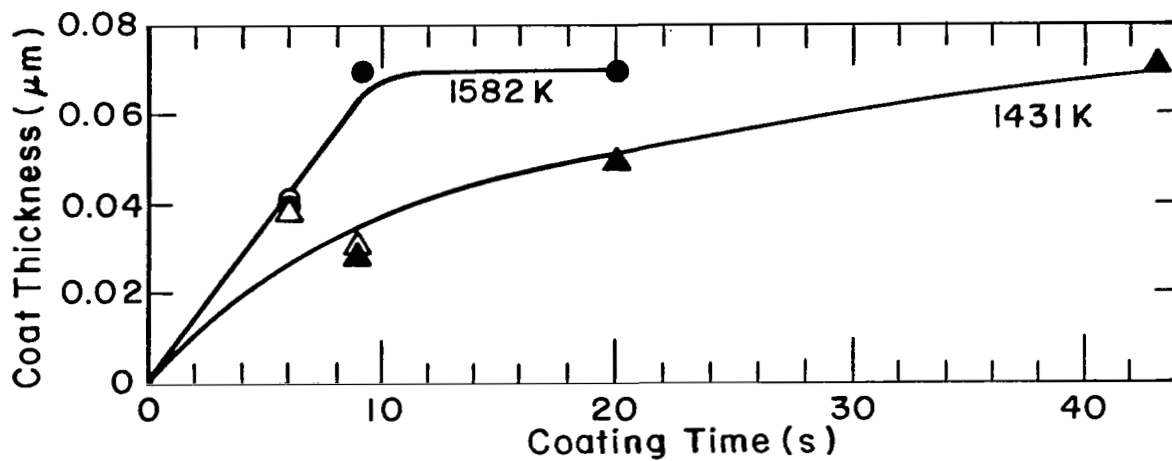
Fig. 3. TiC coat thickness vs coating time. TiCl_4 flow rate = 0.02 l(STP)/min (Series No. 8).

To examine the effect of deposition time on coat characteristics, coating series No. 8 (runs 8AA-8TT) and No. 9 (runs 9A-9L) were made at TiCl_4 flow rates of 0.02 ℓ (STP)/min and 0.20 ℓ (STP)/min, respectively, and deposition time was varied from 6 to 43 sec. In general, the TiC coats produced were thin and smooth with few nodular growths. Very little spallation and cracking occurred, indicating that adherence was also good. For Series No. 8, which was produced using 0.02 ℓ (STP)/min TiCl_4 , welding together of fibers was common, and the coat thickness uniformity for most samples was poor. Not only was the coat thickness non-uniform on individual fibers, but it varied from the outer to the inner fibers of the yarn. On the other hand, Series No. 9, which was produced with 0.20 ℓ (STP)/min TiCl_4 , had few welds between fibers and significantly better coat thickness uniformity. The data from Table I are graphically shown in Figs. 3 and 4. The coat thickness behavior for both series is similar. Initially, thickness increases rapidly with coating time, then tends to level off at a constant value. For the samples coated at 1582 K, with a TiCl_4 flow rate of 0.02 ℓ (STP)/min (Fig. 3), the leveling off occurred at a coating time of about 9 sec and a coat thickness of 0.07 μm . The curve for the samples coated with the higher TiCl_4 flow rate (0.20 ℓ /min) and at a similar temperature (1573 K) appears not to have reached the leveling-off point at this coating time (Fig. 4). Neither of the curves for the samples coated at the lower temperature, for Series No. 8 or No. 9, has reached a constant thickness value at the coating times given here. In general, those samples coated at a TiCl_4 flow rate of 0.20 ℓ (STP)/min (Fig. 4) have greater TiC coat thicknesses, for equivalent coating times and temperatures, than do those coated at 0.02 ℓ (STP)/min (Fig. 3). Again, the few data points from Series No. 4 and No. 5 that could be plotted in Figs. 3 and 4 do not agree at all with the curves plotted there. Instead they fall at thickness values significantly higher, for the equivalent coating time (6 sec).

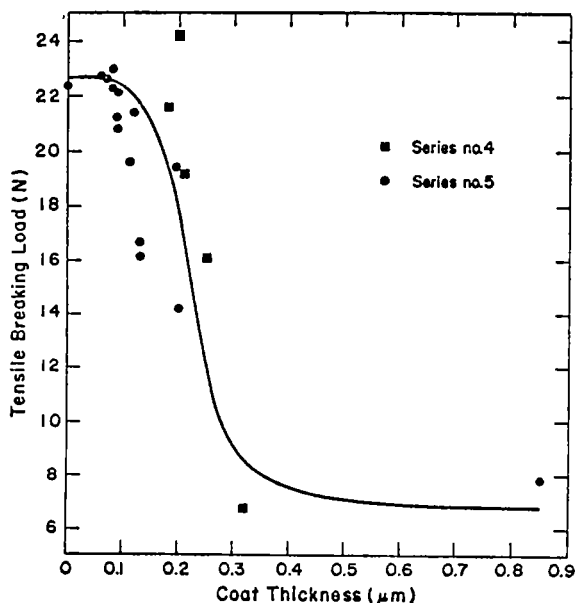
Fig. 5. Tensile breaking load vs coat thickness for TiC-coated Thornel 50 graphite fiber yarns (Series No. 4 and No. 5).

In Figs. 5 and 6, the effect of TiC coat thickness on the strength of the fibers is shown. The values given are the tensile breaking loads for single plies of the two-ply yarns. For Series No. 4, 5 and 9 the strength remained fairly constant, relative to the control (zero-thickness) strength, up to thicknesses of about 0.08 μm . For greater thicknesses, strength dropped rapidly for all three series. Series No. 8, however, differed from the others in that strength decreased significantly with even the thinnest coats and dropped to almost insignificant values at a coat thickness of 0.07 μm .

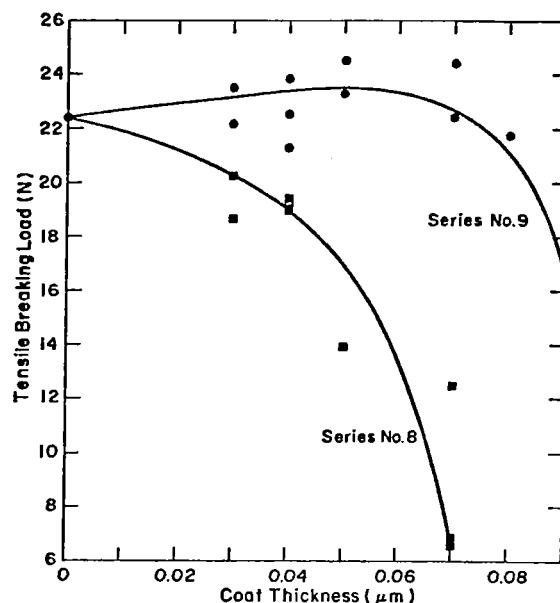
Fig. 6. Tensile breaking load vs coat thickness for TiC-coated Thornel 50 graphite fiber yarns (Series No. 8 and No. 9).

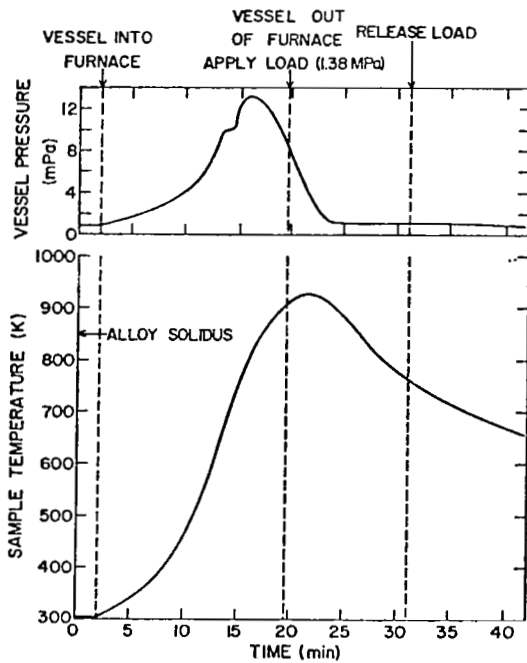
Fig. 12. Typical hot-pressing cycle.

A schematic of the hot pressing assembly and a typical hot pressing cycle are shown in Figs. 11 and 12, respectively. The graphite compacting mold containing the infiltrated fibers is placed within the vacuum vessel and evacuated to a pressure of about 0.1 mPa ($\sim 10^{-5}$ mm Hg). No heat or external load is applied at this point. The furnace for heating the hot pressing assembly is located directly below the vessel on the hydraulic lift. The general arrangement of this system is shown in Fig. 13. When the furnace temperature reaches 1223 K the furnace is raised to a position surrounding the vacuum vessel, and the graphite mold containing the infiltrated fiber samples then rapidly heats up (Fig. 12). At a sample temperature of 903 K, which is ~ 50 K above the alloy solidus, the furnace is lowered away from the vessel and a dead-weight load, corresponding to 1.38 MPa, is applied to the compacting mold. The sample continues to heat up to about 930 K before cooling begins. When it finally cools to about 770 K the load is removed. Typically, the sample remains at temperatures above the solidus for approximately nine minutes. Throughout the compaction experiment, the vacuum in the vessel will vary with temperature (due to outgassing), as shown in Fig. 12. The final size of the flexure bars was approximately 38 mm long, 6.4 mm wide and varied in thickness from about 0.6 mm to 1.2 mm (Table III).

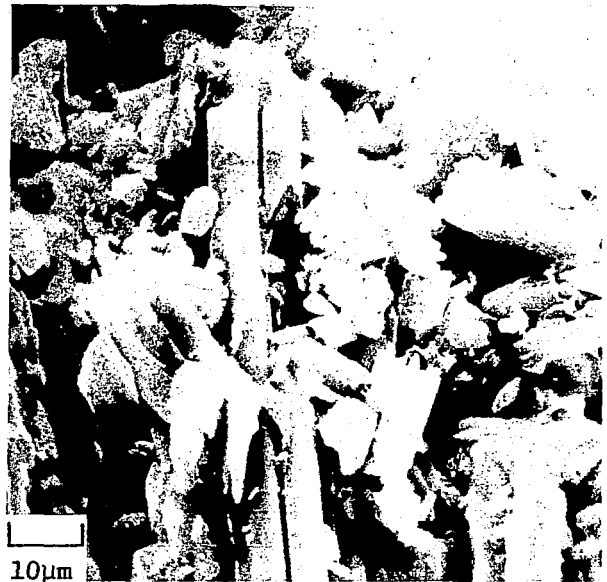
Fig. 16. SEM photomicrograph illustrating fragmentation during flexure testing (Sample C-8).

In all of the samples there was some fragmentation of both fibers and matrix material at the fracture surface. This was most pronounced in the commercially-infiltrated material (C-8). An example of fragmentation is shown in Fig. 16.
