1. Report No. NASA TN D-8206		2. Government Accession No.		3. Recipient's Catalog No.	
4. Title and Subtitle REVIEW OF DRAG CLEANUP TESTS IN LANGLEY FULL-SCALE TUNNEL (FROM 1935 TO 1945) APPLICABLE TO CURRENT GENERAL AVIATION AIRPLANES				5. Report Date June 1976

REVIEW OF DRAG CLEANUP TESTS IN LANGLEY FULL-SCALE TUNNEL
(FROM 1935 TO 1945) APPLICABLE TO CURRENT
GENERAL AVIATION AIRPLANES

Paul L. Coe, Jr.
Langley Research Center

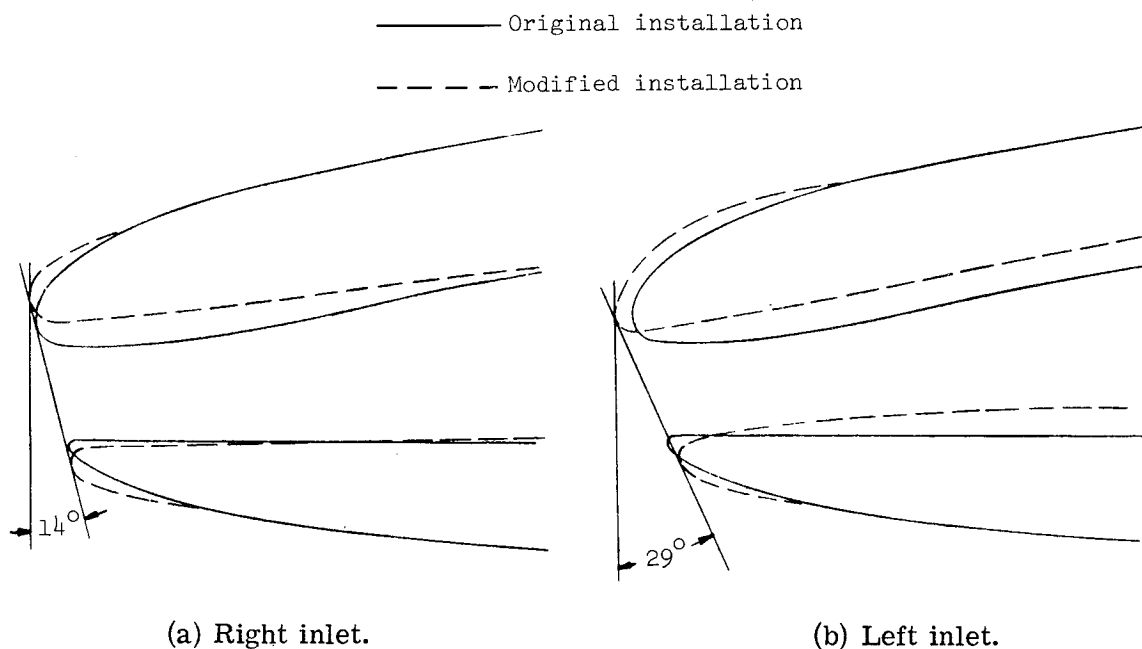
Figure A3.- Wing duct inlets on airplane 22 (Bell P-63).

Propeller operating tests conducted with airplane 22 showed that the slipstream rotation caused a misalignment of the wing duct inlet and the airstream. This resulted in serious losses in total-pressure recovery. To remedy this condition, modified inlets were installed with the plane of the inlet on the side of the upgoing propeller blade tilted 15° farther downward than the plane of the inlet on the side of the downgoing propeller blade. A further modification, which consisted of increasing the inlet area by about 33 percent, was made to lower the ratio of inlet velocity to free-stream velocity. For the high-speed condition the modified inlets decreased the drag coefficient by 0.0005 and increased the total pressure at the faces of the radiators by 15 percent. Cooling was improved for both the high-speed and the climb conditions with the modified inlets.

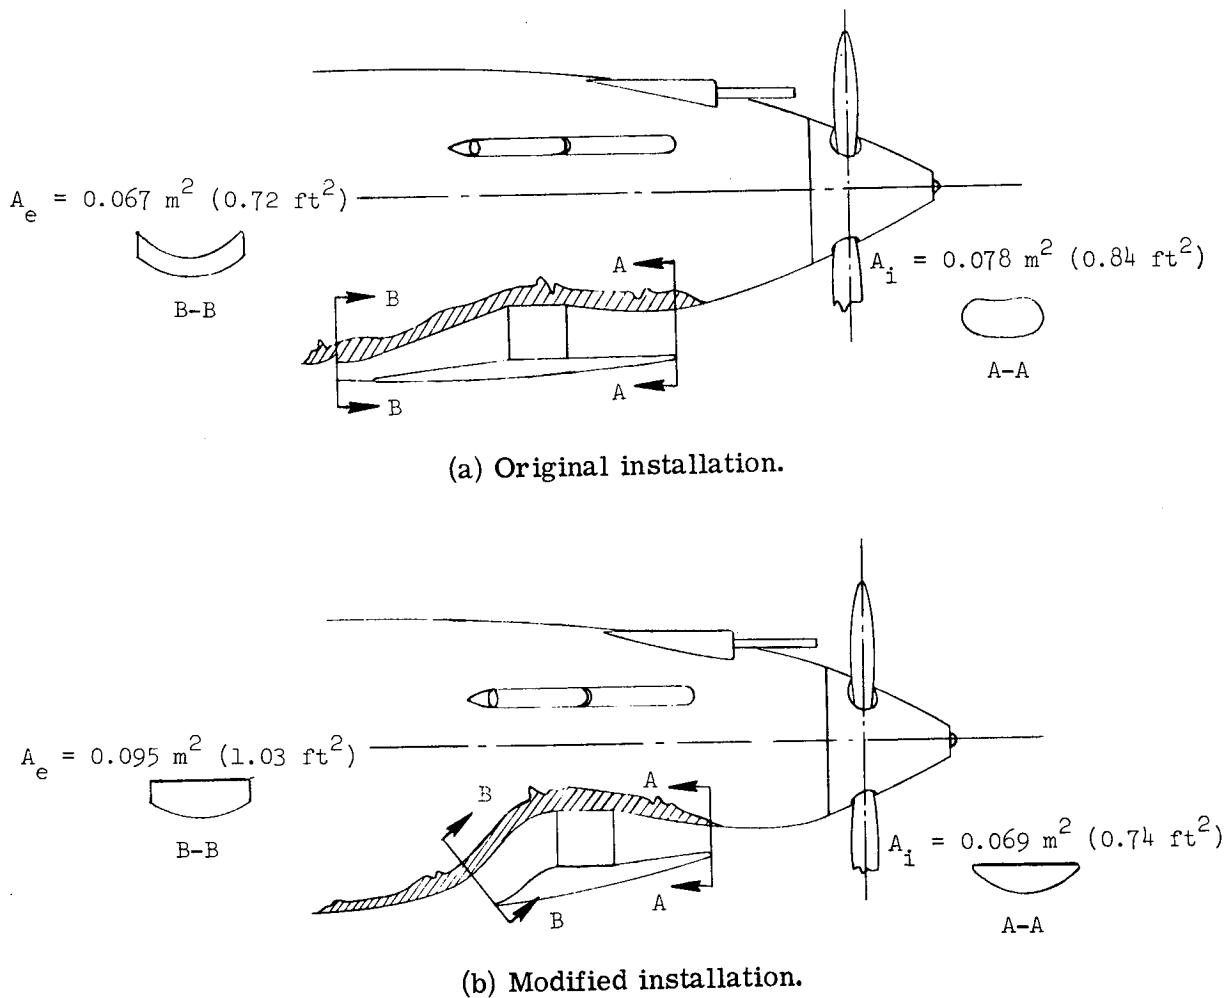
Figure A4.- Cooling installations on airplane 7 (Curtiss XP-40).

In its original condition the radiator on airplane 7 was located under the engine, and the air was taken in by means of the large scoop which protruded below the normal fuselage line. This installation increased the airplane drag coefficient by 0.0034. By raising the installation so that it did not protrude beyond the normal fuselage lines, the drag-coefficient increment was reduced to 0.0017 and the same airflow as that for the original installation was obtained.

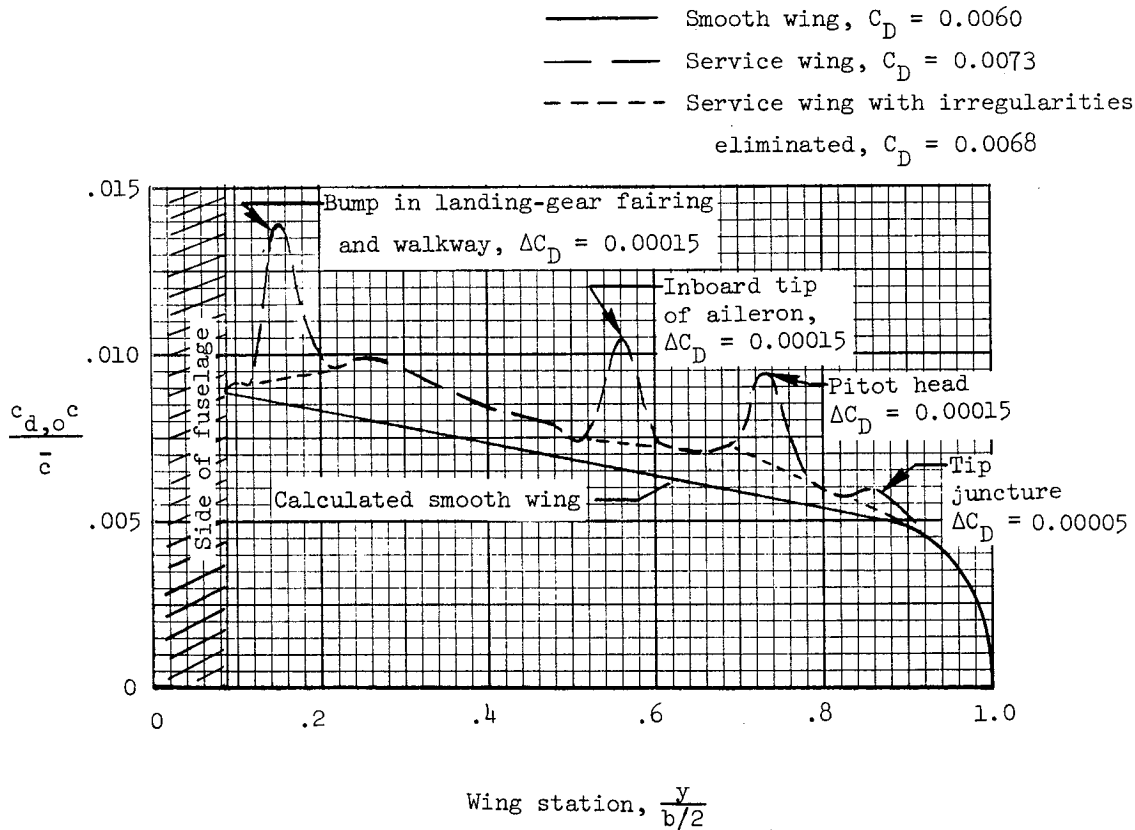
Figure C2.- Wing profile drag for airplane 9 (Bell XP-39).

The results obtained for the wing of airplane 9 are typical of the effects of small protuberances, gaps, and roughness on wing profile drag. The wing was flush riveted and had butt joints on the lateral seams and lap joints on the longitudinal seams.
