NASA CR-134990
SRD-76-021

IMPROVED TOUGHNESS OF SILICON CARBIDE

GENERAL ELECTRIC COMPANY
CORPORATE RESEARCH AND DEVELOPMENT

FINAL REPORT

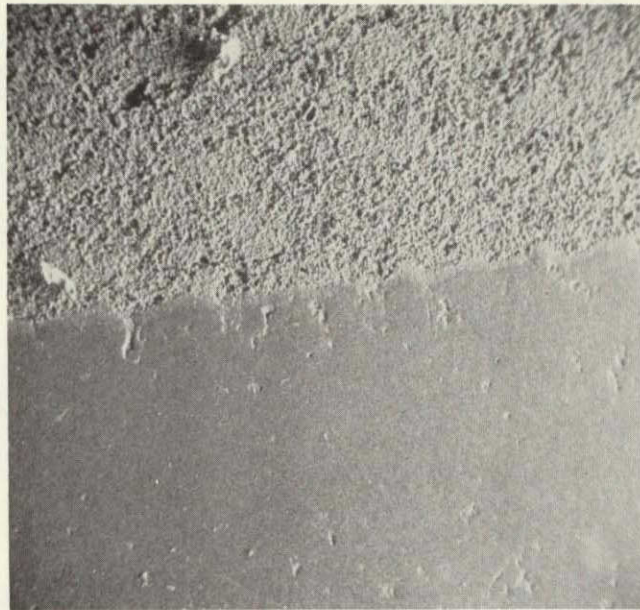
Figure 11. SEM at Interface of SiC Duplex Structure with EAL Containing 0.5% Boron Sintering Aid (20X)

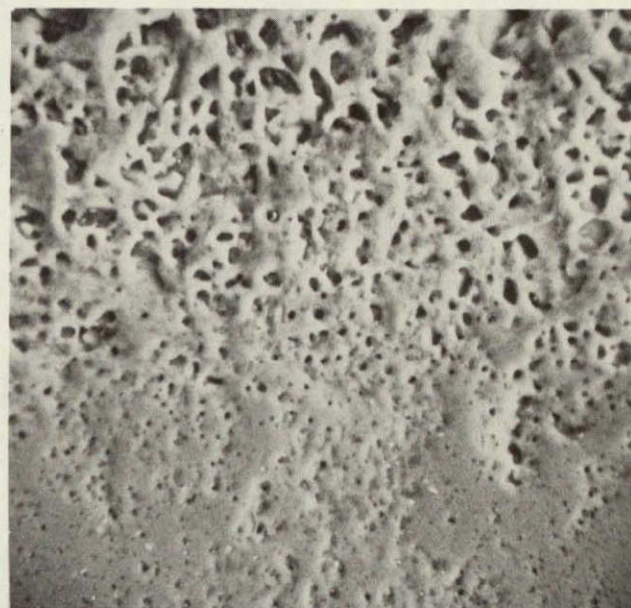
Figure 13. SEMs of Interface Between Dense and Porous Sections with EAL Containing 0% Boron Sintering Aid

Figures 13, 14, and 15 are SEMs of the same three structures showing the interface and adjoining dense and porous zones at magnifications of 200X and 500X. Excellent detail and viewing of the structural character can be noted.

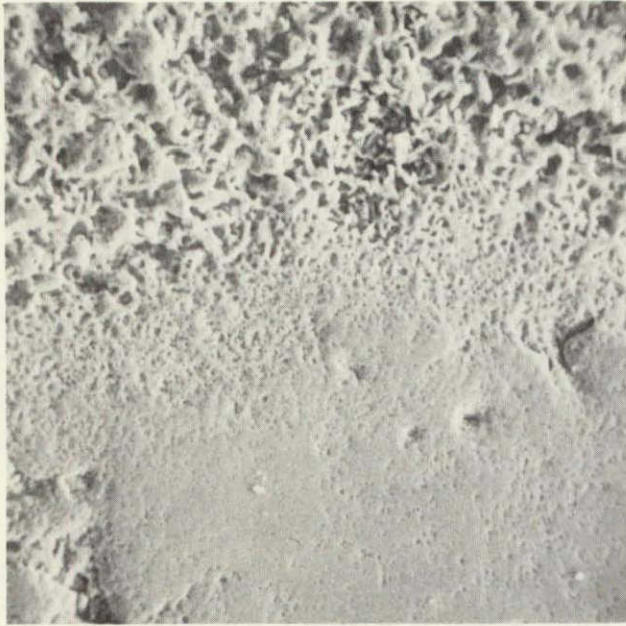
Figure 14. SEMs of Interface Between Dense and Porous Sections with EAL Containing 0.5% Boron Sintering Aid

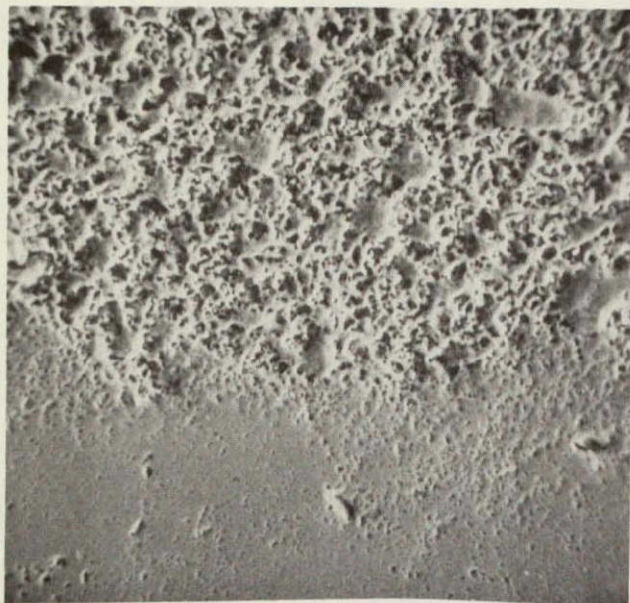
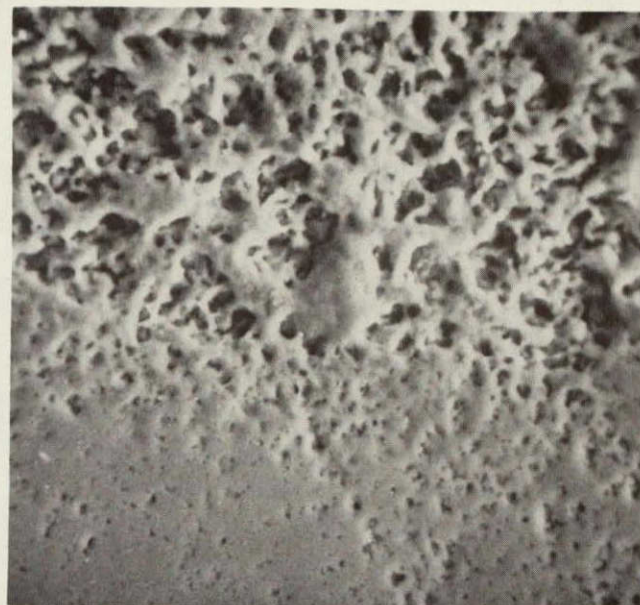
Figure 15. SEMs of Interface Between Dense and Porous Sections with EAL Containing 1.0% Boron Sintering Aid

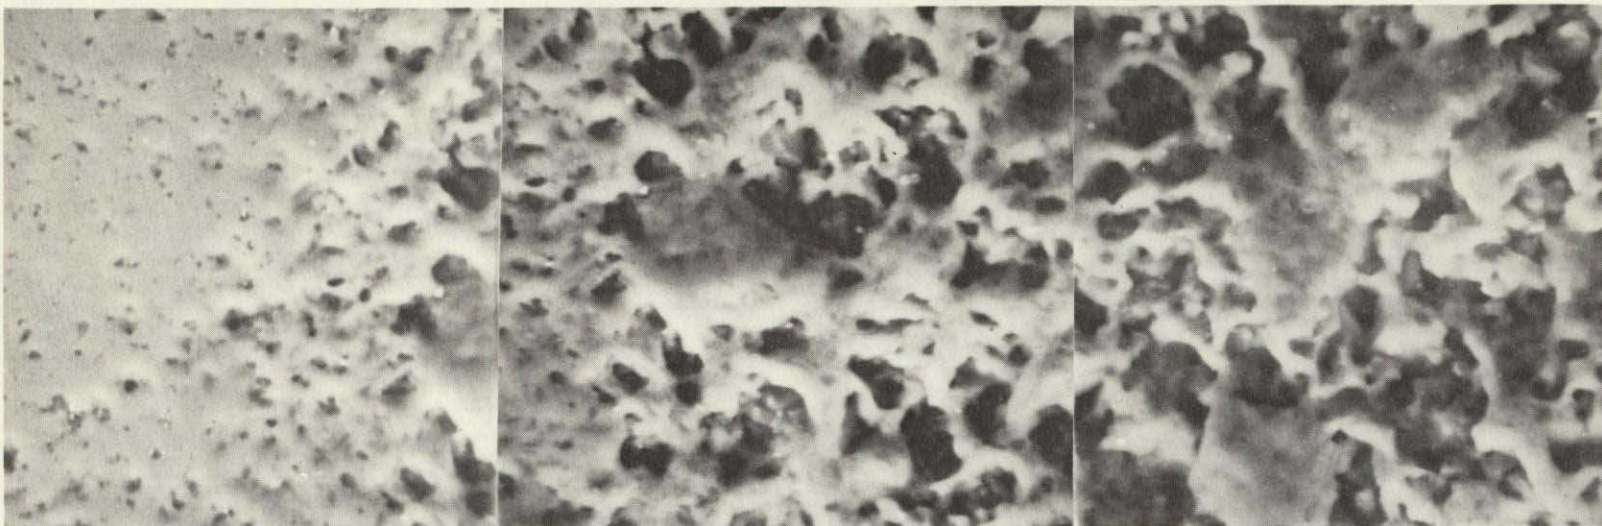
Figure 18. SEM Traverse from Dense Through Porous Zones
with EAL Containing 1.0% Boron Sintering Aid
(900X)

In Figures 16, 17, and 18 an attempt was made to show in more detail, portions of the dense, transition, and porous zones of the same three structures in which the EALs contained 0%, 0.5% and 1.0% boron sintering aid. In each instance, individual SEMs were taken at 1000X of the three zones and joined together to show the structure changes that occur on traversing from the dense into the porous zones. No large differences can be discerned between the three structures at this high magnification. Differences in EAL density are most readily observed at the lower magnifications.

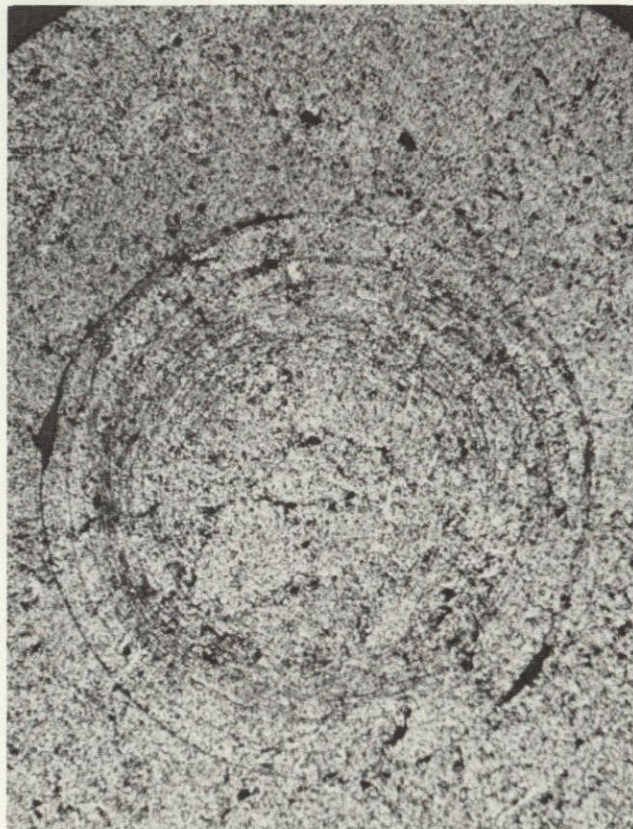
Figure 25. Hertzian Crack Produced by 0.29 J (Ballistic) on Impact Face of Dense SiC Unprotected by EAL

Figure 25 shows the Hertzian damage done to the surface of polished sintered SiC by an impact energy of 0.29 J imparted by the 0.37 g steel ball traveling at 39 m/sec. Surface damage to even this small degree would surely act as a low stress value crack initiator, thereby resulting in a high potential for early failure before the design stress level was imposed. Even with a ballistic impact energy as low as 0.67 J, the unprotected SiC target (5.0 cm x 5.0 cm x 9 mm) suffered catastrophic damage. Figure 26 shows the face of the plate opposite to the 0.67 J impact stress. The Hertzian ring crack produced by that shock is clearly evident.
