HYDROGEOLOGICAL INVESTIGATIONS IN  
THE PAMPA OF ARGENTINA

Dr. Dieter BANNERT

Bundesanstalt für Bodenforschung  
(Federal Geological Survey)

May 1975

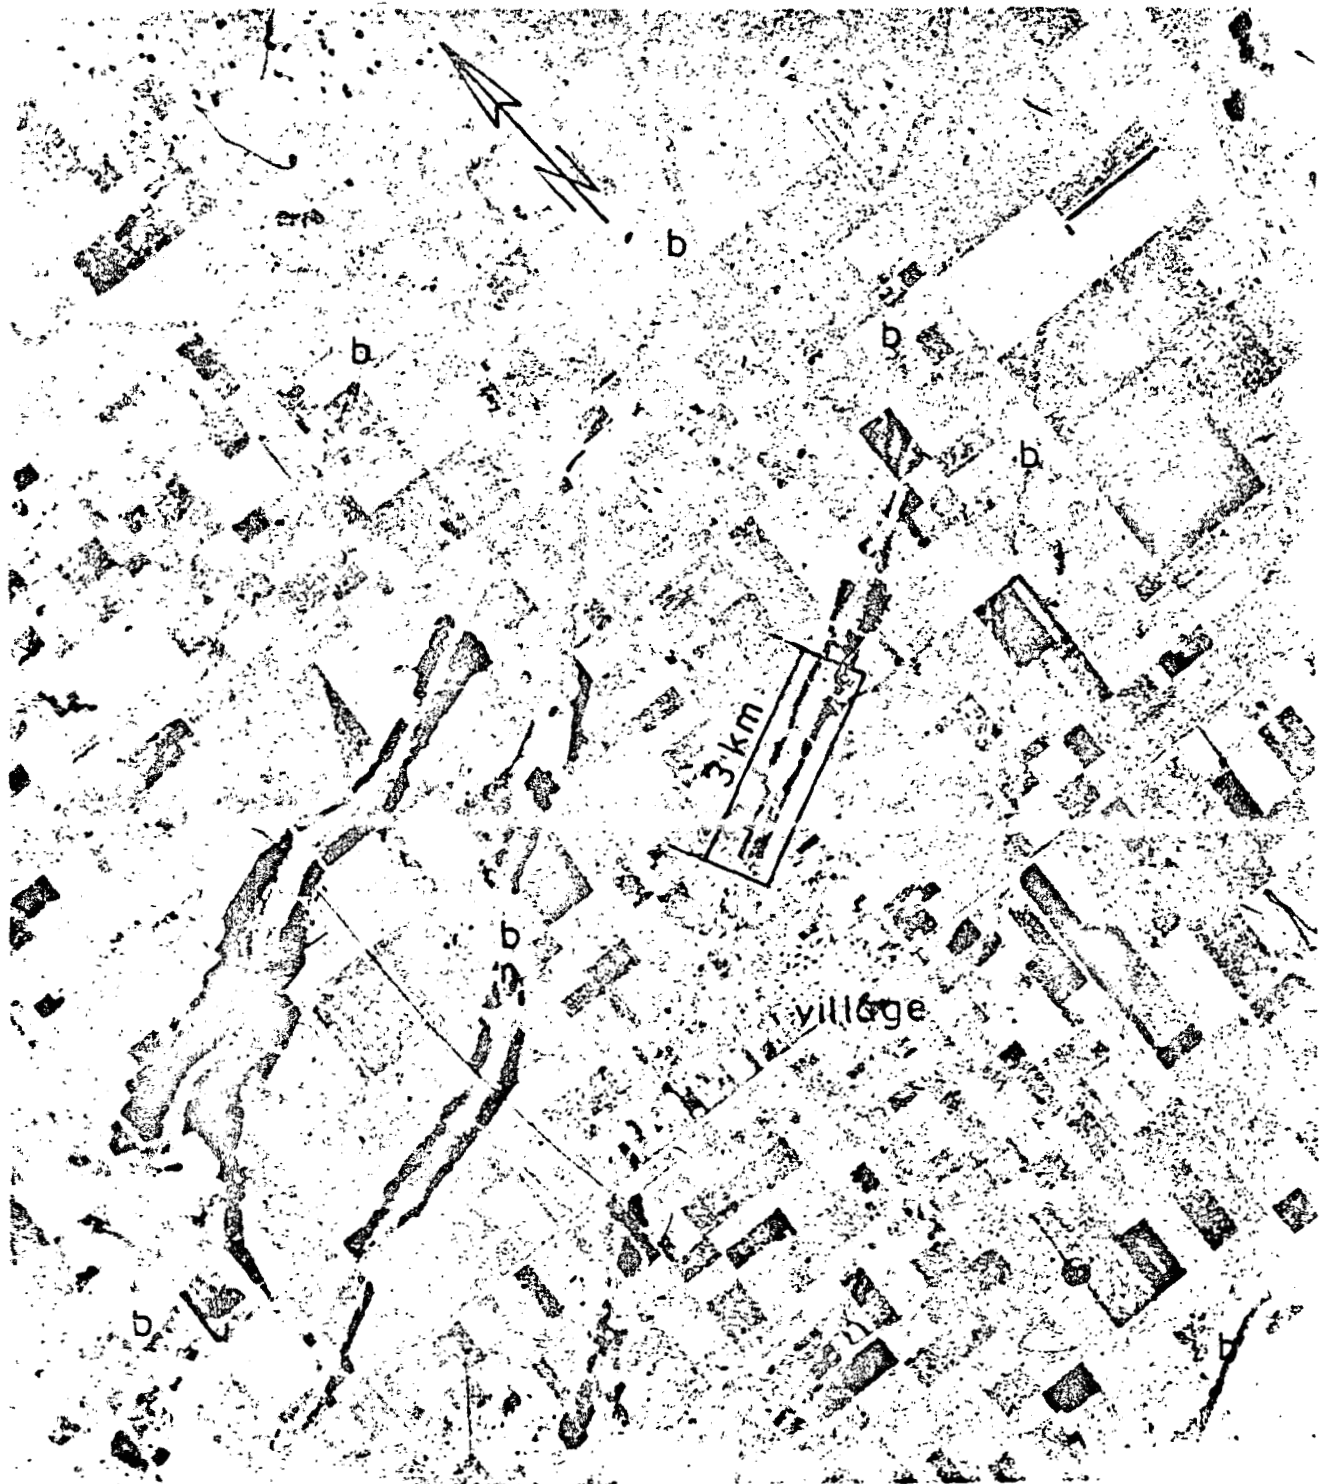
Fig 4

Enlargement of an area with „bajos” ( b )

Boxed bajo section used to demonstrate estimation of fresh ground water reserves ( see text )

Photograph Earth Terrain Camera

Bajo is the Argentinian term used to describe elongated flat depressions without surface drainage. In satellite imagery they appear as sharply defined strips. They run more or less straight in a ENE-WSW direction, are usually between 100-200 m wide and are spaced at relatively even distances of approx. 2 km, as can be seen in satellite imagery (Fig. 2 b and Fig. 4).

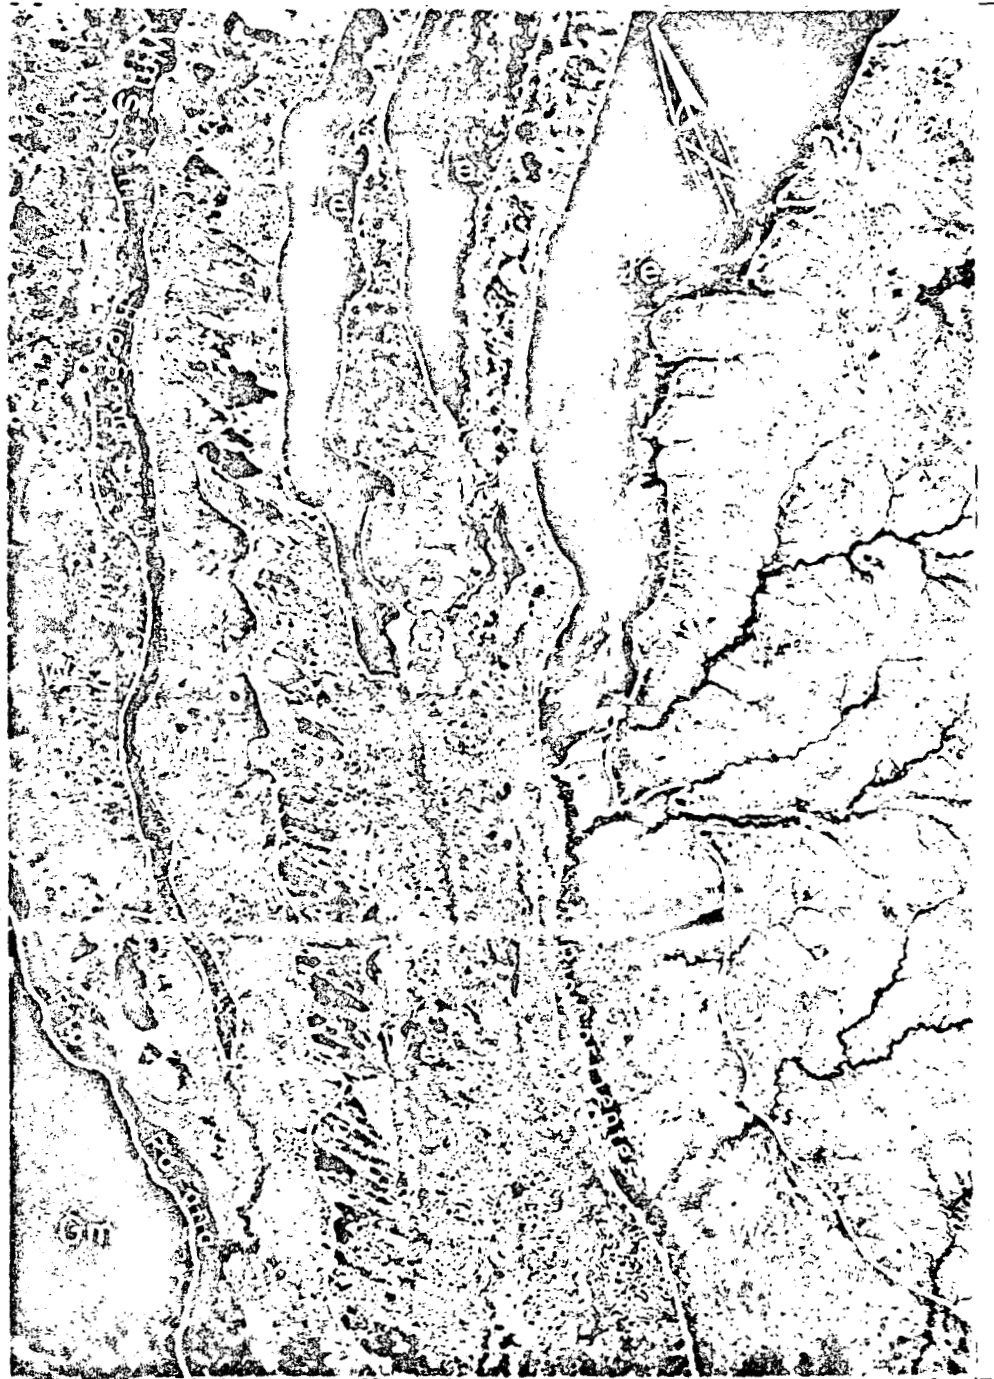
SL 3-34-165

# Soil units in the Province of Corrientes

We <sub>s</sub>	Eutric planosols, sandy
We <sub>c</sub>	" " , clayey
Wm <sub>s</sub>	Mollic planosols, sandy
Wm	" " , clayey
Je	Eutric fluvisols
Gm	Gleysols

Pedological units were delineated on an IR color photo showing about 13,000 km<sup>2</sup> of Corrientes province, Northern Argentina (Fig. 6). No ground truth has been carried out in this region. The investigation was possible only by comparison of different colored and textured units on the photo with the pedological units on the SOIL MAP OF THE WORLD (FAO, UNESCO 1971), as well as by analogic conclusions from the project area further in the Southwest.

The soil types delineated on the SOIL MAP OF THE WORLD (1 : 5,000,000) can be correlated with units on the photo. Locally, due to its larger scale, the image allows a further differentiation, e. g. : East and West of the Rio Paraná where exclusively mollic planosols are delineated on the map. In the Western area where a number of open waters and more intensive vegetation can be observed, the distribution of hydromorphic soils is taken into account.

1. Color Indicates the density of vegetation, the relative soil moisture and the soil sand content.
2. Texture Indicates the distribution of natural vegetation and land use.  
The distribution of surface water and the nature of the drainage pattern gives an indication of the relief, the ground water conditions and the nature of the rock in the underground which influence the soil conditions.
