NASA CR-134921
SRD-75-123

IMPROVED TOUGHNESS OF SILICON CARBIDE

GENERAL ELECTRIC COMPANY
CORPORATE RESEARCH AND DEVELOPMENT

November 1975

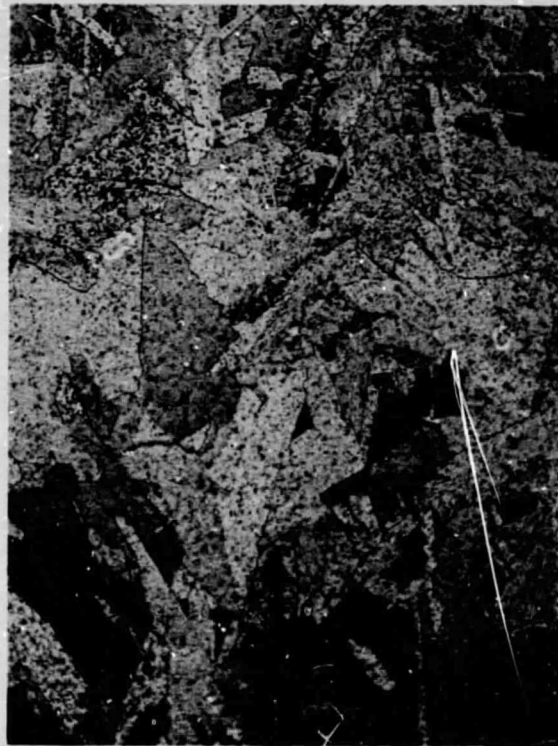
Figure 4. Specimen No. IHP1A Thermal-etched at 1500°C -
(1 mm = 16.6 μm)

Figures 4 through 10 show the improvement in microstructure achieved by lowering the temperature of hot pressing from 2000° C to 1820° C. Although no significant loss in final density occurred in the 1.91 cm thick specimens when pressed at 2000° and 1820° C, it should be noted that a loss of 2% in density did result. The massive amount of exaggerated grain growth occurring at 2000° and 1900° C hot-pressing temperatures is clearly evident in Figures 4, 5, and 6. Figure 7 shows the 40 to 50 micron needles formed during the hot pressing at 1820° C of the purchased SiC powder. Figures 8, 9, and 10 show the fine-grain microstructure developed in hot-pressed discs made from internally synthesized and formulated SiC powders.

Although it was recognized that because of the large grains present in specimens IHP1A and IHP2, the mechanical properties would be poor and there would be considerable scatter in the results. It was decided to perform Charpy impact tests both at room temperature and at 1325° C using a 1.356 to 2.712 J Charpy test unit. The results are shown in Table V. The tests were performed on unnotched 6.35 mm square x 5.08 cm long Charpy bars using the 1.356 J hammer on the test machine.

As is readily noted, sample IHP1A exhibited extreme variation in impact strength at both room temperature and 1325° C. Although it is only one-third as strong in impact as the average of IHP1A, sample IHP2 exhibited remarkably good consistency in results and with little sensitivity to temperature. It was considered to be of little, if any, value to go any further with the mechanical properties of these specimens. Consequently, fracture strengths were not determined. Additionally, no mechanical properties were determined on IHP1A-2, also because of the excessively large amount of grain growth occurring in this specimen.

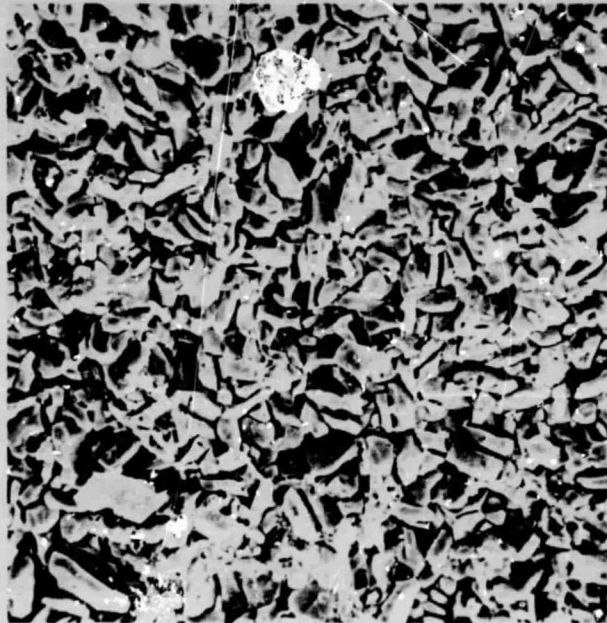
Figure 13. SEM Photomicrograph of Ceralloy 146A SiC - Treated in a CaCl_2 - CaF_2 - CaSO_4 molten salt bath at 830° C for 30 minutes. 500X

Figures 13 and 14 are SEM photomicrographs of the as-treated SiC surface at 500X and 2000X, respectively. They indicate that a uniform surface structure had been created which had no visible intergranular bond. The fact that it was an abrasion-resistant surface, however, also indicated that the grains were indeed bonded below the visible surfaces.

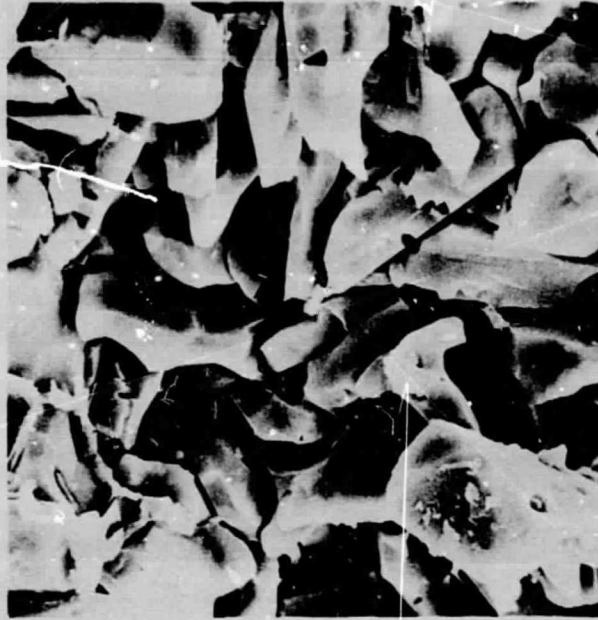
Figure 14. SEM Photomicrograph of Ceralloy 146A SiC - Treated in a CaCl_2 - CaF_2 - CaSO_4 molten salt bath at 830°C for 30 minutes. 2000X

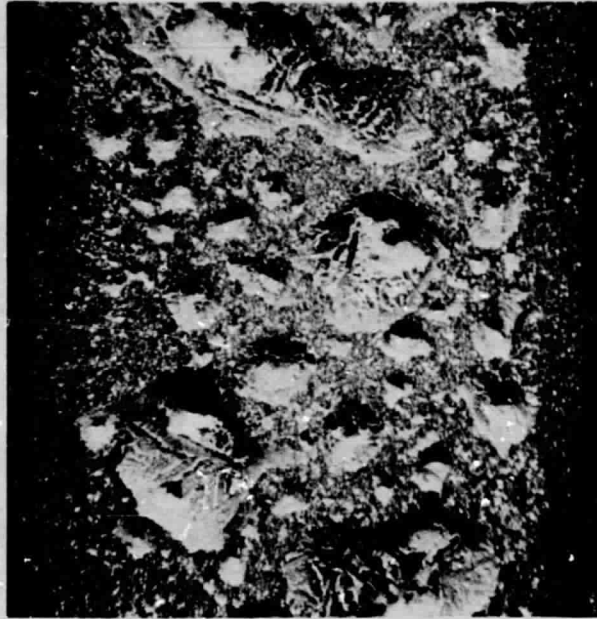
Figure 15. Elemental Si Fusion -Bonded to SiC Substrate 15X

200 Silicon powder, Cat. No. S-164, from the Fisher Scientific Co., was mixed with a solution of ethyl cellulose in amyl acetate and painted on silicon carbide test bars. After evaporation of the amyl acetate, a layer of silicon particles bonded together and to the substrate by the ethyl cellulose remained on the test bar. Removal of the ethyl cellulose was accomplished by pyrolytic decomposition between 1430° and 1475° C. Binder removal was attempted in three different atmospheres: nitrogen, argon, and vacuum. Heating and cooling rates were each 20 minutes long with soak times at temperature of 5 to 30 minutes. Initial results indicated that extremely careful control of atmosphere purity was necessary to prevent oxidation of the silicon during processing. Oxidation to varying degrees occurred in all three atmosphere conditions that were used. In those cases where oxidation was severe, the silicon would not bond to the SiC nor to itself. Where oxidation of the Si was less severe, it apparently formed a good but uneven bond to the SiC substrate. Figure 15 shows the islands of fusion-bonded silicon to silicon carbide. Since the desired and final layer of Si₃N₄ was required to be both porous and evenly distributed over the surface of the SiC, this approach to that end did not appear to be too promising. The uneven wetting of the SiC by Si was not desirable. Because of this situation, further work was not expected to be worthwhile, and this approach was also terminated.
