NASA CR-134887

COMPOSITE IMPACT STRENGTH IMPROVEMENT THROUGH A FIBER/MATRIX INTERPHASE

P. J. Cavano and W. E. Winters

prepared for
NATIONAL AERONAUTICS AND SPACE ADMINISTRATION
NASA Lewis Research Center
Contract NAS 3-18902
Raymond F. Lark , Project Manager

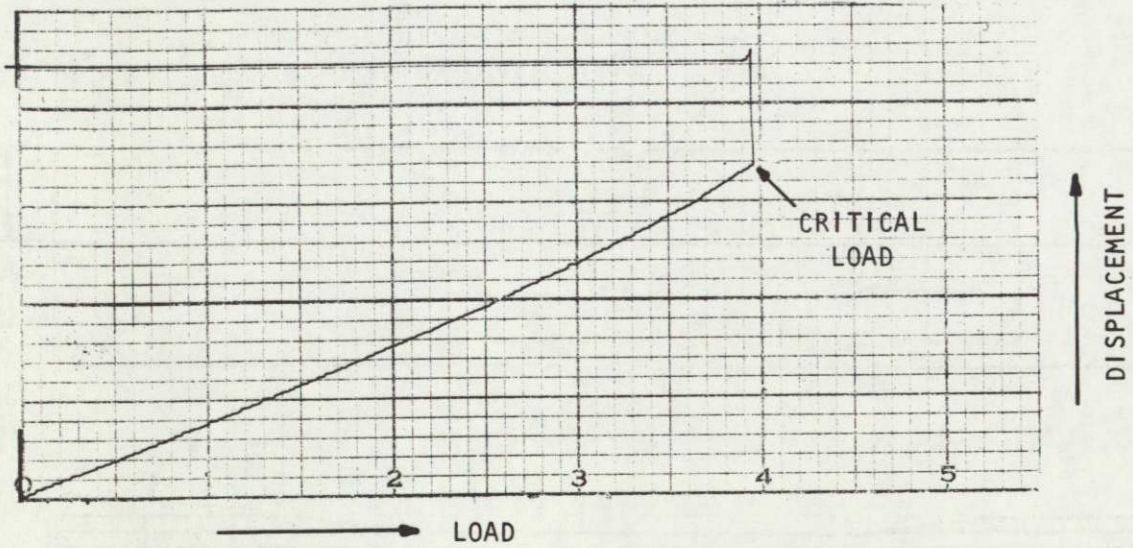
LAM 719-72 SPECIMEN #2 A-U FIBER WITH 0.05 μm K-500 COATING

LAM 722-14 SPECIMEN #2 A-U FIBER WITH 0.10 μm K-500 COATING

FIGURE 10 TYPICAL FRACTURE TOUGHNESS LOAD-DEFLECTION CURVES FROM INSTRON TENSILE TESTER

In first trials of this specimen in test, it was planned to accept, as the critical load, that load which corresponded to first visual signs of cracking or splitting in the specimen. However, it was noted that visual splitting was preceded by both audible indications of specimen damage and a disruption of the load-displacement curve being autographically recorded. Since these events indicated initiation of crack propagation, the first significant disruption of the load-deflection curve was finally chosen as representing the critical load and was used for calculating all values shown. Figure 10 shows two typical load deflection curves collected on fracture toughness test specimens. The upper curve clearly shows a large extension without accompanying increase in load; this point was selected as indicating the critical load (P_C) for this specimen. In the bottom curve of figure 10, an example is shown that is perhaps not quite so clear cut. However, judgments were made with each curve, and as can be seen from the data, concordant results were obtained.

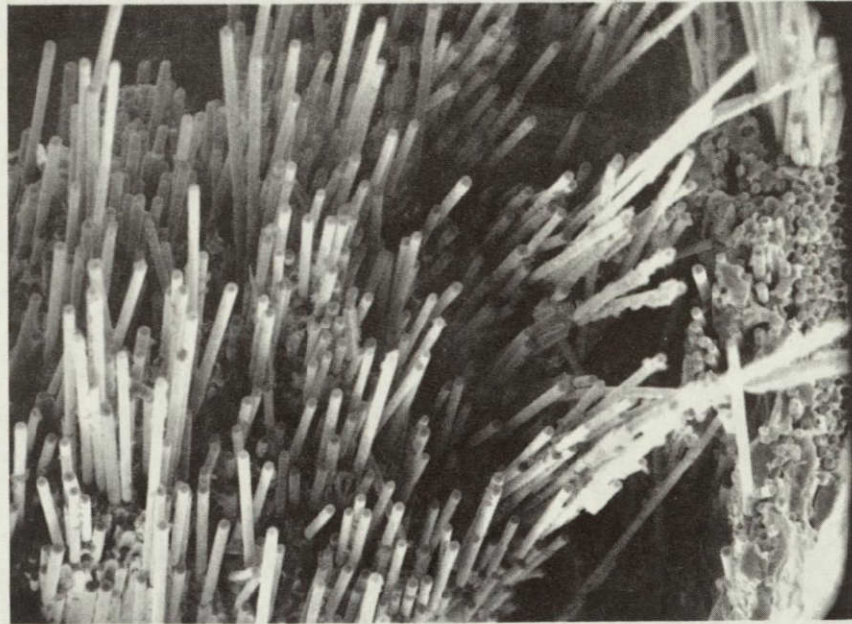
FIGURE 29 SEM OF FRACTURE SURFACE OF IZOD IMPACT STRENGTH SPECIMEN 719-91/2. NICKEL COATED ($0.50 \mu\text{m}$) HM-S FIBER.

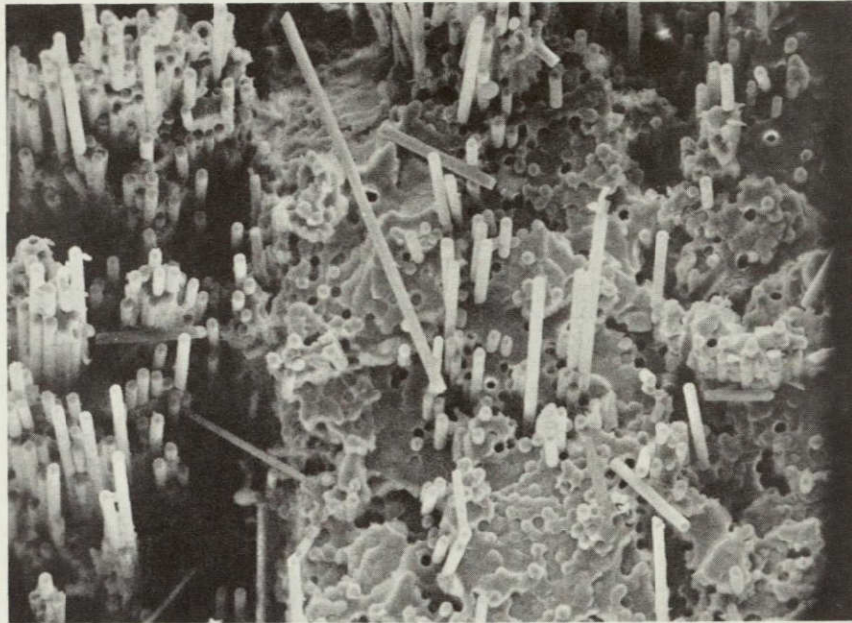
FIGURE 31 SEM OF FRACTURE SURFACE OF IZOD IMPACT STRENGTH SPECIMEN 722-23/2. BORON COATED (0.20 μm) HM-S FIBER.
