Report No. R-75-022
July 1975

FINAL REPORT
HIGH RELIABILITY BOND PROGRAM USING
SMALL DIAMETER ALUMINUM WIRE

General Dynamics Electronics Division
Microelectronics Center
Mail Zone 7-08

George C. Marshall Space Flight Center
Marshall Space Flight Center
Alabama 35312

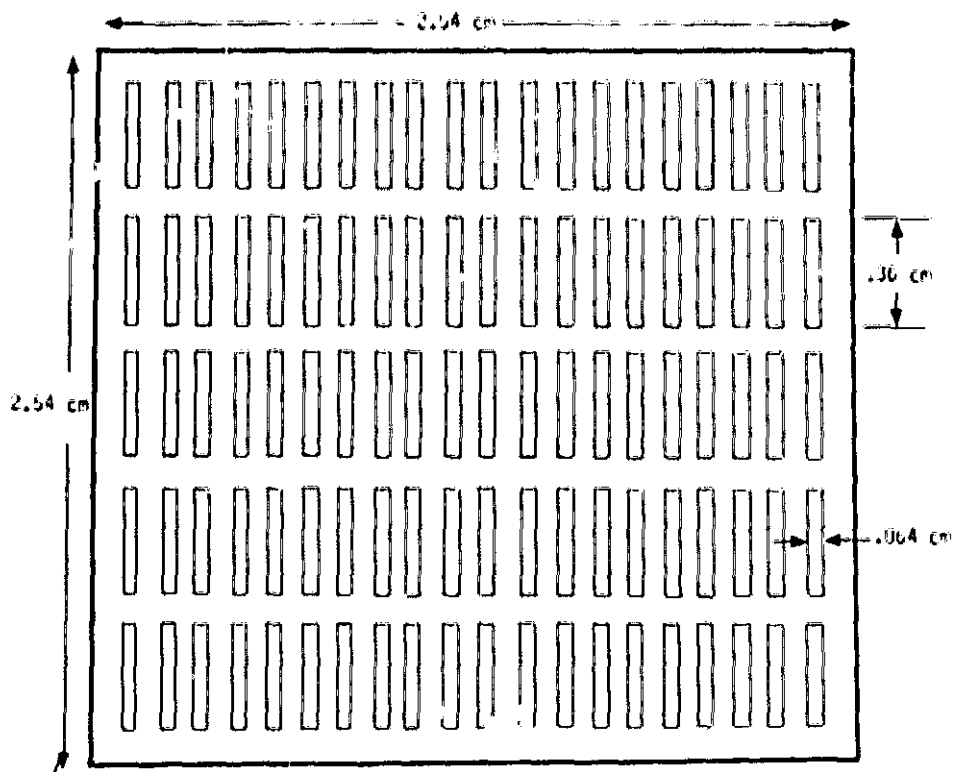
Figure 2-1. Substrate Pad Pattern

The pattern of bonding pads shown in Figure 2-1 was employed for the whole study. The wiring pattern shown in Figure 2-2 was used for both the thick and thin film gold. This pattern accomplishes several requirements. It provides a large number of bonds in series (99 loops - 198 bonds) for the purpose of electrical measurements. In addition, it provides sites for a large number of bonds (50 loops - 100 bonds) of three different wire sizes on the same substrate. In these tests, the substrates were arranged in three groups. Group "A" had 25.4 μm (1 mil) series connections with 25.4, 38.1 (1.5 mil) and 50.8 μm (2 mil) jumper wires for pull testing. Group "B" had 38.1 μm series connections and three sizes of jumpers, and Group "C" had 50.8 μm series connections and three sizes of jumpers. From 30 to 37 substrates were used for each group and each type of metallization. Each substrate carried its own serial number for identification.

The bonding pattern (Figure 2-1) was printed on 200 mesh stainless steel screen using a 25- μ m thick D-Cote emulsion. After the gold pattern was screened on the substrates, it was dried and fired in a seven-zone BTU belt furnace at a peak temperature of 882°C with the temperature held above 875°C for 10 minutes. The air flow through the furnace was 12 atm-liter/min. The as-fired gold was 10-12.5 μ m thick with a surface finish of 0.5 μ m as measured on the Talysurf. The overall process of fabrication and testing is shown in Figure 2-14.

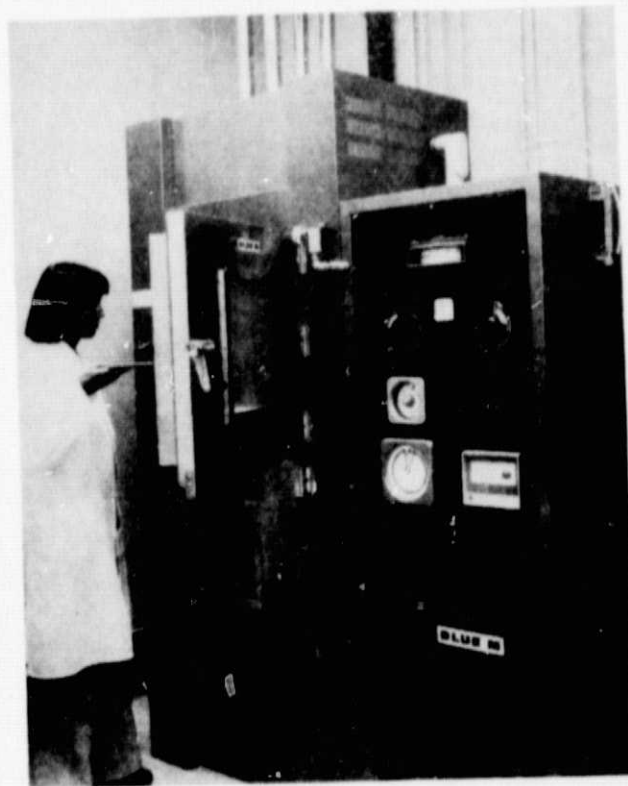
Figure 2-11. Thermal Shock Chamber

A Blue M, Model WSP 109C-3 Dual Thermal Shock Test Cabinet (shown in Figure 2-11) was used for the thermal cycling tests. The work to be cycled is placed on a low mass elevator having a suitably insulated floor and ceiling. The elevator periodically cycles the work between the upper heated chamber and the lower cooled chamber, with the transition being made in about two seconds. Blowers circulate the air in both chambers. This unit although it works adequately, has several undesirable features which could be improved.

The timer used to control the transfer from hot to cold and vice versa is adjustable from 0 to 5 hours and is poorly calibrated at short times. The cycle time used for this program and for testing typical microcircuits calls for 10 minutes at each temperature. Thus achieving a reasonably accurate 10-minute half cycle requires a considerable amount of time consuming trial and error.

A high quality controller is used for the low temperature chamber, but it also has a poorly chosen range (-100°C to +300°C). Since there is no provision to heat this chamber and room temperature is at less than 25% of the physical length of the scale, 75% of the scale can never be used, and setting the instrument to within ±5°C at -65°C is very critical. Careful calibration has established the excellent accuracy of the control, but its ability to be set accurately leaves much to be desired.

The elevator mechanism exhibits a destructive lateral jerk at its two extremes. As a result, a batch of 100 substrates which were packaged for this test in glass petri dishes received extensive damage when the substrates within the dishes (four per dish) shifted laterally and ended up on top of each other. The only safe packaging scheme for unprotected samples in this chamber is in individual dishes.

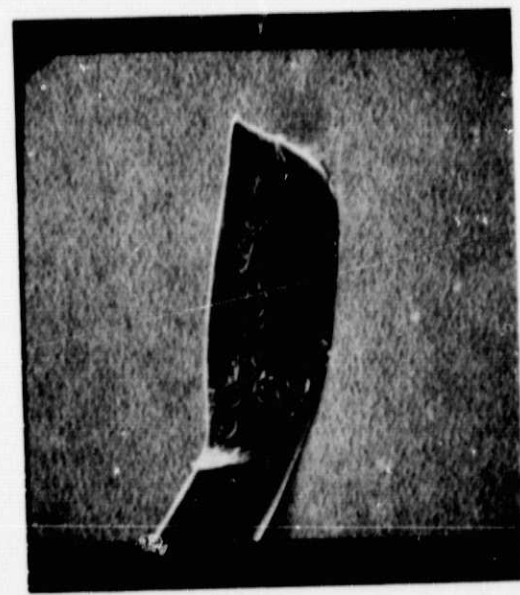
Figure 4-1. Wire Bonds (25.4 μm)

B. THIN FILM GOLD, STANDARD SUBSTRATE

D. THIN FILM ALUMINUM, STANDARD SUBSTRATE

A. THICK FILM GOLD

C. THIN FILM GOLD, GLAZED SUBSTRATE

The thick film gold studied in this program would not be satisfactory for hybrids required to operate at elevated temperatures for extended periods of time. The bonding process itself was marginal for the 50.8 μm film due to inadequate film adhesion, although the hard wire may have contributed to that problem. The major failing of the overall Al wire/thick-film gold system was that the adhesion of the wire to the film seriously degraded as a result of the heat treatment in all cases.

The thin film gold did not exhibit the failure of adhesion characteristic of the thick film. However, if one uses the data from the thin film aluminum as a standard and assumes that the degradation there was all due to wire annealing, then the thin film gold suffered from 5 to 15% additional loss of strength for a total loss of from 30 to 40%. Observation of the failure mode indicates that the bonds themselves get stronger relative to the wire. This could be due to one of two mechanisms: Either the bonds actually got stronger by some heat related mechanism (perhaps by interdiffusion). This assumes that the temperature-time relationship was too low to cause Kirkendall voids. Or else the adhesive strength did not actually change, but degradation of the strength of the wire because of some heat related cause simply caused the heel to break before the adhesive limit of the bonds was reached. If the latter is true, then some other metallurgical change related to the specific combination of materials and certainly including the possible effects of impurities has to be involved in order to explain the greater strength loss compared to Al on Al.

The results of bonding to thin film aluminum were excellent. By carefully controlling the geometry and the bonding schedule, very tight distributions were obtained. In addition, the degradation of the bond pull strength with thermal treatment was less than with either the thick or thin film gold. The lowest pull strength measured, even after heat soak and thermal cycling, was 7 gmf.
