DEVELOPMENT OF SPUTTERED TECHNIQUES FOR THRUST **CHAMBERS**

INTERIM REPORT

by: J. R. Mullaly, R. J. Hecht, T. E. Schmid, and C. T. Torrey

Pratt & Whitney Aircraft Division of United Technologies Corporation Contract NAS3-17792

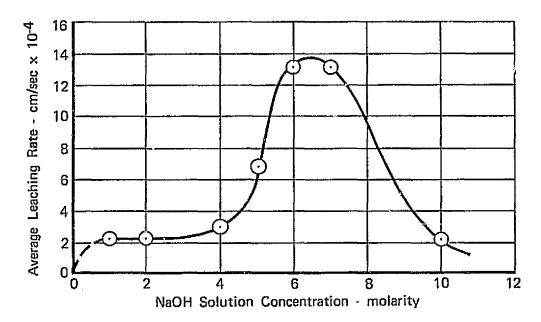
Figure 6. Effect of NaOH Solution Molarity on the Average Leaching Rate of the Flame-Sprayed Aluminum Filler at Ambient Temperatures

Techniques were established for removal of the CERROTRU and aluminum fillers. Removal of the flame-sprayed aluminum by leaching with NaOH was found to be most rapid between 6.0 and 7.0 molarity. (See figure 6.) Ultrasonic vibration and tilting of the sample did not result in significant increases in the rate of removal. A maximum rate of 1.3 x 10⁻⁴ m/s (0.48 cm/hr) was obtained using 7.0 molar NaOH at 348 to 353°K (167 to 176°F) without ultrasonic vibration. Removal of the CERROTRU was accomplished by placing one end of the cylinder in a pool of molten CERROTRU at 453°K (356°F) for about 300 seconds and withdrawing slowly. Final removal of the last remnants of the CERROTRU was accomplished by etching in a concentrated HCl solution.

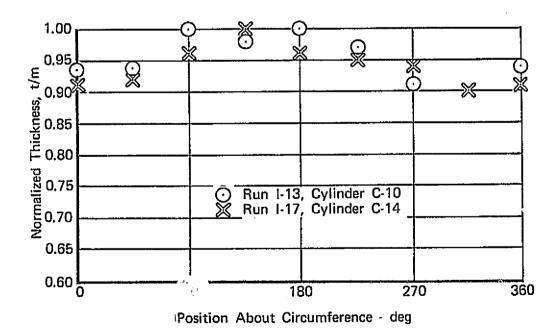
Figure 7. Circumferential Closeout Layer Thickness Distribution at Cylinder Center

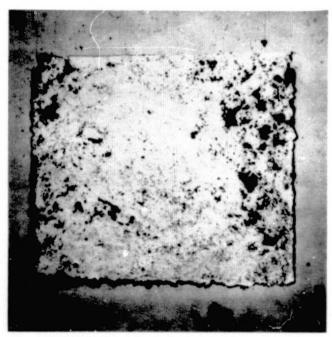
Mag: 83X Unetched

Figure 9. Typical Appearance of Aluminum Filler

Aluminum was found to be the most suitable filler for thrust chamber fabrication. However, the method of application by flame-spraying was found to be unacceptable. The application by flame-spraying resulted in a porous structure (figure 9), which exhibited extensive outgassing. System contamination was the most excessive in the experiments in which this filler material was used. A direct result of the contamination was the oxide layer at the bond interface observed in runs I-14 and I-16. Whether the oxide layer formed entirely during the sputter cleaning, the in-situ bakeout cycles, or the initial stages of the deposition cycle could not be determined from the experiments performed.

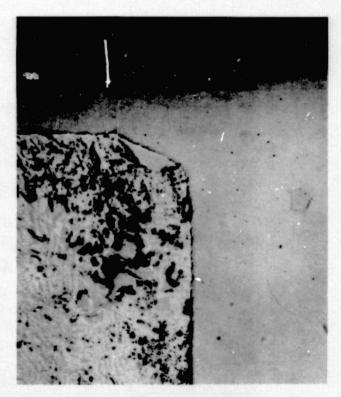
Figure 10. Burring and Closeout Layer Cracking Resulting from Normal Lathe Machining, Run I-7

From the initial depositions performed on cylinders prepared by normal lathe machining techniques, it was observed that this method of machining tended to smear the filler and substrate and result in the formation of a large burr on one side of the rib edge. On the nonburred side of the rib edge, the filler material was pulled away from the rib wall. The sputtered closeout layer persistently exhibited cracks extending from the nonburred side of the groove. (See figure 10.) Longitudinal surface grinding was evaluated in run I-12 as a means of forming burrs on both sides of the grooves. The grinding technique introduced deep machining marks into substrate, which required excessive sanding for removal. Longitudinal milling did not result in deep machining marks, but did yield significant burring along both sides of the grooves. As is apparent in figure 11, burring the groove sides did not in itself eliminate the cracking problem, although a reduction in severity of the cracking was noted.

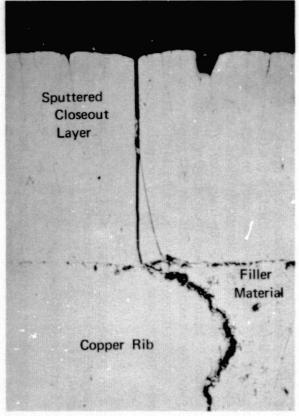
Figure 11. Burring and Closeout Layer Cracking Resulting from Lengthwise Milling, Run I-16

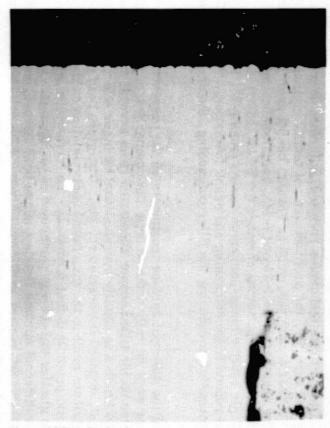
FD 78486A Figure 12. Appearance of Closeout Layer on Dry Machined and Sanded Substrate, Run I-20

Suspecting that the machining lubricants trapped in the filler material during milling also contributed to the crack formation through the introduction of contaminants, dry milling was used in run I-19. Though the outgassing rate of the aluminum filler was significantly reduced, the cracking problem persisted. Dry machining using a reversing cutting technique resulted in minimal cracking at the rib wall and reduced the extent of cracking in the closeout layer. (See figure 12.)

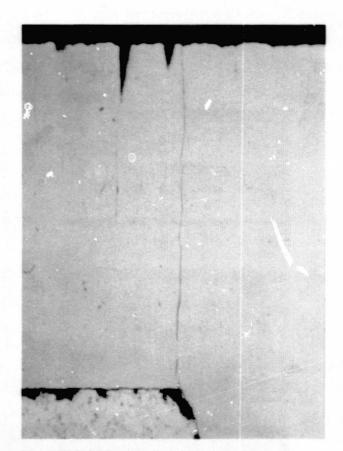
Figure 13. Cracking of Closeout Layer on Glass-Bead-Peened Surface, Run I-13

Concurrent with the variations in machining, surface deformation techniques such as glass bead peening and shot peening were also tried as a means of further sealing the incipient cracks at the rib walls and, in the case of the flame-sprayed aluminum filler, densifying the surface layer to decrease outgassing and seal the surface porosity. Though these techniques resulted in further decreasing the cracking frequency and severity, the problem was not totally eliminated. (See figures 13 and 14.) Other techniques, such as vacuum baking prior to installation in the sputtering chamber (runs I-16 and I-24), radiation heating of the sample at high vacuum in the sputtering chamber for 54 ks (15 hr) (runs I-17 and I-18), and multiple sputter clean-pumpdown cycles (runs I-13, I-14, and I-16), were used to reduce filler outgassing and crack formation. Though these techniques were successful in reducing the filler outgassing, the cracking problem persisted.

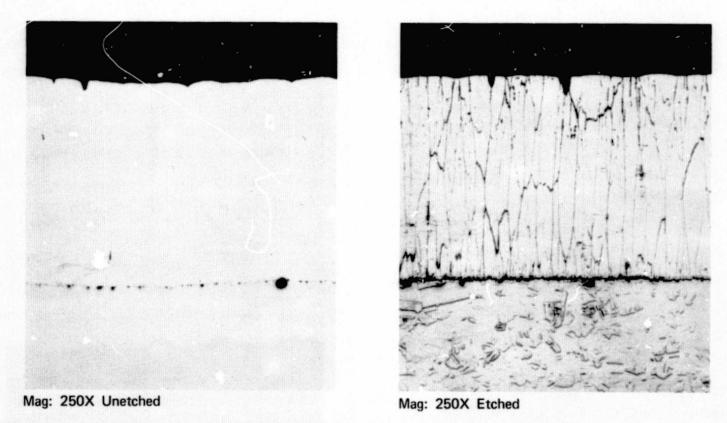
Figure 15. Interfacial Contamination Resulting from Glass Bead Peening, Run I-16

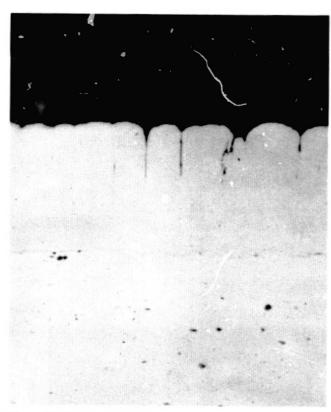
Figure 16. Microstructure of Sputtered OFHC Copper on Glass-Bead-Peened Region of Type 6061 Aluminum Alloy Substrate

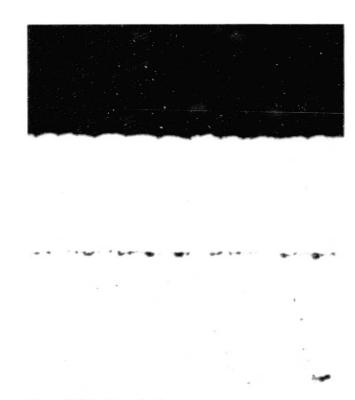
Figure 17. Microstructure of Sputtered OFHC Copper on Vapor-Blasted Region of Type 6061 Aluminum Alloy Substrate

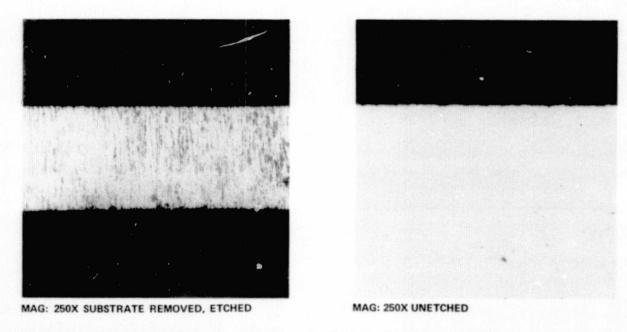
Figure 19. Microstructure of Sputtered OFHC Copper on 600-Grit-Sanded Region of Type 6061 Aluminum Alloy Substrate

The effects of the different surface treatments on the presence of defects in the closeout layer were initially deduced from the comparison of the structures of the closeout layers on the filled copper substrates from several runs. However, the effect of surface finish was usually overshadowed by other effects, attributable to the filler material, deposition parameters, etc. The glass bead peening operation seemed to contribute most to the interfacial contamination on the copper substrates (figure 15) and promote defect formation. To further confirm this, a separate deposition similar to I-14 was performed on an aluminum substrate prepared with three different surface finishes (glass bead peened, vapor blasted, and sanded with 600-grit SiC paper) on different areas of the cylindrical substrate. It was again observed that the glass bead peening operation promoted the formation of defects in the coating. (See figure 16.) The defects were normal to the surface and traced back to the centers of the concave regions of the surface. The defects probably resulted because of the deposition rate difference between the concave regions and the convex regions. The concave regions exhibited a lower growth rate since these areas were exposed to a smaller segment of the cylindrical target (shadowing effect) than the convex regions. As the deposition continued, the difference in growth rate increased, resulting in deeper and deeper "valleys." The junction between the coating on adjacent "hills" eventually became a sharp cusp moving outward trailing a thin crack or open boundary. The vapor-blasted area exhibited the same effect, but with fewer resultant defects. (See figure 17.) This may have been due, in part, to the contamination at the interface, attributed to the vapor blasting process. It should be noted that vapor blasting usually resulted in a clean interface, (figure 18), so that the above result was not taken to indicate that vapor blasting should be discontinued. However, the preparation by sanding with 600-grit of paper resulted in a defect-free structure, smooth deposit surface, and a high quality interface. (See figure 19.) Hence, sanding was the preferred preparation technique for the latter runs.

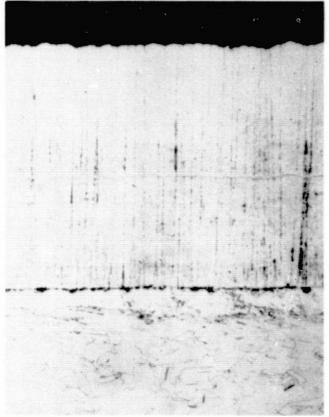
Figure 23. Columnar Grain Structure of Sputtered OFHC Copper Applied at a Substrate Temperature of 355°K (82°C) - Run I-13

The effect of deposition temperature on coating structure generally correlated well with that observed by Thornton. $^{(9)}$ The depositions performed at T/T_m = 0.2 to 0.3 (271 to 406°K) exhibited columnar grains. (See figure 23.) The depositions performed at T/T_m = 0.3 to 0.5 (406 to 678°K) exhibited a more equiaxed structure and, for the highest temperatures in this T/T_m range, showed indications of concurrent recrystallization. (See figure 24.) As was expected, the temperature of deposition affected the hardness of both the closeout layer and the substrate, (figure 25 and table VI). The scatter in the closeout layer hardness at low temperatures was attributed to the openness of many of the low temperature deposits. (See figure 26.)

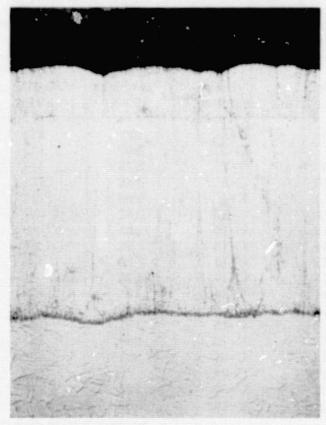
Figure 24. Microstructure of Sputtered OFHC Copper Applied at a Substrate Temperature of 566°K (293°C), Run I-15

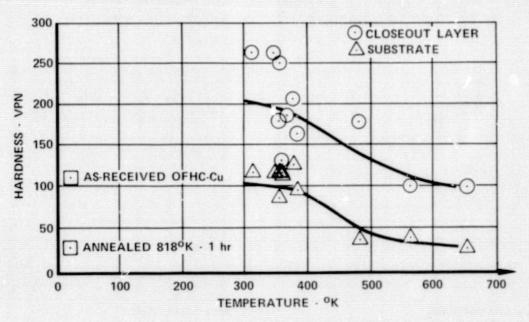
Figure 25. Effect of Substrate Temperature on Closeout Layer and Substrate Hardness

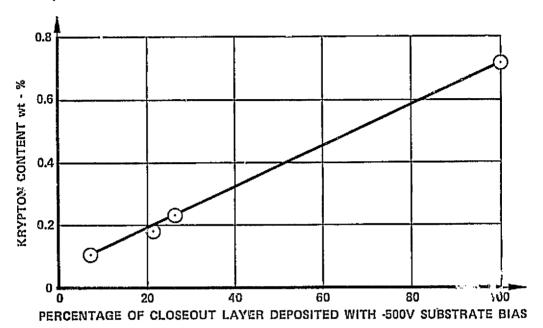
Figure 29. Variation of Closeout Layer Krypton FD 78480 Content With Percentage of Closeout Layer Applied With -500V Bias

The bias on the substrate was varied to determine its effect on cone formation and closeout layer structure. The competing effects of substrate surface finish, filler material outgassing, deposition rate, and temperature made it impossible to single out the effect of substrate bias on structure and cone formation. However, bias was found to affect the level of sputtering gas entrapment. (See table V.) The amount of krypton in the samples seemed to correlate well with the percentage of the deposit applied with a substrate bias of -500V. (See figure 29.)

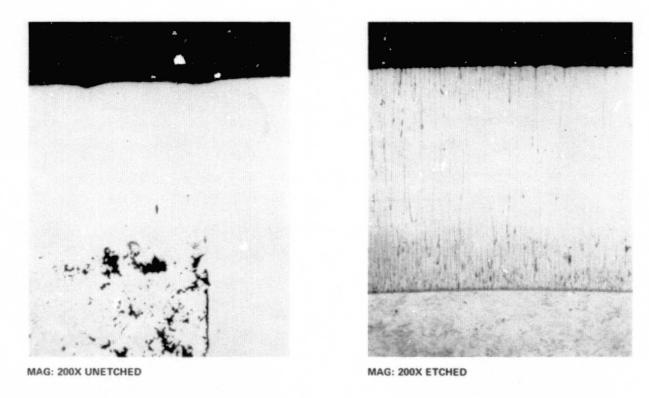
Figure 30. Microstructure of Closeout Layer Applied Using Lower Discharge Pressure - Run I-24

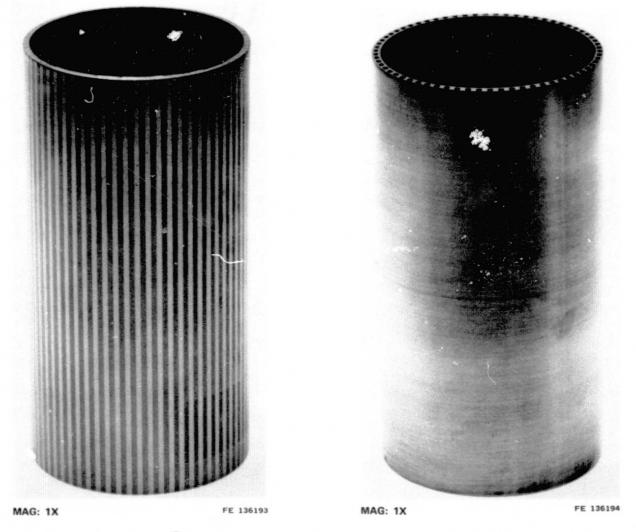
Figure 31. Appearance of CERROTRU®-Filled Ribbed Wall Cylinder and Final Finished Cylinder

Based on the results of the previous depositions and evaluations, a final cylinder representative of a regeneratively cooled thrust chamber was fabricated in run I-25. (See tables II and III and figure 31.) The initial layers were deposited at about 4 nm/s (0.6 mils/hr) to avoid filler heatup and to bridge the filler with a heat conductive layer. The remaining deposition was performed at a slightly higher rate, approximately 14.1 nm/s (2.0 mil/hr). The applied closeout layer thickness was approximately 0.102 cm in the center and 0.051 cm on the ends.

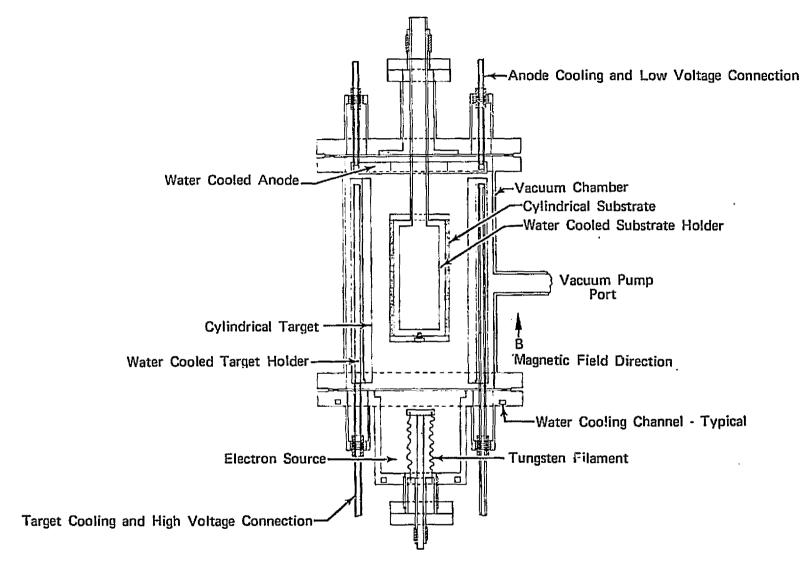
Figure 32. Schematic of Hollow Cathode Coater

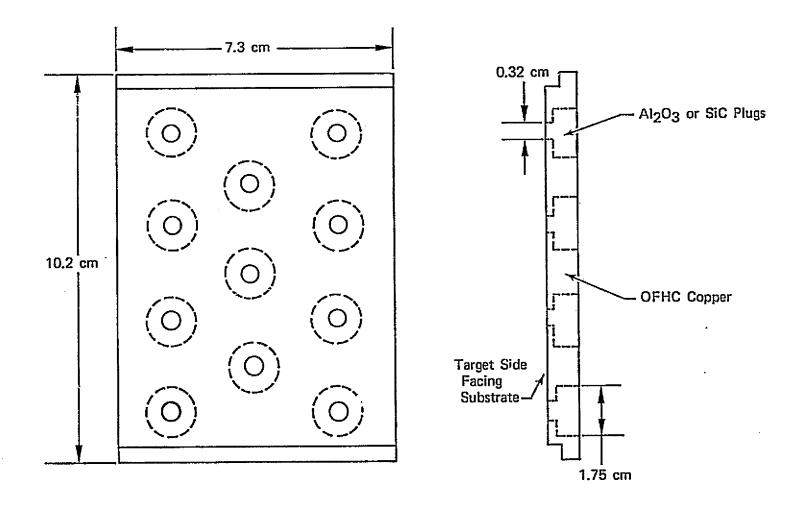
Figure 34. Composite $\mathrm{Al_2O_3}$ - OFHC Copper and SiC - OFHC Copper Used in Flat Plate Coater

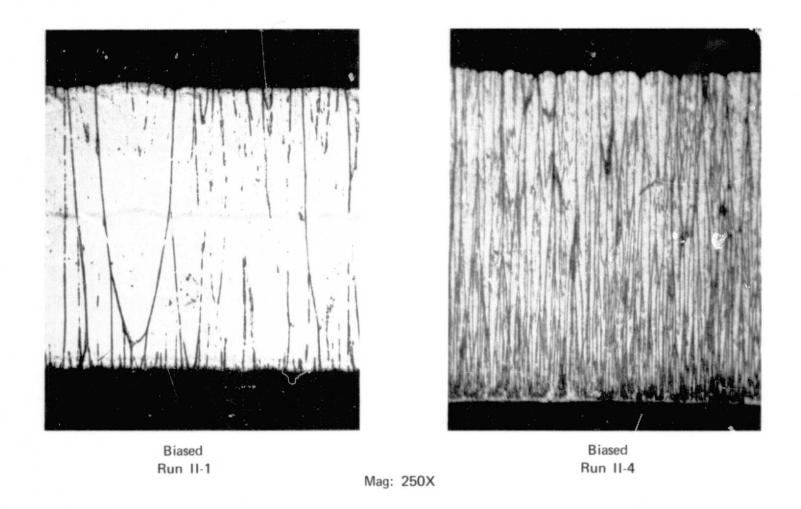
Figure 35. Open Fibrous Structure of OFHC Copper Sputtered at Low Substrate Temperatures (333 to $389^{\circ}\mathrm{K}$)

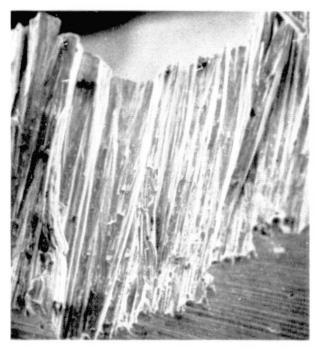
Figure 36. Typical Fracture Topography of OFHC Copper Deposited at Low Substrate Temperatures

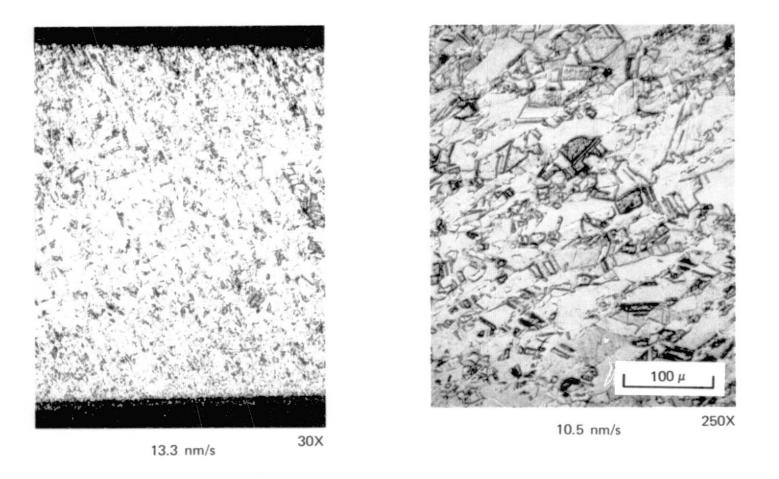
Figure 37. Microstructure of OFHC Copper Sputtered at 700°K (800°F) With Low Deposition Rates, Run II-7

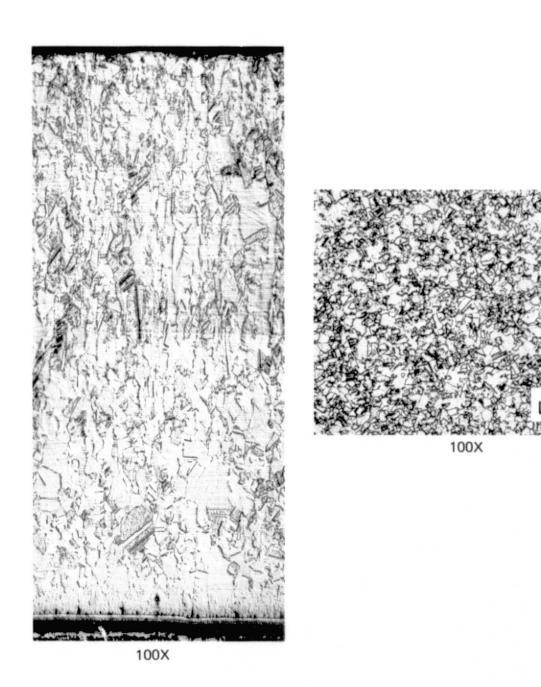
Figure 40. Microstructure of OFHC Copper Sputtered With a Substrate Temperature of 644°K (700°F) and a Deposition Rate of 8.5 nm/s (1.2 mils/hr) in Run II-8

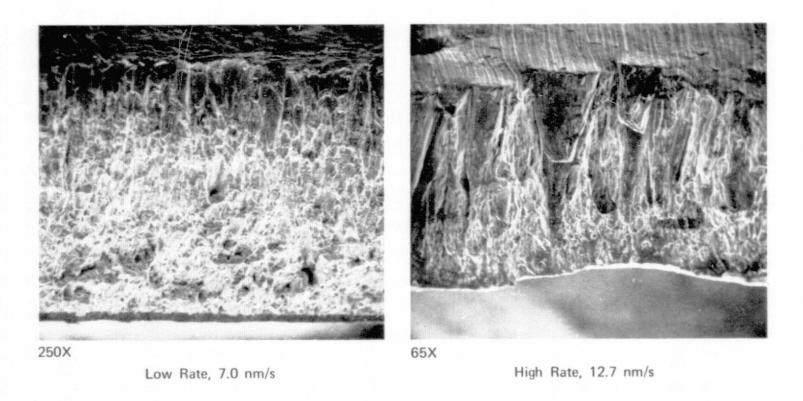
Figure 41. Fracture Topography of OFHC Copper, Run II-8

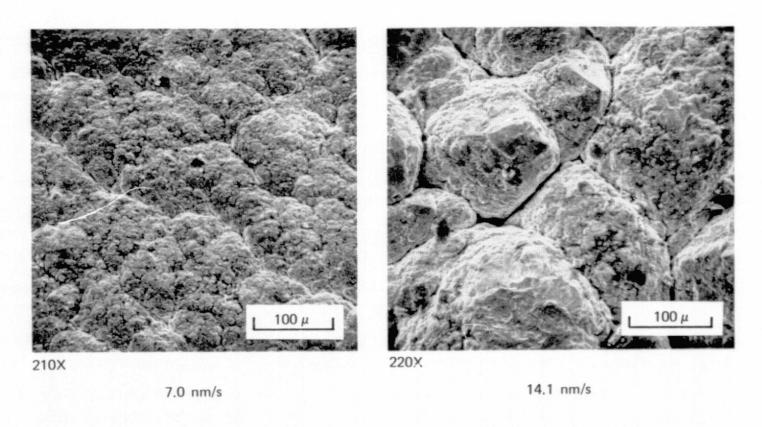
Figure 42. Surface Topography of High and Low Deposition Rate Deposits on Run II-7 Substrate

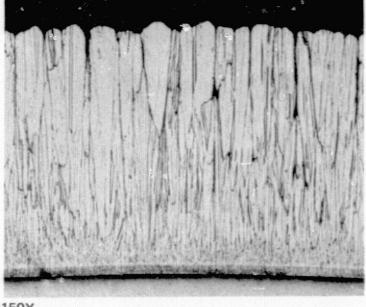
Figure 45. Microstructure of 0.15 Zr-Cu Deposited at 24.6 nm/s (3.5 mils/hr) and a Substrate Temperature of 698°K (800°F)

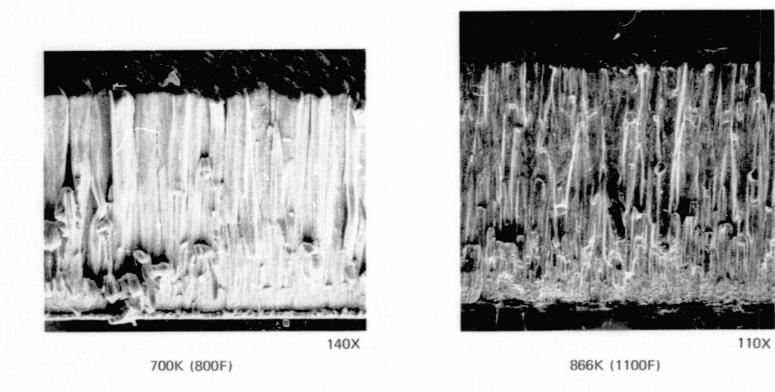
Figure 48. Typical Brittle Fracture Topography of 0.15 Zr-Cu Sputtered With High Substrate Temperatures FD 91410

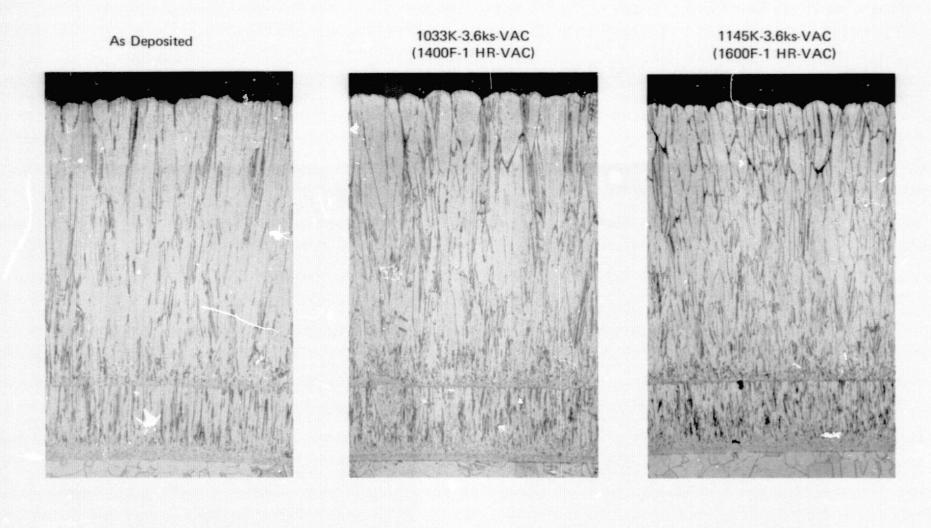
Figure 49. Microstructure of As Sputtered and Heat Treated 0.15 Zr-Cu Alloy Deposited in Run II-18. Substrate - OFHC Copper

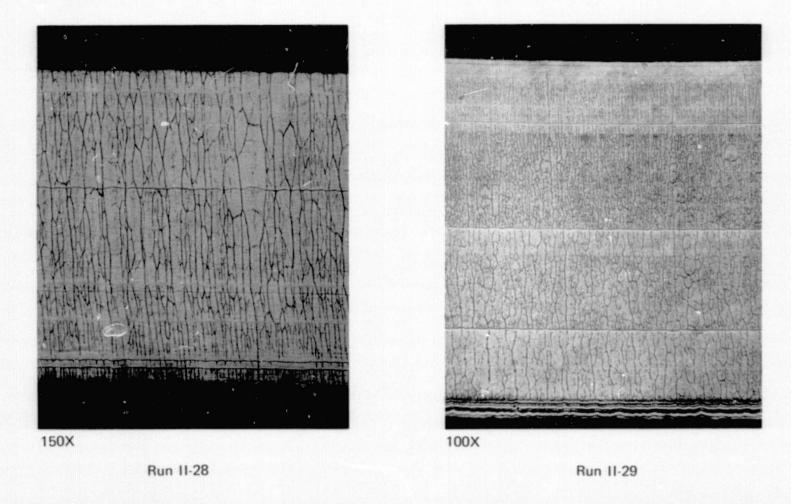
Figure 50. Dense Structure of 0.15 Zr-Cu Deposited from a Triode Discharge (Biased) in Runs II-28 and II-29

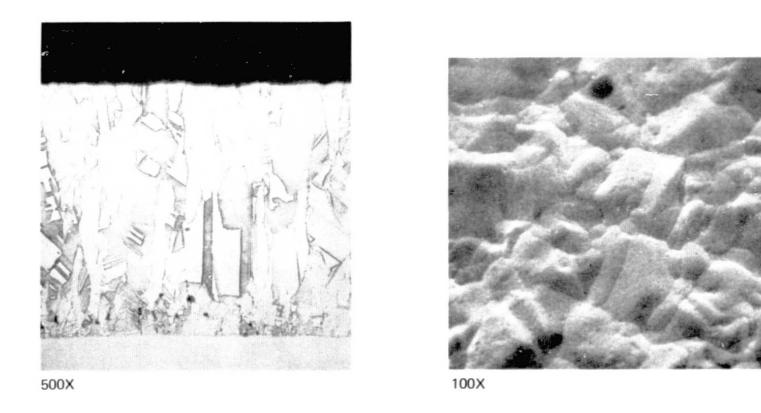
Figure 54. Microstructure and Surface Topography of 0.15 Zr-Cu Sputtered in Run II-A-2. Substrate Temperatures 1115° K $(1550^{\circ}F)$

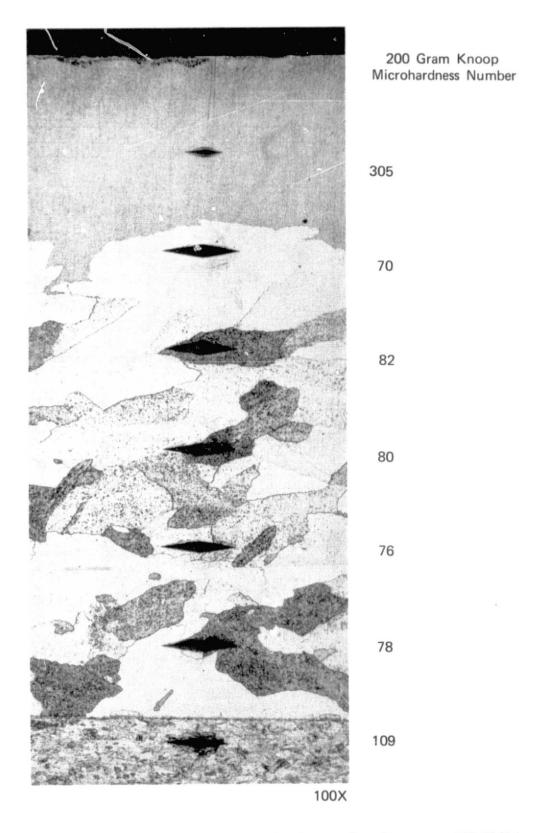
Figure 58. Structure and Microhardness of as Deposited Cu + SiC in Deposition II-A-15

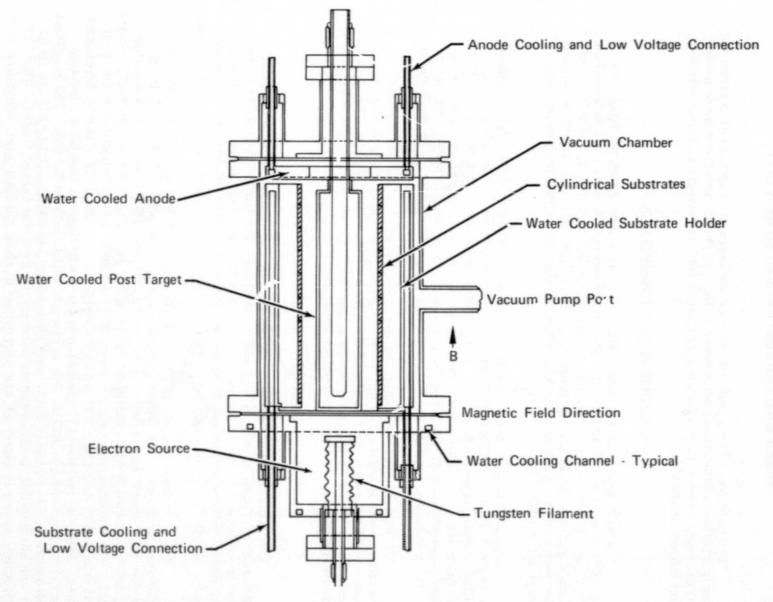
Figure 60. Schematic of Post Cathode Coater

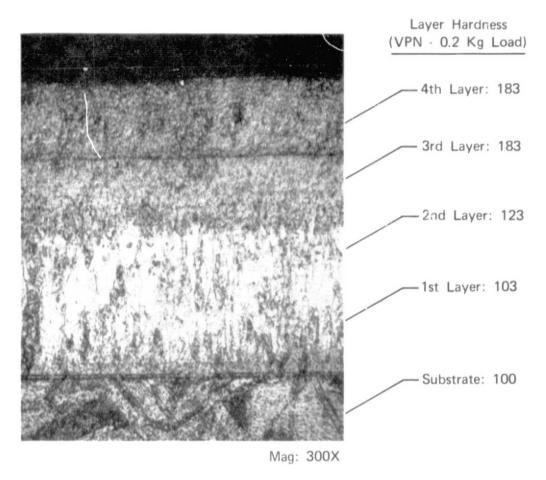
Figure 61. Microstructure and Hardness of 4 Layer FD 91427 OFHC Copper Deposit (Run III-1)

The four layer deposit microstructure and layer hardness of run III-1 is shown in figure 61. The first layer was deposited with a -50V bias, while the successive layers were applied with a -25V, OV and +11V bias. The deposition rate was approximately equivalent for each layer; 2.4 to 2.8 nm/s (0.34-0.39 mils/hr). The substrate reached a temperature of 730°K during deposition of the first layer and decreased to 616°K during deposition of the third layer due to decreasing bias. With the positive 11V bias imposed in sputtering the last layer, the temperature increased to (661°K) due to electron bombardment heating. The resultant structure was completely dense with high quality interfaces, figure 61. In fact, it was not possible to afferentiate between the first and second layers. The structure shown in figure 61 was overetched to show the finer grain structure of the outer layers and the outer layer thickness.

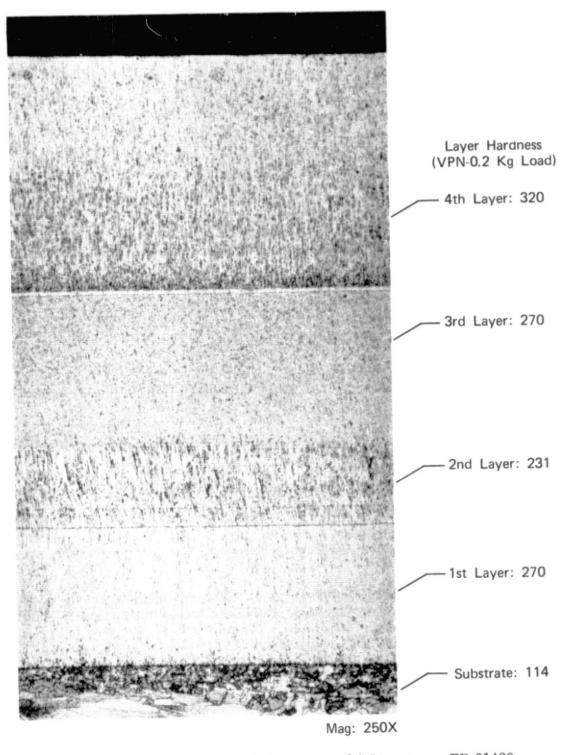
Figure 62. Microstructure and Hardness of 4 Layer FD 91428 0.15 Zr-Cu Deposit, Run III-2

In LCF testing, the difference in performance of the two deposits was readily apparent, table XIV. The layered OFHC copper withstood 374 cycles until a surface crack resulted, and failed at 585 cycles. This life was comparable to the baseline OFHC copper fatigue life. A significant reduction in fatigue properties was observed with the first 0.15 Zr-Cu layer structure tested.

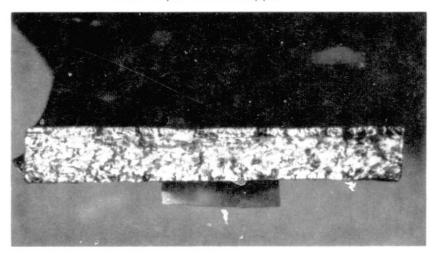
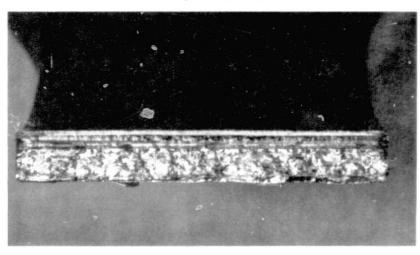
Four Layer OFHC Copper

62 Cycles to Crack 267 Cycles to Failure

Four Layer 0.15Zr-Cu

374 Cycles to Crack 585 Cycles to Failure

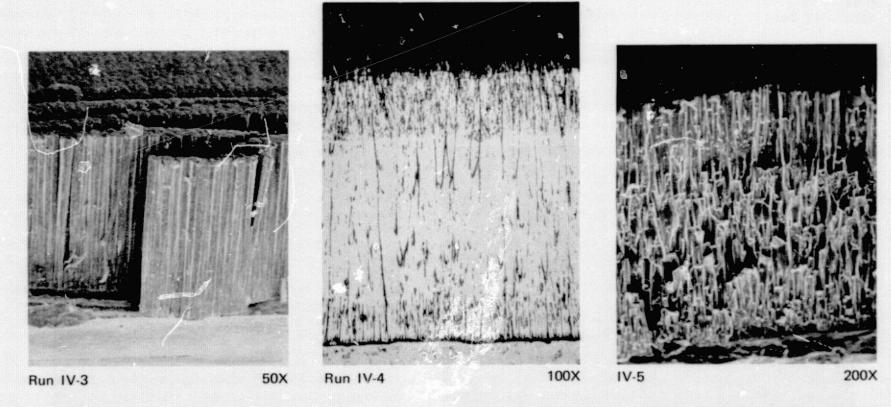
Figure 67. Representative Microstructure of Ti-5A1-2.55n Deposited at Elevated Temperatures on Copper Substrates in Diode Mode

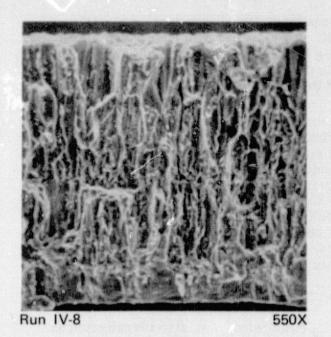
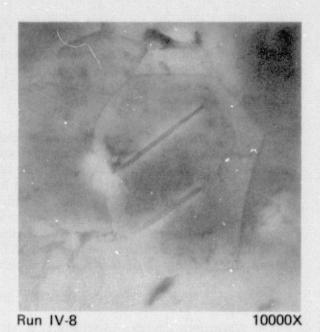
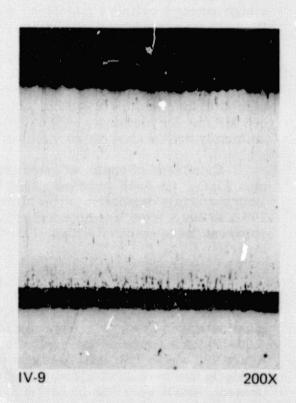
Figure 68. Typically Dense Ti-5Al-2.5Sn Deposits and Ductile Appearing Fractures Resulting from High Temperature, Low Rate Depositions in the Triode Mode. Note Especially the Fine Grain Size in the Transmission Photomicrography, the Acicular Hydride Phase and the TiCu₃ Intermetallic at the Cu-Ti Interface

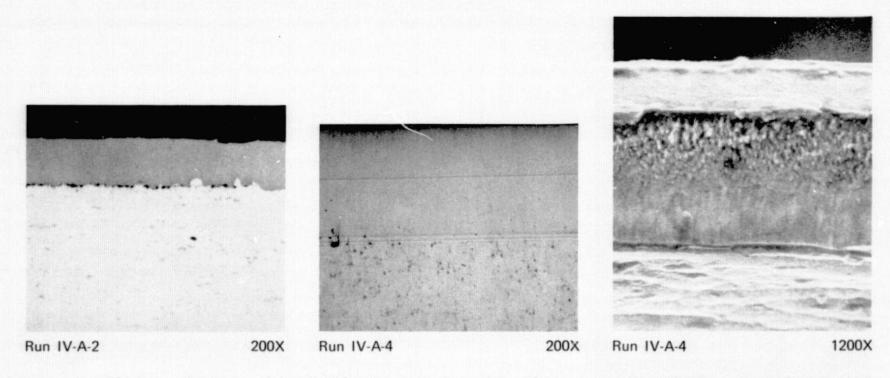
Figure 69. The Dense Structure of the Ti-5Al-2.5Sn Deposits and Ductile Appearing Fracture Were Typical FD 91433 of Triode Depositions. Note the Abrasive Inclusions at the Interface of IV-A-2 Where the Substrate was Vapor Blasted Prior to Sputter Cleaning Compared to the Relatively Clean SiC Sanded Interface of Run IV-A-4

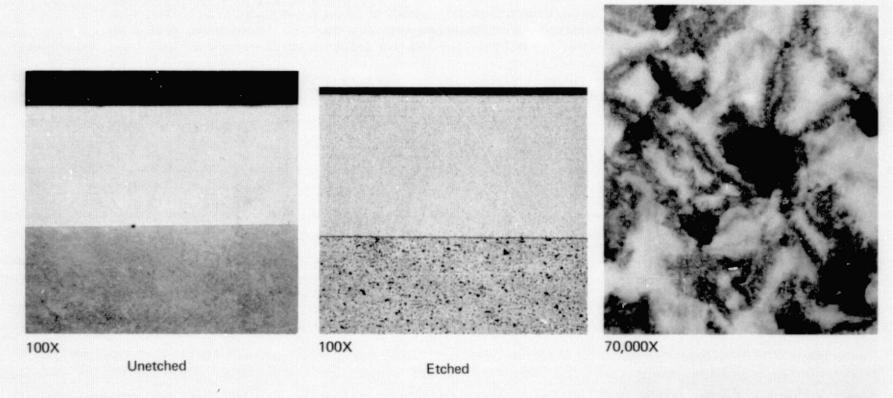
Figure 70. Microstructure of Pure Aluminum As Sputtered in Deposition IV-A-11. Note the Dense Deposit, Clean Interface and Extremely Fine Grain Size

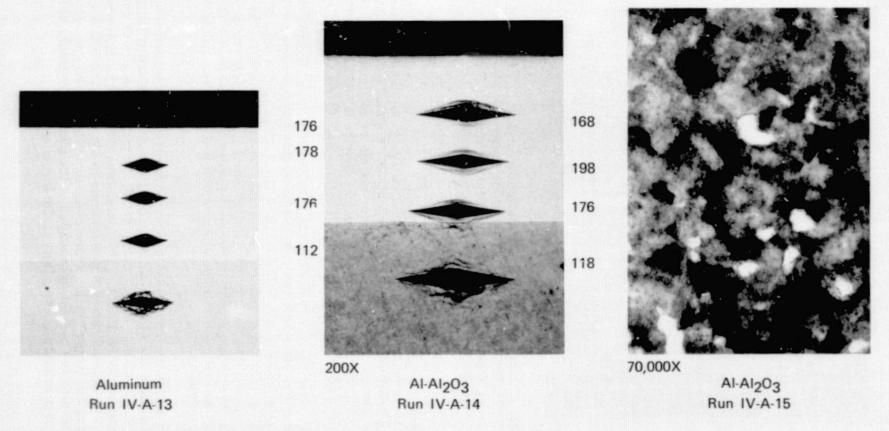
Figure 71. Two Hundred Gram Knoop Microhardness Measurements Show the Slight Increase in Hardness Realized in the Co-Deposited Al+Al₂O₃. The Ultra Fine Grain Size is Evident from the Transmission Photomicrograph

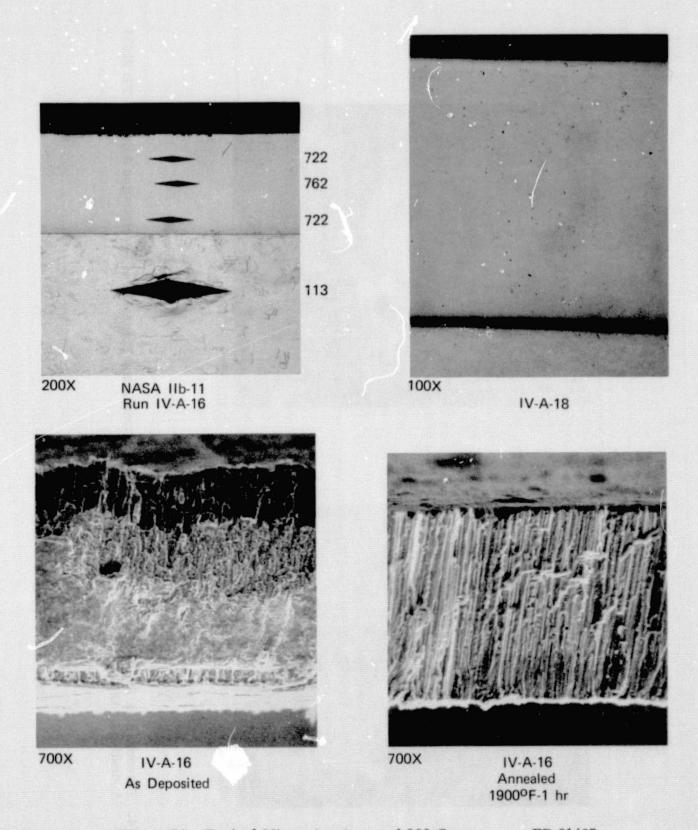
Figure 73. Typical Microstructure and 200 Gram Knoop Microhardness of NASA IIb-11 Sputtered Deposits

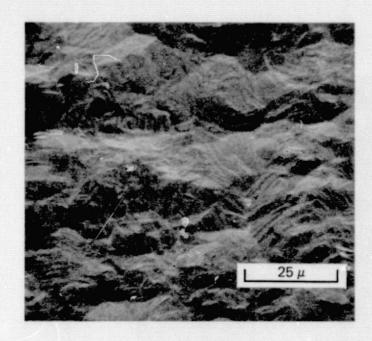
Figure 79. Typical Surface Topography of Task V Sputtered OFHC Copper Deposits. (Surface Shown from Run V-6 Deposit)

The surface of all deposits exhibited a faceted topography, figure 79. Although deposition rate was varied between 3.5 to 8.5 nm/s (0.48 to 1.21 mils/hr), an effect of rate on structure and topography was not observed.

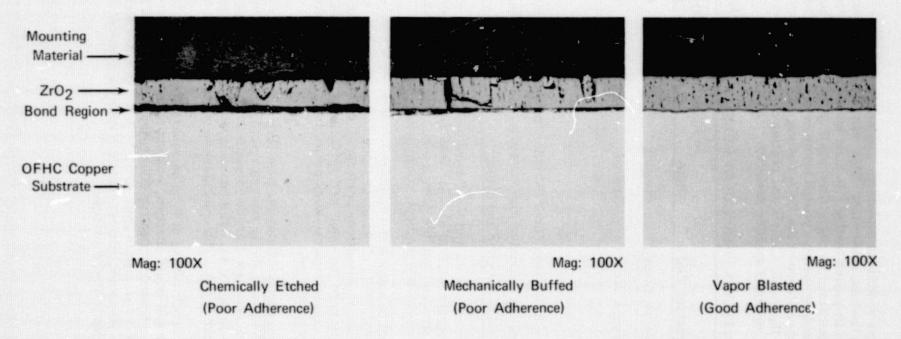
Figure 81. Effect of Substrate Surface Finish on Bonding of RF Sputtered ZrO₂ on ID Surface of OFHC Copper Cylinder (Note Substrate Grounded During Deposition), Run V-12

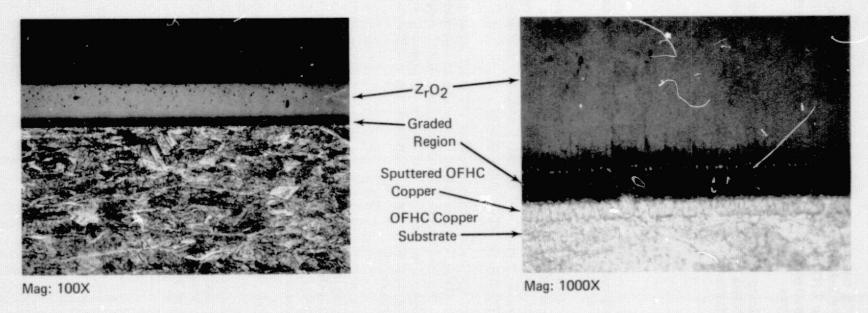
Figure 83. Microstructure of Graded OFHC Copper ZrO₂ Coating on Inner Surface of 2.6 inch ID OFHC Copper Cylinder (Applied by RF Sputtering; Etched), Run V-14
