NASA CR-143724

ASE-3604

ANS HARD X-RAY EXPERIMENT DEVELOPMENT PROGRAM

30 NOVEMBER 1970 - 30 SEPTEMBER 1974

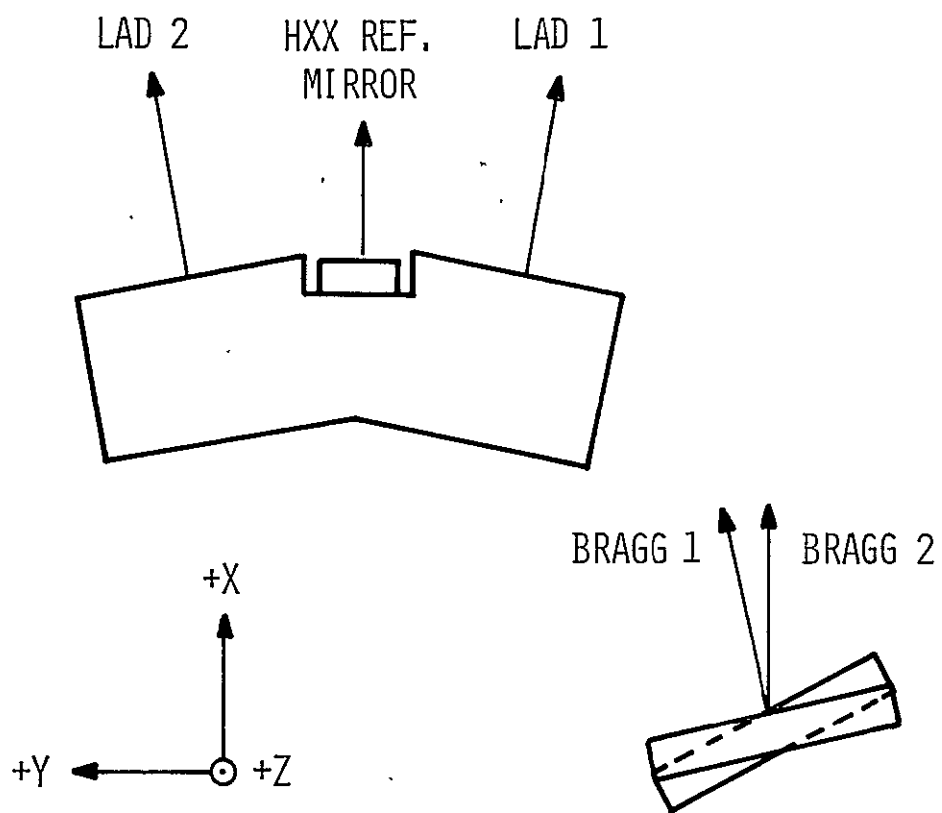
Figure 1-4. Crystal and Collimator Alignment

Figure 1-4 shows schematically the alignment of the 2 crystals and of the 2 LAD Proportional Counters around the z-axis relative to the reference HXX mirror. The HXX mirror is itself aligned to better than 0.5 arc minute to the X-axis of the S/C. The angles in the figure are greatly exaggerated for clarity. The angles in the x-y plane increase as the vector rotates around the z-axis from the +x-axis toward the +y-axis.

The values for these different vectors are given in Table 1-2, and are for an experiment temperature of 19.5°C .

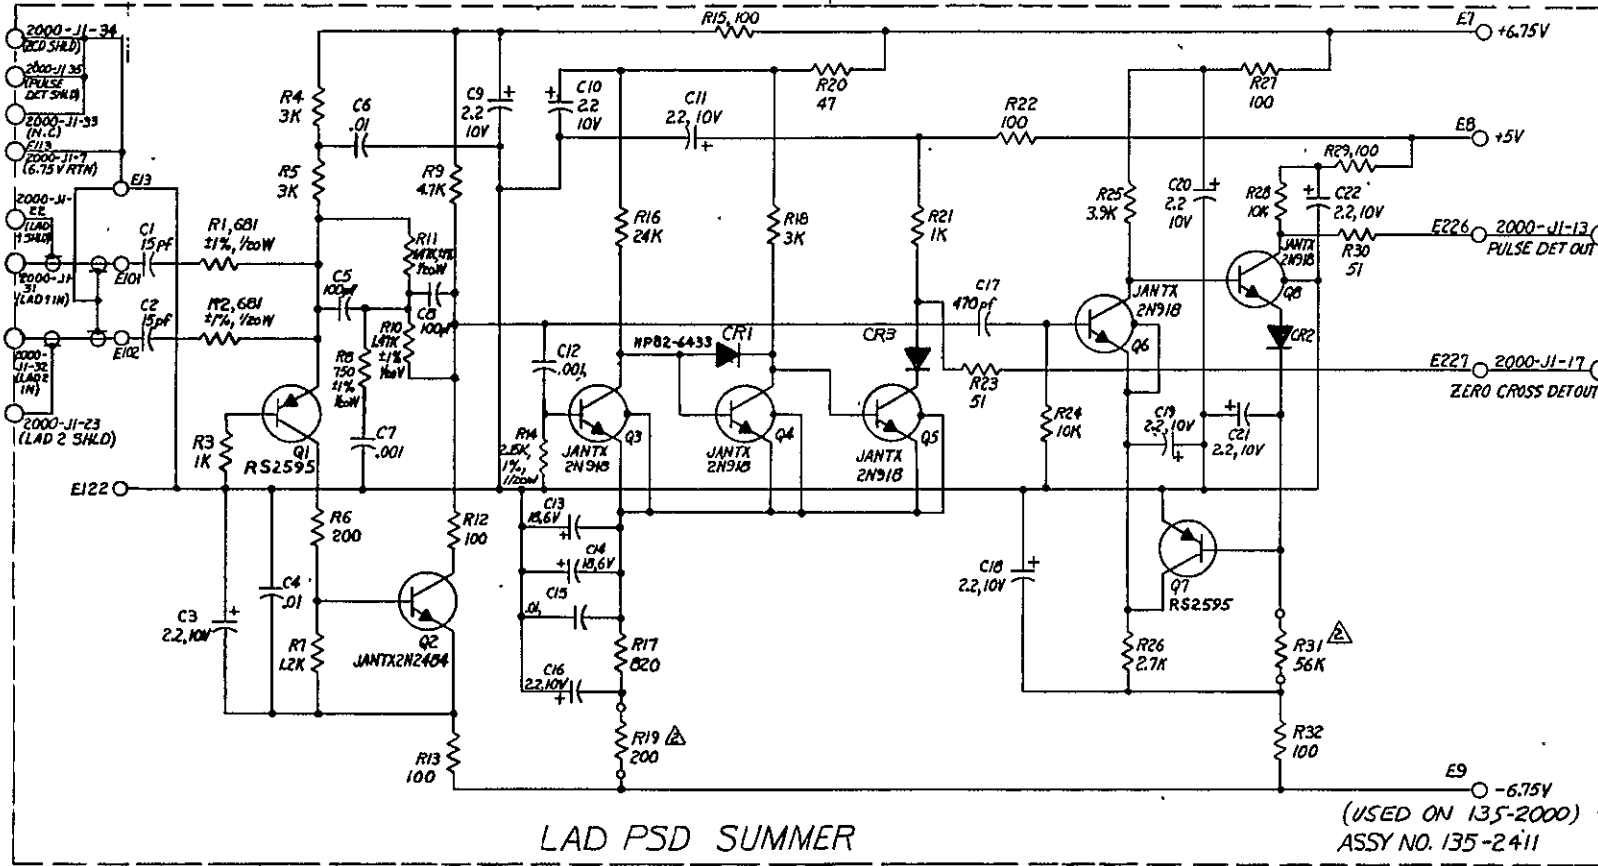
Figure 2-6. LAD PSD Summer Assembly No. 135-2411

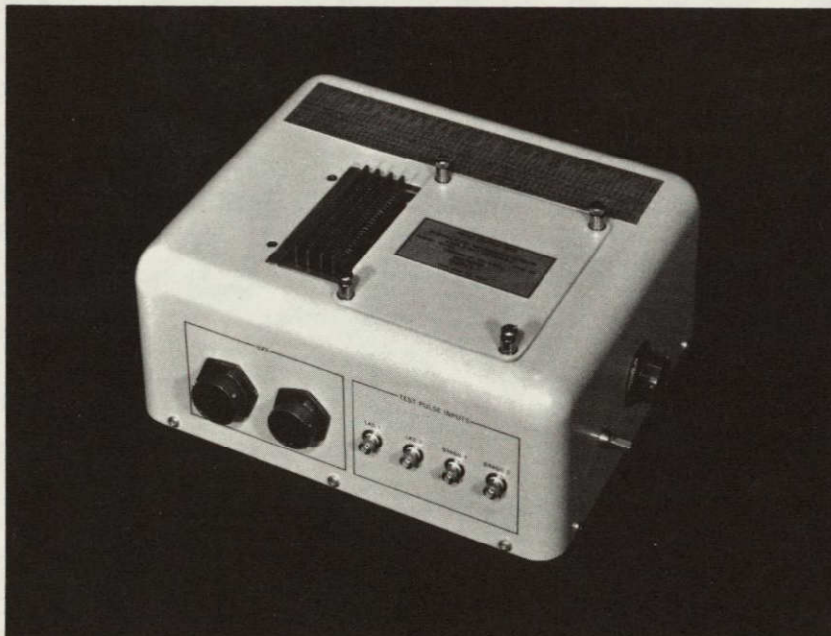
Figure 2-9 Input/Output (IOU)
ANS HXX Experiment
Experiment Checkout Equipment (ECE)
