NASA TN D-7669

A FLIGHT INVESTIGATION WITH A STOL AIRPLANE FLYING CURVED, DESCENDING INSTRUMENT APPROACH PATHS

1. Report No. NASA TN D-7669		2. Government Accession No.		3. Recipient's Catalog No.	
4. Title and Subtitle A FLIGHT INVESTIGATION WITH A STOL AIRPLANE FLYING CURVED, DESCENDING INSTRUMENT APPROACH PATHS				5. Report Date October 1974

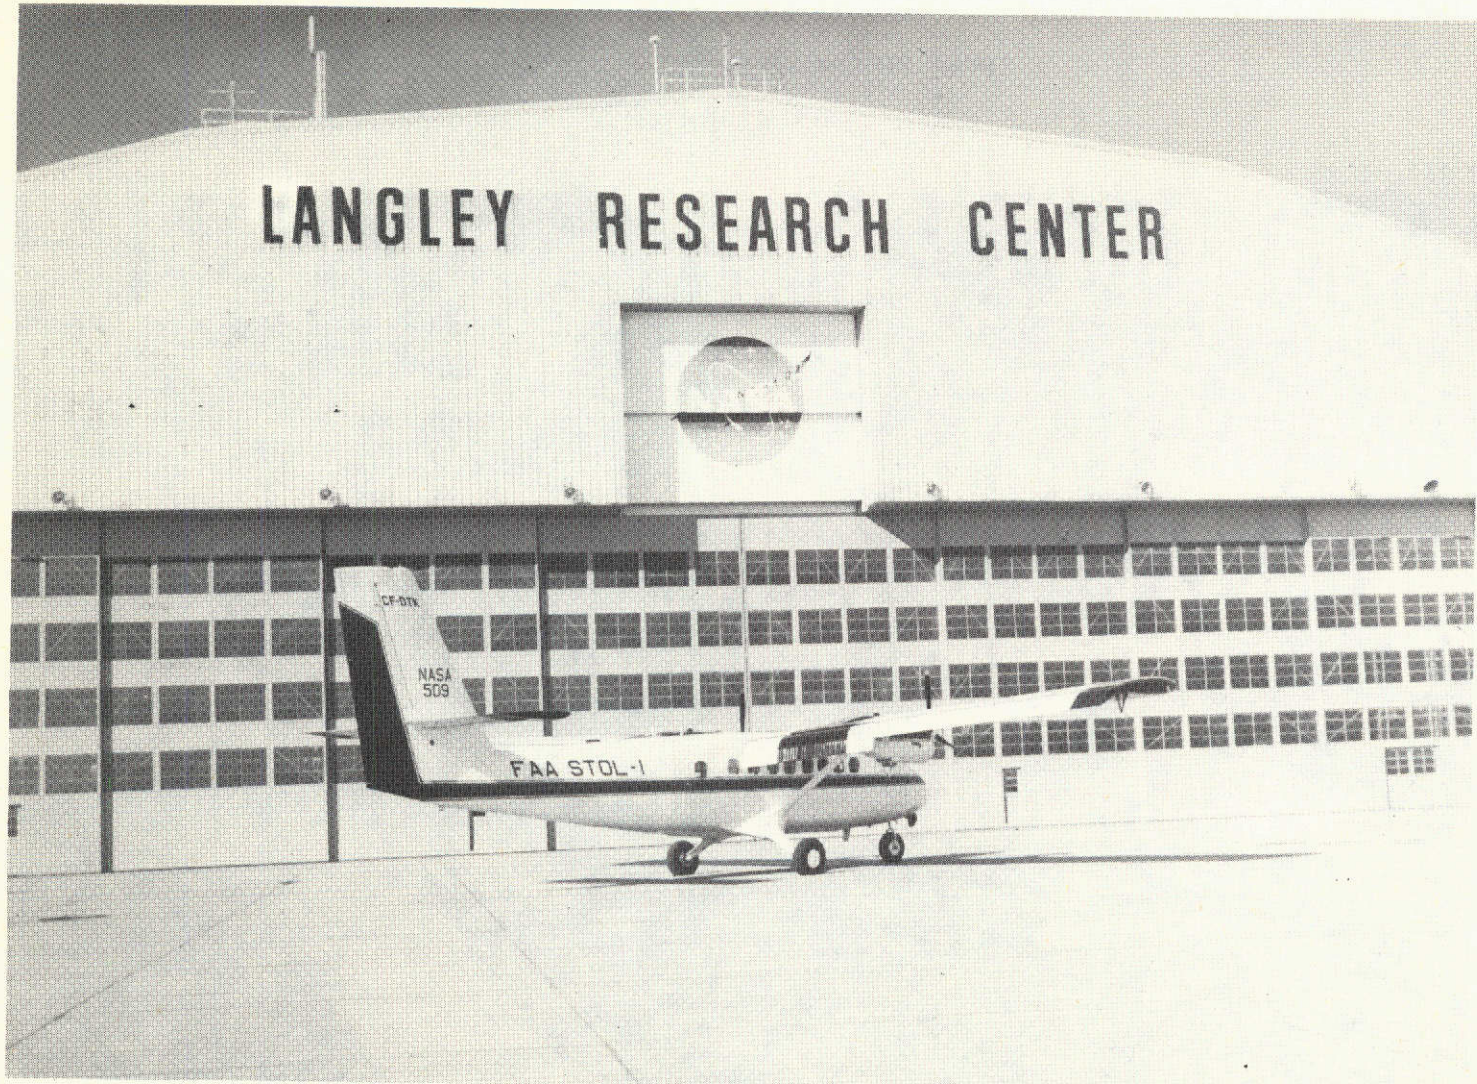
L-73-338

Figure 2.- Twin Otter airplane.

The test airplane, a De Havilland Twin Otter, is a twin turboprop driven airplane with high lift devices (double slotted flaps), a high wing, fixed landing gear, and STOL capability. It is capable of carrying up to 20 passengers and a crew of 2. Table I lists the airplane characteristics, and a photograph of the airplane is presented in figure 2.

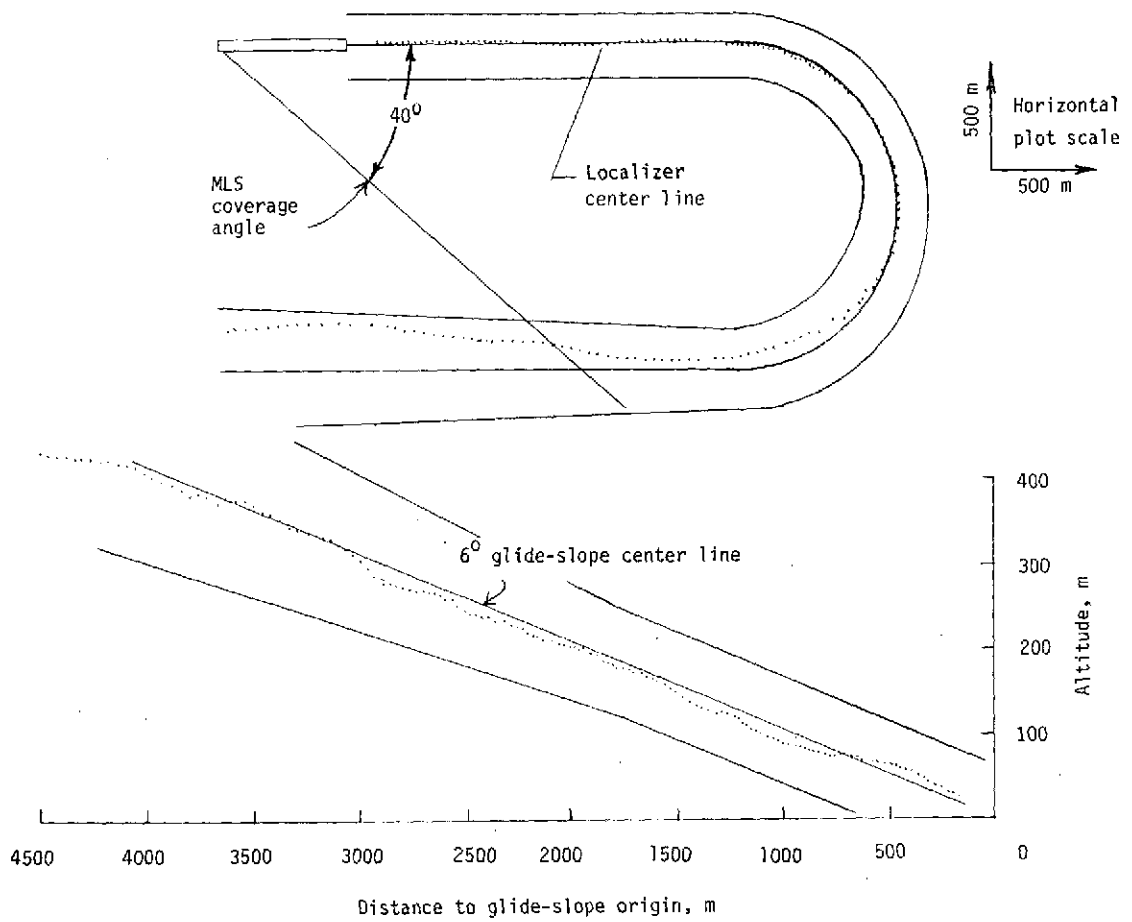
(a) Radar plots.

Figure 9.- Typical curved approach path results.

(b) Time histories of flight conditions.

(c) Time histories of flight director inputs and commands and glide-slope and localizer deviations.

Typical results of the pertinent quantities recorded are shown in figure 9. The records end at the decision height of 30.5 m (100 ft). Figure 9(a) shows a radar plot of the airplane position relative to the horizontal and vertical flight paths to be flown. The solid lines represent the localizer and glide-slope center lines and beam boundaries. The dotted lines are the consecutive positions of the airplane at 1-second intervals. The assumed MLS azimuth coverage angle of 40° is indicated. The location where the flight path entered the assumed MLS coverage was the point at which telemetry of the guidance data from the ground was initiated. Figure 9(b) shows pertinent flight conditions as a function of time along the flight path. Glide-slope acquisition and the time period in the turn are indicated. For this test, the glide slope was acquired at 130 seconds before reaching an altitude of 30.5 m (100 ft). The turn occurred in the period from 126 seconds to 35 seconds before reaching an altitude of 30.5 m (100 ft). Figure 9(c) shows some of the input and output signals to the flight director computer. The pitch- and roll-command signals were calculated by the onboard flight director computer. (See fig. 5.) The pitch- and roll-command signal variations from zero represent the pilot's failure to satisfy the commands. The scales on these two time histories are deviation signals normalized with respect to the equivalent signal for the half-beam width deviation. The reference track angle signal was calculated by the Wallops ground-based general purpose computer and was continuously sent to the airplane beginning at 152 seconds before an altitude of 30.5 m (100 ft) was reached. This time corresponds to the airplane's entrance into the assumed MLS coverage. Although the reference bank angle signal was sent 14 seconds before the turn initiation, this signal was not switched to the flight director computer until a discrete signal was transmitted from the ground 5 seconds before turn entry.
