*DEVELOPMENT OF A MINIATURE SOLID PROPELLANT
ROCKET MOTOR FOR USE IN PLUME SIMULATION STUDIES*

Calspan Report No. AA-4018-W-10

APRIL 1974
CONTRACT NO. NAS8-26701
PROJECT NO. AA-4018-W

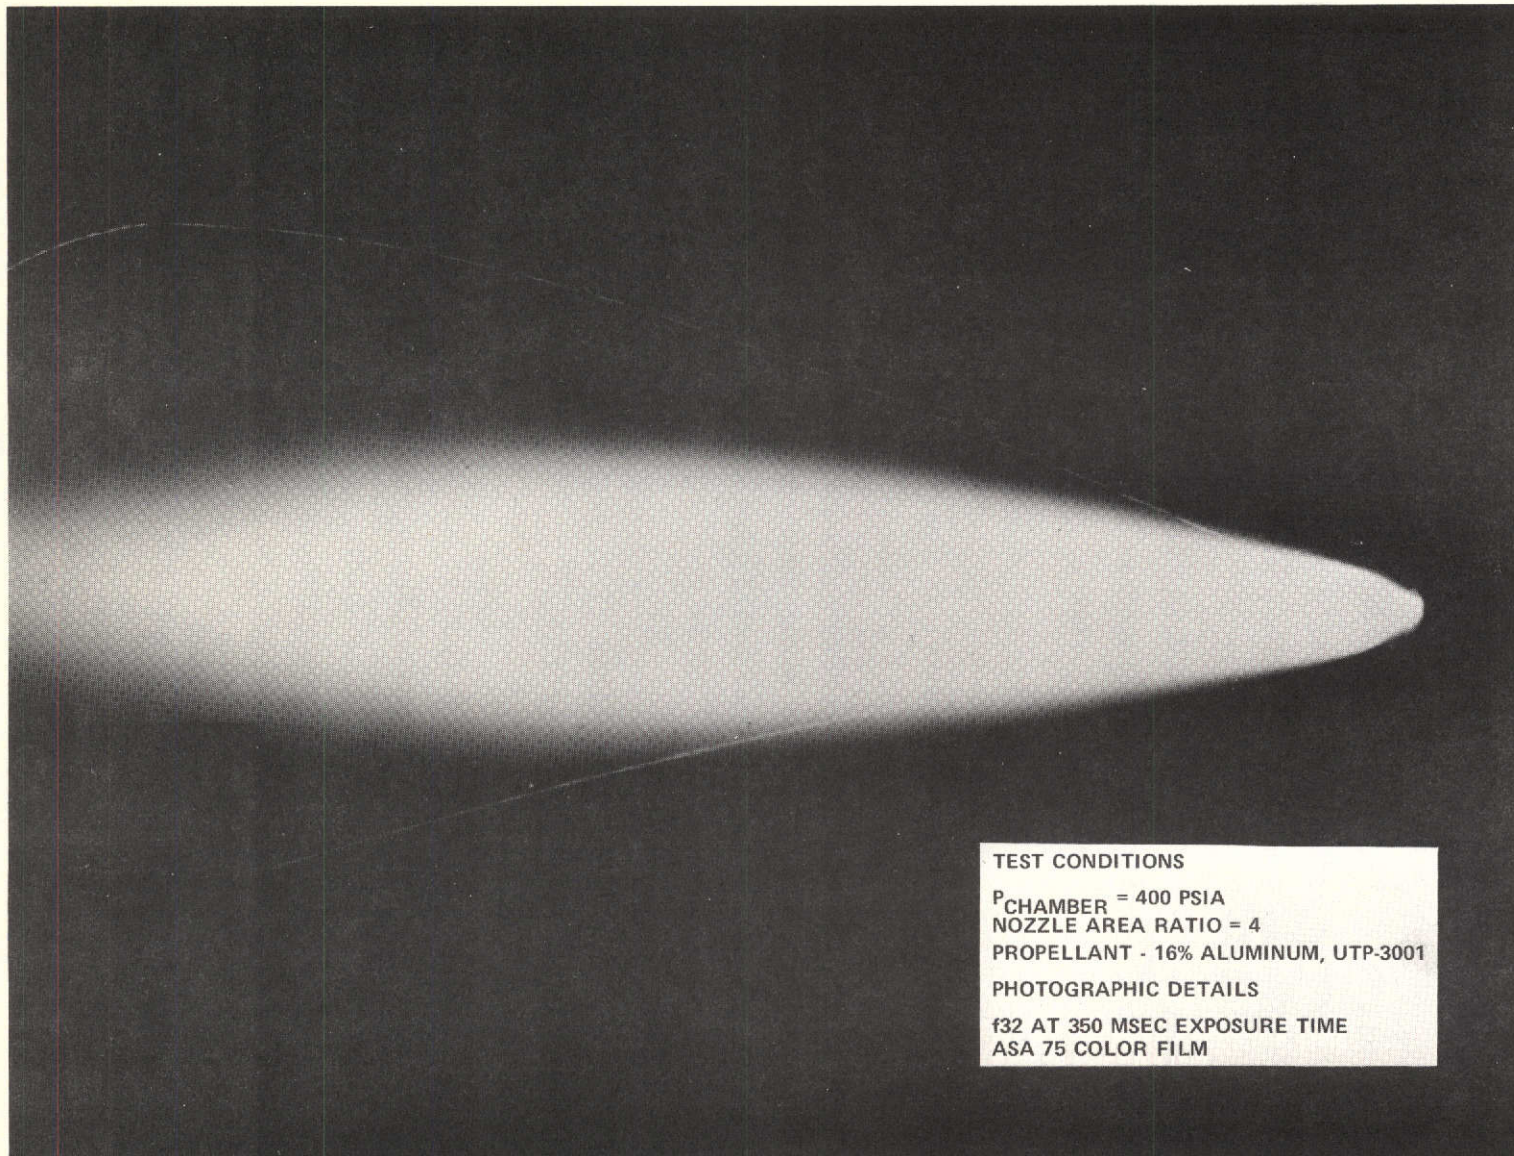
Figure 15 TIME EXPOSURE PHOTOGRAPH OF A SOLID PROPELLANT ROCKET PLUME

A time exposure photograph of a typical high aluminum content propellant rocket plume is presented as Figure 15.
