NASA CR-134600

DETERMINATION OF LIFE FOR A POLYIMIDE-EPOXY
ALTERNATOR INSULATION SYSTEM

GENERAL ELECTRIC COMPANY
AIRCRAFT EQUIPMENT DIVISION
ERIE, PENNSYLVANIA 16501

March 4, 1974

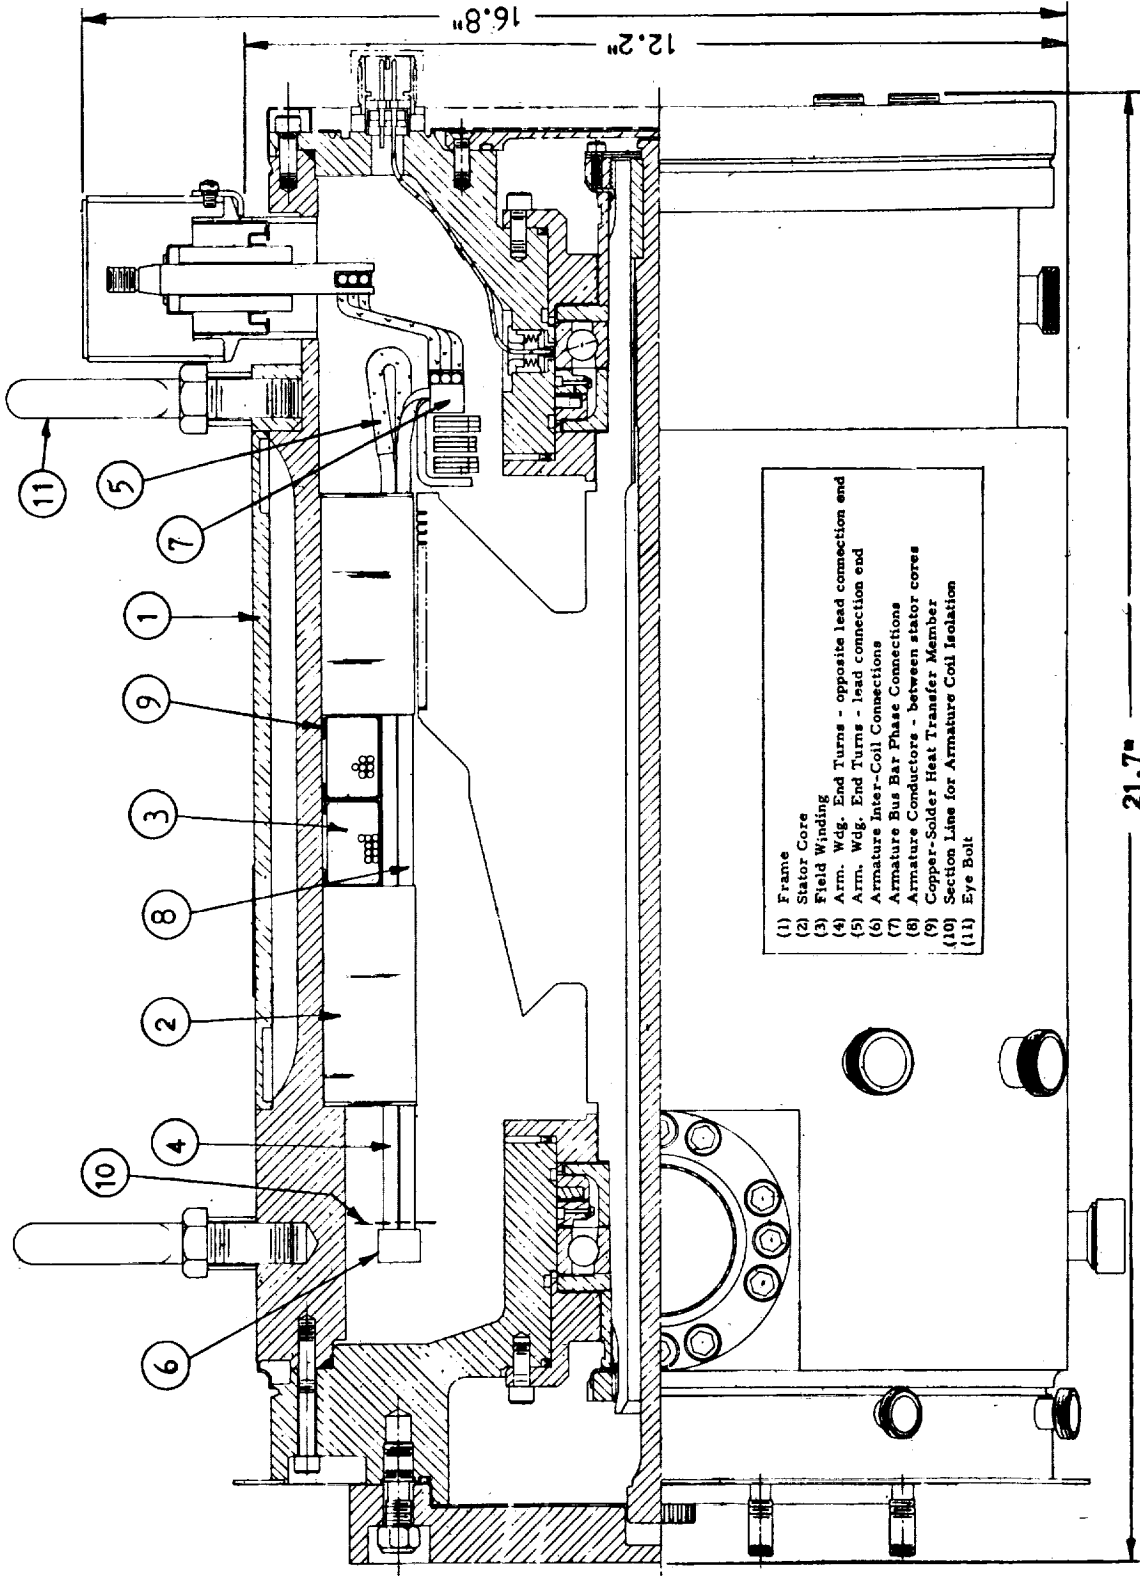
FIGURE 1. Cross Section View, Alternator Components and Insulations

C. E. = Stator Connection End; Statorette Measurement Lead End
O. C. E. = Stator Opposite Connection End
Middle = Between Core Ends
F. C. A. = Field Coil Area

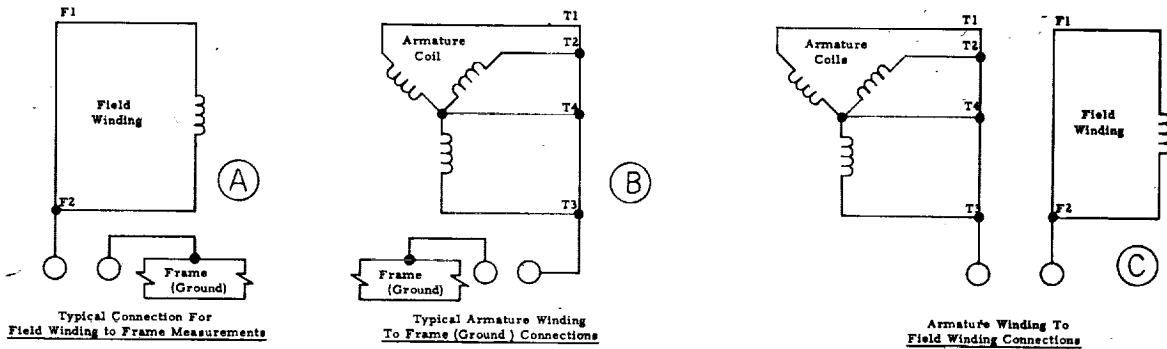
Figure 10a - Stator

FIGURE 10 - Test Measurement Schematic Diagrams
