EVALUATION OF COMMERCIALY SUPPLIED SILVER COATED TEFLON FOR SPACECRAFT TEMPERATURE CONTROL USAGE

JAMES B. HEANEY

JANUARY 1974

———— GODDARD SPACE FLIGHT CENTER ————
GREENBELT, MARYLAND

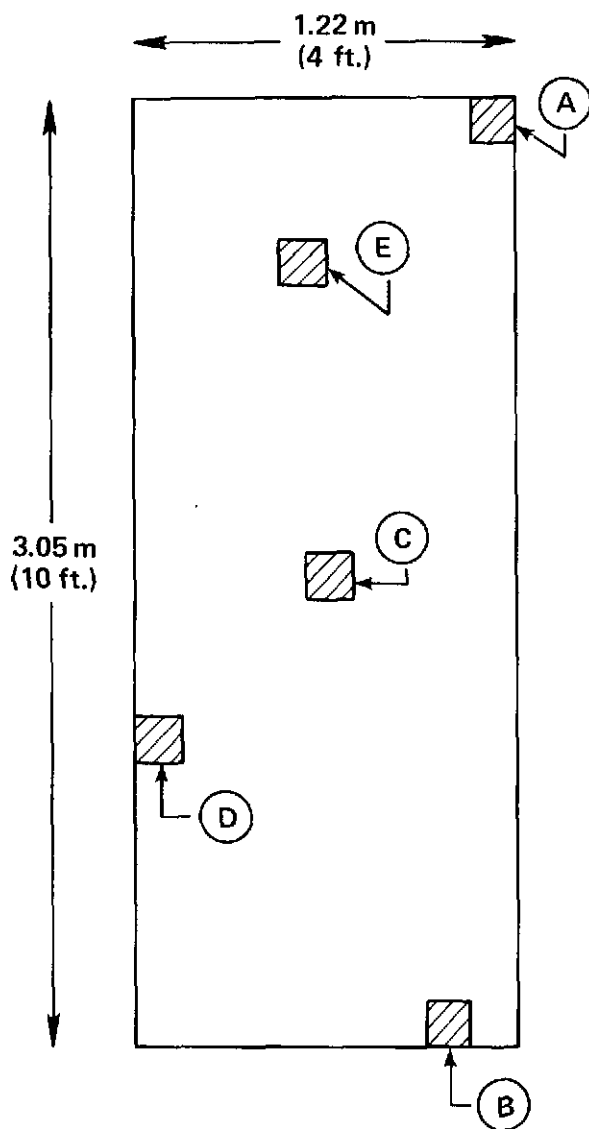
Figure 1. Location of Samples Selected From 1.22 m by 3.05 m (4' x 10') Sheets

The sample selection scheme used to achieve a degree of randomness with a relatively small number of samples is depicted in Figure 1 for the large sheets. Each piece cut out was approximately 15.2 cm by 15.2 cm (6 in. x 6 in.) square. Test samples were taken from the tape rolls at the beginning, 1/4 of the way in, near the middle and near the end and were each about 5 cm long.

Figure 1 also demonstrates the identification scheme. Each sample can be identified by its sheet number (I, II, III, etc.) and location on the sheet (IA, IIC, etc.). Letters A, B, C, D refer to the upper right corner, bottom right offset 15 cm from edge, middle, and left edge 2/3 of the way down from the top, respectively. Letter E refers to a randomly located badly scuffed area from sheet I. Only two tape rolls were studied, identified as TI and TII, and sample location is spelled out when needed.

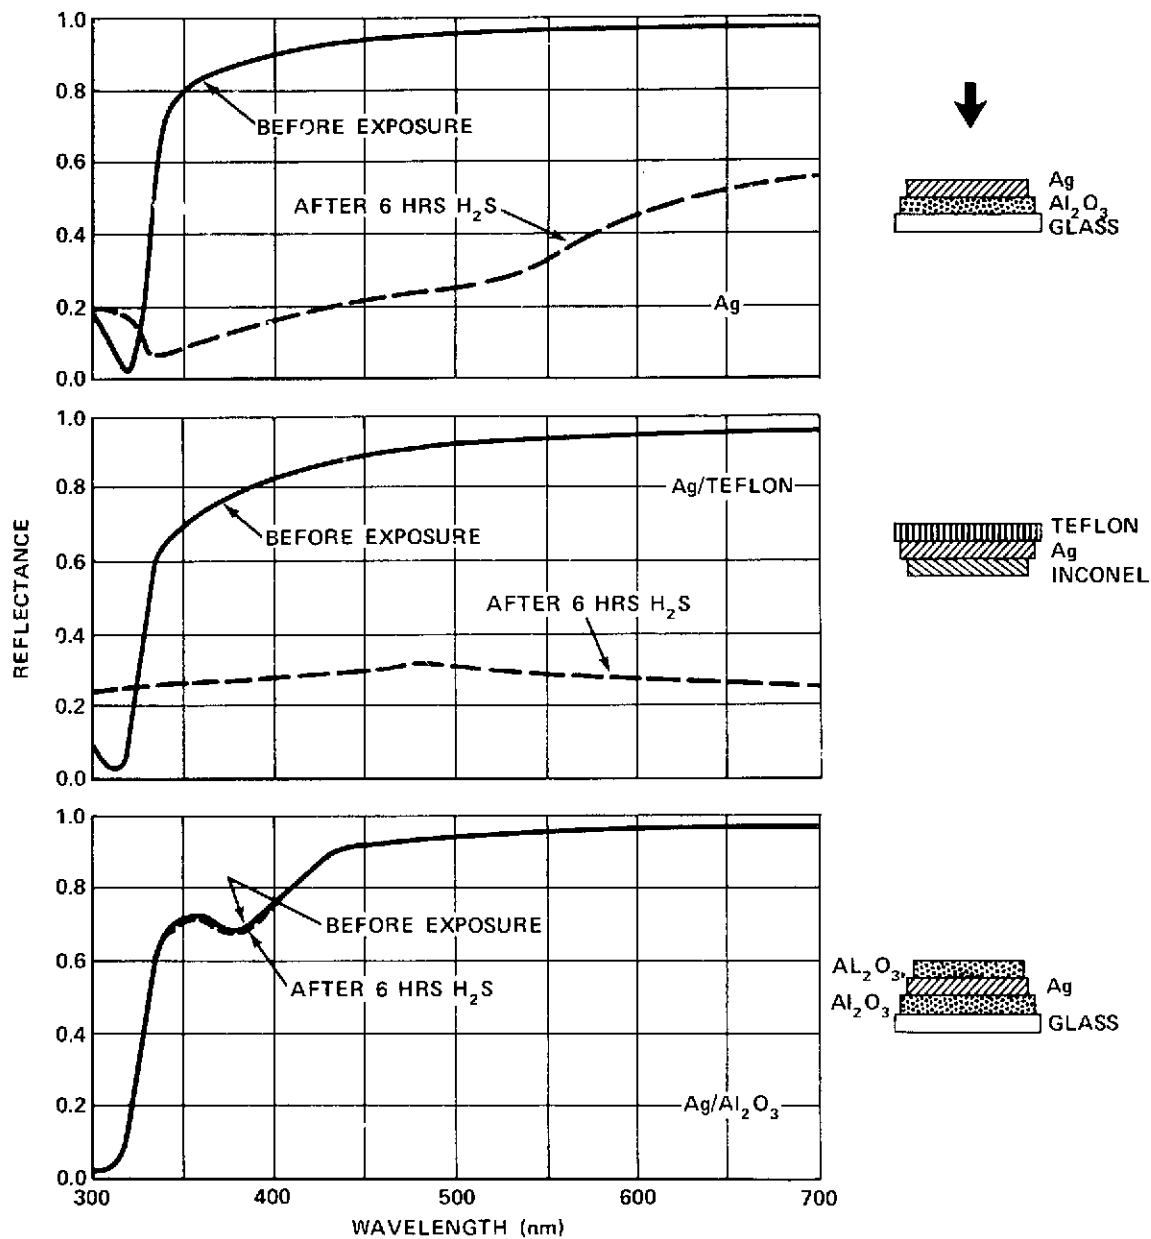
Figure 2. Reflectance of Ag/Teflon, Unprotected Ag and Ag Protected With Thin Evaporated Al₂O₃ Before and After H₂S Exposure

enriched H₂S atmosphere. The severity of the environment can be gauged from the performance of the other 2 Ag coated reflectors also plotted in Figure 2. The first coating consists of exposed Ag evaporated onto glass with an intermediate Al₂O₃ layer; the third is an identical surface overcoated with a thin protective layer of Al₂O₃. Although the degradation indicated in Figure 2 is the result of an accelerated aging process, it nevertheless demonstrates the susceptibility of Ag/teflon to long term aging in a hostile sulfur environment. In the case of coated teflon, pinholes act as avenues to allow sulfur to pass through the protective inconel layer and degrade the Ag. For this reason, adhesives containing sulfur compounds should be avoided when bonding Ag/teflon to a substrate.

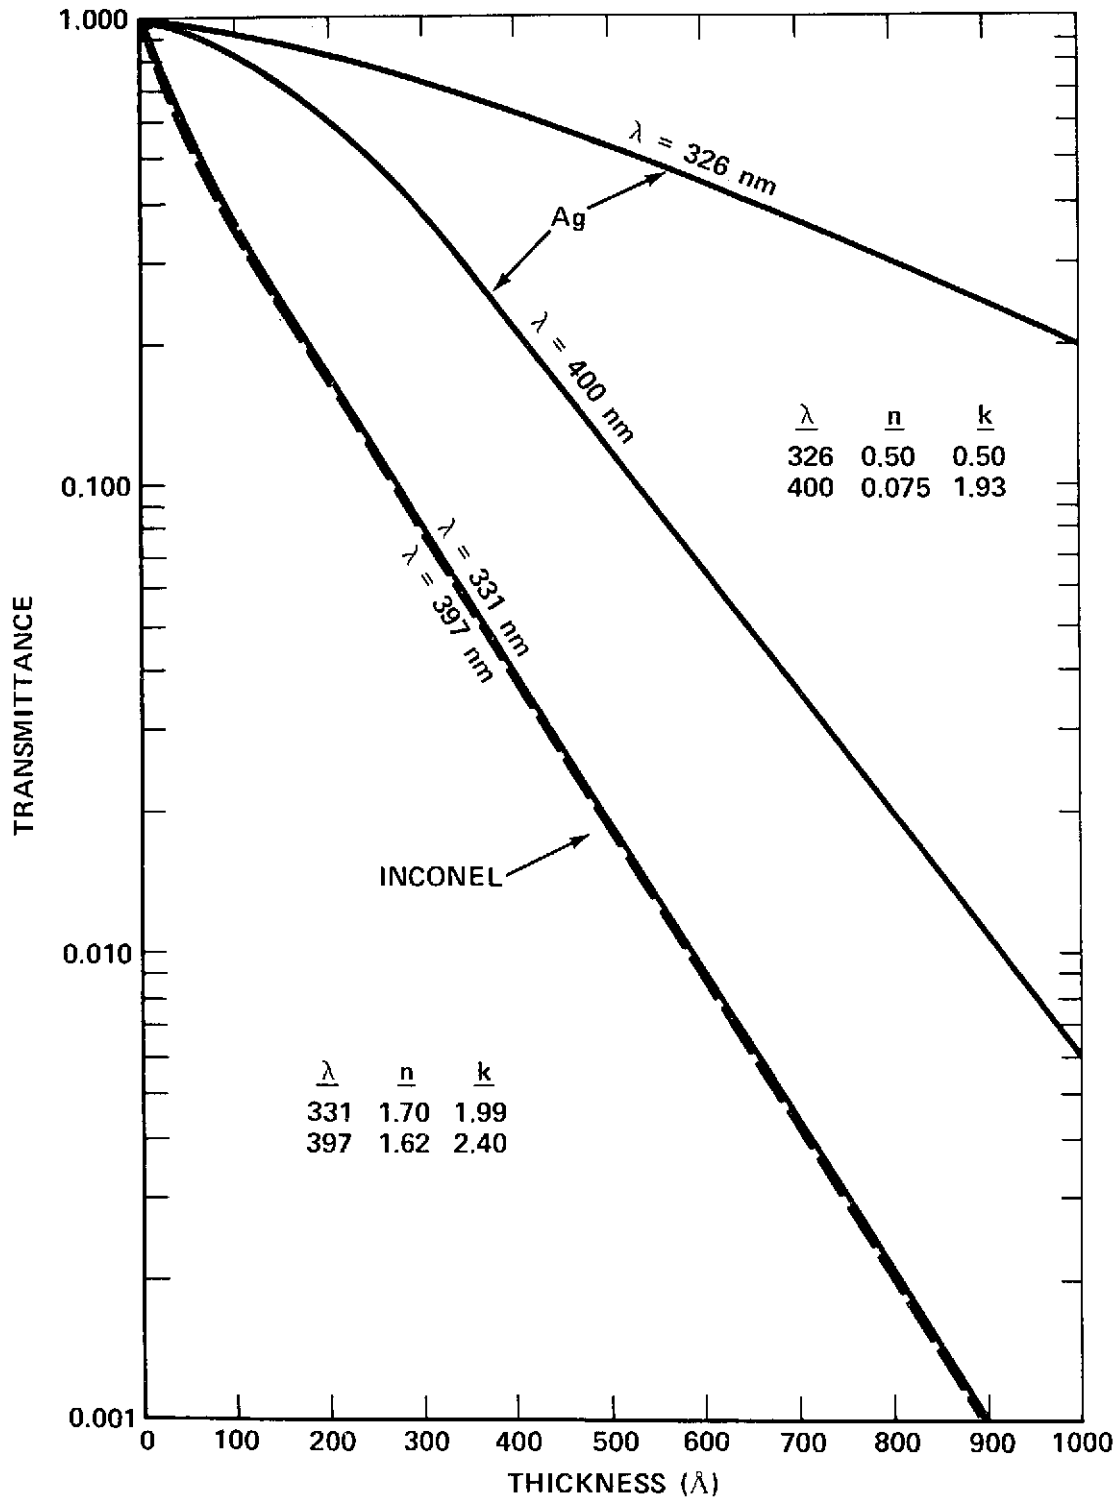
Figure 3. Calculated Transmittance of Ag as a Function of Thickness at $\lambda = 326 \text{ nm}$ and $\lambda = 400 \text{ nm}$; Transmittance of Inconel #600 Alloy as a Function of Thickness at $\lambda = 331 \text{ nm}$ and $\lambda = 397 \text{ nm}$

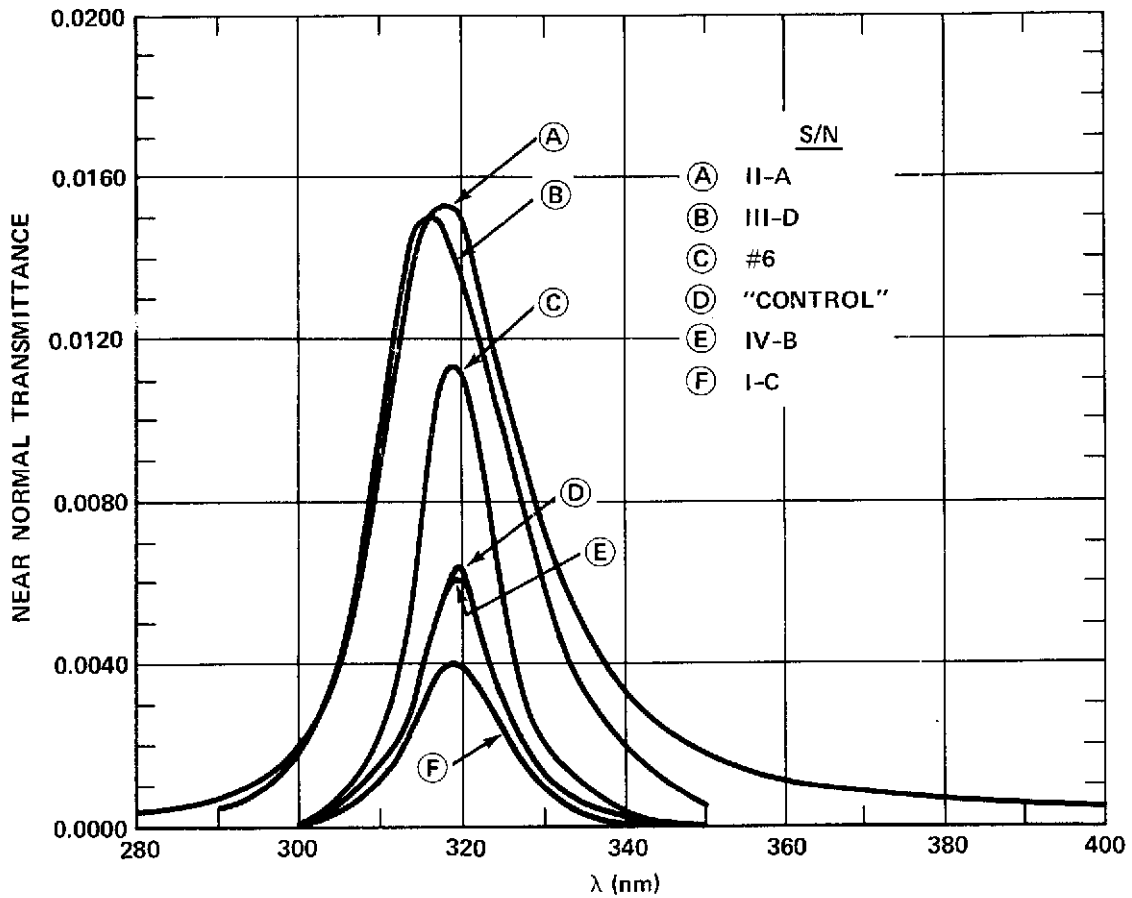
Figure 4. Transmittance of 125 μm (5 mil) Teflon/Ag/Inconel #600 Alloy Over the Wavelength Region From 270 nm to 400 nm for Selected Samples

As mentioned above, visual examination had revealed variations in the reflectance of the inconel protective layer. The inconel on the control sample prepared at GSFC was noticeably brighter than any of the commercial source material. This is shown in Figure 5 where the reflectance of the inconel side of selected samples is plotted over the wavelength region from $0.30\mu\text{m}$ to $2.4\mu\text{m}$. The specimen labeled S/N 6 was an especially dark piece supplied by G. T. Schjeldahl Co. and introduced for the purpose of comparison. This specimen was not from the group of samples undergoing evaluation but was inserted here because it is the darkest piece encountered to date and therefore represents the limit of our experience. The uv transmittance of S/N 6 can be found in Figure 4. The calculated reflectance

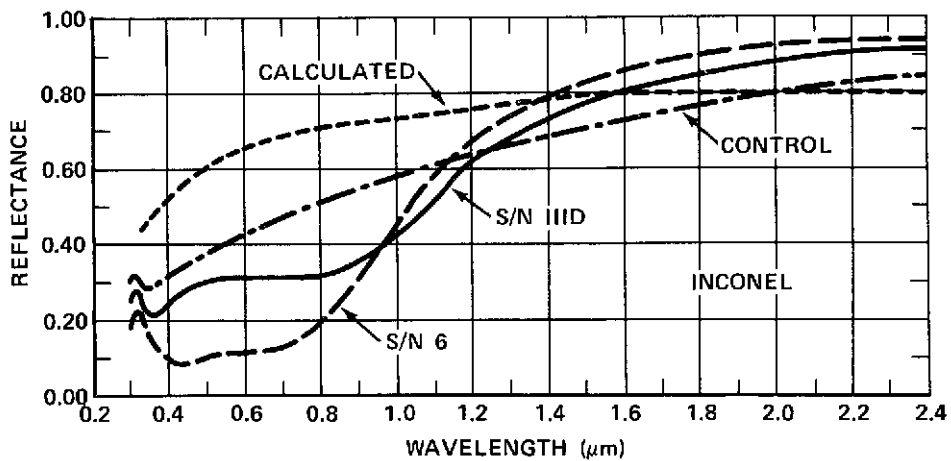
Figure 5. Reflectance of the Inconel Side of Selected Ag/Teflon Samples Over the Wavelength Range From 0.30 μm to 2.4 μm

curve of Figure 5 is based on optical constant measurements obtained from Reference 13 which relate to a film of inconel #600 alloy 625 Å thick. These referenced data indicate an increase in reflectance with thickness that is especially apparent at wavelengths greater than 1.0 μm. Connecting these observations with the measured data of Figure 5 leads to the inference that the inconel backing on the measured samples is thicker than 625 Å. The low visible reflectance in the case of the test samples is most likely due to evaporation conditions—pressure, rate, etc.—and not caused by any post-evaporation degradation. Test specimens measured before and after an 11 month aging in an ambient laboratory environment, including exposure to fluorescent room lighting, exhibited less than 1% change in total reflectance. Some aging was evident, however, from a visually observed increased surface scattering apparently due to small scale irregularities forming on the surface and perhaps associated with pinholes as discussed above. The inconel film deserves separate attention because the protective benefit that the Ag layer derives from the inconel is directly translated into the long term stability of α and, to a lesser extent, ϵ .

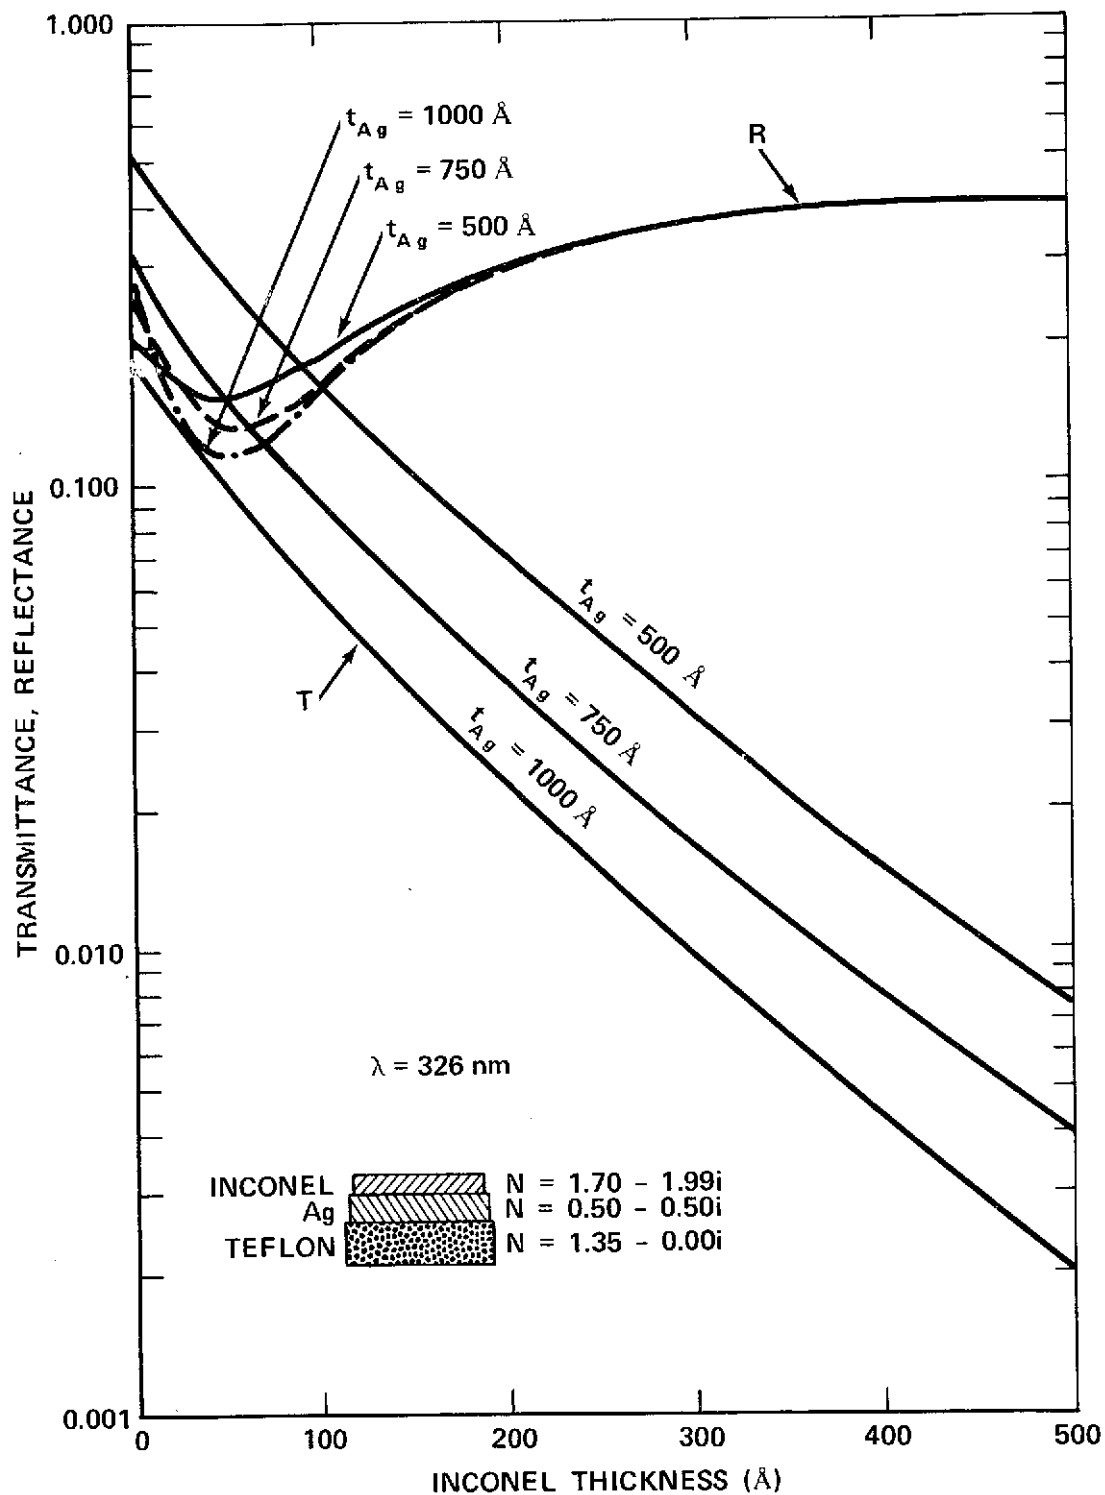
Figure 6. Calculated Reflectance and Transmittance of Teflon Coated with Ag plus Inconel as a Function of Inconel Thickness for 3 Specific Thicknesses of Ag—500 Å, 750 Å and 1000 Å—at $\lambda = 326 \text{ nm}$

Transmittance measurements have already indicated that deposition conditions probably vary during the evaporation of the Ag and inconel layers. The α data of Table 1, obtained by measuring the reflectance of the Ag backing through the clear teflon film, supports this interpretation of the results. Finally, Figure 5 reveals that the reflectance of the outer inconel layer also varies. This point is examined further with the aid of Figure 6. In Figure 6, the calculated reflectance and transmittance of teflon coated with Ag plus inconel is plotted as a function of inconel thickness for 3 specific thickness of Ag—500 Å, 750 Å and 1000 Å—at $\lambda = 326$ nm and with inconel as the surface of incidence. The teflon layer is assumed to be non-absorbing, which is a fair assumption that helps keep the results of Figure 6 consistent with those of Figure 3. Figure 4 has indicated that the Ag/teflon test samples have a peak transmittance of about 1% to 1.5% at $\lambda \simeq 320$ nm. If this value is superimposed on Figure 6, and the Ag layer is assumed to be 500 Å thick, then the thickness of the inconel layer must be ≤ 400 Å. This already disagrees with the reflectance data of Figure 5. If the Ag is assumed to be thinner, the disagreement grows. It is apparent that the idealized calculated results of Figures 3 and 6 are not matched in reality by the Ag/teflon test samples. This is not an unusual occurrence and can most probably be attributed to the less than ideal quality of the Ag and inconel layers on the test samples. Since defects induced by flawed evaporation are more evident at shorter wavelengths, this could explain the low visible reflectances of Figure 5, even for thick inconel films. Figure 6 also reveals that the reflectance of very thin inconel films ($t < 250$ Å) on Ag is dependent on the Ag thickness at $\lambda = 326$ nm. It is unlikely that the inconel film would ever be this thin.

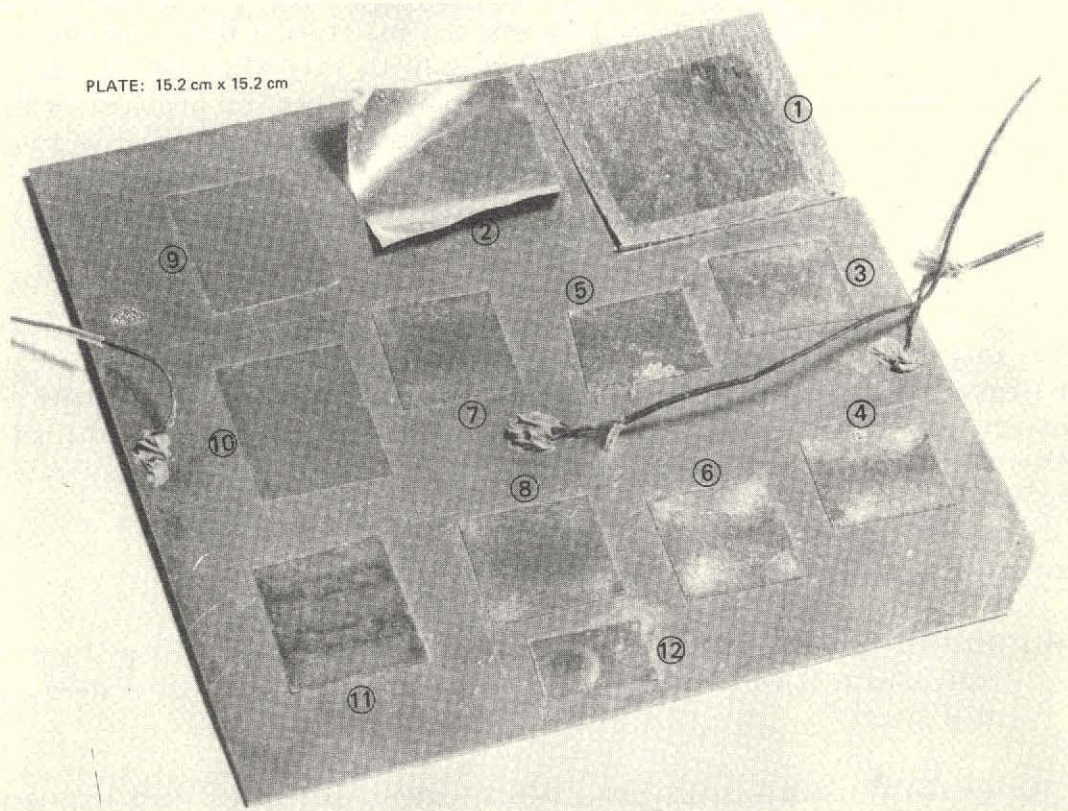
①	S/N IB	+	Gelva 263 adhesive thinned 1:1 (vol.) hexane : ethyl acetate.
②	S/N ID	+	RTV 6-1104 diluted with toluene.
③	S/N IB	+	Mystik #7366
④	S/N IIC	+	Mystik #7366
⑤	*CONTROL	+	Mystik #7366
⑥	S/N IIIB	+	Mystik #7366
⑦	S/N IVA	+	Mystik #7366
⑧	GSFC (2)	+	Mystik #7366
⑨	S/N TII	+	3M #467 (Adhesive applied to Ag/teflon by supplier).
⑩	S/N TI	+	3M #467 (Adhesive applied to Ag/teflon by supplier).
⑪	S/N IVD	+	Mystik #7366 applied in 3 separate strips.
⑫	CONTROL	+	Mystik #7366 with no prior in-air aging or outgassing.

Figure 7. Photograph of Test Samples After Thermal Cycling Test, Including Identification and Description of Ag/teflon-Adhesive Combination

All the test specimens were bonded to the same aluminum substrate with the various adhesives as shown in Figure 7. Each sample-adhesive combination is also identified in Figure 7. Two specimens were added here to examine applications problems. S/N 11 consists of a single piece of teflon placed down on 3 strips of #7366 adhesive separated by about 3 mm. This arrangement subjected the bonded and unbonded areas to unequal stresses resulting in a fracturing of the Ag film over the unbonded portion. Applying heat to this sample allowed the fracturing to be studied as a function of temperature. The Mystik #7366 tape used in this test was "outgassed" prior to bonding the various Ag/teflon specimens. Outgassing was accomplished by applying each piece of adhesive to the Al sheet with their release covers intact and then setting the sheet aside at room temperature in the laboratory for 2 weeks. At that point, the tape release backing was removed and the Ag/teflon specimens were applied. In order to demonstrate what happens if the Ag/teflon is bonded to #7366 tape that has not first been aged in this manner, S/N 12 was prepared by placing a piece of Ag/teflon down on #7366 tape taken directly from the roll. No high temperature cure or other preparatory procedure was used on any of the specimens.

Since the "scotch tape" test had revealed poor adhesion at the Ag/teflon interface in the case of the control sample, a newer GSFC supplied specimen with a thinner Ag layer was added to the temperature cycling test array. This is identified as S/N 8—GSFC(2) in Figure 7.

A post-test photograph of the specimens mounted on the Al sheet is given in Figure 7. Note that the corner piece containing S/N 1 had been sawed from the

plate prior to being photographed. The Ag film of S/N 1 had separated from the teflon in some places and had lifted from the adhesive in others. The Ag was badly fractured. S/N 2 has obviously lifted. Specimens 3 through 10 remained in good contact with the plate. The fracturing of the Ag film on certain specimens that occurred during the unexpected chamber venting is highlighted by the contrast between bright and dark areas. All the test samples and even the test plate are quite specular which accounts for the contrast irregularities in the photograph.

S/N 12 blistered (as shown in Figure 7) very soon after initial pumpdown prior to thermal cycling, as expected. The blister increased in area, to perhaps 25% larger than shown, when heat was applied. Since this sample was bonded with Mystik #7366 that had not received prior aging before applying the Ag/teflon, it confirms qualitatively that prior outgassing or aging is essential to avoid bubbling. Specimens 3, 4, 5, 6, 7 and 8 were bonded with "outgassed" Mystik #7366 and experienced little or no bubbling or lifting.

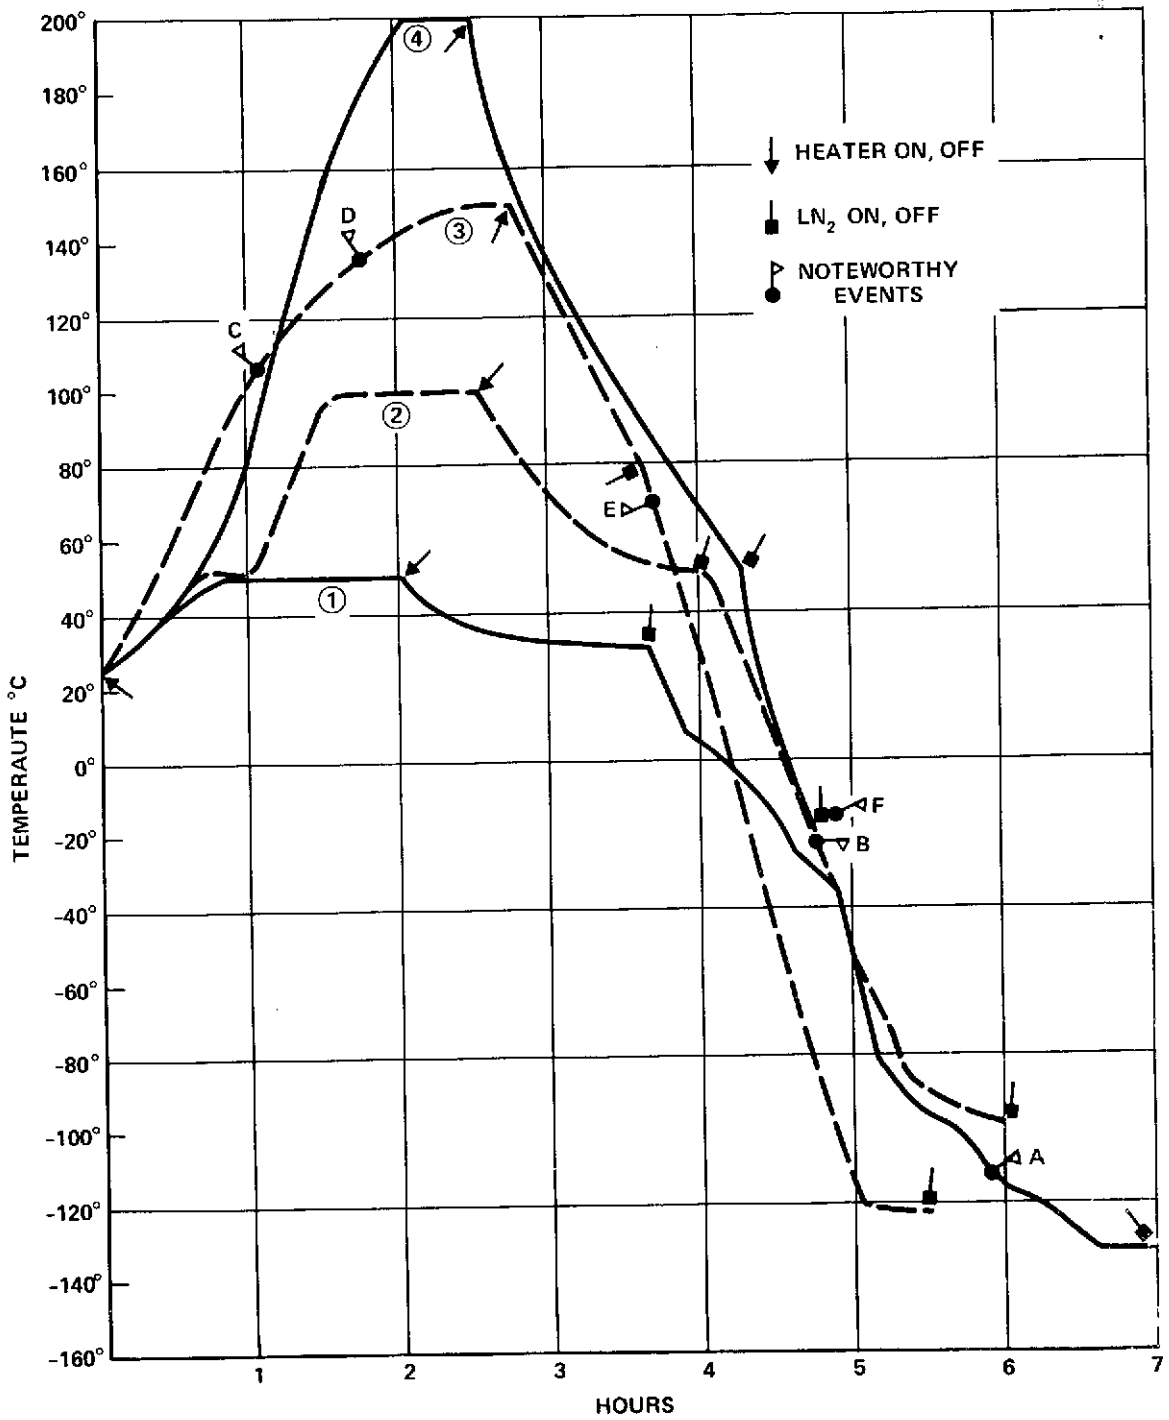
Figure 8. Variation of Temperature with Time for 4 Cycles

The 4 cycles are graphically displayed in Figure 8 where temperature is presented as a function of time. The progress of each cycle is plotted in the figure with flagged points indicating noteworthy events. These events are defined in summary form below. Before proceeding into this summary it should be noted that an unfortunate chamber failure caused by a ruptured seal in a liquid nitrogen line prematurely ended the test at the -15°C point in cycle 4.

Summary of events occurring during thermal cycling:

- a. At -112°C in the first cycle, S/N 1 began to lift extensively at 1 corner. Delamination and cracking of the Ag was also evident. S/N 1 failed at this point.

- b. At -20°C in the second cycle, S/N 2 began to lift up and curl at 1 corner. The Ag did not crack or delaminate but came away intact. S/N 2 failed at this point.

- c. Between $+108^{\circ}\text{C}$ and $+115^{\circ}\text{C}$ in cycle 3, S/N 2 lifted extensively and curled along corners and edges. Approximately 50% of the total area had lifted. Warping occurred with temperature variations for the remainder of the test.

- d. At $+135^{\circ}\text{C}$ in cycle 3, a corner lifted slightly on S/N 8. The lifting was confined to less than 5% of the total area.
- e. At $+70^{\circ}\text{C}$ on the cool down slope of cycle 3, S/N 10 exhibited a slight lift along 1 edge, confined to less than 2% of the total area.

- f. At -15°C in cycle 4, a liquid nitrogen connection separated inside the chamber causing a rapid compression that ended the test. This compression produced microscopic fracturing in the Ag backing preferentially located in certain well defined areas.

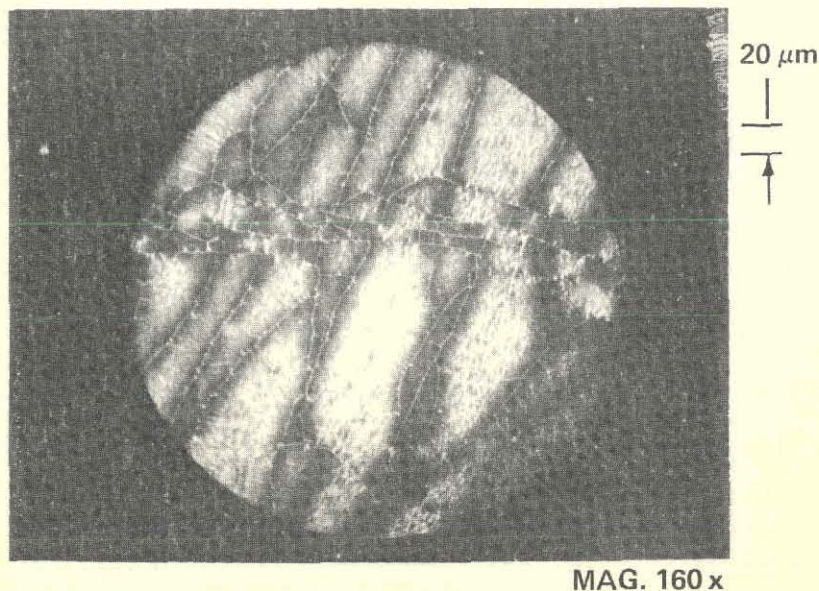
Figure 9. Photograph of Crazed and Fractured Portions of S/N 6. Magnified 160 x

A photograph of the crazed area of S/N 6 enlarged to 160 x is presented in Figure 9. This type of effect was common to all specimens but was much less pronounced on S/N's 9 and 10 (i. e. TI and TII, bonded with 3M #467). The crazing, identified by the "map" cracks in Figure 9, was caused by thermal cycling. This occurs when the Ag/teflon is heated above 125°C (approximately) and has been observed and discussed in earlier work.¹⁷ It is very similar in appearance to the mechanical fracturing of Ag that occurs whenever Ag/teflon is bent sharply, stretched or pulled away from an adhesive. This effect can increase α by about 0.03 and is responsible for an increase in scattering and loss of specularity of the Ag/teflon coating.¹⁷ In viewing S/N 11 in Figure 7, the 3 strips of underlying adhesive are easily recognized. The 2 intermediate clearer areas are unbounded and were extensively flexed by thermal cycling. The Ag/teflon part that was unbonded exhibited crazing at an earlier stage in the test than any other sample. Slight crazing was in fact evident at the end of cycle 2.

The effects caused by rapid compression, typified by Figure 9, are unexplained. The brighter "cloudy" areas of Figure 9 are caused by microscopically small fractured areas apparently coinciding with film portions that retained more rigid contact with the Al plate. This latter conclusion is drawn from the fact that the deliberately unbonded areas of S/N 11 did not show this microscopic fracturing. A further investigation of this phenomenon was considered outside the scope of this effort and is merely noted here for the sake of completeness. Although the unexpected venting produced the most evident defects to come out of the thermal test, they were not relevant to the test's defined objective.

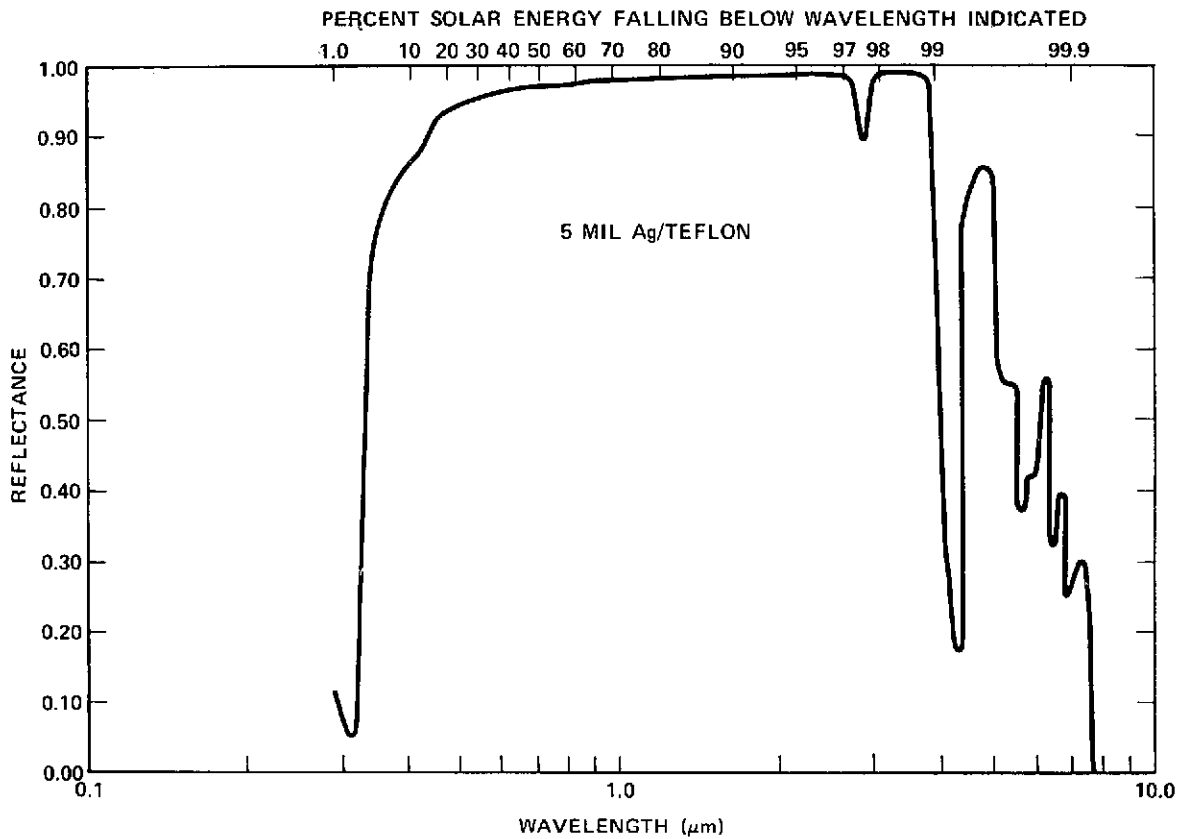
Figure A.1. Spectral Reflectance of 125 μm (5 mil) Thick Ag/teflon over the Solar Wavelength Region ($0.29\mu\text{m} \leq \lambda \leq 8.0\mu\text{m}$)

The spectral reflectance of a $125\mu\text{m}$ (5 mil) Ag/teflon sample over the wavelength range $0.29\mu\text{m} \leq \lambda \leq 8.0\mu\text{m}$ obtained using the above instrumentation is given in Figure A.1. The measured specimen was from the control sample used in the qualification test discussed earlier. Approximately 99% of the total

solar spectral irradiance is contained within the measured bandwidth as indicated by the upper scale gradations in Figure A.1.
