NASA TN D-7587

**APOLLO EXPERIENCE REPORT -
DEVELOPMENT AND USE OF
SPECIALIZED RADIO EQUIPMENT
FOR APOLLO RECOVERY OPERATIONS**

by William A. Middleton and H. F. Breshears

Lyndon B. Johnson Space Center

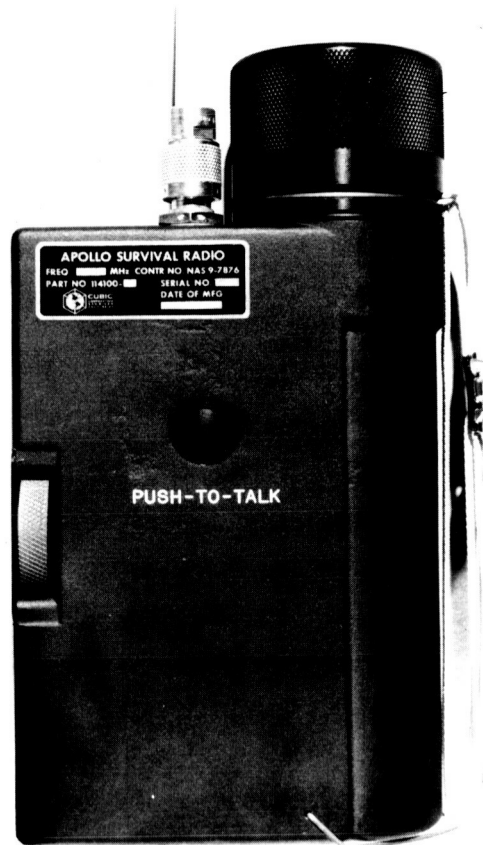
Figure 5.- Front view of Apollo survival radio.

1. The back cover was machined, and a Parker seal was installed in it (fig. 4).
2. An O-ring seal was provided for the battery cap.
3. The push-to-talk switch was installed in a waterproof housing as procured (fig. 5). The switch was secured by a plate inside the radio, and a commercial potting compound was placed around the edges.
