Accelerated rain erosion of wind turbine blade coatings

Ph.D. Thesis

CHEC Research Center
Department of Chemical and Biochemical Engineering
Technical University of Denmark, DTU, Denmark
August 2014

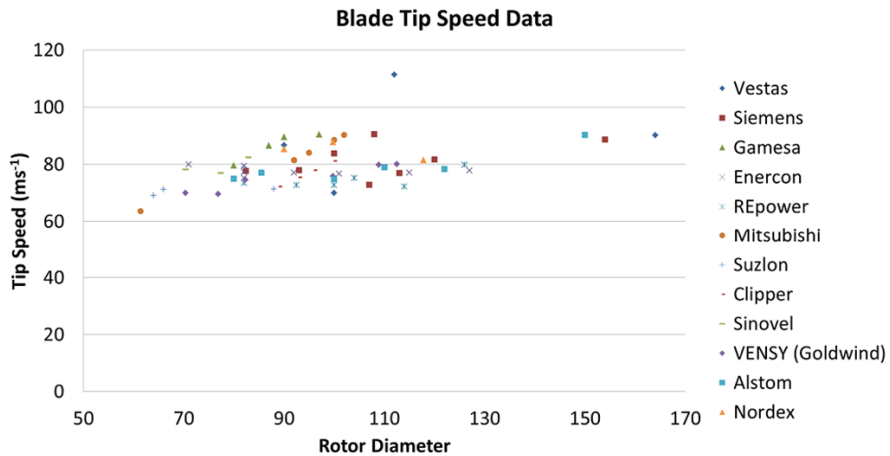
As shown in Figure 1.5, there is a slight trend in increasing tip speed with increasing rotor diameter with the increase of blade length, the blade tip speeds can be as high as 100 m/s.

Figure 1.5 Blade tip speed versus rotor diameter for various utility scale wind turbine blades. Reproduced from [10].

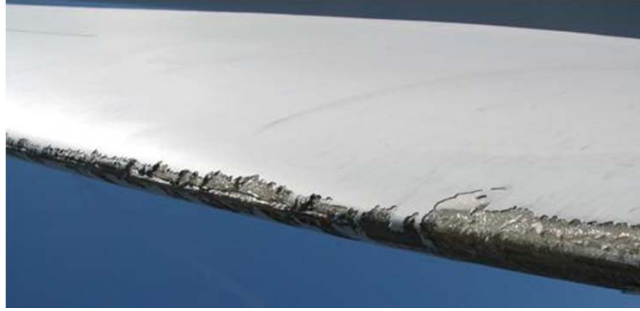
Depending on operating conditions, erosion of rotor blade leading edges (Figure 1.7) can affect wind turbine energy generation efficiency.

Figure 1.7 Leading edge erosion of a wind turbine blade. Reproduced from [21].

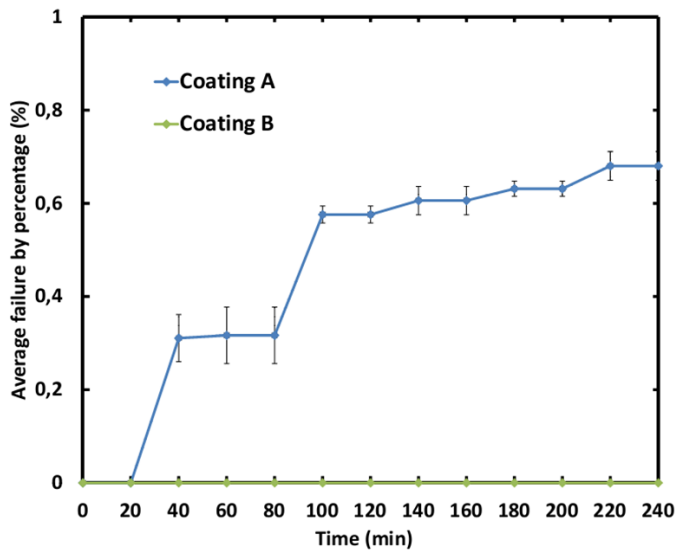
The next experiment, Experiment 2, was conducted in the rig V2 (Figure 2.2) which incorporated a rotating wheel. The average velocity of the flat fan jet was about 157 m/s and three replicates of each coating was used so that the repetability of the experiments could be investigated. Figure 2.7 shows the average eroded surface area of the three samples of each coating system, measured using image analysis.

Figure 2.7 Experimental data of fraction of exposed coating area eroded in water jet setup. Standard deviations are shown as error bars. Coating B coincides with the x-axis.

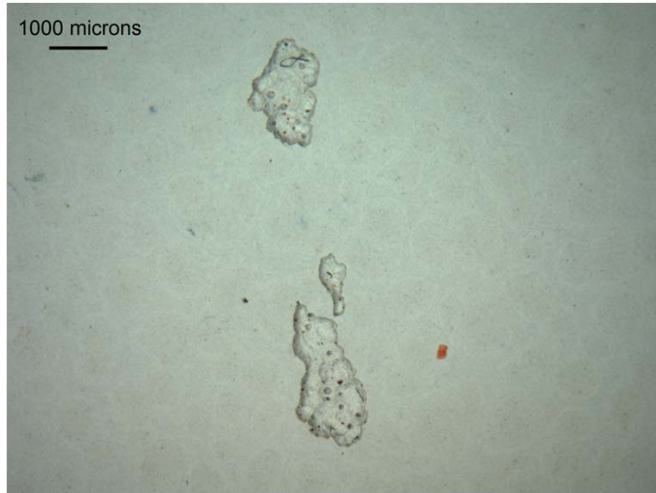
Figure 3.6 Optical microscopy of water jet erosion failure of Coating A applied on flat steel panels and using a water nozzle-coating distance of only 5 cm (Experiment 4).

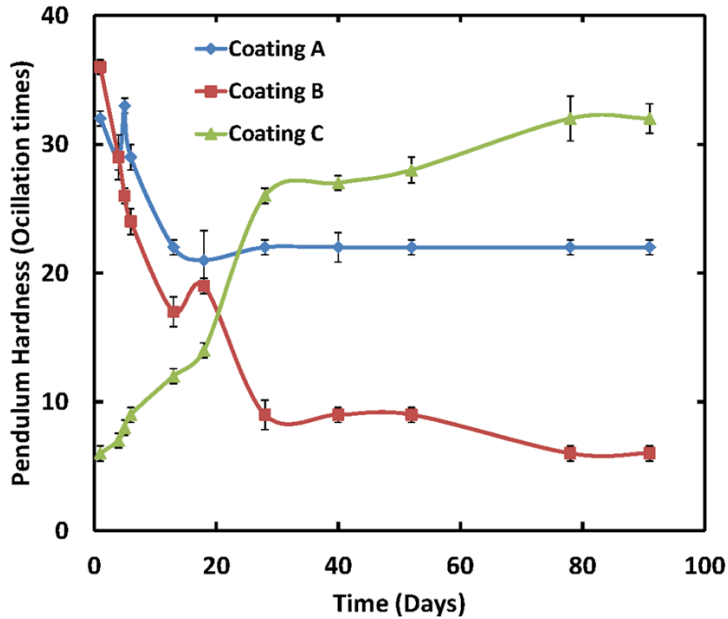
Figure 3.9 Measurements of pendulum hardness for the three blade coatings over time.

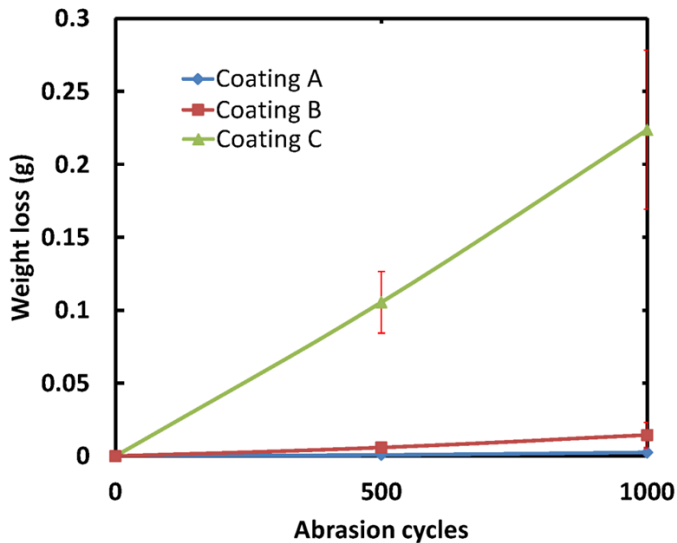
Figure 3.10 Weight loss data for the three blade coatings when exposed to abrasion cycles.
