RESISTANCE OF CRACKED CONCRETE HEALED BY MEANS OF POLYURETHANE AGAINST CHLORIDE PENETRATION.

M. Maes¹, K. Van Tittelboom¹ and N. De Belie¹

¹ *Magnel Laboratory for Concrete Research, Ghent University, Technologiepark-Zwijnaarde 904, 9052 Ghent, Belgium – E-mail: mathias.maes@ugent.be; kim.vantittelboom@ugent.be; nele.debelie@ugent.be*

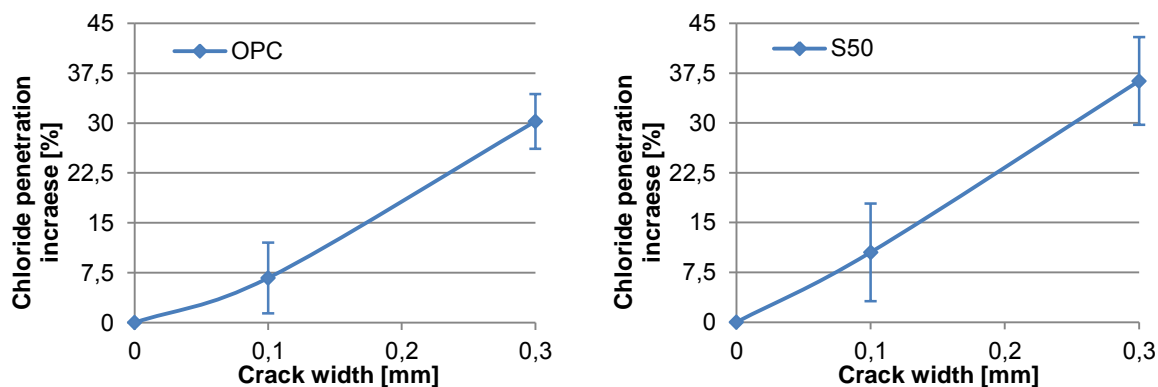
The results show a big difference for the chloride penetration measured at the crack tip of a 0.1 mm crack and a 0.3 mm crack. The wider the crack, the higher the penetration depth measured from the crack tip onwards. Besides, the penetration depth at the crack tips is higher than the penetration depth measured from the exposed surface. In Fig. 1 this relative increase is shown, with the penetration depth at the surface (= crack width 0 mm) as a reference. The increase in penetration depth at the tip of a 0.3 mm crack compared to the penetration from the surface amounts to 30 % and 36 % for OPC and S50 respectively (see Fig. 1).

Figure 1: Chloride penetration increase in function of the crack width, for OPC and S50.

Chloride penetration at the crack tip increases in function of the crack width when the crack width is in the range of 0 mm (= penetration from the surface) until 0.3 mm. A possible solution to repair the cracked concrete is self-healing concrete. Manual healing by means of polyurethane injection shows good results. For cracked concrete with a crack width of 0.1 mm, regardless the composition, 83 % of the samples regained almost full resistance against chloride penetration. In the case that cracks have a width of 0.3 mm, 67 % of the samples regained almost full resistance.

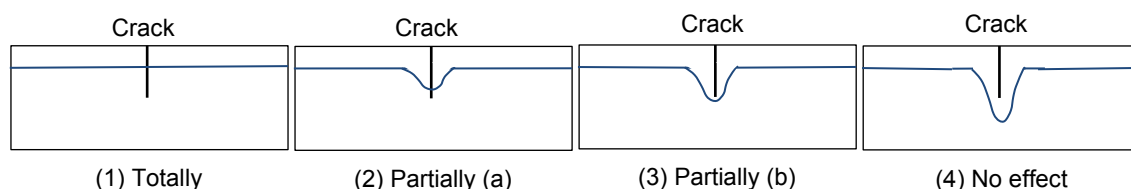
In order to evaluate the healing effect with regard to the resistance against chloride penetration, four healing categories are defined, see Fig. 2: (1) Totally healed (no Cl^- -penetration around the crack), (2) Partially healed (a) (Cl^- -penetration perpendicular to the crack + no Cl^- -penetration at the crack tip), (3) Partially healed (b) (Cl^- -penetration perpendicular to the crack + Cl^- -penetration at the crack tip (< from the surface)) and (4) No effect.

Figure 2: Visual indication of the four categories to evaluate healing based on the chloride penetration depth around the crack.

Table 1 gives an overview of the regained resistance against chloride penetration due to manual healing by means of polyurethane injection. The percentages represent the part of the healed samples belonging to the specific category. To class them, chloride penetration depths were measured and compared.

According to these results, it seems that cracks with width 0.1 mm and depth 15 mm can regain almost full resistance against chloride penetration (categories 1 and 2) in 83 % of the cases. Besides, cracks with width 0.3 mm and depth 20 mm can be healed almost totally in 67 % of the cases. These findings are independent of the concrete mixture. For all samples some positive effect due to the presence of PU in the cracks was measured.
