**Tribology of HVOF- and HVAF-sprayed WC-10Co4Cr hardmetal coatings: a  
comparative assessment**

This paper provides a comprehensive assessment of the sliding and abrasive wear behaviour of WC-10Co4Cr hardmetal coatings, representative of the existing state-of-the-art. A commercial feedstock powder with two different particle size distributions was sprayed onto carbon steel substrates using two HVOF and two HVAF spray processes.

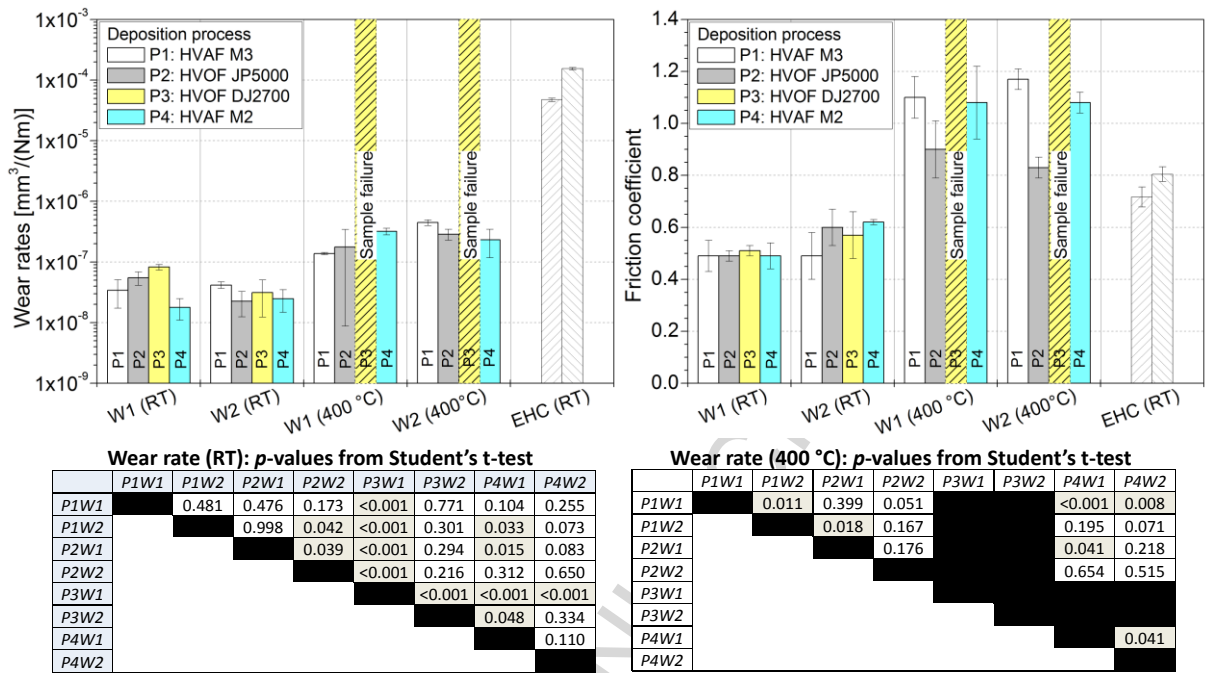
Figure 7

At room temperature, the sliding wear rates of all WC-10Co4Cr coatings (Figure 7) are below  $10^{-7} \text{ mm}^3/(\text{Nm})$ , i.e. they correspond to a mild wear regime [60]. Under the present experimental conditions, they are orders of magnitude lower than those of electroplated hard

chromium references. The differences between the various WC-10Co4Cr coatings are small and often negligible within experimental error, as the probability of the “*null hypothesis*” from the Student’s t-test is  $p > 0.05$  for many of the data pairs (see the related table in Figure 7). Most of the statistically significant differences concern samples P2W1 and, particularly, P3W1. They indeed exhibit slightly higher wear rates than all other samples, which can be interpreted based on the following analysis of wear mechanisms.

At 400 °C, the wear rates of WC-10Co4Cr coatings increase by one order of magnitude and become somewhat higher than  $10^{-7}\text{ mm}^3/(\text{Nm})$  (Figure 7), with the exception of samples P3W1 and P3W2, which failed due to the development of a macroscopically visible network
