Detection of diesel engine valve clearance by acoustic emission.

Elamin, Fathi, Fan, Yibo, Gu, Fengshou and Ball, Andrew (2009) Detection of diesel engine valve clearance by acoustic emission. In: Proceedings of Computing and Engineering Annual Researchers' Conference 2009: CEARC'09. University of Huddersfield, Huddersfield, pp. 7-13. ISBN 9781862180857

## DETECTION OF DIESEL ENGINE VALVE CLEARANCE BY ACOUSTIC EMISSION

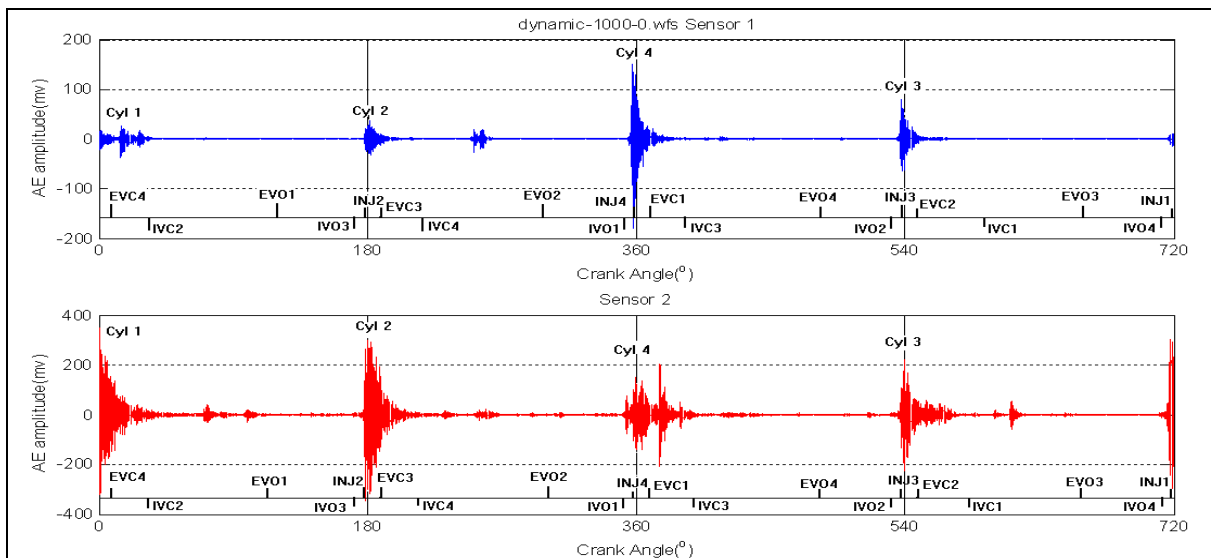
Fig. 7 shows the raw AE waveform recorded from a healthy engine running at 1000 rpm and zero load in a laboratory environment without any special consideration or precautions. It presents the AE signal acquired from one working cycle of the running engine versus crank angle from the two sensors mounted on the cylinder head of the engine (see Figs. 4 and 5). The mechanical events corresponding

to crank angle are shown along the bottom of Fig. 7. The main feature extracted from the AE waveform shown in Fig. 7 is that it exhibits four peaks equivalent to the engine firing sequences and each peak is caused by combustion in one of the cylinders of the engine, from left to right, cylinders 1, 2, 4, and 3. There is obvious difference in amplitude between sensors one and two, because of the different frequency ranges of each sensor, and the different sensor's mounting positions.

Thin vertical lines indicate TDC for each cylinder in their fire order: 1/ 2/ 4/ 3. On the figure, INJ is injector; EVO is exhaust valve opening; EVC is exhaust valve closing; IVO is intake valve opening; IVC is intake valve closing; and the numbers 1 to 4 represent the number of the cylinder.

**Fig. 7** Raw AE signal from a running engine at zero Nm with 1000 rpm

As can be seen from Fig. 7, the largest AE signals, observed at both sensor positions are associated with injection events and occur around TDC for each cylinder. The highest AE amplitudes are, as would be expected, observed at the sensor close to the source, since the magnitude of the signal will decrease with distance from source. Smaller amplitude events are also associated with exhaust valves opening.

The major mechanical events in the engine cylinder head are injection, fluid excitation, exhaust valve opening and mechanical impacts. It can be seen from the AE waveform shown in Fig. 7 that there were four large AE events equivalent to the engine firing sequences and each event was caused by the combustion in one of the cylinders of the engine.

The AE peaks, observed from both AE sensors were associated with injection events and occurred around TDC for each cylinder. Smaller AE events associated with exhaust valves opening can also be observed. The highest amplitude signal detected by sensor one was due to the events occurring in cylinder four. This is because sensor one was mounted closest to cylinder four. The highest amplitude at sensor two is due to events occurring in cylinder one. Numerous authors have confirmed that the highest amplitude AE signals are detected by those sensors placed closest to the source [7].

For a given sensor the figures show that the dominant event follows the fuel injection; that exhaust valve opening is the most significant of valve events that events associated with the engine exhaust valve differ from those associated with the intake valves. The intake valve movement involves lower kinetic energies and the pressure differences across it might be expected to show lower inherent signal energy, and this almost certainly explains the non-appearance of clear exhaust valve closing events.

The injector events for each cylinder occur at crank angles of around  $0^{\circ}$ ,  $180^{\circ}$ ,  $360^{\circ}$  and  $540^{\circ}$  after TDC for cylinder-1, consistent with the firing order of 1, 2, 4, 3. However, it is possible that the valves events include a number of related events associated with impacts of the rocker arm with the push rod or valve stem. This is also evident in the AE data that the actual timing of the events can be slightly different. The difference in energy between cycles - e.g. as the kinetic energy between the two potential impact points at push rod and valve stem - is relatively random, depending on exactly the position of the rocker from the previous cycle. There are apparent inconsistencies between cycles, e.g. the exhaust valve opening events show differences between the various running conditions. This is due to the exhaust valve opening energy changing with the force the hot products of combustion exert on the face of the valve, an effect whose magnitude will depend on running conditions.
