# **The restoration of sediment-related disasters and driftwood from national forest in Taiwan caused by Typhoon Morakot in 2009**

Su Chin Chen \*, Jau Pao Wang \*\*, Chun Hsien Yang \*\*

Department of Soil and Water Conservation, National Chung Hsing University\*

Forestry Bureau, Council of Agriculture, Executive Yuan\*\*

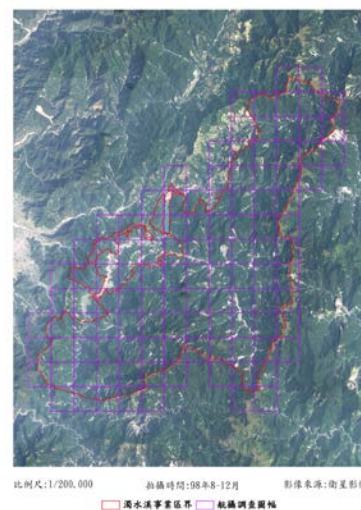
Fig. 1 Satellite photograph and scope of landslide survey-Example of the Zhuoshui River District

Following the Typhoon Morakot, images taken in cloudless weather by the FORMOSAT-2 (FSAT-2) satellite from August 8 to October 31 were used to determine the damage caused by the typhoon. After determining the area of land affected by landslides in areas under the jurisdiction of the Nantou, Chiayi, Pingtung, and Taitung forest district offices in the wake of Typhoon Morakot, the Forestry Bureau Aerial Survey Office found that the area of landslides increased from 13,786 hectares to 32,923 ha after the typhoon, which indicated that new landslides had affected an area of 19,137 ha. In addition, for all of Taiwan, the area affected by landslides increased from

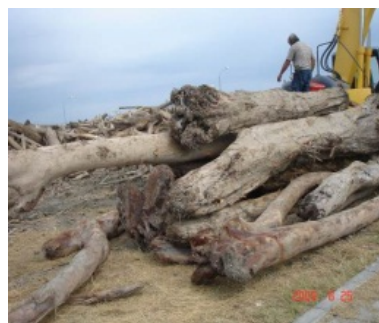
Fig3.1 Gathering woody debris from Yanpu Fishing Harbor for shipment. Most of this wood consists of highly abraded tree trunks with the roots still attached.

The first priority consisted of the clean-up of navigation channels, followed by clean-up of entire harbors. A total of 52 fishing harbors clogged with woody debris were distributed in 10 cities and counties, and included such major fishing harbors as Fugang in Taitung County and Yanpu in Pingtung County. Working 12 hours a day, navigation channels were cleared by August 18, enabling fishermen to get to fishing and restoring the transport of supplies to Lanyu and Green Island by ship. All woody debris was subsequently removed from fishing harbors, and any woody debris that floats into a harbor from offshore is promptly removed (Fig 3.1).

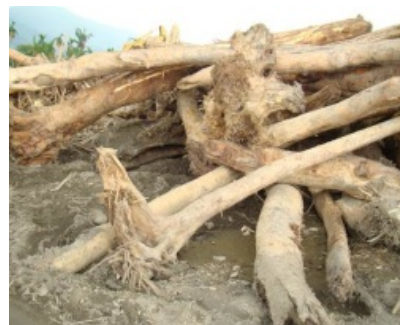
Fig3.2 Woody debris in Xinfeng Village, Gaoshu Township. Most of the wood consists of trunks with attached roots, and there are no saw marks.

Because of the failure of major dikes, much woody debris was deposited on farmland. More than a thousand hectares of farmland in the Kaohsiung-Pingtung area was covered with woody debris, and the situation was particularly severe in Jiuru, Gaoshu, Wandan, Daliao, and Qishan townships. This woody debris had to be removed as quickly as possible in order to restore farming. In this type of situation, past operating procedures called for Forestry Bureau personnel to

first record the presence of any valuable wood and then remove all woody debris. In the wake of Typhoon Morakot, however, all woody debris was removed, regardless of whether it contained valuable wood that could be sold at auction, and piled at storage yards; the wood was then recorded and subsequent handling procedures implemented (Fig 3.2).

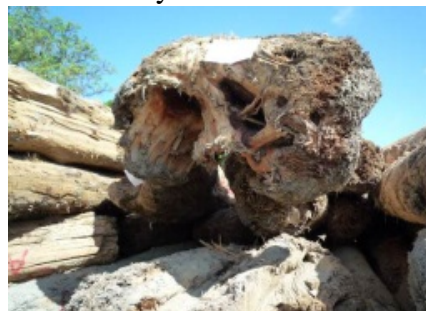
Fig3.4 Recorded valuable woody debris consisting of trunks with the roots still attached and constituting national property. The roots have been abraded into irregular forms. (photo taken in Taitung City)

According to Article 76 of the Water Utilization Act, the river management agency must remove any woody debris threatening river control on an emergency basis. Based on the fact that large amounts of woody debris were deposited in riverbeds by Typhoon Morakot, and the Water Resources Agency undertook many river management reconstruction and dredging projects in the wake of the typhoon, the Water Resources Agency also removed woody debris when implementing these projects or clearing sediment. Town and township public offers were assigned to clean up woody debris lying in riverside areas after joint surveys by river bureaus, city and county governments, and forest district offices (Fig 3.3 & 3.4).
