Acoustic diagnosis of driving belt physical condition in enclosures

**37th International Congress and Exposition on Noise Control Engineering  
26-29 October 2008·Shanghai·China**

## **Acoustic Diagnosis of Driving Belt Physical Condition in Enclosures**

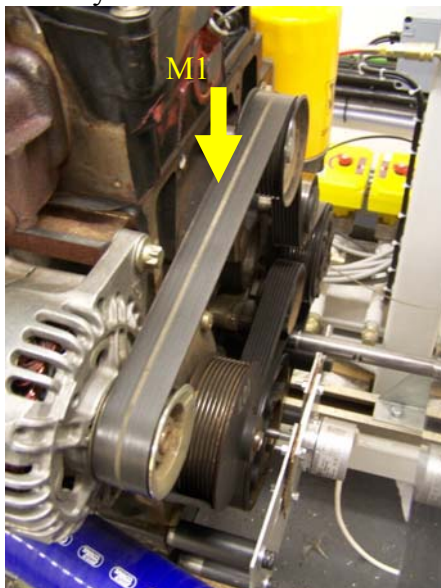
Figure 2 - Engine belt system and microphone M1 position. M1 has a very directional polar pattern

The belt under analysis is driven from the crankshaft and is part of the engine ancillary system that drives the alternator and the oil pump. Figure 2 shows a picture of the belt system under study.

The tension on the belt was maintained by a spring loaded pulley. The tension was altered by a mechanism that applies a torsional load in an anti-clockwise direction onto the spring loaded pulley, as shown in Figure 2. This reduces the tension by reducing the load that the spring applies onto the belt. To apply the load onto the pulley the mechanism uses a lever arm that has a load of 5kg at a distance of 235mm from the pivot, which reduces the tension load of the spring by 11.5Nm.

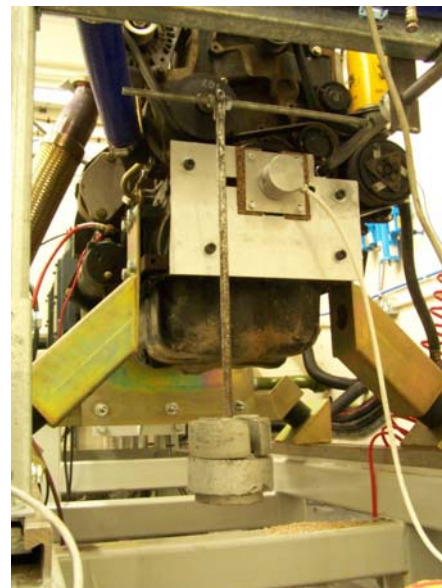
Figure 3 – Belt tensioner system

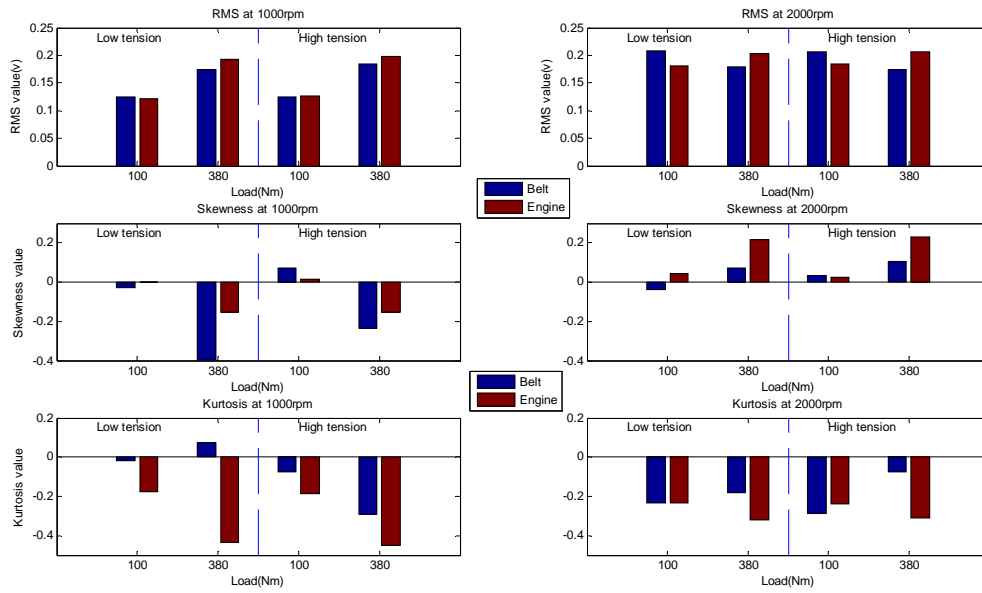
Figure 4 – RMS, Skewness and Kurtosis for signals acquired.

Three common statistical parameters: RMS, Skewness and Kurtosis are calculated firstly to study the signal differences measured for different belt cases, operating conditions and microphone placement. Figure 4 shows the results of the statistical parameters obtained in the time domain. RMS values from the microphones, a measure of the strength of noise amplitude for overall engine acoustics, increases with load and speed, which is consistent with that of engine noise expected to increase with engine load and speed. As expected there are some differences in RMS values between the two microphones. However, the difference amplitude varies with different operating conditions. Importantly, RMS from the belt microphone shows little difference between the low tension and high tension. This shows that it is not possible to extract a significant difference between belt conditions with the RMS values alone.

In contrast, the higher order statistics: Kurtosis and Skewness, measures of signal structures in the time domain, show a noticeable difference between the low tension and high tension from acoustic signals measured close to the belt. Especially, Kurtosis values of belt measurement show significant difference between the two tension conditions whereas the Kurtosis values of the engine measurement remain identical. This means that it is possible to detect belt faulty conditions from the Kurtosis difference.

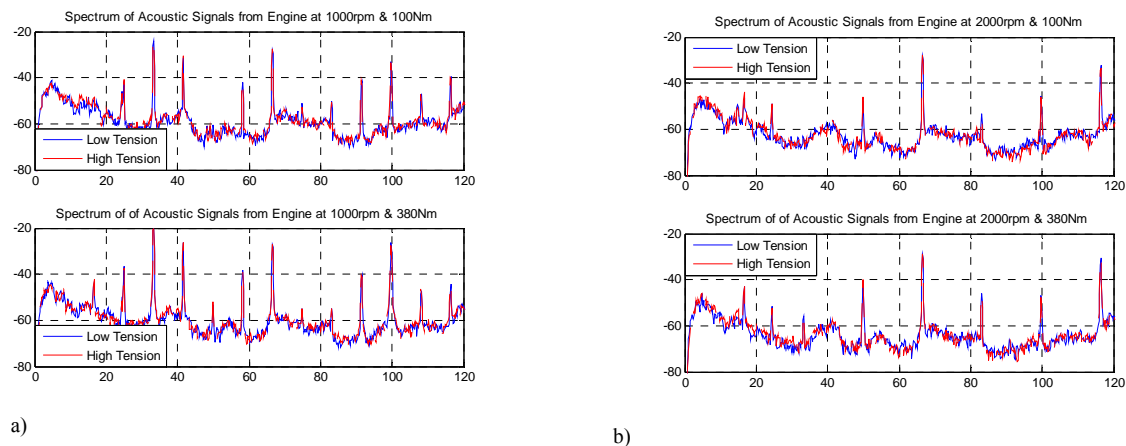
Figure 5 – Spectral data for acoustic signal from engine at different test cases. a) Speed of engine 1000rpm  
b) Speed of engine 2000rpm

Figure 5 shows the power spectra of the signal acquired with microphone 2 (overall engine and enclosure microphone) for the 8 cases tested. The frequency axis range has been set to 120Hz where most of the relevant information is contained. The spectral peaks clearly show the engine fire frequency:

As is clear from Figure 5, the spectrum evolves for different operating conditions, showing that the measured acoustics reflects the engine behaviour consistently. However, the engine acoustic signals obtained across the two belt tension cases are nearly identical. This suggests that the acoustic effects generated by the changing tension on the belt can not be

separated by the far-field measurement because of the strong reverberation in the enclosure and interferences from different engine noises sources.

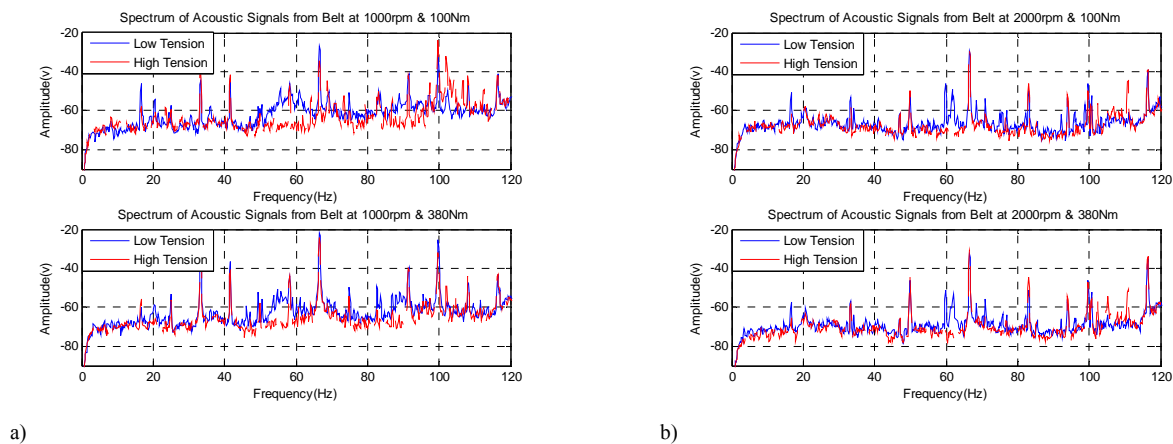
Figure 6 - Spectral data for acoustic signal from belt at different test cases. a) Speed of engine 1000rpm;  
b) Speed of engine 2000rpm

Figure 6 shows the acoustic signals acquired in the near-field of the belt mechanism using the directional microphone. The same features regarding the engine cycle are obvious, compared with that in Figure 5. However, and in contrast with the previous data, there is a clear difference between the two belt tension cases.

At low speed, 1000rpm, there is a clear indication that the first resonance of the belt in the low tension case is around 55Hz. At high tension this resonance appears to move up to around 105Hz. At higher engine speed, Figure 6b, the low tension resonance appears to move from around 62Hz to 110Hz. It is important to note that the 3<sup>rd</sup> harmonic of the engine fire frequency is around 100Hz which makes the extraction of belt diagnostic information difficult at these frequencies.

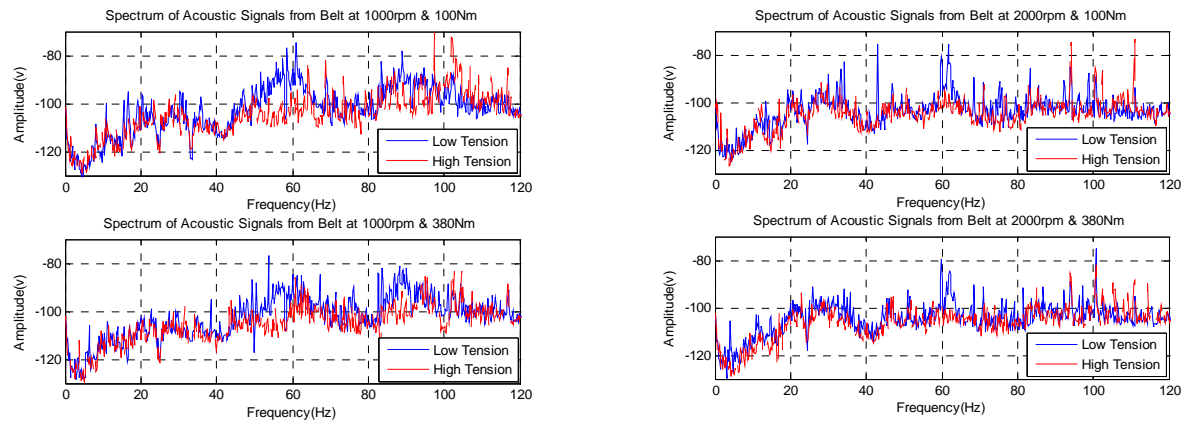
Figure 7 - Spectral data for acoustic signal from belt deconvolved from engine and enclosure shown at different test cases. a) Speed of engine 1000rpm; b) Speed of engine 2000rpm

In order to separate the acoustic emission from the engine from that of the belt, a deconvolution technique was attempted [8]. This was obtained by multiplying the complex signal captured in the near field by the inverse of the one in the far field. The resulting data is shown in Figure 7. In this way the acoustic components such as fire frequency and its harmonics can be suppressed significantly and the resultant spectrum thus contains mainly the acoustic emissions from the belt.

The differences observed between the two tension cases are now clearer. At high tension, a number of spectral peaks are more evident. However, corruption from engine noise is still evident. It is therefore early to make any clear distinctions between the cases and use this as a diagnosis method. Nevertheless, the technique appears promising and further studies are now being carried out that employ a spatial average of the far-field at various enclosure positions that may improve the separation between the data.

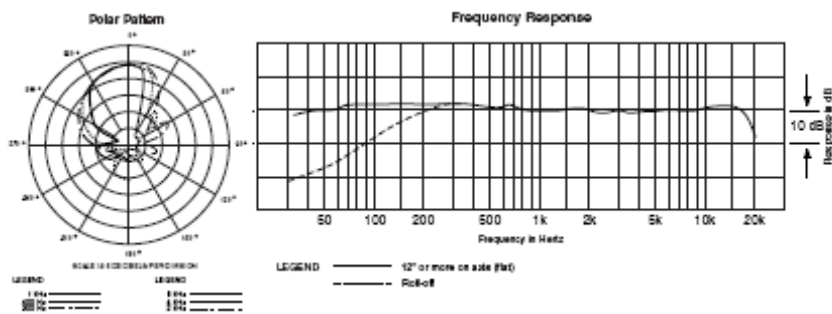
Figure 8 – Directional and Frequency responses for Audio Technica 4071a

The acoustic measurement was performed using two condenser type microphones of specific polar pick up patterns as shown in 6.1. Microphone 1 has a highly directional pick up pattern which is able to reject most sound arriving from the sides or back whilst capturing sound waves arriving on axis to the microphone. This microphone was placed in the *near field* of the belt, as indicated in Figure 2, pointing towards the centre area of the moving belt at 90mm from it. This is a point of maximum displacement for odd order transverse modes which are believed to be those most likely to radiate noise. Furthermore, the directional properties of the microphone will focus on the noise radiation in the surrounding area of the belt, including the 2 uppermost pulleys, as likely sources of useful diagnostic data for faults developing in the belt. Microphone 2 was placed in the *far-field*, 330mm away from the left pulley and to the side of the engine. This microphone has an omni-directional polar response and as such is able to capture the acoustic radiation from the whole engine and reflected energy from the enclosure. Detailed magnitude frequency responses for the microphones used can be found at Appendix 6.1 for reference.

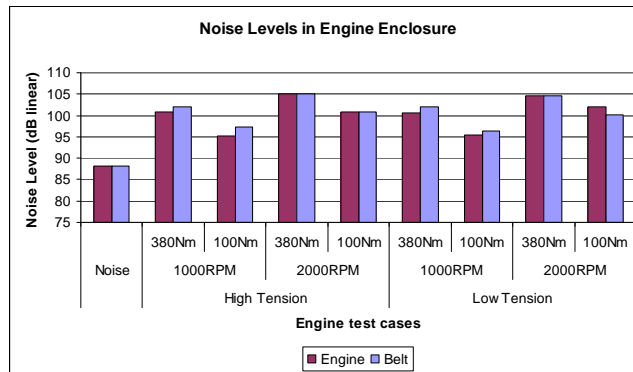
Figure 10 – Noise levels measured in enclosure with engine running under the different test conditions. Results indicated correspond to the linear average of values in the range 16Hz-16KHz. The background noise levels with the ancillary equipment of the facility running are indicated in the first 2 bars.

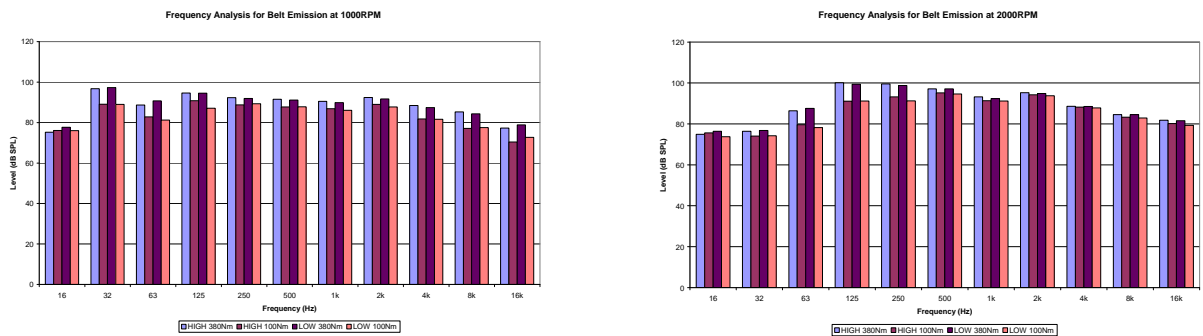
Figure 11 – Levels for Belt acoustic emission with engine running at 1000rpm and 2000rpm. The different tension and torque cases are presented.

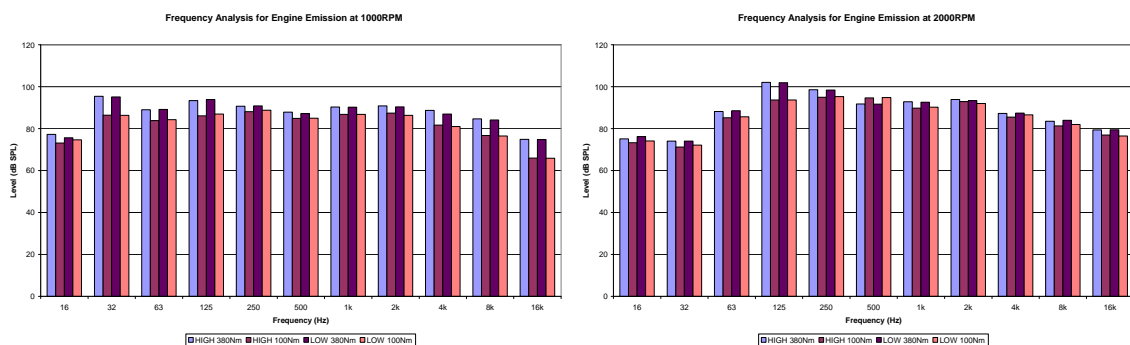
Figure 12 – Levels for Engine acoustic emission with engine running at 1000rpm and 2000rpm. The different tension and torque cases are presented.
