## **European Experience of Low Crested Structures for Coastal Management**

## European experience of low crested structures for coastal management

This paper aims to describe selected study sites monitored and analyzed during the DELOS project. All the selected sites are protected by Low Crested Structures (LCSs) under various environmental conditions.

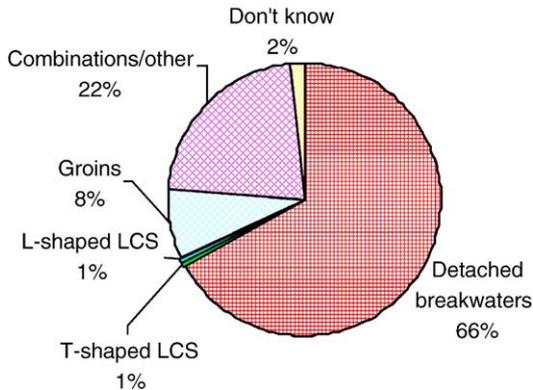
Fig. 2. Types of low crested structures in Europe.

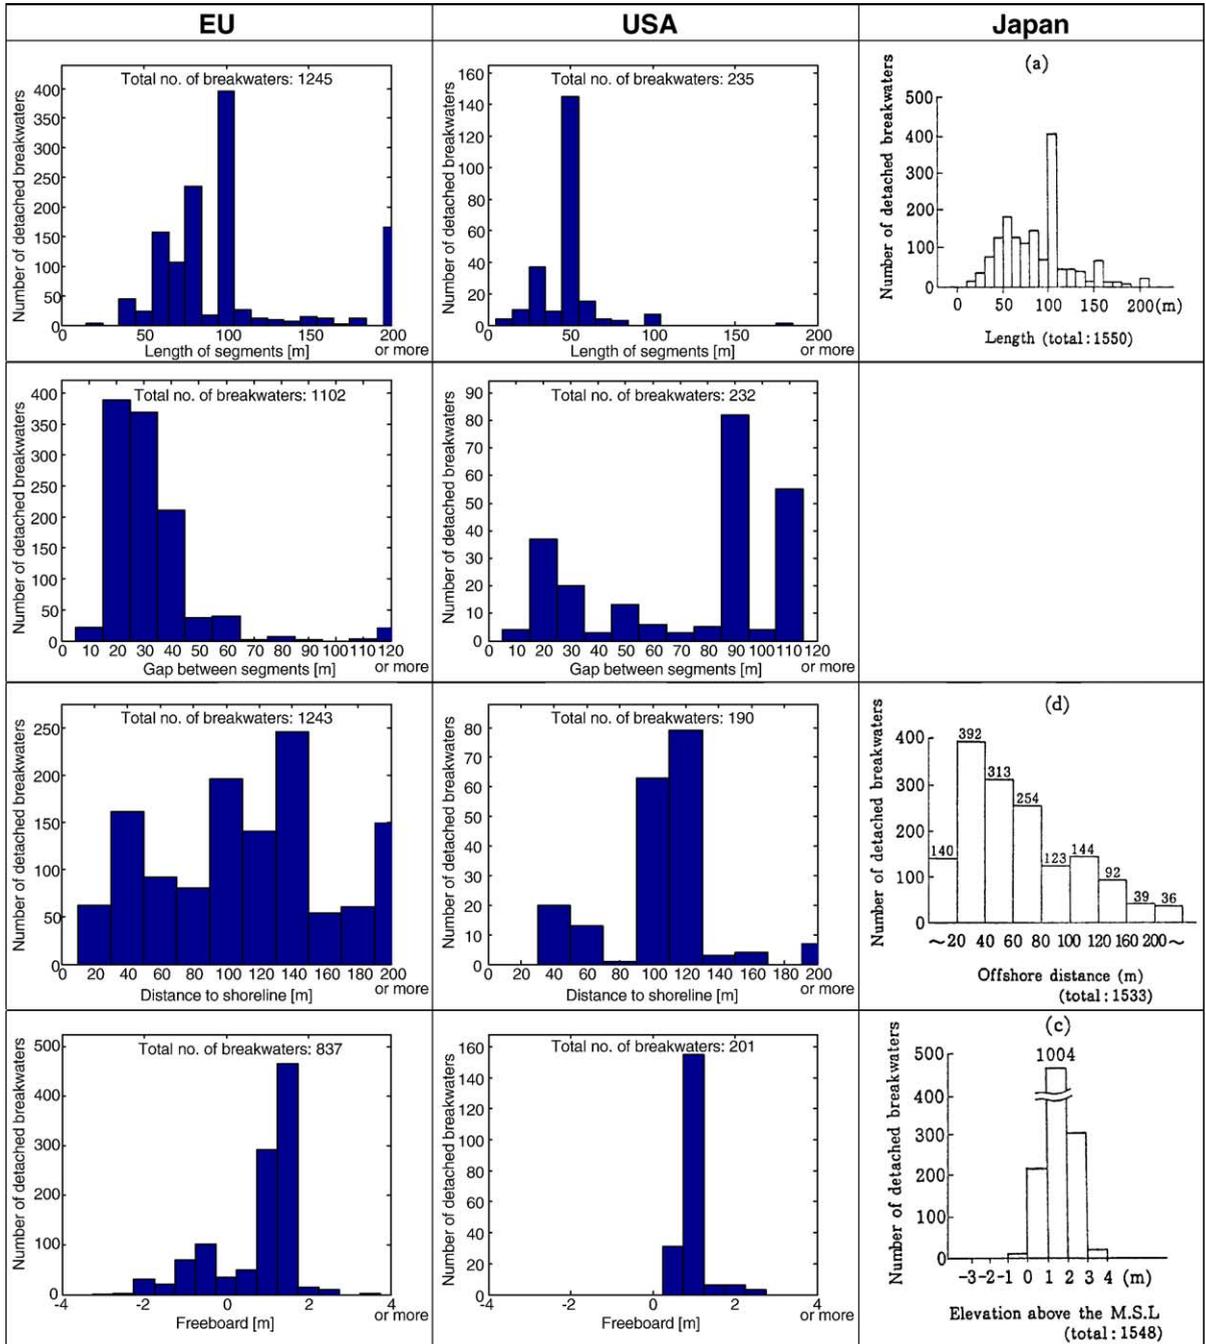
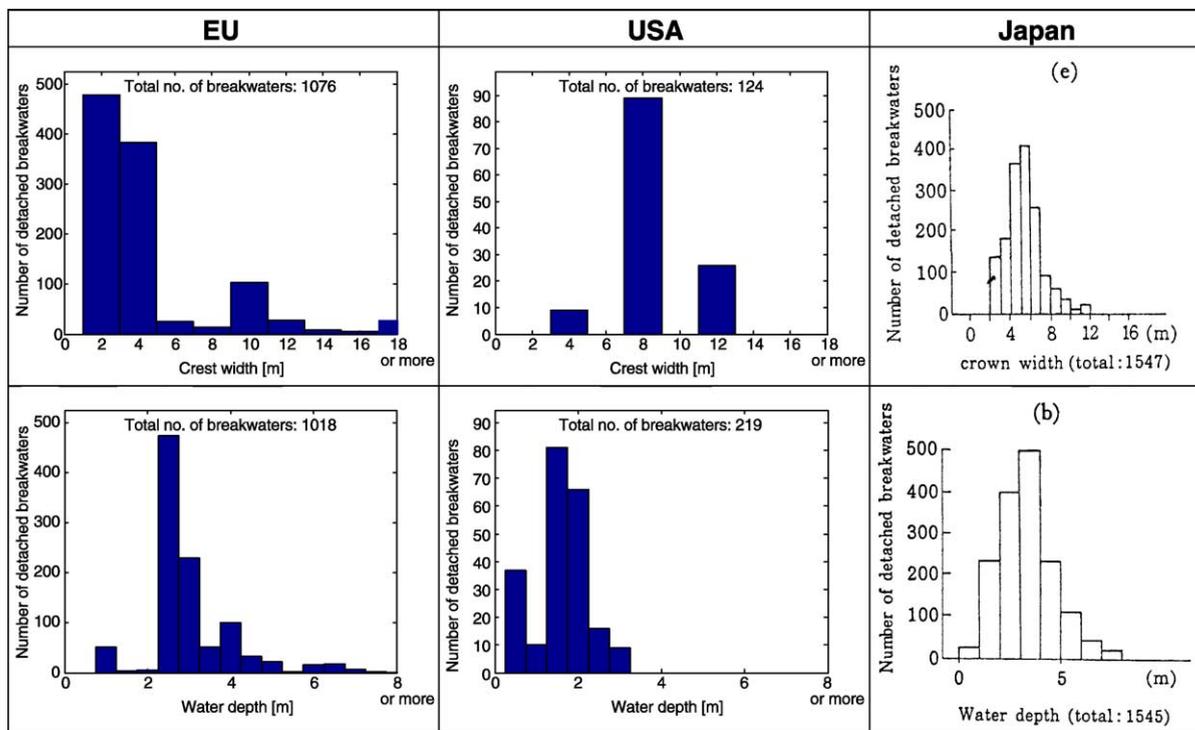
Fig. 4. Part I. Histograms showing the distribution of LCSs for each investigated parameter. Part II. Histograms showing the distribution of LCSs for each investigated parameter.

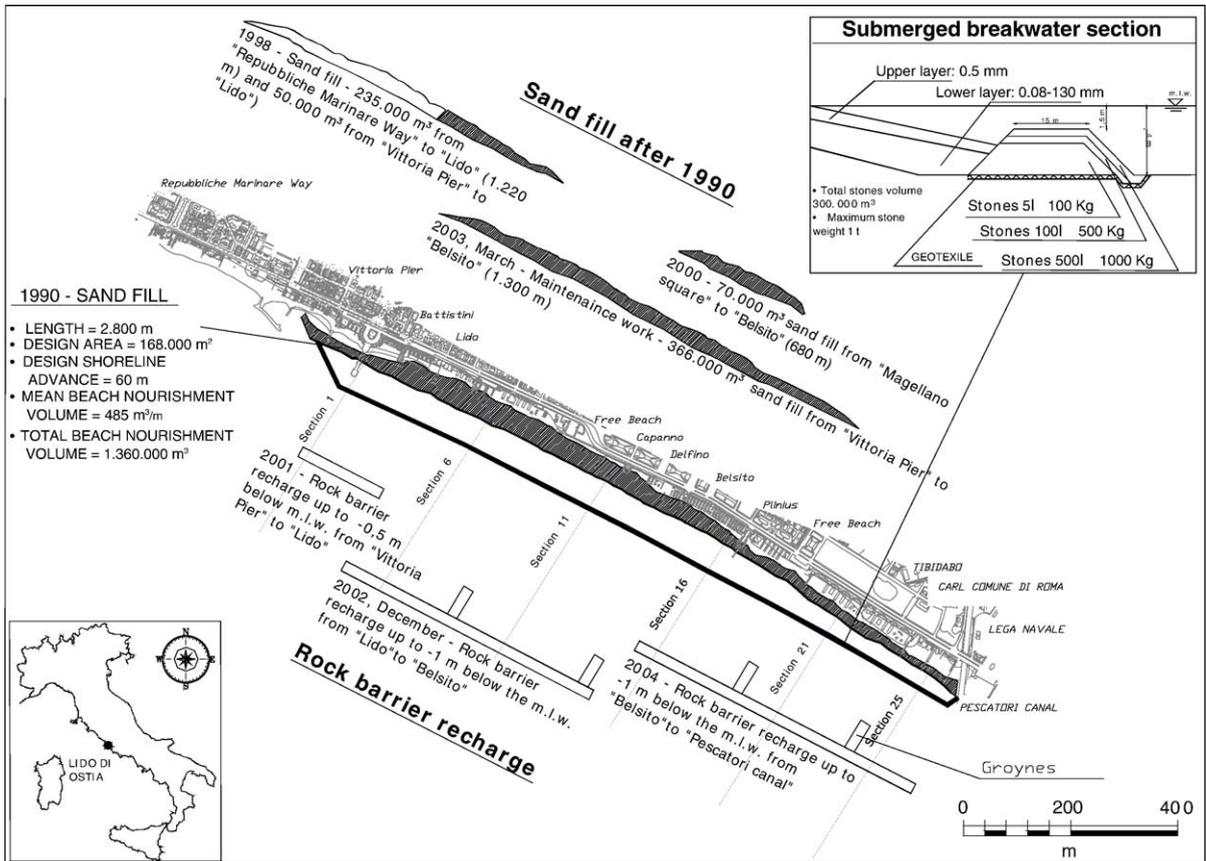
Fig. 6. Plan view and submerged breakwater section scheme.

Historical beach profiles were compared for 6 representative sections at 500 m spacing (Fig. 6),

where the rock barrier position is also indicated. The disappearance of the offshore bar is noted. Volumetric computations carried out with BMAP (CERC) show the beach reduction in the first period 1992–96 with an erosion peak of 234 m<sup>3</sup>/m at Section11, while accretion obviously occurs after additional recent fills, particularly at the downdrift sections (due to the expected deposit against the Canal groin) and at the most updrift section (due to the LCS raising at –0.5 m MSL).

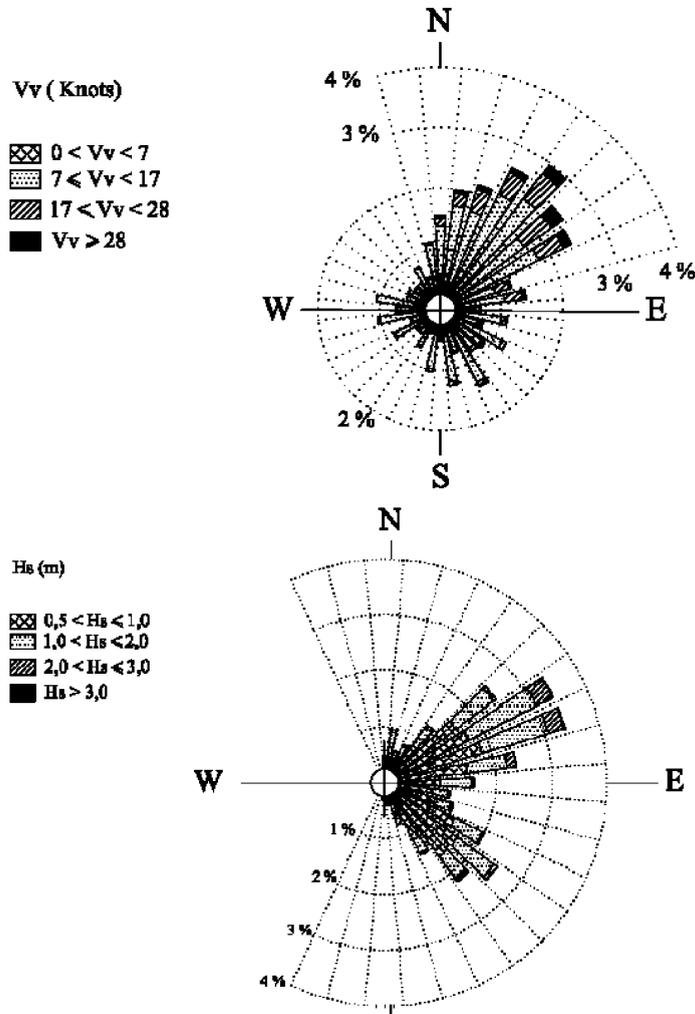
Fig. 8. Wind rose (up) and wave rose (down) at CNR (National Research Council) tower (Venice). Period: October 1987– December 2002.

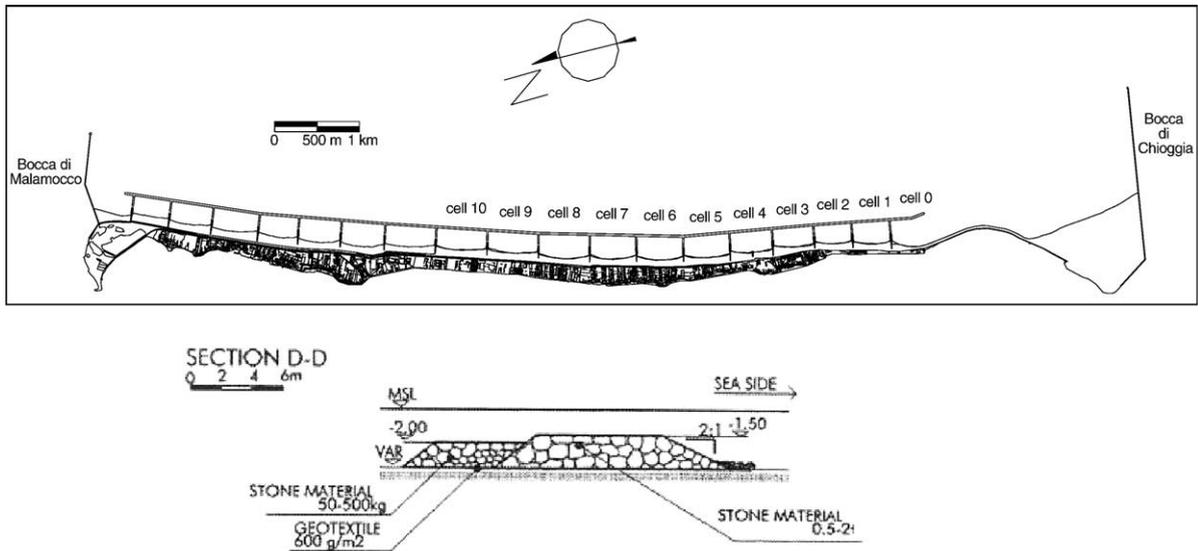
Fig. 9. Plan view of Lido of Pellestrina and LCS section.

reshaping phenomena where sand is moved toward the submerged structure (Fig. 9). The project foresees a loss of about 10% in ten years, so the results are acceptable.

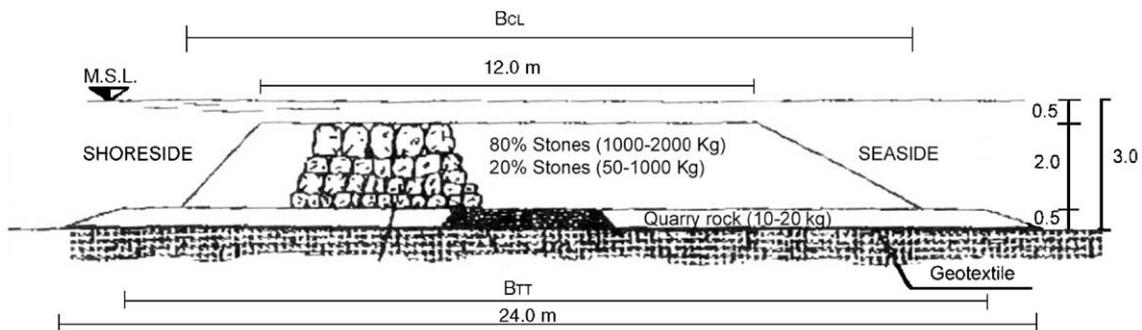
Fig. 10. Typical cross-section of LCS in Lido di Dante (before 2001).

The submerged breakwater (770 m long placed at 180 m from the coast at a 3.5 m depth, interrupted by a surface opening 30 m wide) is part of a more complex project made in 1995 mainly to solve the problem of the extensive erosion. The original submergence was 0.5 m, which was reduced to 0 in 2001 (Fig. 10).

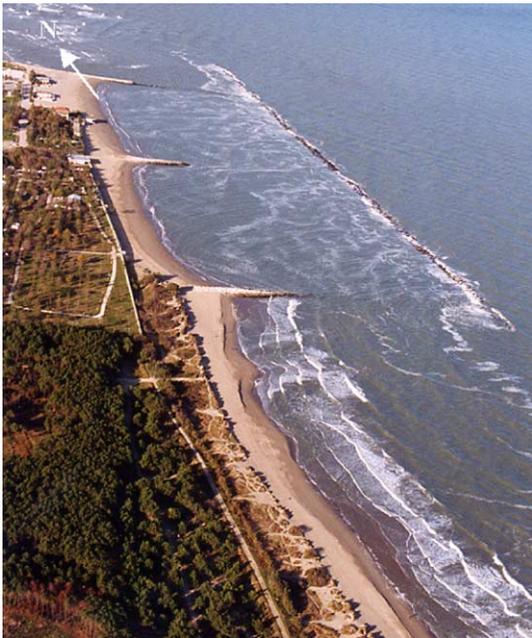
Fig. 11. Perspective view of the shore-protection system defending Lido di Dante beach.

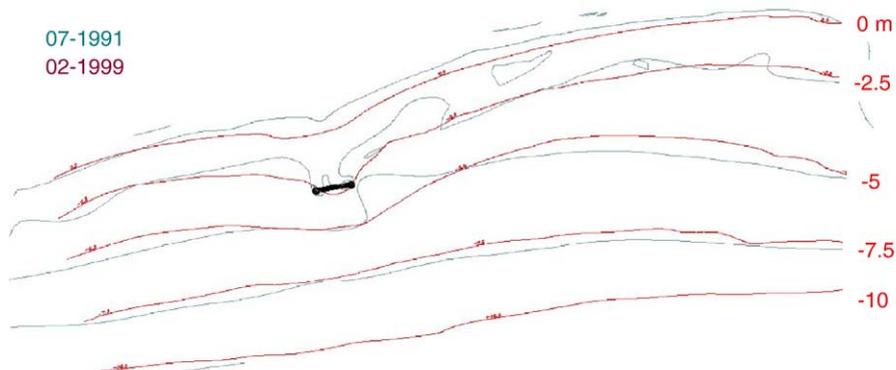
Fig. 13. Comparison between 07-1991 and 02-1999 Altafulla bathymetries.

In Fig. 13, the first and last available bathymetries are shown. It can be observed how the greatest changes have occurred in the lee side of the structure. The irregularities observed on the right side of the 1991 bathymetry can be attributed to the nourishment made 3 months before the measurements.

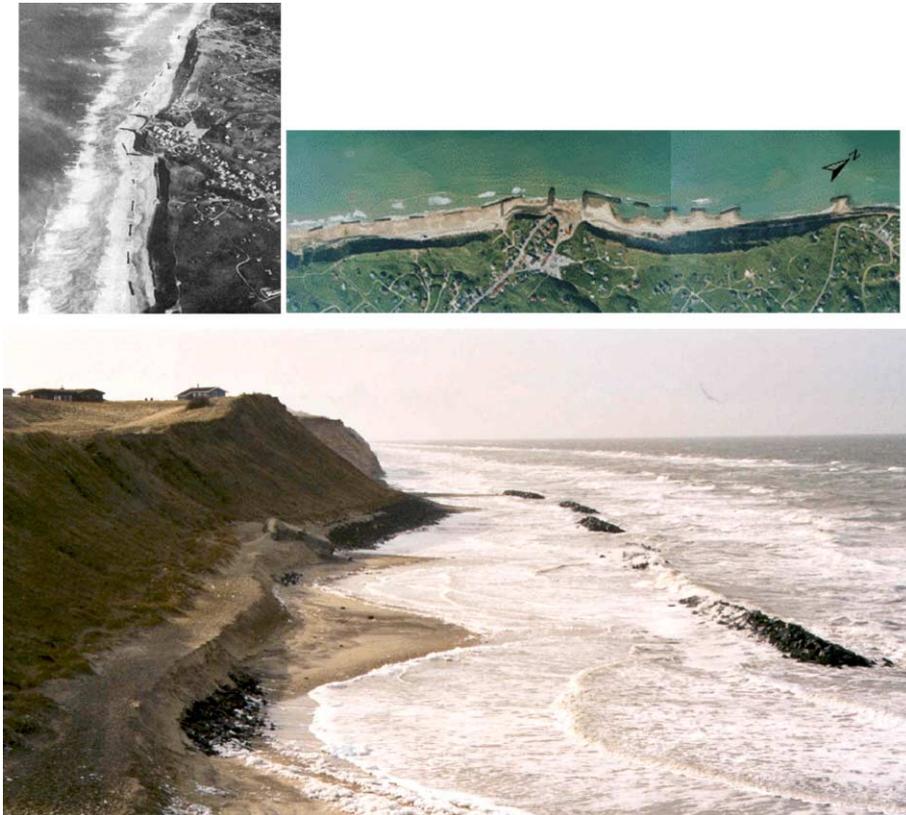
Fig. 15. Pictures of the study site at Lønstrup.

The map in Fig. 14 shows the location of Lønstrup and a picture of the breakwater is given in Fig. 15. A system of breakwaters is placed both north and south of this site. The breakwaters were built to protect the small village Lønstrup located near the sea and the adjacent beaches from the ongoing coastal erosion caused by the North Sea waves. The most frequent wind direction is from West and South West where the strongest winds also occur. Due to the large fetch in Western direction the waves and the storm set-up is large during autumn storms. If unprotected the coast at Lønstrup will erode 1.5 m/year. In fact during a storm back in 1981 some places were eroded up to 15 m. This event induced the construction of the protection scheme in 1982/1983.

The support of the European Commission through the DELOS project contract EVK3-CT-2001-00041 is gratefully acknowledged. The lower photo in Fig. 15 was provided by Poul Jacobsen SIC.

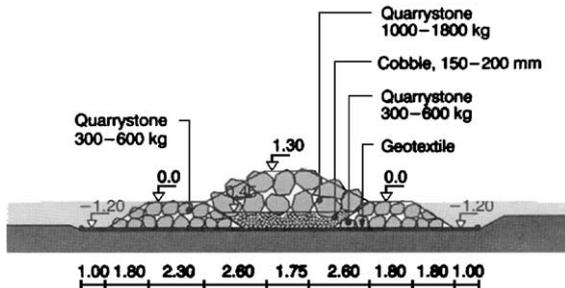
Fig. 16. Cross-section of breakwaters at Lønstrup. From Lastrup and Madsen (1994).

The area of interest is being nourished with 20,000–30,000 m<sup>3</sup>/y sand between the coast and the breakwaters. The area is a popular tourist and nature spot in Denmark and many summerhouses are located here. The system of breakwaters at Lønstrup is 1100 m long. Each breakwater is 45 m long and is in turn separated by 45 m. All breakwaters have circular roundheads and are aligned parallel to the coast. The system of breakwaters found along the coastline is located sufficiently close to the beach so that tombolo formations are generated. The water depth on the offshore side of the breakwaters is approximately 1 m and the steepness of the bottom slope is approx. 1:150. All breakwaters are rubble mound breakwaters. A sketch of a typical cross-section is shown in Fig. 16 (from [Laustrup and Madsen, 1994](#)).

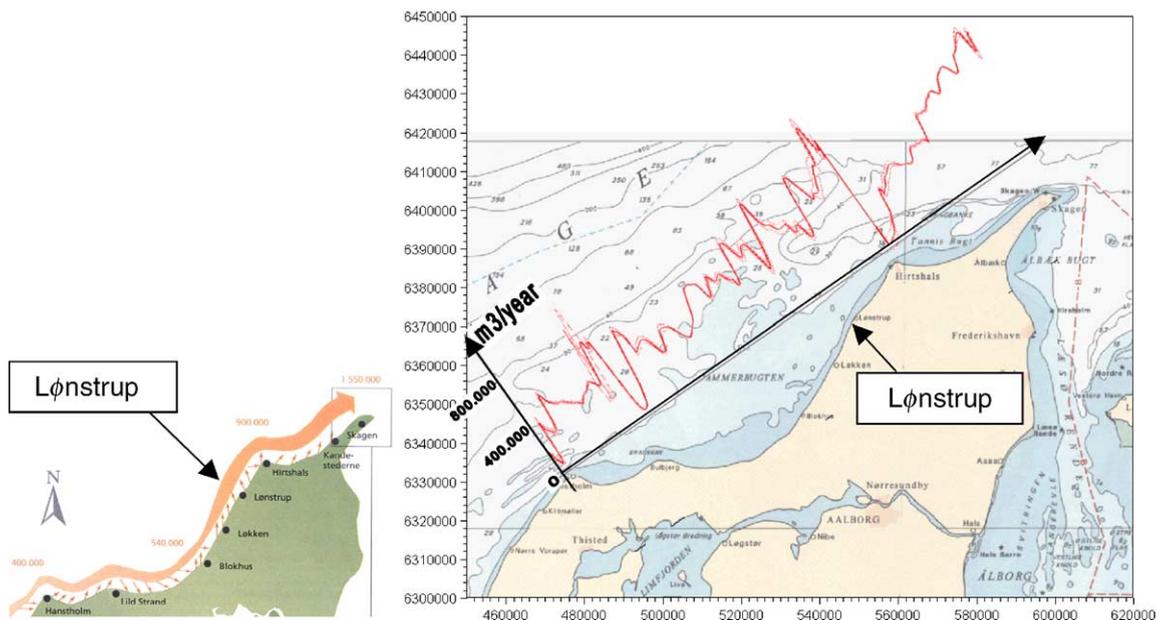
Fig. 17. Sediment transport at the West Coast in the Northern part of Denmark (Kystdirektoratet, 2001).

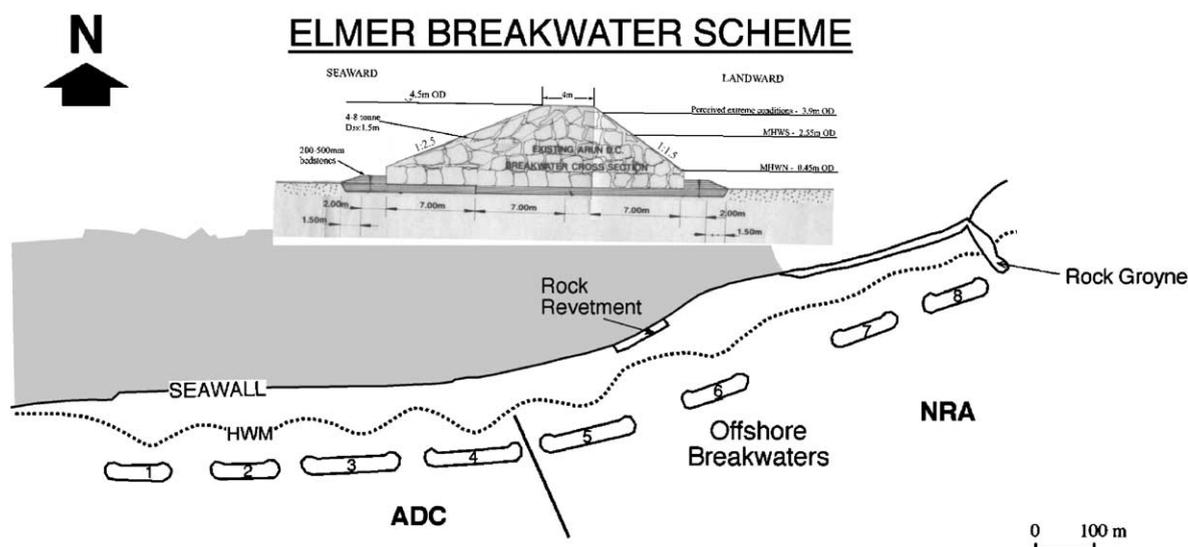
Fig. 18. Elmer breakwater scheme and cross-section.

Bognor Regis, on the West Sussex coastline (Fig. 17) (this frontage is the joint responsibility of the Arun District Council (ADC) and the National Rivers Authority (NRA)). This particular section of coastline has been associated with increasing residential development; this, in turn, has created the need for effective flood control works through coastal protection schemes, resulting inevitably in significant environmental changes. The area is protected, at present, by a segmented offshore breakwater scheme constructed in 1992. The length of the segments range between 80 to 140 m at a distance from the shoreline between 40 – 90 m. In Fig. 18 the cross-section is sketched.

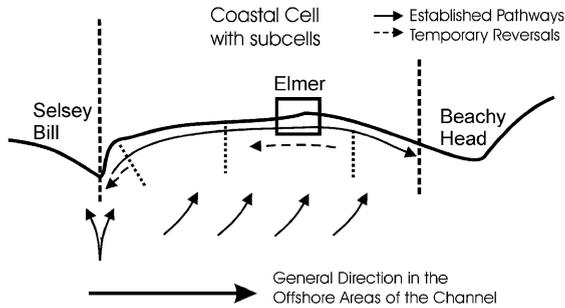
Fig. 19. Regional sediment transport direction in the West Sussex coastal cell (adapted from various sources).

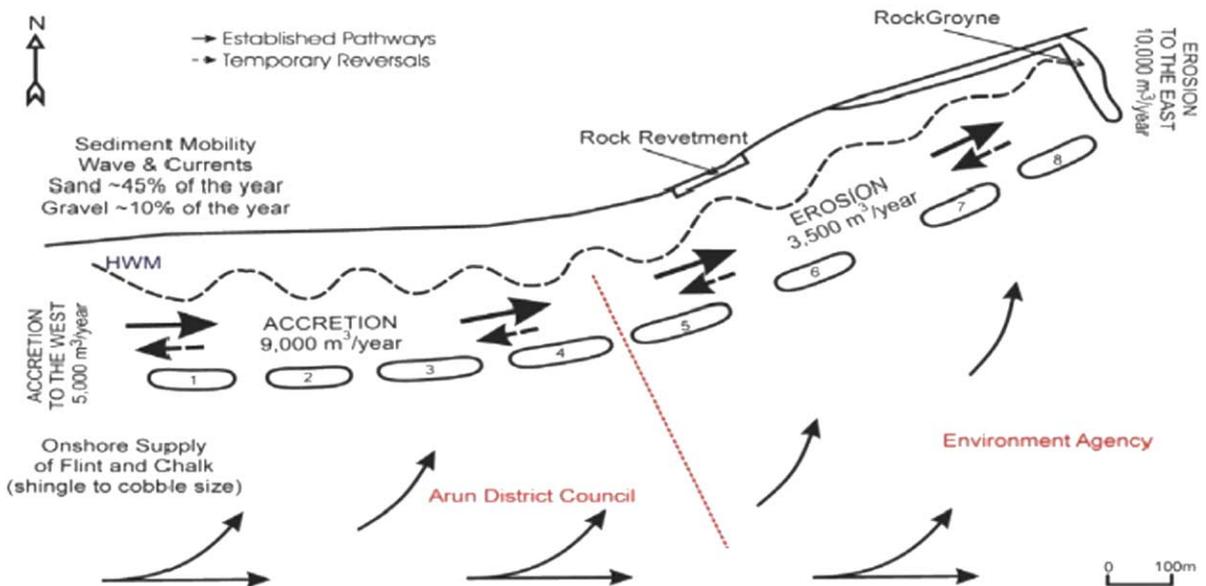
Fig. 20. Localised sediment transport in the vicinity of the Elmer (offshore breakwater) scheme (adapted from various sources).

The regional littoral drift in the area is from west to east, as implied by sediment accumulation on the western side of the groins. Elmer is positioned in the middle of the coastal cell that extends from Selsey Bill to the west and Beachy Head to the east, with west to east littoral transport (Fig. 19). In the sub-cell incorporating Elmer occasional reversals of the sediment transport direction have been observed. The coast is losing sand-sized material from the lower part of the beach (Bray et al., 1995). The input of sedimentary material to the macro cell is mainly by beach nourishment and wave-driven shingle and chalk supplied from offshore.
