IMI Country Paper, Sri Lanka No.13

**Nature of Small Tank Cascade Systems
and a Framework for Rehabilitation
of Tanks within Them**

R. Sakthivadivel
Nihal Fernando
C.R. Panabokke
C.M. Wijayaratna

INTERNATIONAL IRRIGATION MANAGEMENT INSTITUTE

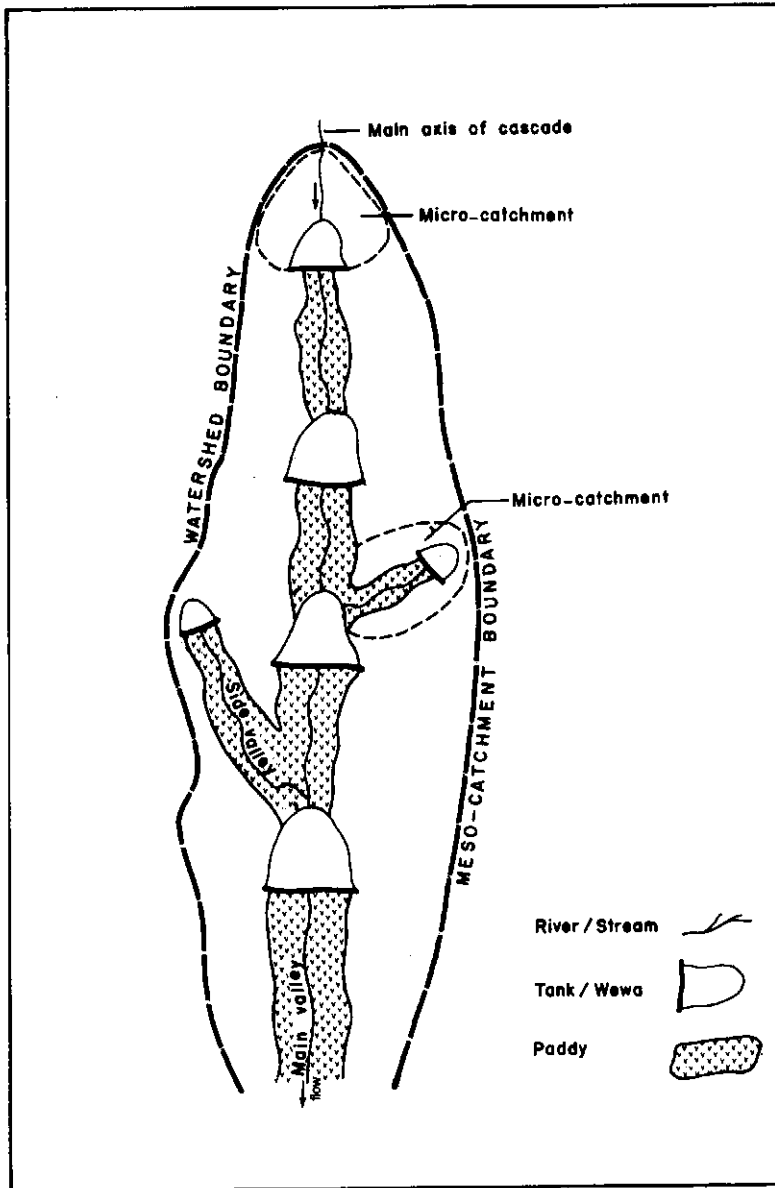
Figure 2. Schematic representation of a small tank cascade (scale, 1:50,000).

A schematic representation of a typical small tank cascade system at a scale of 1:50,000 is shown in Figure 2. The main elements that make up a cascade, namely (a) the watershed boundary of the meso-catchment, (b) the individual micro-catchment boundaries of the small tanks, (c) the main central valley, (d) side valleys, (e) axis of the main valley, and (f) the component small tanks as well as the irrigated rice lands are shown in the same figure.

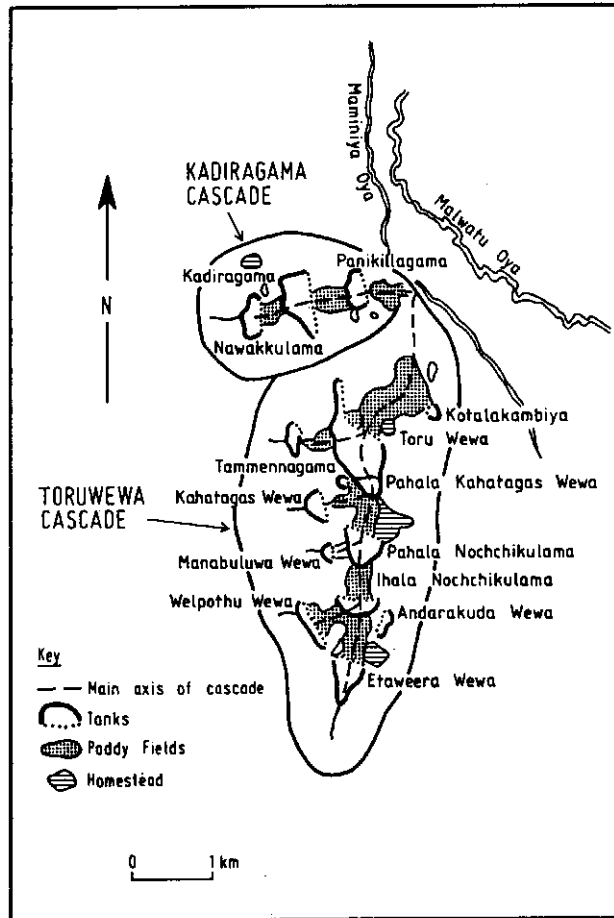
Figure 3. Toruwewa and Kadiragama cascades as appearing on a topographic sheet.

An actual depiction of two adjacent small tank cascades as described by Madduma Bandara (1991) and shown in Figure 3, illustrates the general manner of occurrence of cascades in this landscape. In a similar manner, as depicted for the Toruwewa and Kadiragama cascades in Figure 3 where the main elements of the individual cascades have been identified and demarcated by an appropriate study and interpretation of the 1 inch to 1 mile topographic

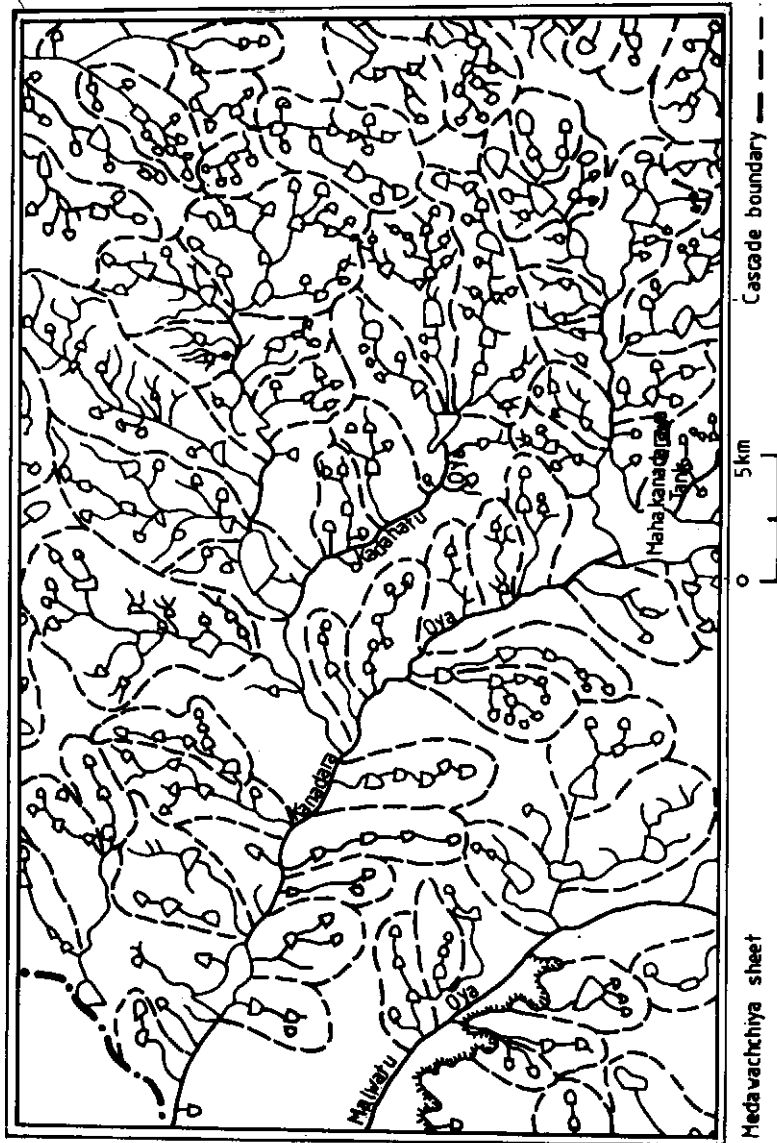
Figure 4. Distribution pattern of small tank cascade systems: The Medawachchiya topographic sheet.

As could be observed in Map 1, a considerable degree of variation occurs in both the small tank as well as the small tank cascade densities across the whole district. The highest density of small tank cascades occurs around the upper aspects of the Kanadara Oya and Kadahatu Oya as shown in the Medawachchiya topographic sheet, as well as around the third-order streams that flow into the Maha Kanadarawa reservoir and which are situated in the northeastern portion of Anuradhapura as shown in the topographic sheet. This is in conformity with the normal process of landscape evolution, where a higher drainage density occurs in the upper aspects of the watershed (which decreases as one proceeds to the mid- and lower aspects of the watershed). This is clearly observed in the Kanadara Oya and Weli Oya tributaries of the Malwathu Oya, which are located in the mid- and lower aspects of the watershed as could be observed in the southwestern portion of the Medawachchiya topographic sheet.

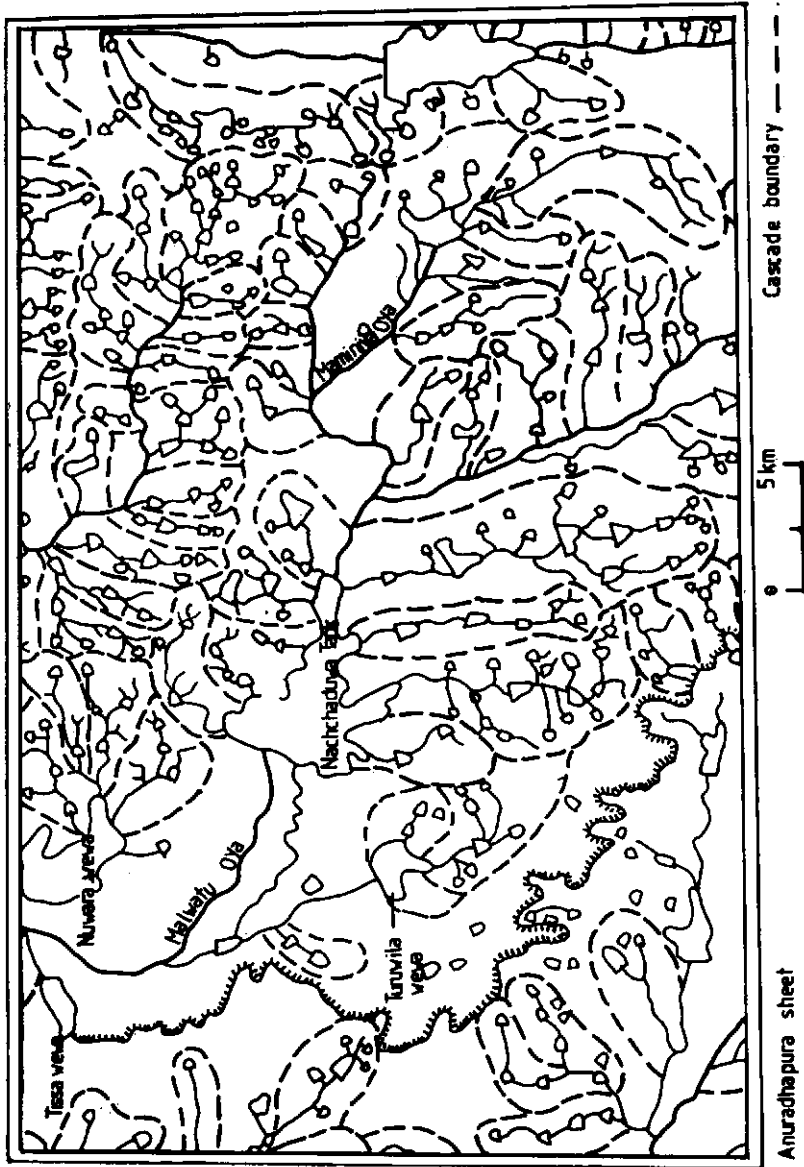
Figure 5. Distribution pattern of small tank cascade systems: The Anuradhapura topographic sheet.

Similarly, a higher density of small tank cascades is observed around the upper aspects of the Malwathu Oya watershed as well as around the upper watershed of the Maminiya Oya and Malwathu Oya branch in the south eastern portion of the Anuradhapura topographic sheet. The density of small tank cascades similarly decreases in the mid- and lower aspects of the main Malwathu Oya, which is a fourth-order stream.

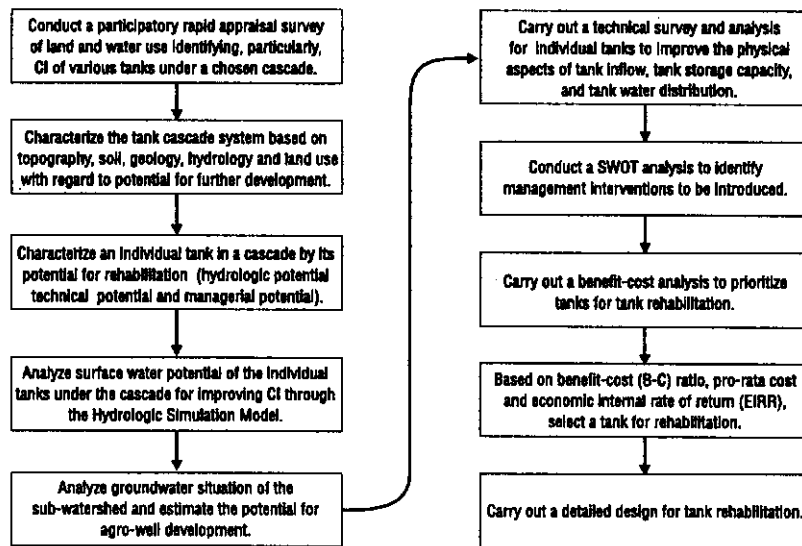
A Framework for Small Tank Selection for Rehabilitation

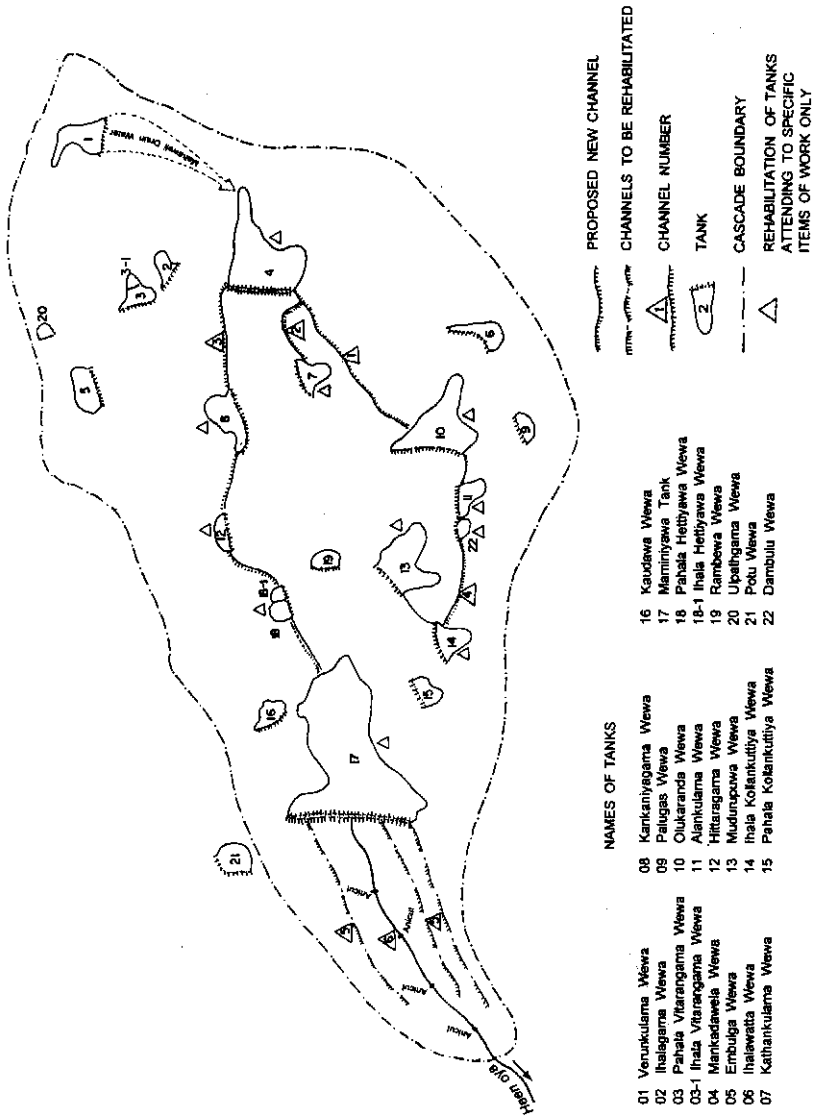
Figure 7. Maminiyawa Cascade—proposed water resources development plan.

In the first step of the technical appraisal of the farmers' development plan, minor modifications to the farmers' development plan may be done on the basis of hydrological simulation. The next step would be a quick appraisal of the technical feasibility of the proposals by engineers during which phase the proposals are technically evaluated. The third step is a quick appraisal of the cost of the proposals in order to evaluate the pro-rated costs so as to approve the proposals.
