# TEMPORARY SPEED HUMP IMPACT EVALUATION

CTRE Project 00-73

Sponsored by  
the Office of Traffic and Safety,  
Iowa Department of Transportation

**Final Report • July 2002**

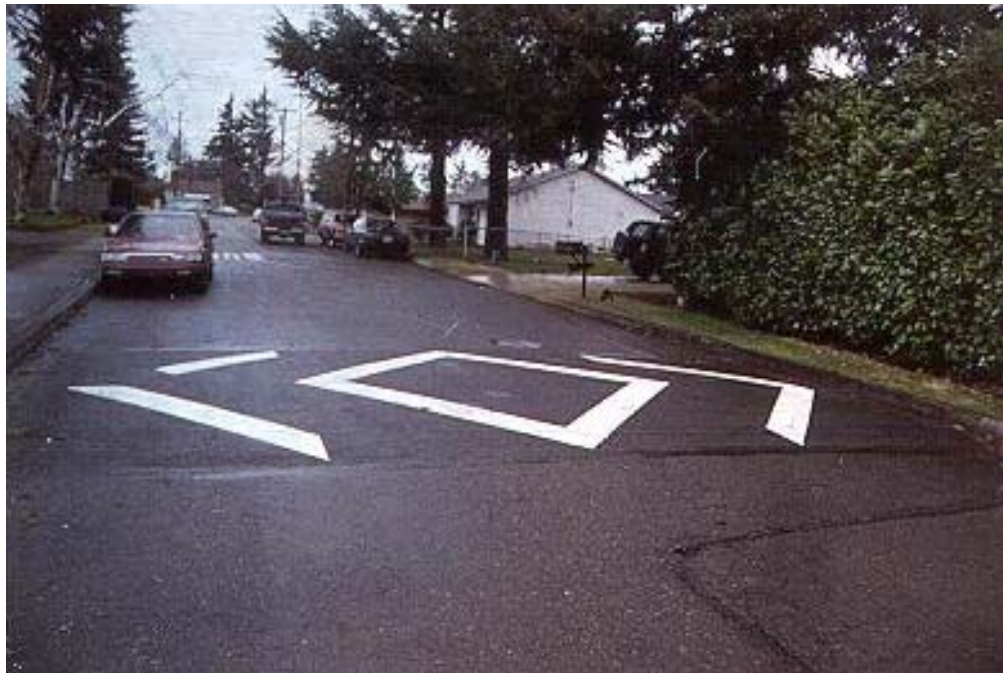
**Figure 1. Typical Speed Hump  
(Traffic Calming for Communities, 2001)**

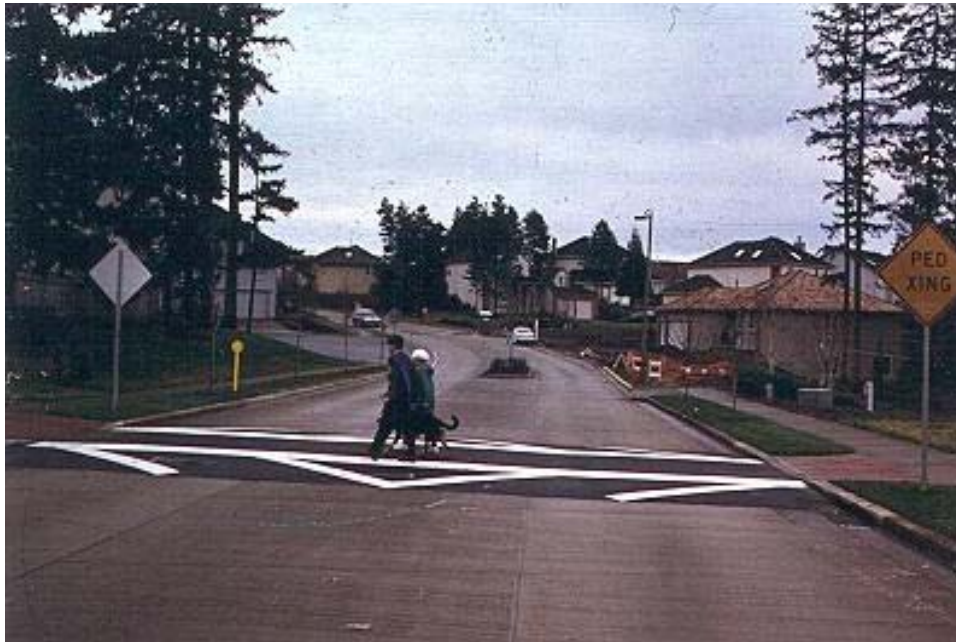
**Figure 2. Typical Speed Table  
(Traffic Calming for Communities, 2001)**

same manner. The flat portion of the table is typically longer than the wheelbase of a passenger car. Speed tables are sometimes referred to as “Seminole County speed humps” or “trapezoidal speed humps” (Ewing, 1999). Speed tables also are often used at pedestrian crossings and may be referred to as a raised crosswalk (Ewing, 1999). A typical speed table is shown in Figure 2.

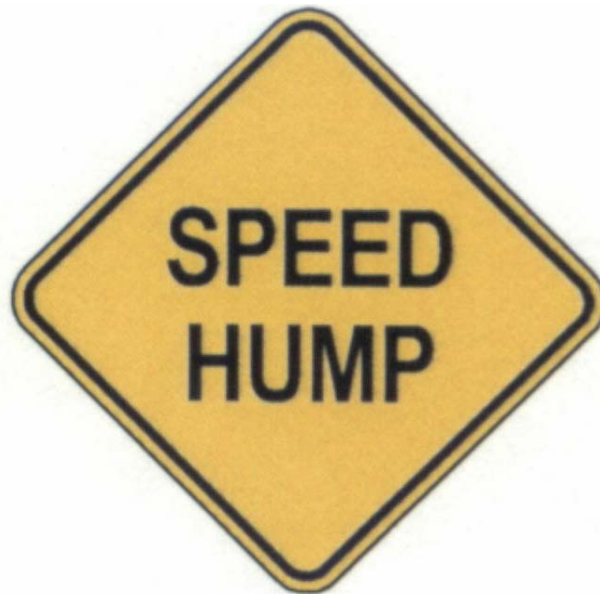
**Figure 4. Typical W17-1 SPEED HUMP Warning Sign (FHWA, 1988)**

Although the MUTCD recommends the use of the W17-1 SPEED HUMP sign (Figure 4), the most commonly used sign with speed hump installation is the W8-1 BUMP sign as shown in Figure 5 (ITE Traffic Engineering Council, 1997). Other signs that have been used by agencies include HUMP and ROAD HUMP. The ITE design guidelines also recommend the use of advisory speed plaques as shown in Figure 6. Some agencies also include a supplemental plaque with the legend Next XX Feet for a series of speed humps, and others install special attention flags or flashing lights.

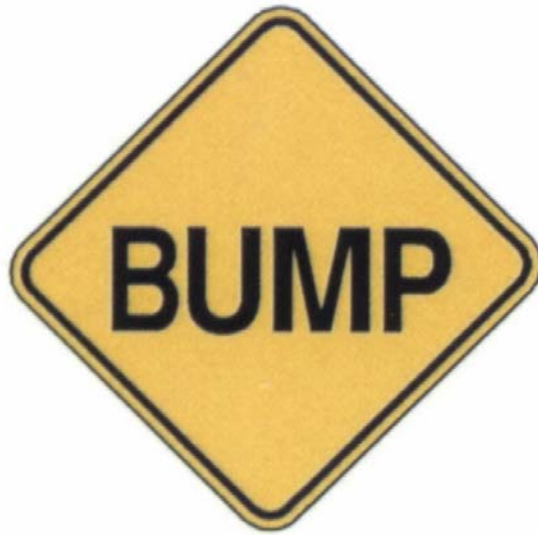
**Figure 5. Typical W8-1 BUMP Warning Sign (FHWA, 1988)**

Warning signs and pavement markings were used while the devices were in place. Standard W17-1 warning signs were placed in advance of the speed hump/table in each direction. The yellow warning signs used were 30-inch by 30-inch diamonds with a black border and legend reading SPEED HUMP AHEAD as shown in Figures 4 and 22. Placement of the warning signs was left to the participating cities, but it was specified that the warning signs should be placed at least 100 feet in advance of the speed hump/table. The 100-foot distance meets the placement requirements of warning signs set forth by the 2000 MUTCD (FHWA, 2000). The warning signs were either mounted on signposts or banded to existing utility poles.

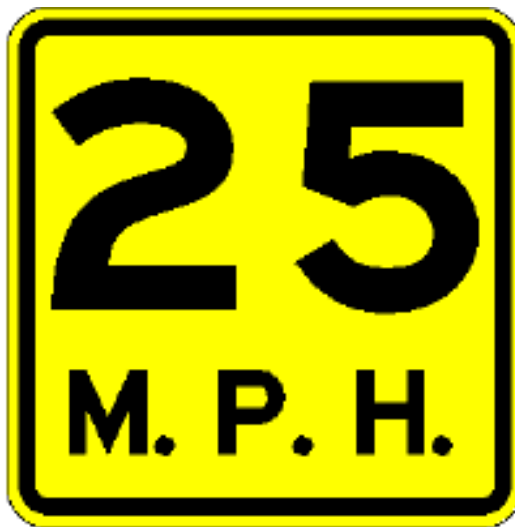
**Figure 6. Typical W13-1 Advisory Speed Plaque (Moeur, 2001)**

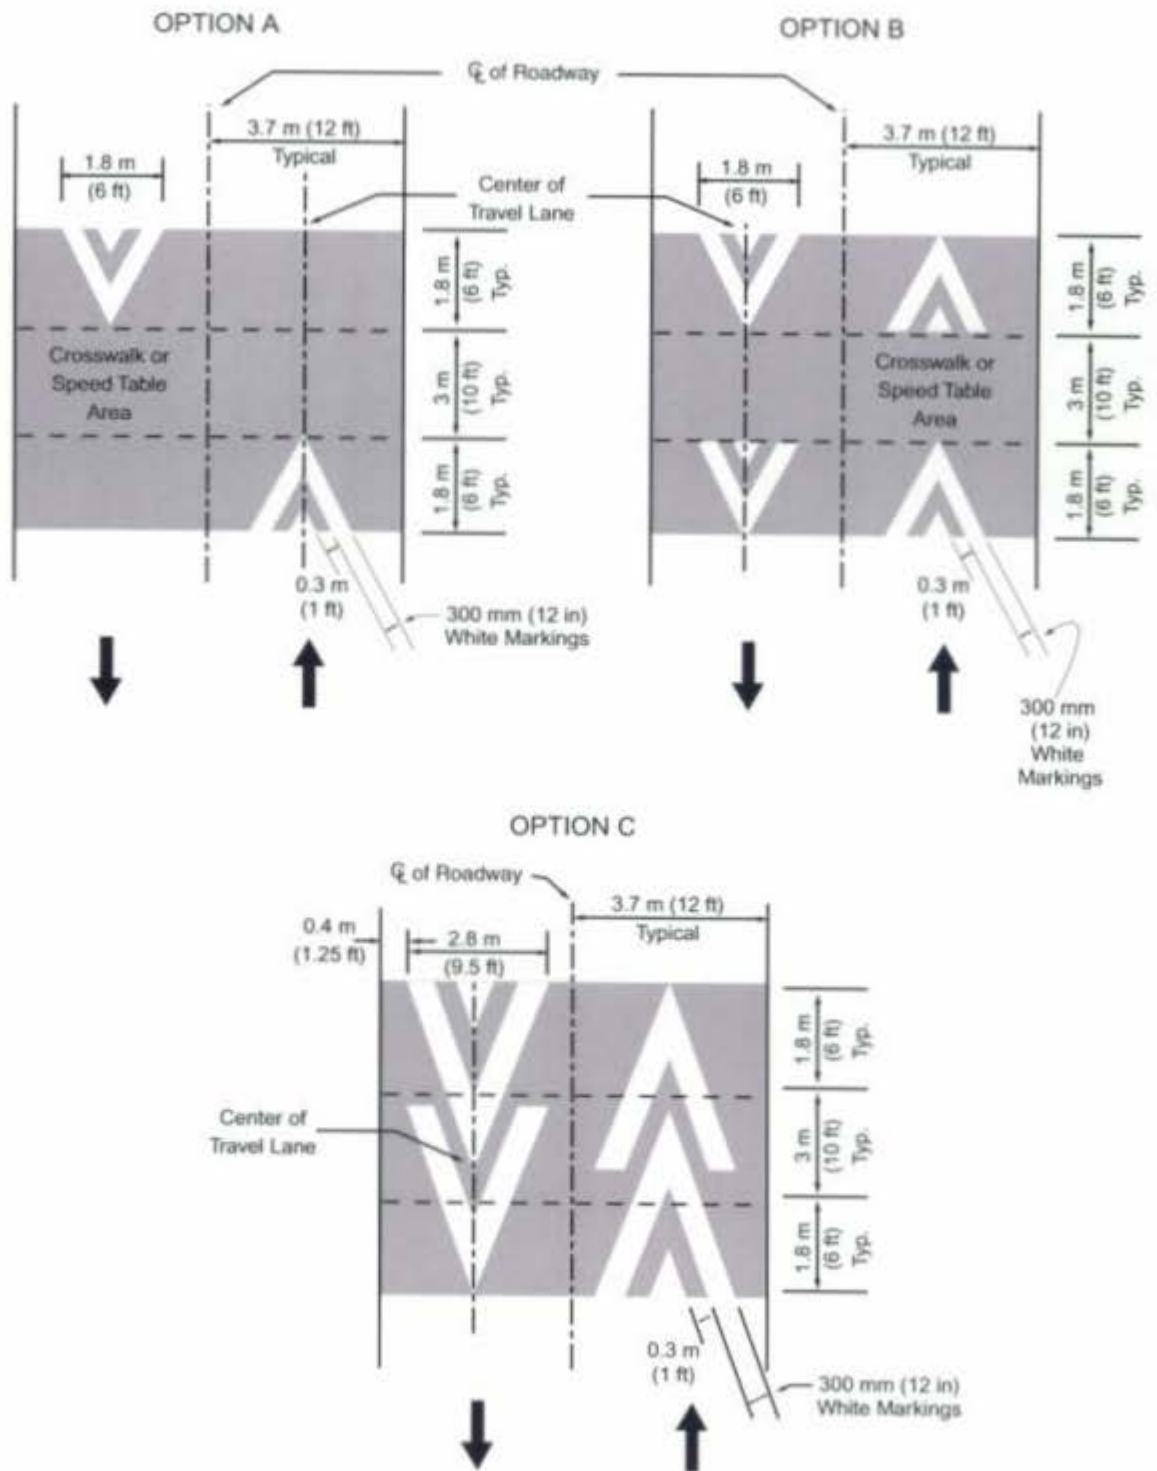
Figure 10. Typical Speed Table Pavement Markings Shown in the MUTCD (FHWA, 1988)

Pavement markings are also typically used with speed humps and speed tables. Again, the MUTCD does not require or provide required layouts for these pavement markings. However, if pavement markings are used with a speed hump/table, the markings must be white and located on the hump/table (FHWA, 1988). MUTCD suggested pavement markings for speed humps and speed tables are shown in Figures 9 and 10 respectively. A suggested layout for advanced speed hump/table pavement markings is also provided in the MUTCD as indicated in Figure 11.

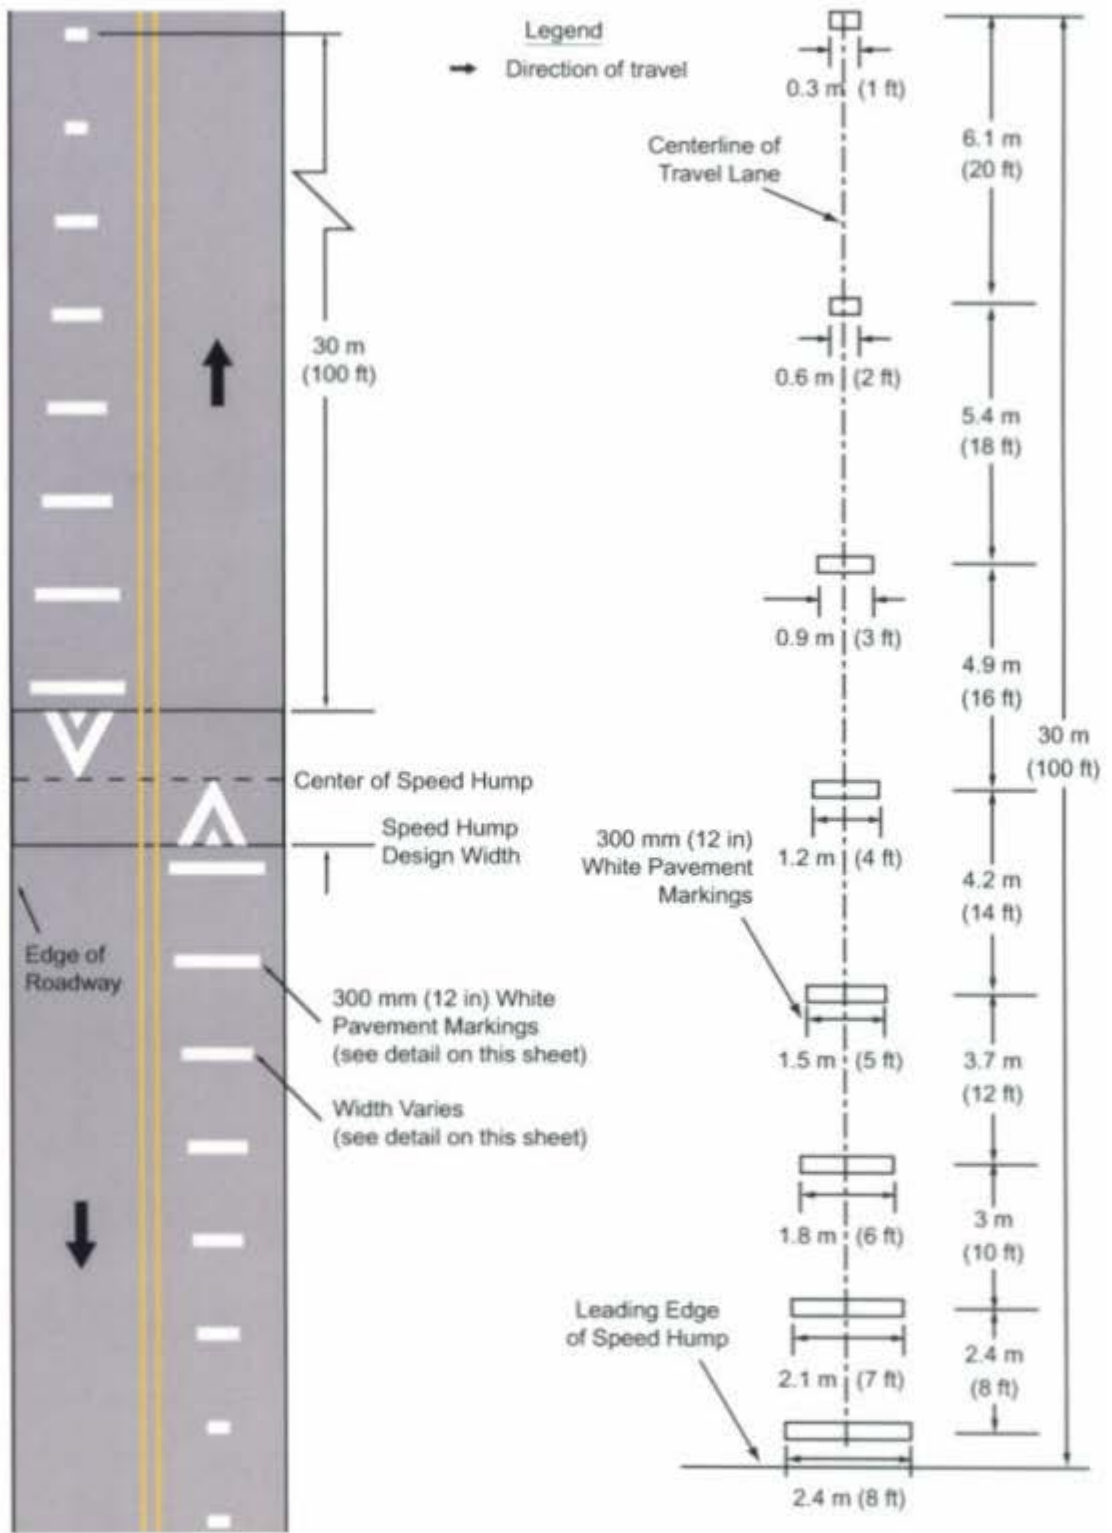
Figure 11. Typical Advanced Speed Hump/Table Pavement Markings Shown in the MUTCD (FHWA, 1988)

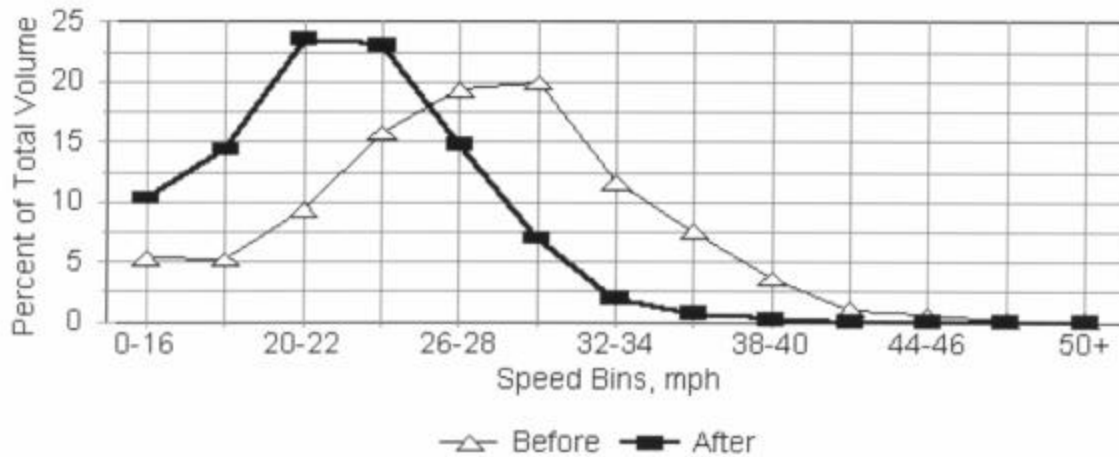
**Figure 12. Portland 14-Foot Speed Hump Speed Distribution (Kittelsson and Associates, Inc., 2000)**

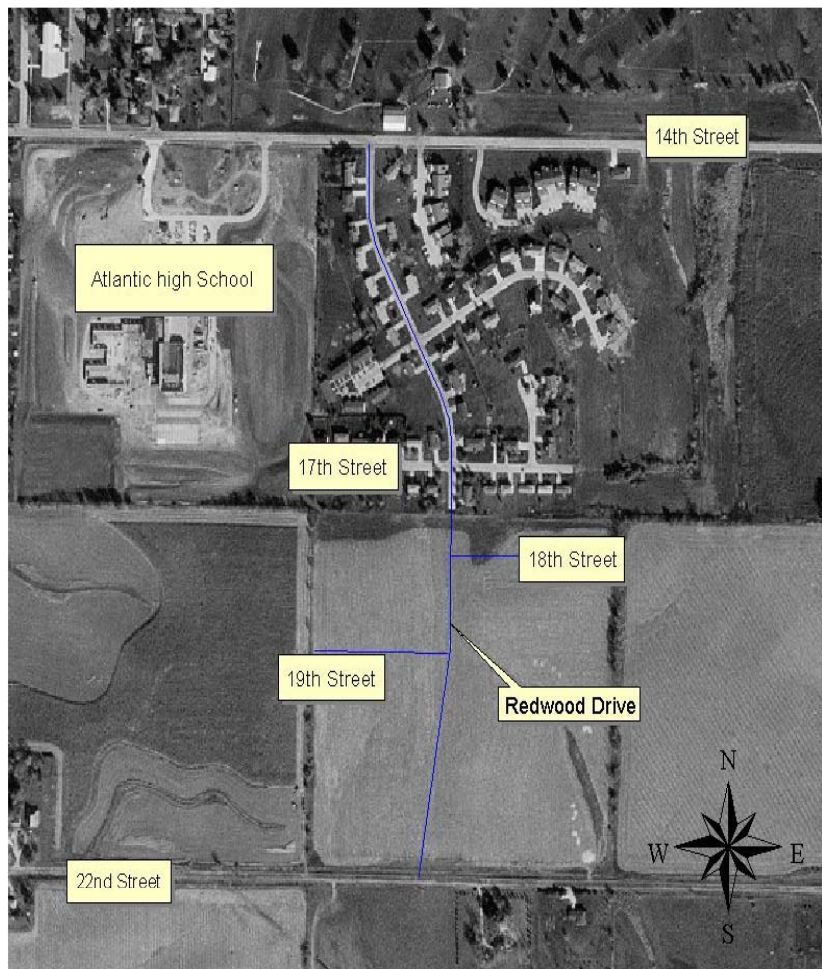
Figure 15 shows the study area as farmland since the only available aerial photograph was taken prior to development along Redwood. Consequently, Redwood Drive and three intersecting minor streets, 17th Street, 18th Street, and 19th Street, were drawn on the aerial photograph to show location. Currently, ten houses have been built adjacent to Redwood

**Figure 15. Redwood Drive in Atlantic, Iowa  
(USDA Natural Resources Conservation Service, 2001)**

An aerial view, taken in 1994, of the area surrounding Redwood Drive is shown in Figure 15. The Redwood Drive test section is located in a new residential housing development and is bounded by 17th Street to the north and 22nd Street to the south. It is a 30-foot wide concrete residential street with curb and gutter. The intersection of Redwood Drive and 17th Street has four-way stop control, and the intersection of Redwood Drive and 22nd Street is a T-intersection, controlled by a stop sign on Redwood Drive. On-street parking is permitted but is rarely utilized. A crest vertical curve was located on the south end of the section under

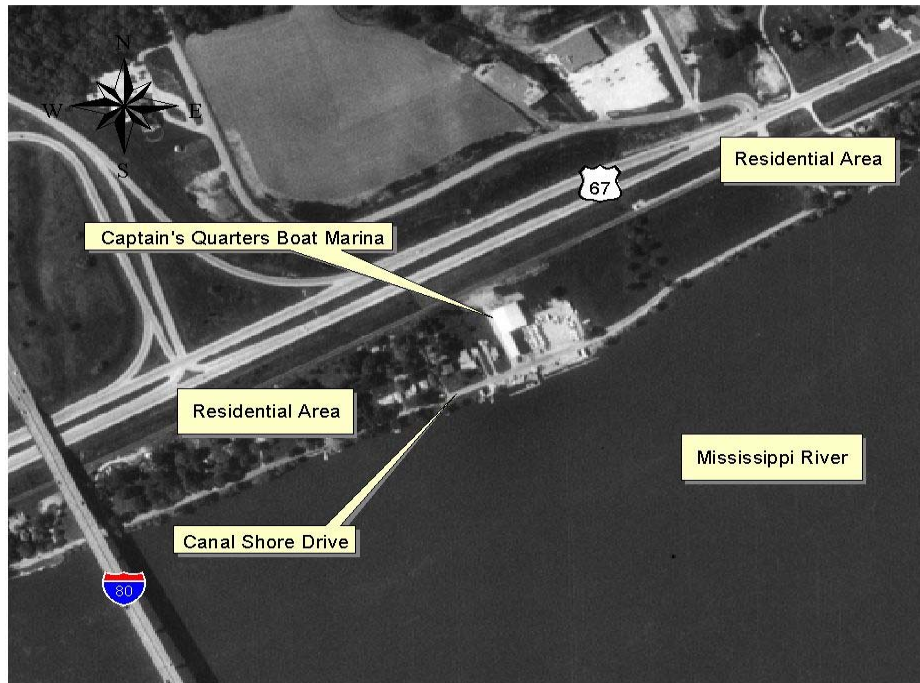
As shown in Figure 16, Canal Shore Drive is located between the Mississippi River and U.S. Highway 67 in Le Claire, Iowa. Canal Shore Drive is a 21-foot wide asphalt street without curb and gutter. The land along Canal Shore Drive is used both for residential and recreational purposes. The area of interest for the speed hump/table installation was the section of Canal Shore Drive near Captain's Quarters (a local boat marina) and two adjacent residential areas. This section of Canal Shore Drive is flat with a minor horizontal curve located east of Captain's Quarters marina. City officials had received numerous complaints from both the owner of Captain's Quarters and nearby residents, especially those on the western end of Canal Shore Drive, about traffic traveling at excessive speeds.

**Figure 16. Canal Shore Drive in Le Claire, Iowa  
(USDA Natural Resources Conservation Service, 2001)**

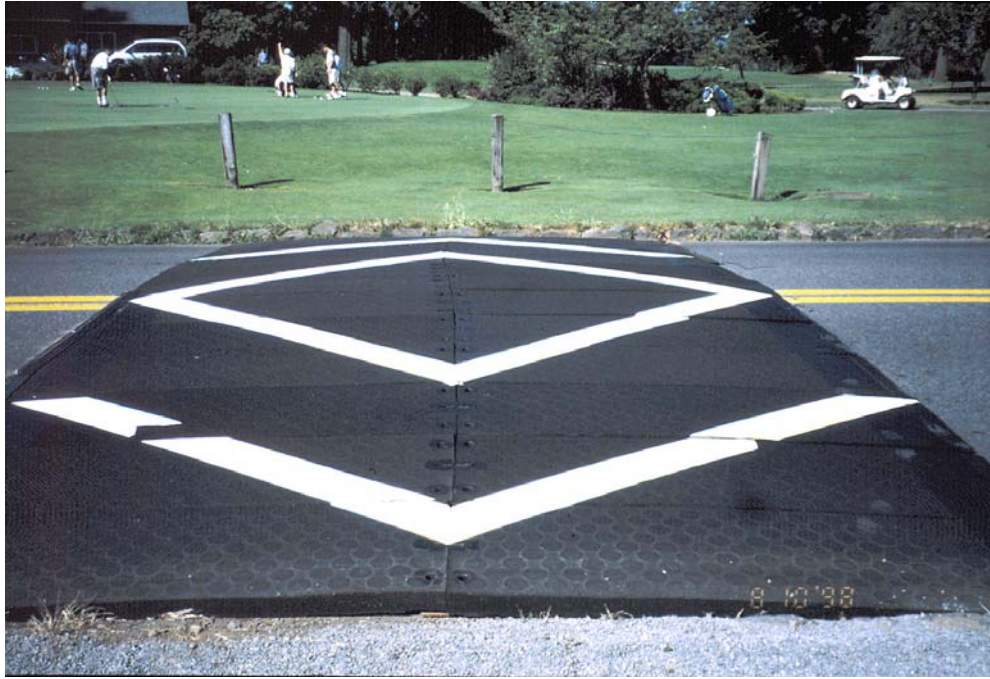
**Figure 17. 14-Foot Temporary 25 mph Speed Hump  
(City of Portland, 2001)**

Two different temporary traffic calming devices, a speed hump designed for a crossing speed of 25 mph and a speed table designed for a crossing speed of 30 mph, were purchased from *Recycled Technologies* for this research. The temporary devices are made of recycled rubber and can be installed for any length of time and then removed and installed in another location. Both devices were installed and evaluated at each of the three chosen test sites. The 25 mph speed hump was installed first and then converted to the 30 mph speed table at all three test locations. The 25 mph speed hump measured 14 feet in the direction of travel, three inches in height, and had parabolic seven-foot ramps. The temporary 30 mph speed table measured 18 feet in the direction of travel, three inches in height, and had seven-foot parabolic ramps on either side of a four-foot wide plateau. A side view of a temporary 25 mph speed hump and a temporary 30 mph speed table are shown in Figures 17 and 18, respectively. The temporary devices consist of recycled rubber mats anchored to the existing pavement through the use of anchor plates and 5/8-inch lag bolts. The anchor plates are metal plates with pre-punched holes for the lag bolts and threaded studs extending upward and are available in lengths of six or eight feet.

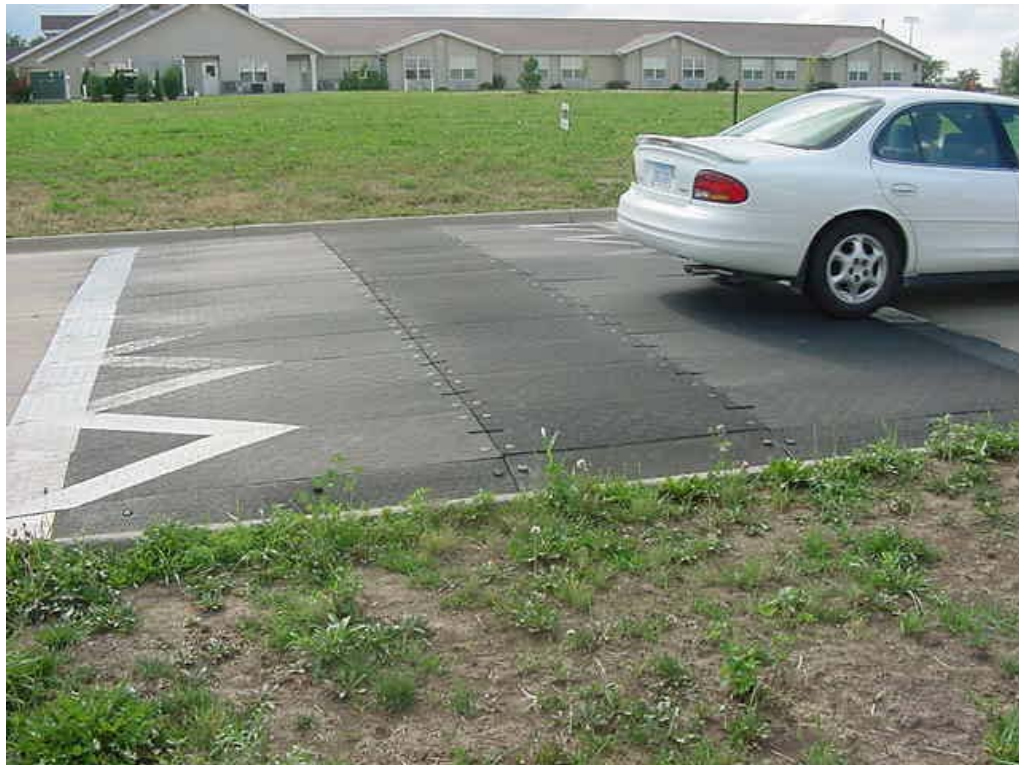
**Figure 18. 18-Foot Temporary 30 mph Speed Table**

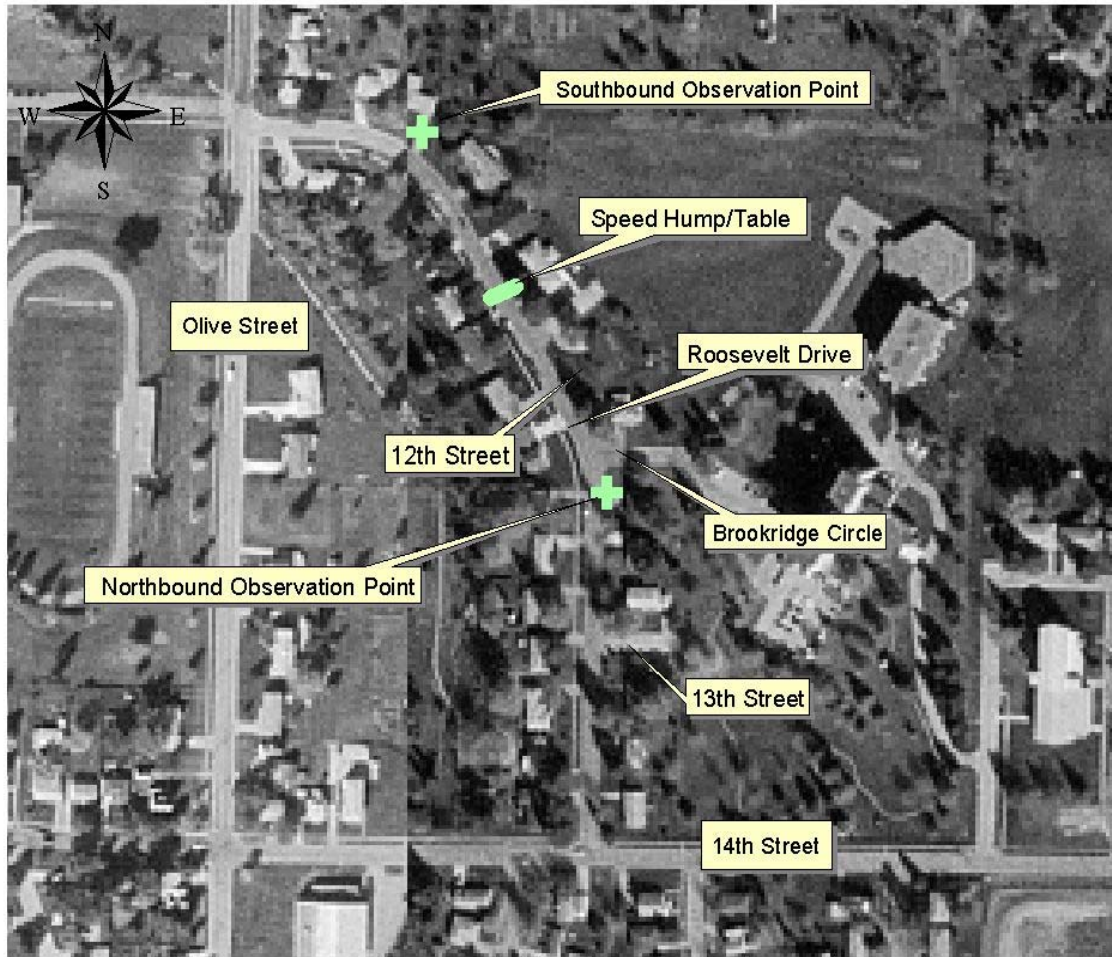
**Figure 19. Data Collection and Installation Locations on Roosevelt Drive (USDA Natural Resources Conservation Service, 2001)**

The section of Roosevelt Drive used for this research was the tangent section located between the Brookridge Circle intersection and the beginning of a minor horizontal curve. This section of Roosevelt Drive is approximately 450 feet in length and appeared to carry the largest volume of vehicles along Roosevelt Drive. The temporary devices were installed at approximately the midpoint of this road segment. This location made it possible to observe vehicles approaching, traversing, and exiting the speed hump/table. The closest driveway to the installation was approximately 25 feet from the nearest edge of the device. The centerline of the closest intersecting side street, 12th Street, was located approximately 270 feet from the nearest edge of the device. The warning signs in advance of the temporary device for northbound traffic and southbound traffic were located 220 feet and 170 feet from the nearest edge of the speed hump/table, respectively.

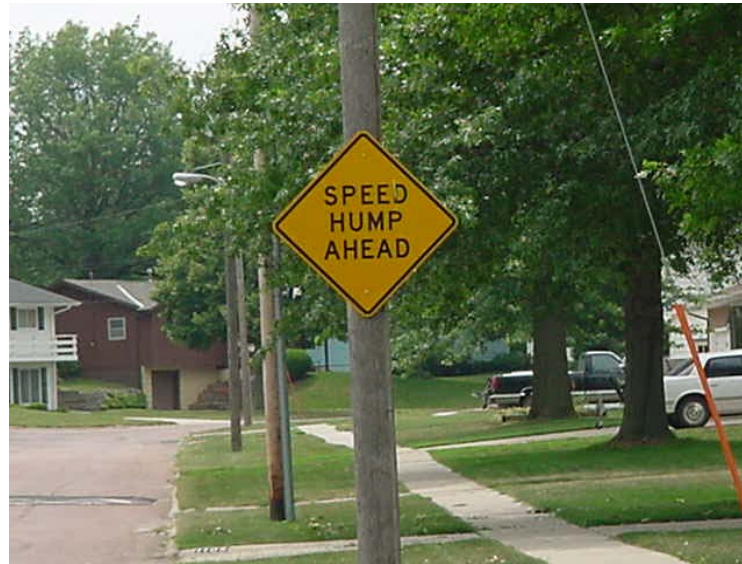
**Figure 22. Speed Hump Warning Sign**

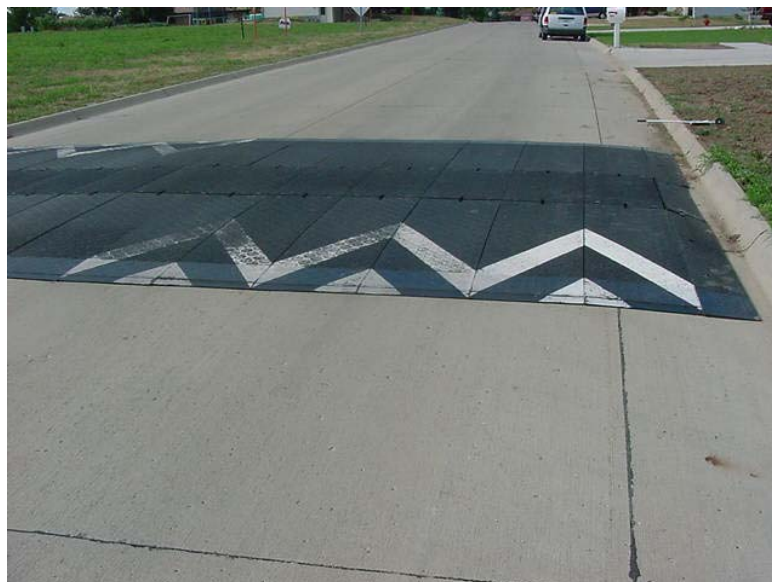
**Figure 23. Pavement Markings on Speed Hump/Table**

Pavement markings were applied to the ramps of the speed hump/table. A triangular pattern on the approach sides of the speed hump/table was used as illustrated in Figure 23. The solid inner triangles were 20 inches in width and 14 inches in height. The outer triangles had a base of 48 inches, a height of 53 inches, and were 8 inches wide. The same markings were used at each test site. It should be noted that the markings had begun to wear, as shown in Figure 24, by the end of the research project, a period of approximately six months. These markings would need to be periodically reapplied if the devices are to be used as permanent installations or rotated between sites.

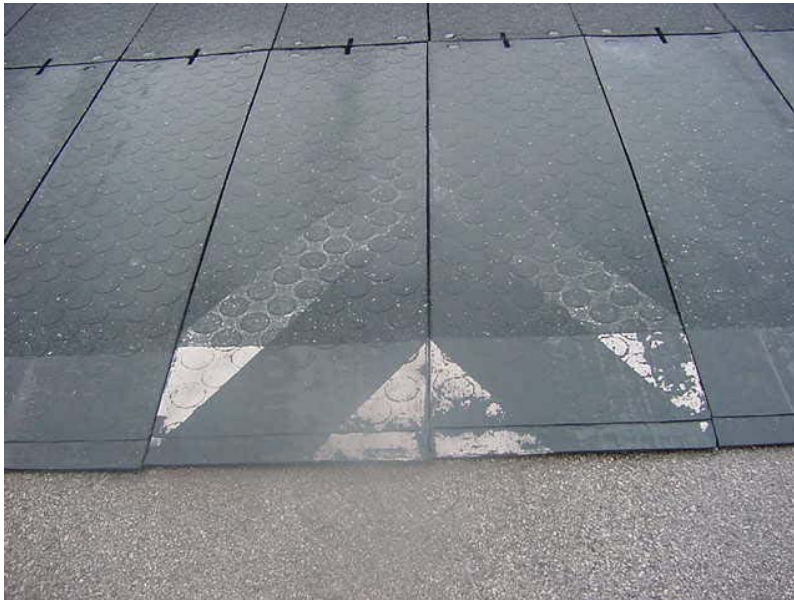
**Figure 24. Pavement Markings After Approximately Six Months**

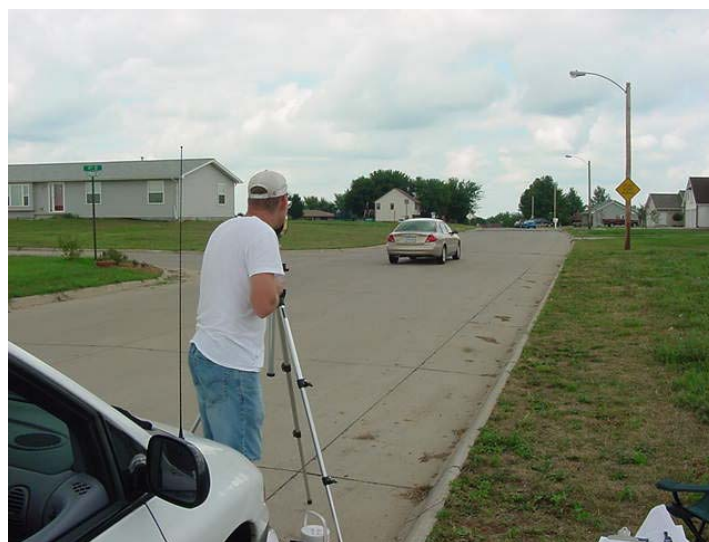
**Figure 25. Data Collection on Redwood Drive**

The laser gun requires a clear sight distance between the laser gun and the vehicle being observed to obtain accurate data. The laser gun was positioned so that the line of sight of the laser gun was clear of tree branches, bushes, utility poles, traffic signs, parked cars, and other obstructions.

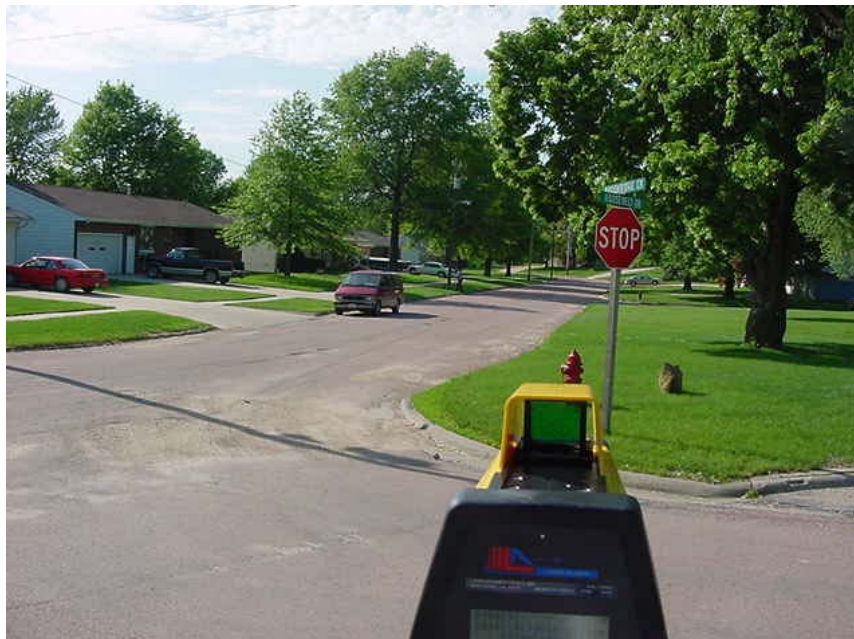
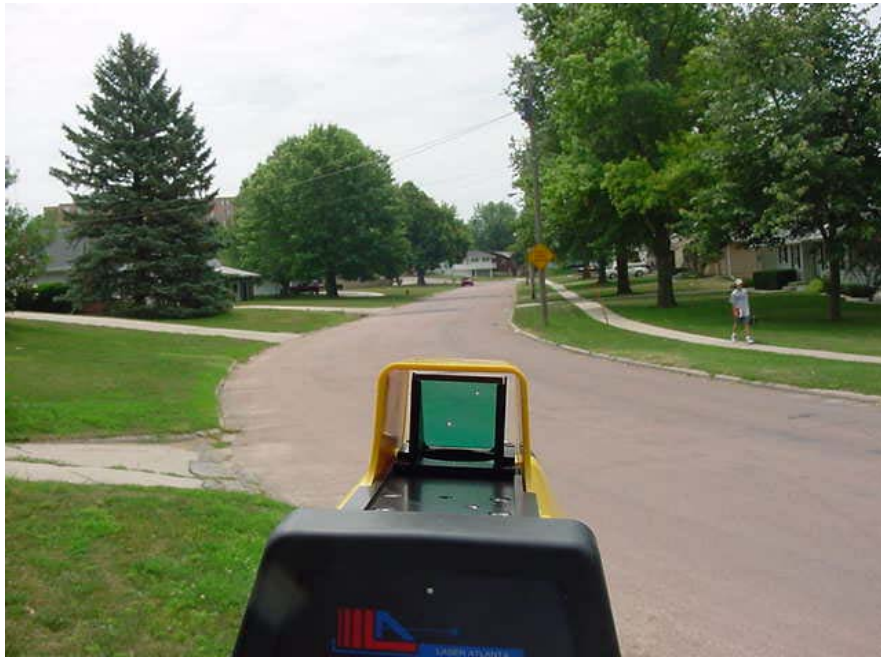
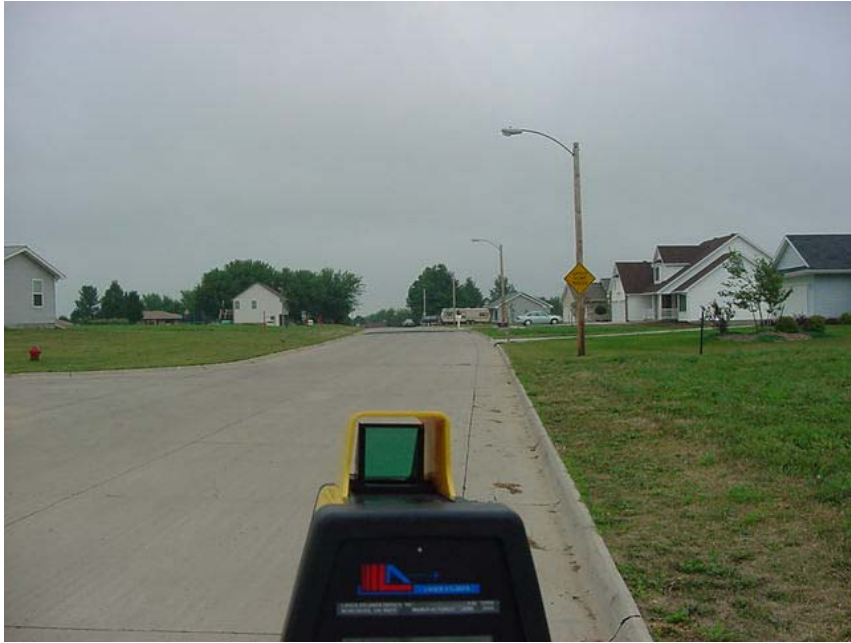
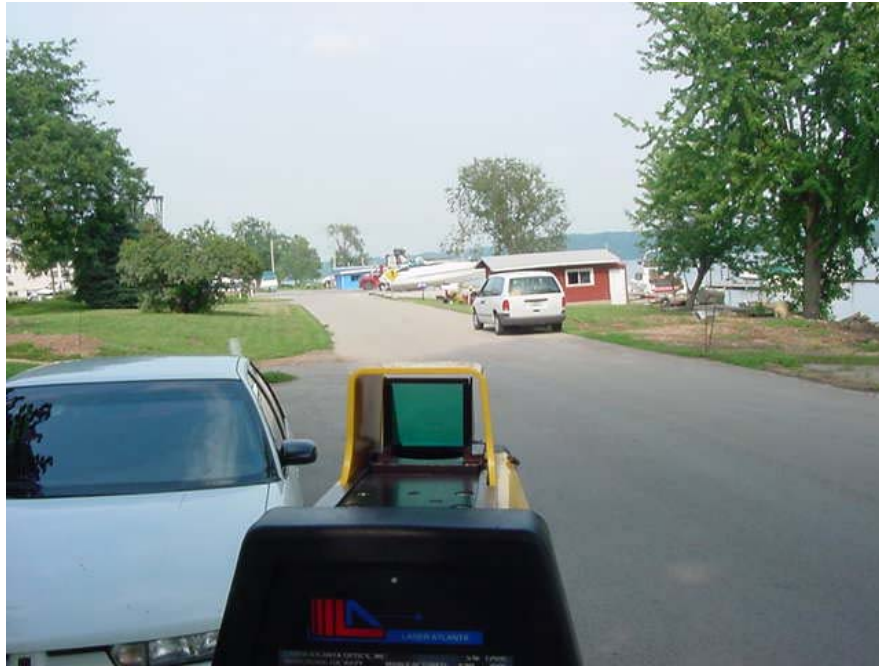
**Figure 26. Northbound Data Collection View on Roosevelt Drive**

**Figure 27. Southbound Data Collection View on Roosevelt Drive**

**Figure 28. Northbound Data Collection on Redwood Drive**

**Figure 29. Eastbound Data Collection View on Canal Shore Drive**

Figures 26, 27, 28, and 29 show the line of sight of the laser gun for Roosevelt Drive northbound, Roosevelt Drive southbound, Redwood Drive, and Canal Shore Drive, respectively. An attempt was made to locate the laser gun in a position that allowed observation of vehicles in the main direction of travel. From preliminary field observations, the directional traffic movements on Roosevelt Drive were nearly even throughout a typical day. Thus, data were recorded for both the northbound and southbound lanes. Southbound vehicles were collected in the morning hours and the northbound traffic was collected during the afternoon hours. On Redwood Drive, the majority of the traffic on Redwood Drive appeared to be in the northbound direction so data were collected in that direction for Redwood Drive. The majority of traffic appeared to travel in the eastbound direction along Canal Shore Drive. Thus only eastbound vehicles were observed on Canal Shore Drive.

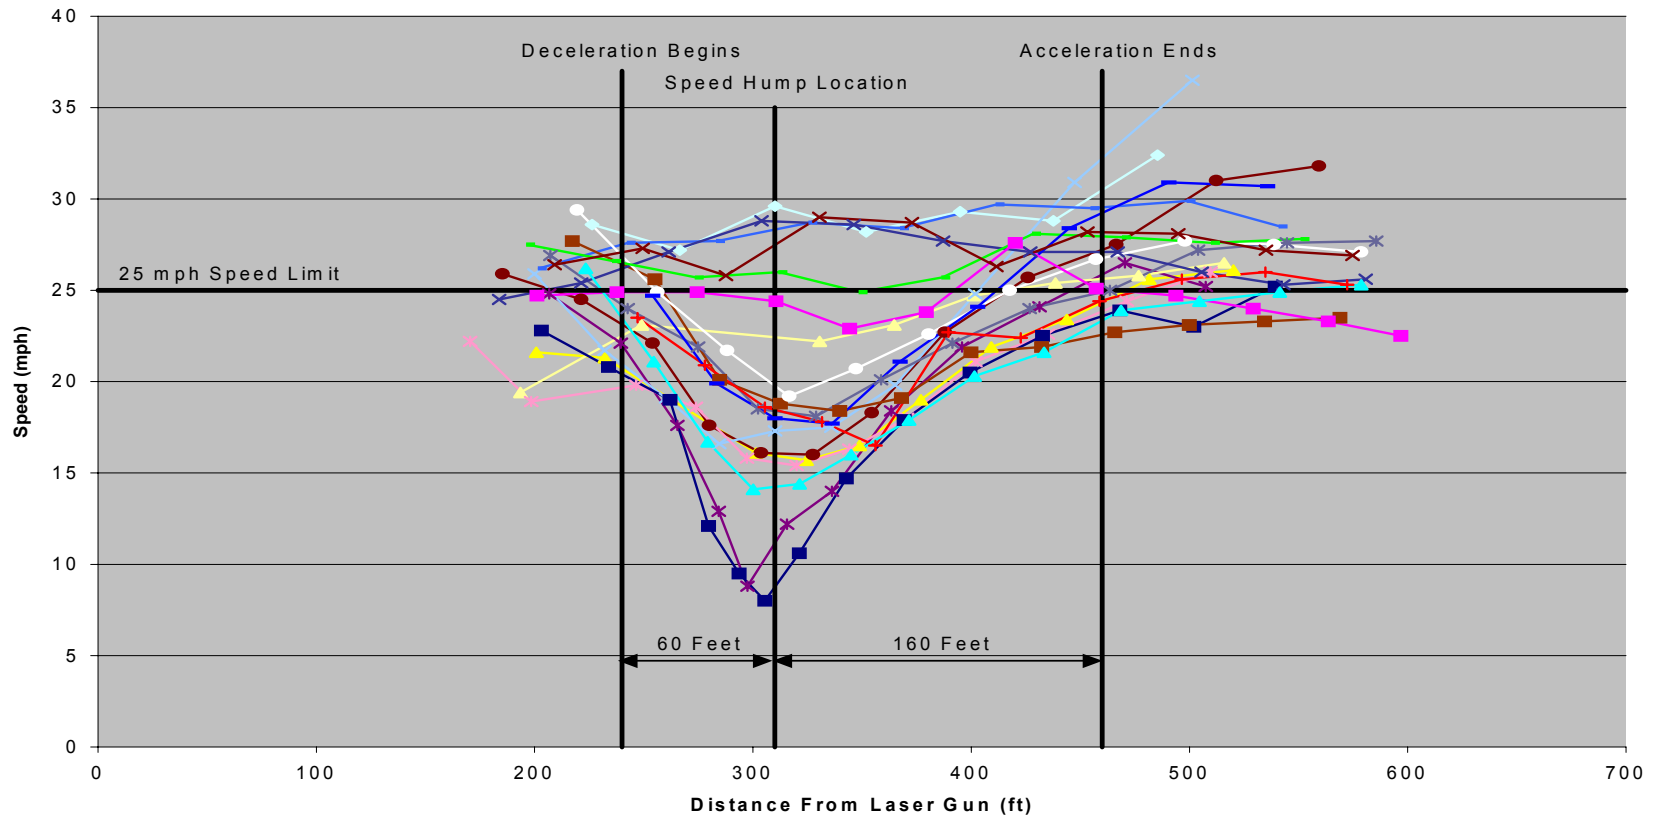
**Figure 35. Roosevelt Drive Southbound Speed Hump Spacing Analysis**

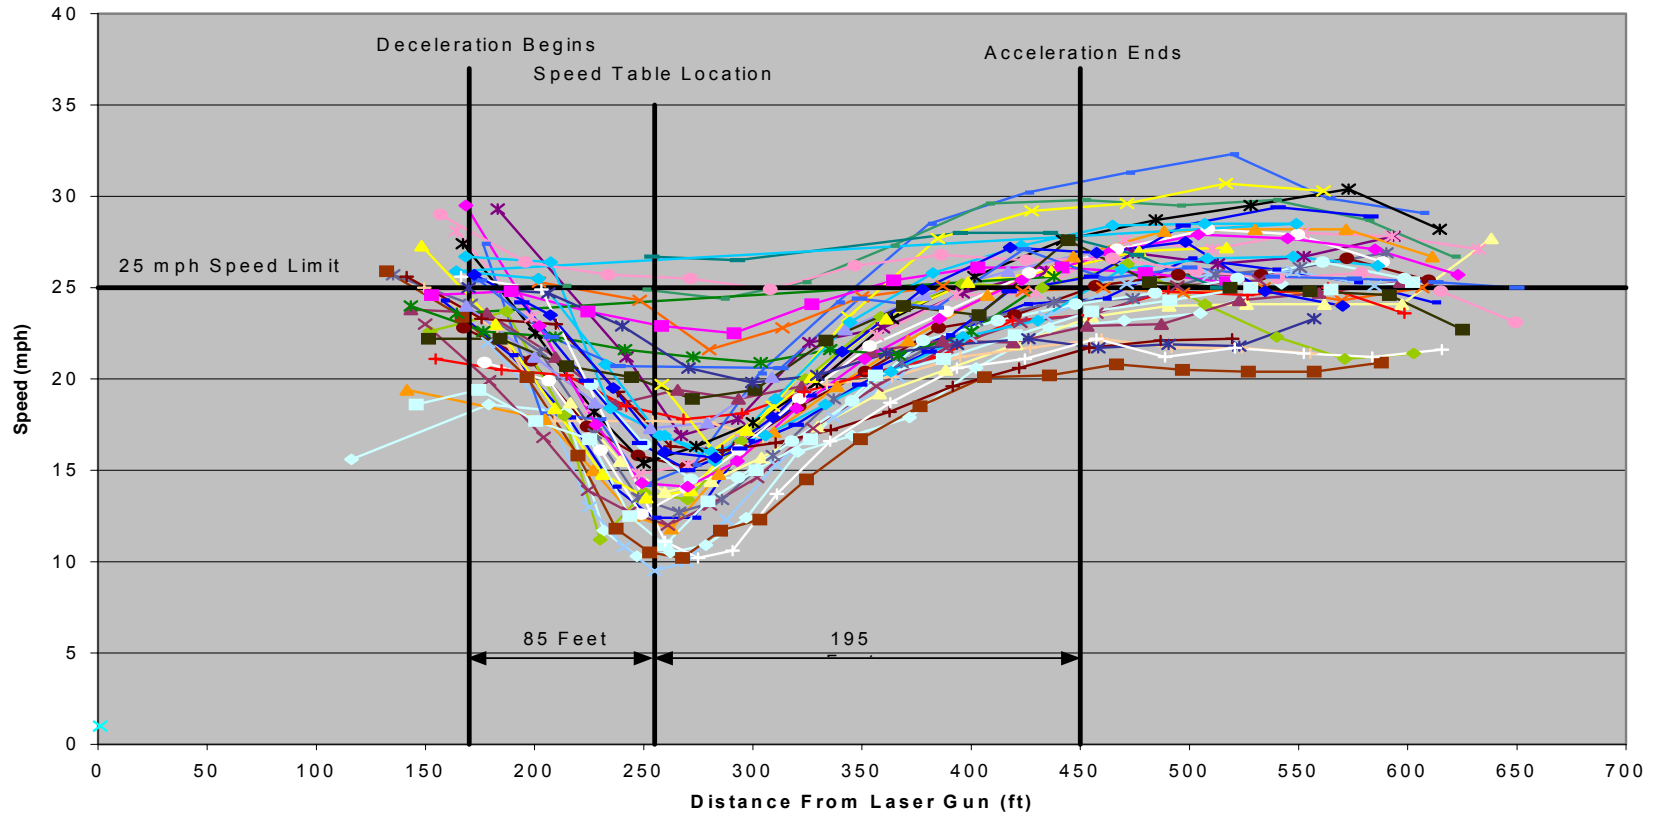
Figure 37. Redwood Drive Speed Table Spacing Analysis

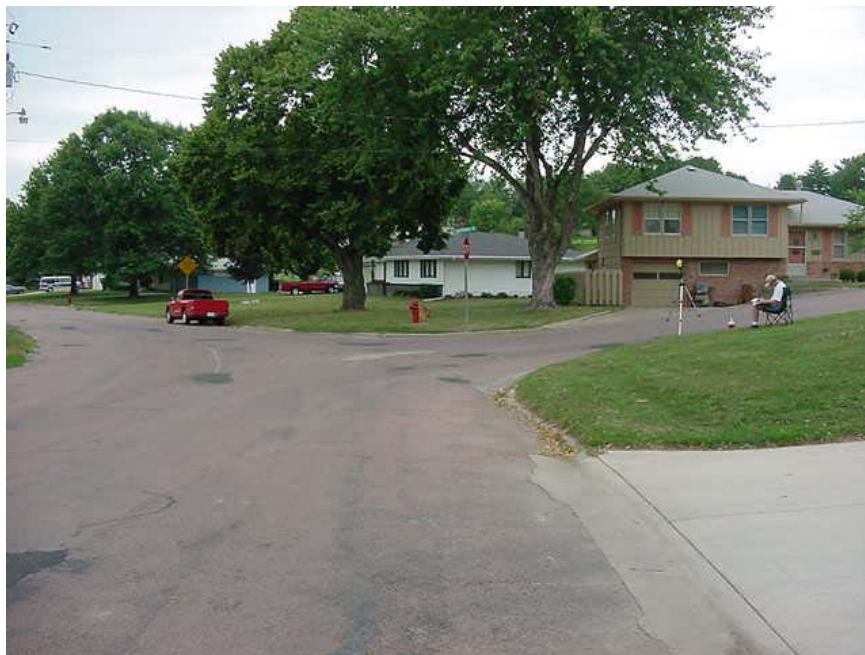
**Figure 38. Approaching Driver's View of Data Collection Equipment on Roosevelt Drive Northbound**

Several potential sources of error were introduced during the data collection phase. The first and possibly the most significant source of error was the location of the data collection equipment and personnel. The clear line of sight needed for the laser gun required the data collection equipment as well as the data collectors to set up near the traveled way. This may have influenced vehicle speeds if drivers realized their speed was being measured. However, this could not be avoided. Figures 38–41 show the view that approaching drivers had of the data collection equipment. As shown in Figures 40 and 41, the data collection equipment was somewhat hidden from approaching drivers along Redwood Drive and Canal Shore Drive. Nonetheless, numerous drivers at all three test sites were noted observing the data collection equipment and personnel. Some motorists stopped to ask what was being surveyed or photographed. The impact may have lessened as motorists became used to the equipment. However, it is speculated that this may have had some impact on vehicle speeds.

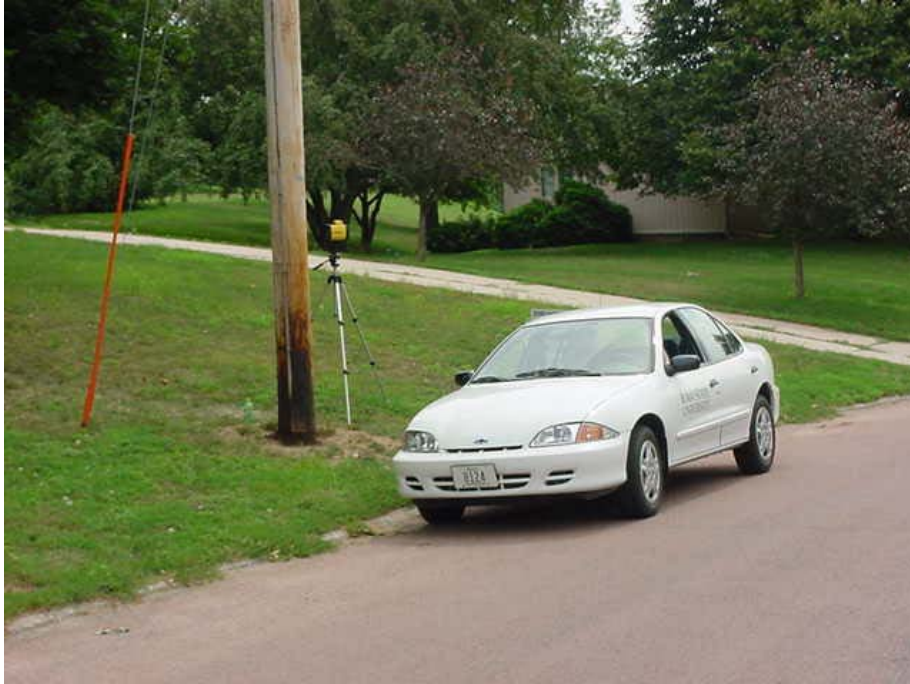
**Figure 39. Approaching Driver's View of Data Collection Equipment on Roosevelt Drive Southbound**

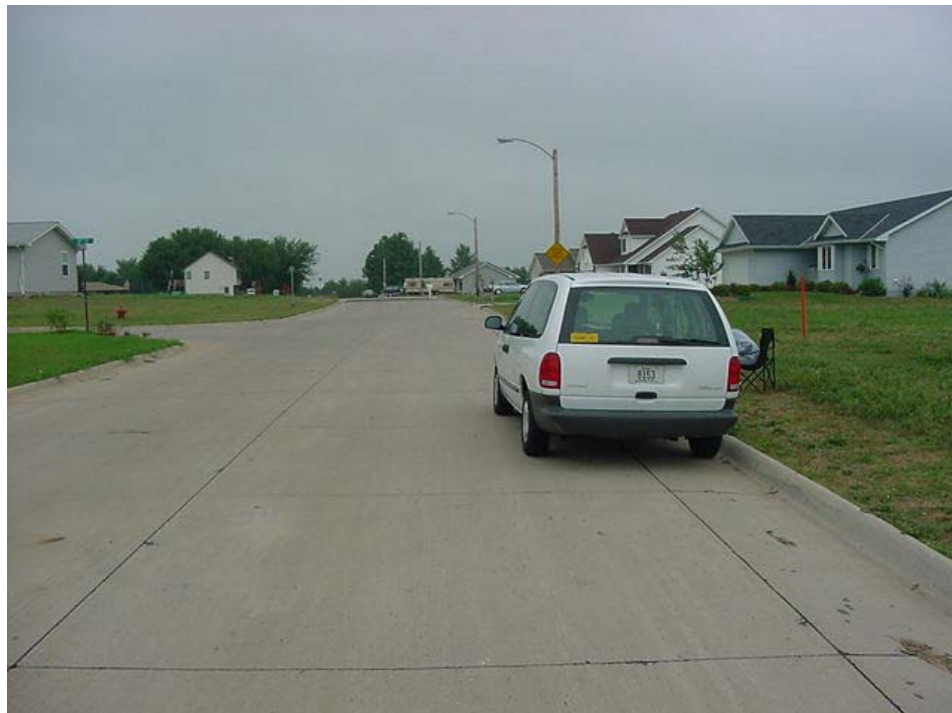
**Figure 40. Approaching Driver's View of Data Collection Equipment on Redwood Drive**

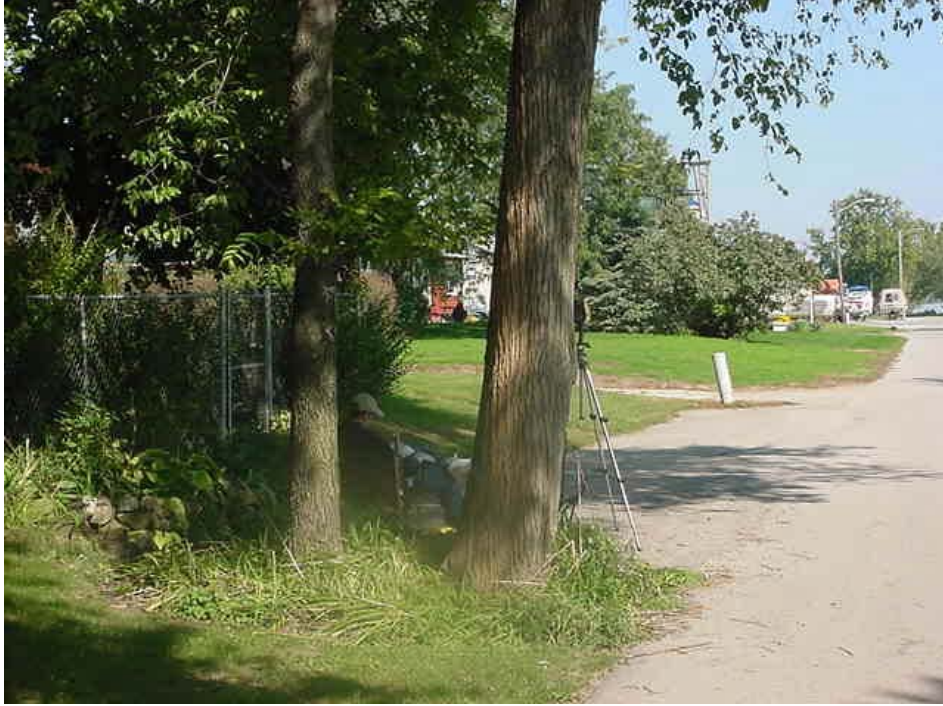
**Figure 41. Approaching Driver's View of Data Collection Equipment on Canal Shore Drive**
