# TEMPORARY SPEED HUMP IMPACT EVALUATION

CTRE Project 00-73

Sponsored by  
the Office of Traffic and Safety,  
Iowa Department of Transportation

**Final Report • July 2002**

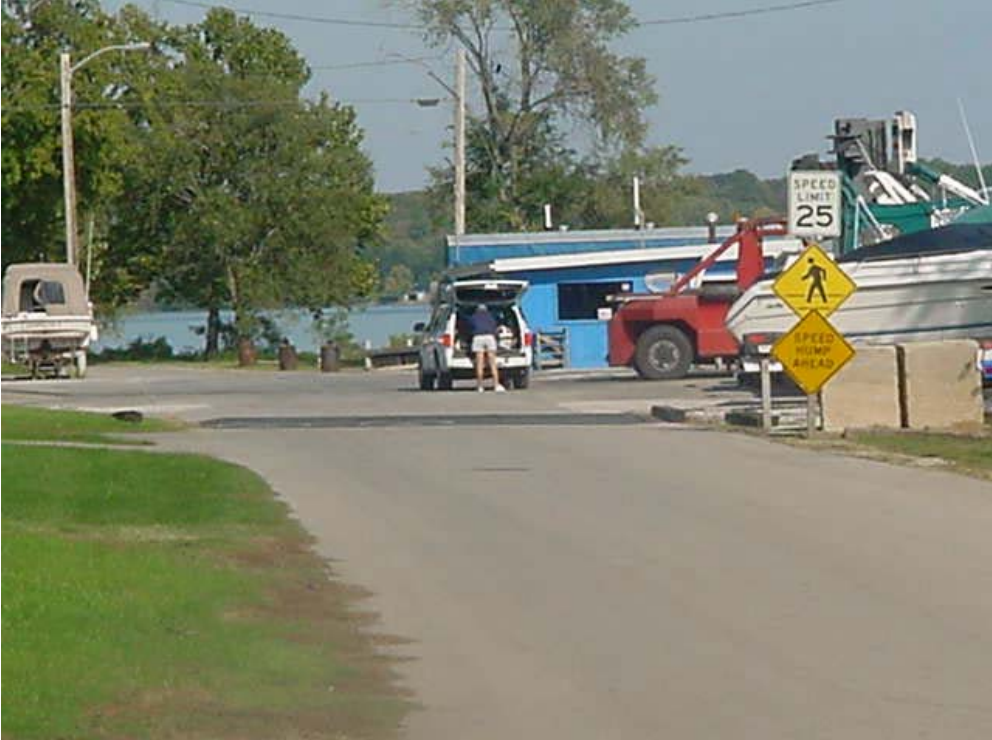
**Figure 42. Marina Patrons Along Canal Shore Drive**

It should also be noted that the speed data collected along Canal Shore Drive, especially during the boating season, may have yet another source of error associated with it. The area being studied along Canal Shore Drive passes through the Captain's Quarters boat marina as shown in Figure 42. Therefore, the speed of a vehicle traveling through the area may have been influenced by the operations of the marina. It was not uncommon to have pedestrians walking around the marina and crossing Canal Shore Drive. Many vehicles also stopped along Canal Shore Drive within the marina area to unload picnic baskets, fishing gear, and coolers before parking in the designated area shown in Figure 42. Also, some vehicles were required to stop or slow while boats were being transported across Canal Shore Drive with a forklift from the dry dock storage to the river as shown in Figure 43.

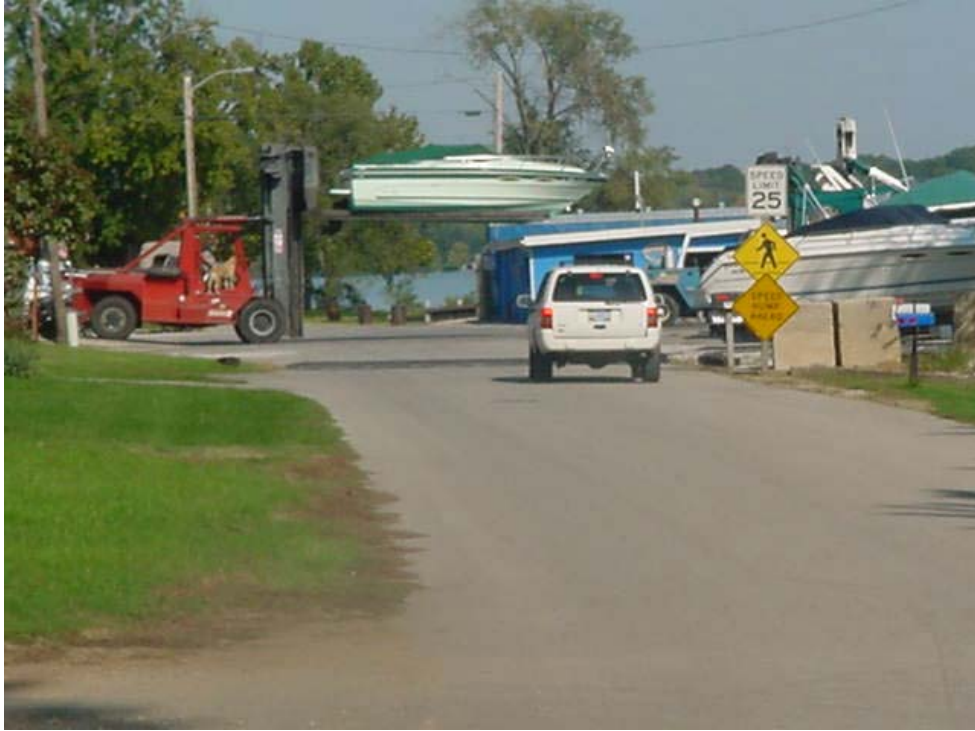
**Figure 43. Typical Marina Operations**

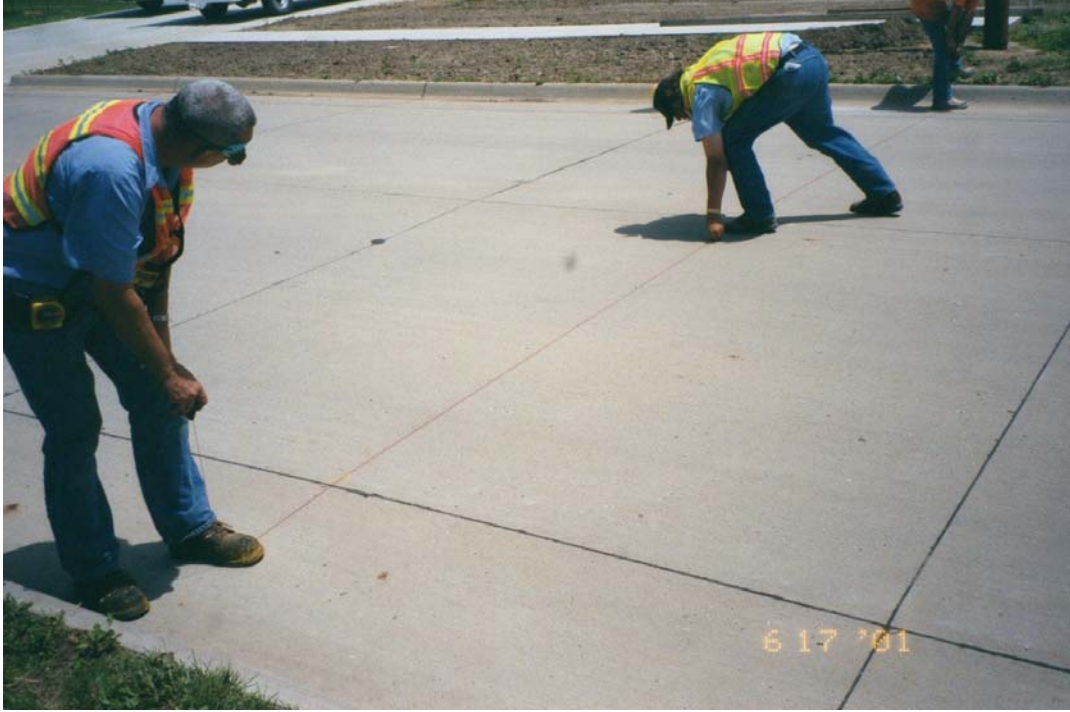
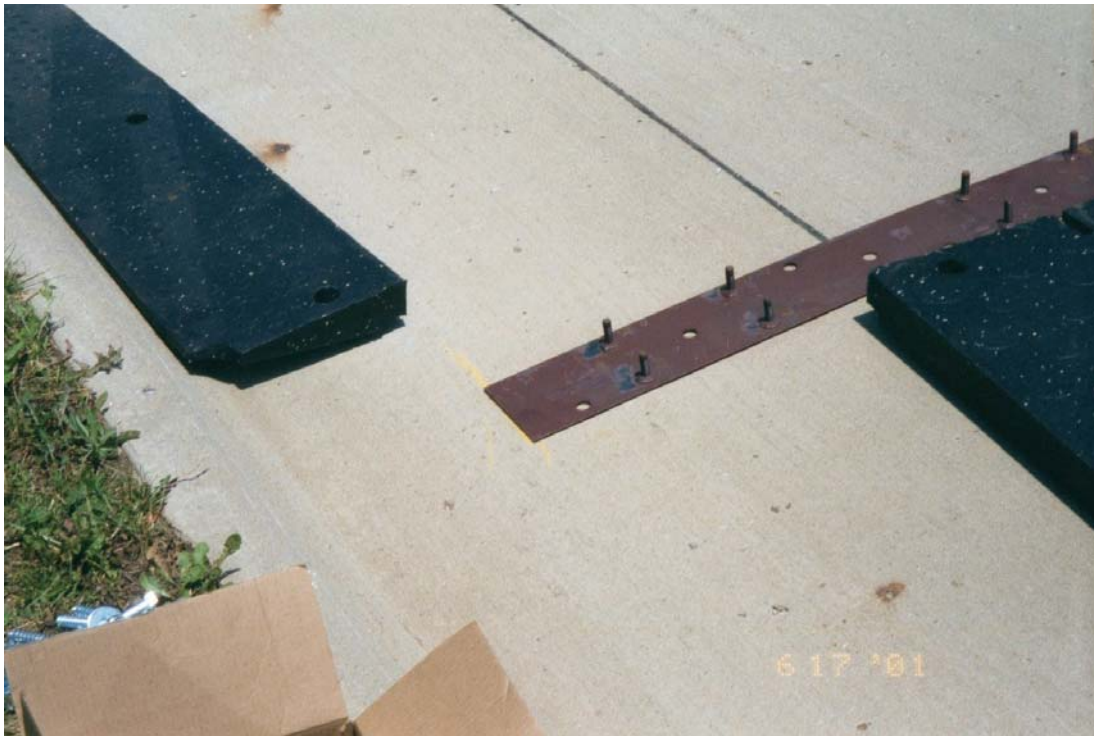
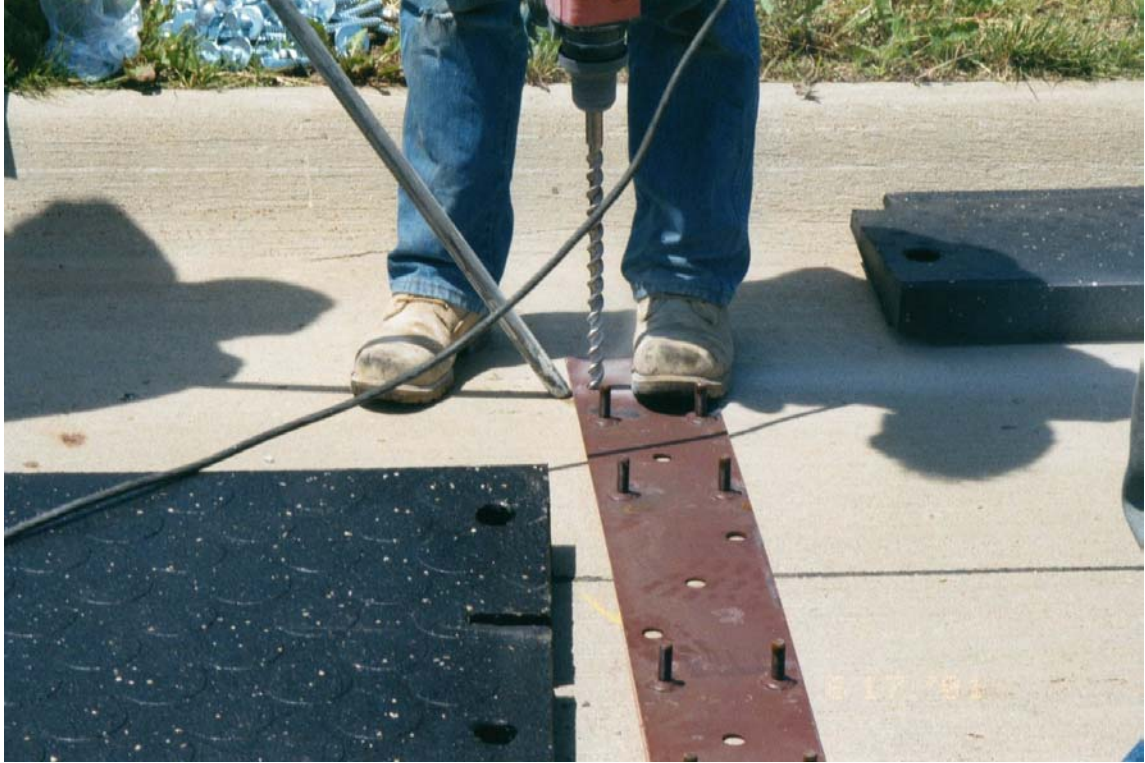
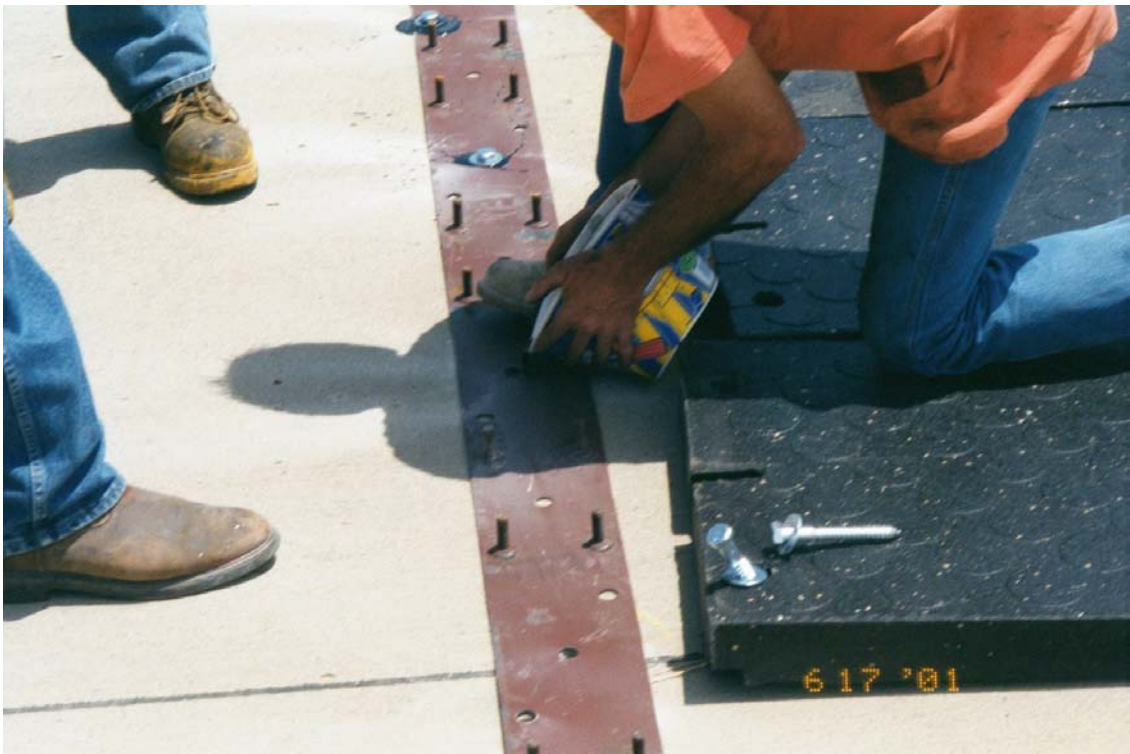
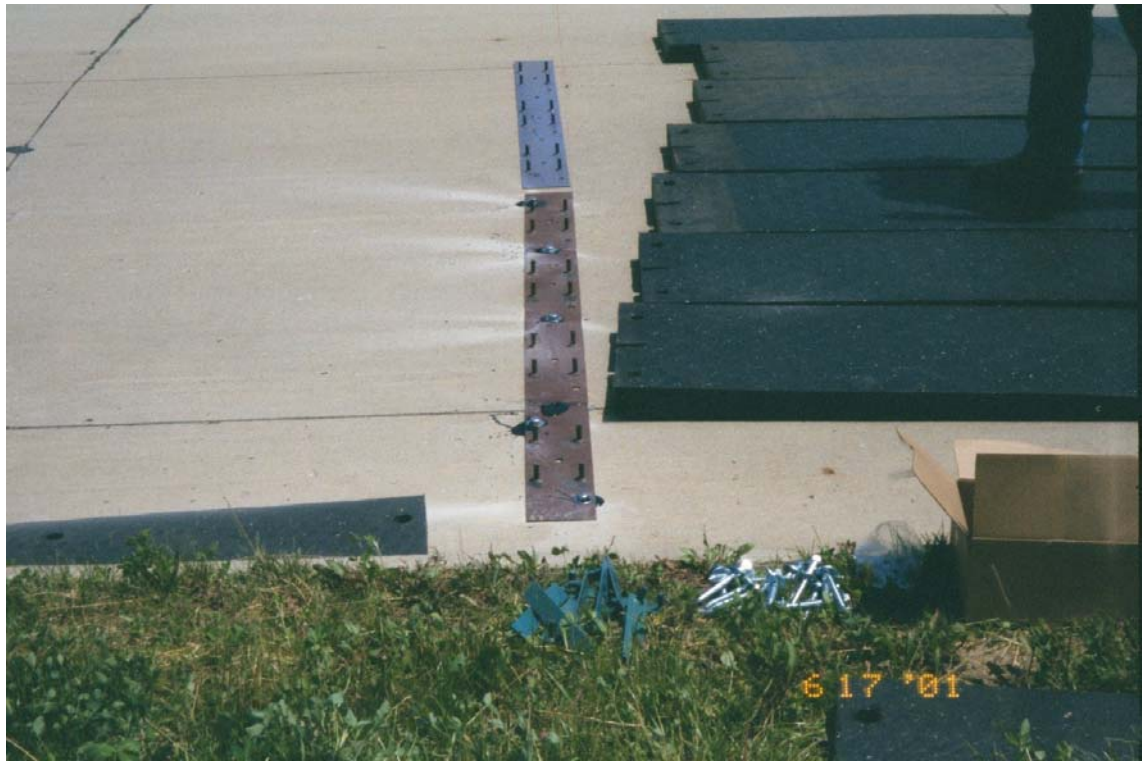
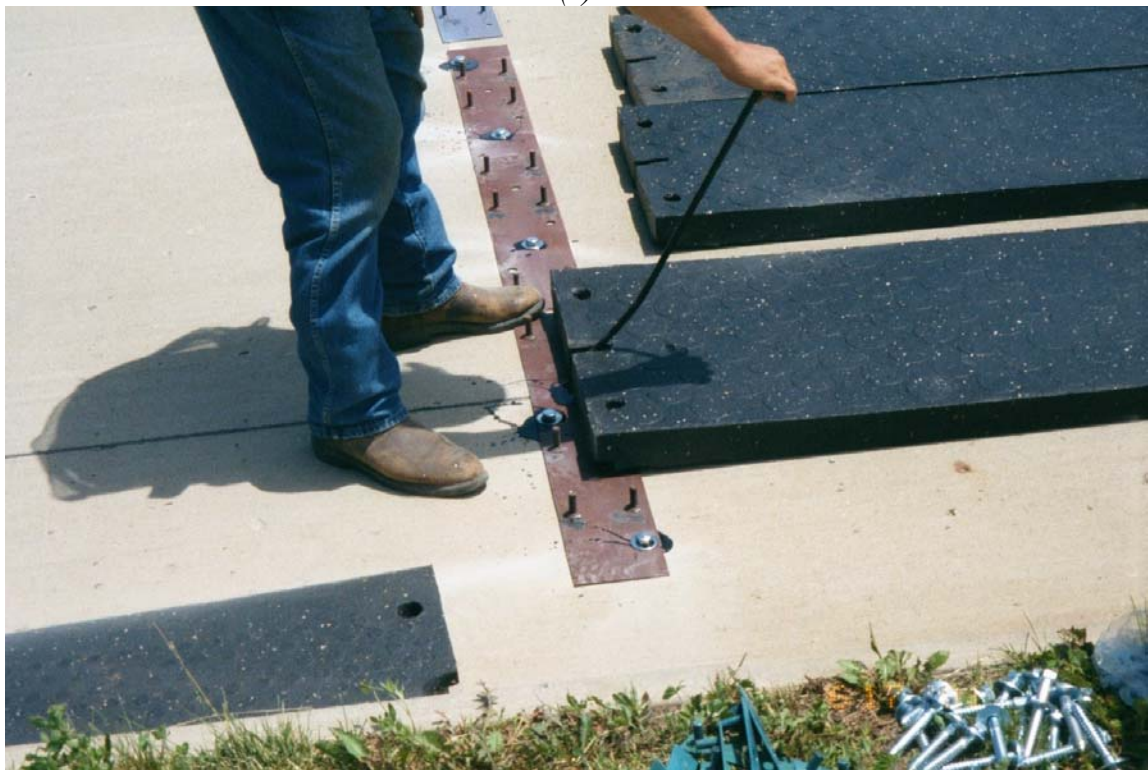
**Figure B1: Temporary 25 mph Speed Hump Installation.**

Tapered edge panels are used to help facilitate drainage. To install the tapered edge panel, a hole must be drilled in the pavement through the threaded tie strap with the hammer drill and  $\frac{1}{2}$  inch masonry bit to a depth of six inches as shown in Figure B1m. Once the hole is drilled, two-part resin is poured in the hole until the hole is approximately  $\frac{3}{4}$  full and a  $\frac{5}{8}$ -inch lag bolt and washer are inserted. Once the resin has set, the tapered edge panel is placed on the threaded stud of the tie strap and the exposed threaded stud of the anchor plate as shown in Figure B1n. Once the tapered edge panels are in place,  $\frac{1}{2}$  inch nuts and washers are placed on the studs and tightened with the impact wrench and rubber plugs placed over the holes. Due to the slope of the tapered edge panel, the rubber plugs may have to be cut for a flush.

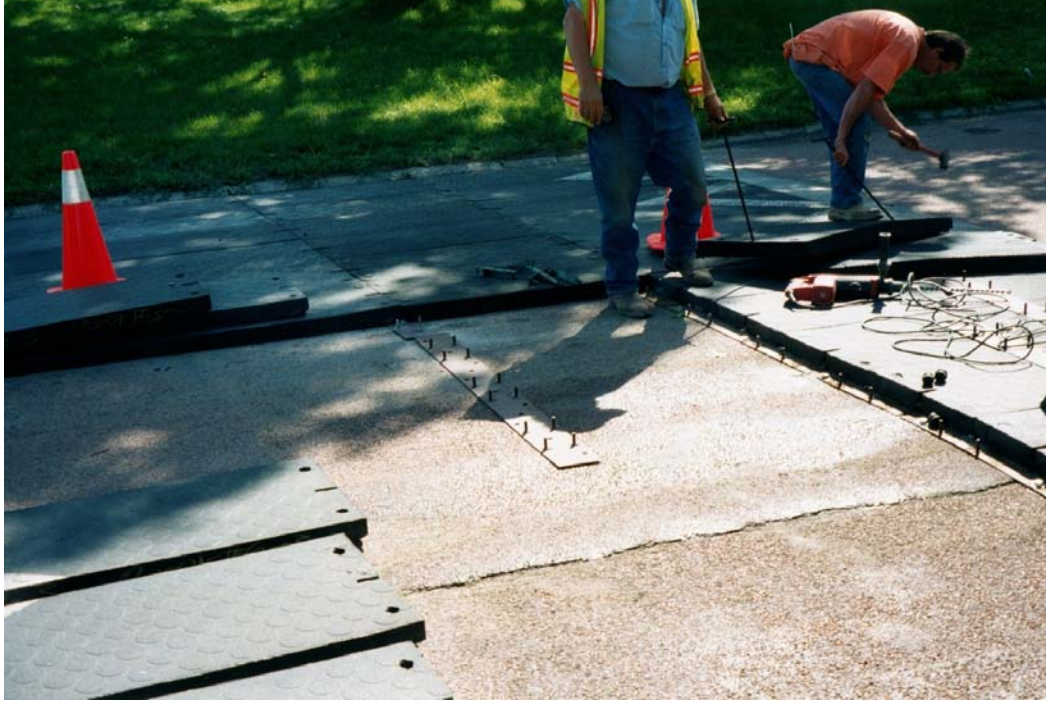
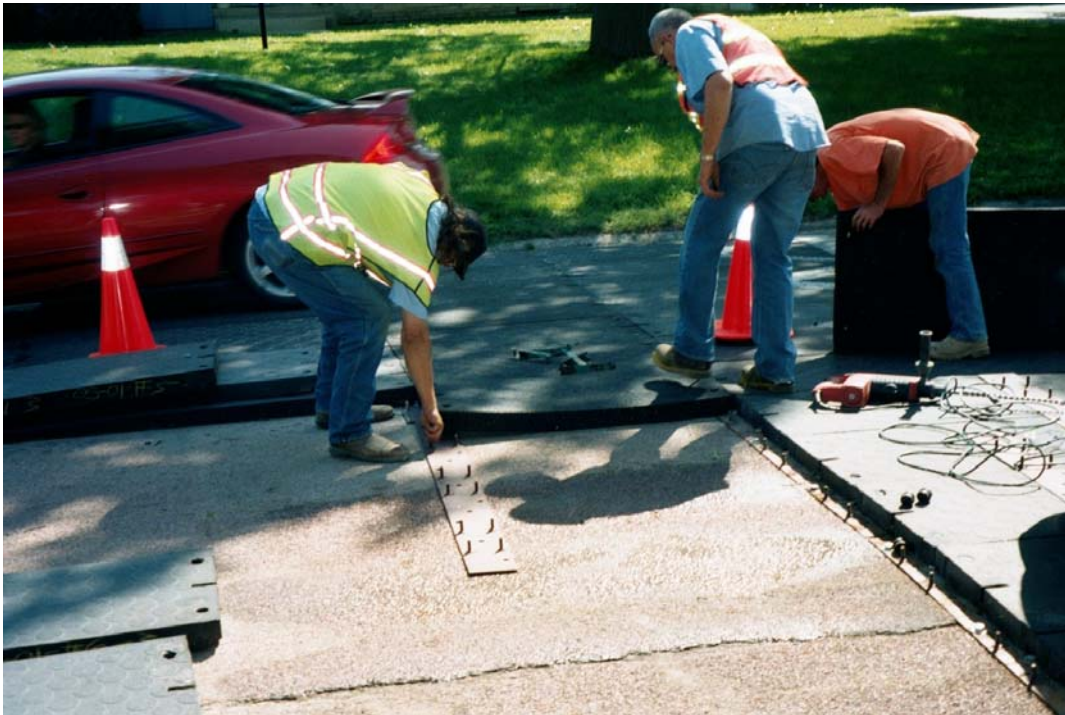
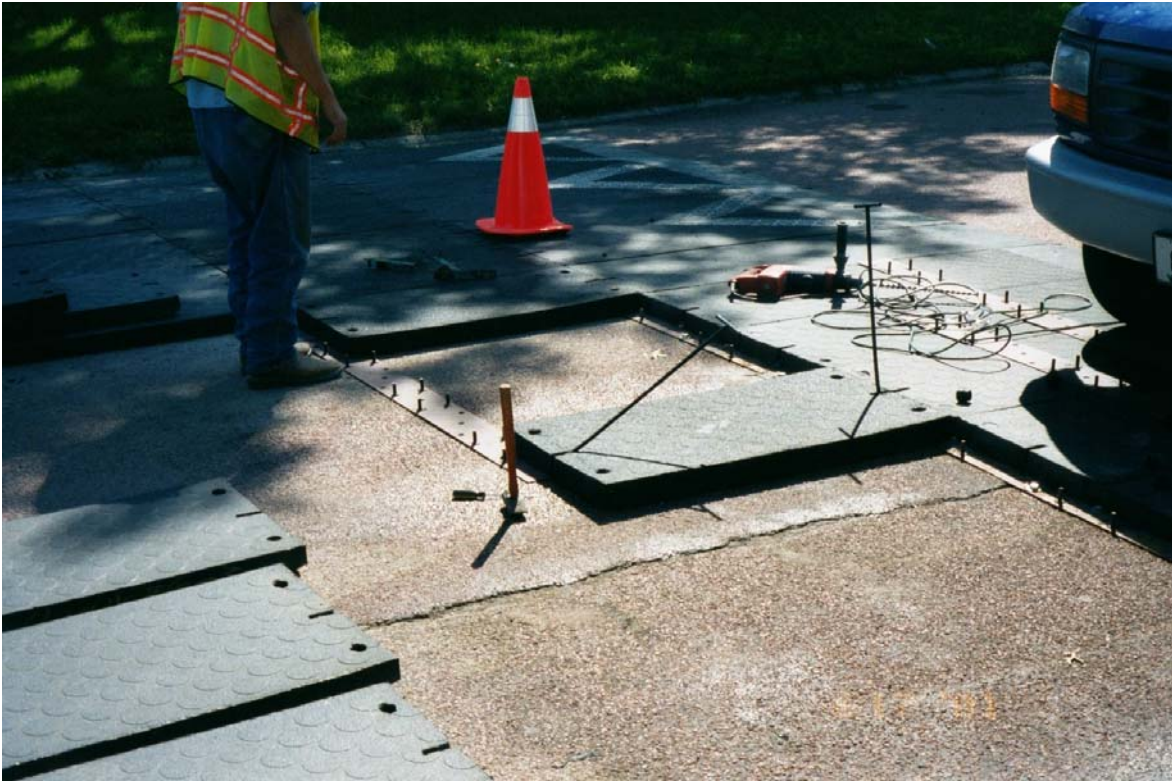
**Figure B2. Temporary 30 mph Speed Table Installation.**

Removal of the temporary speed hump is as straightforward as the installation. A four-man crew can remove a temporary 30 mph speed table in about one hour. It is speculated that the temporary 25 mph speed hump can be removed in about half that time. The ½ inch nuts are loosened and removed with the impact wrench. It was found useful to have a magnet on hand to remove the nuts and washers from the holes in the ramp mats. Once the nuts are removed, the mats can be lifted off. Once the mats are removed, the impact wrench is used to remove the 5/8-inch lag bolts as shown in Figure B3 and the anchor plates can be simply lifted off the pavement. The exposed holes in the pavement are completely filled with two-part resin to protect the pavement from chemical and frost damage.

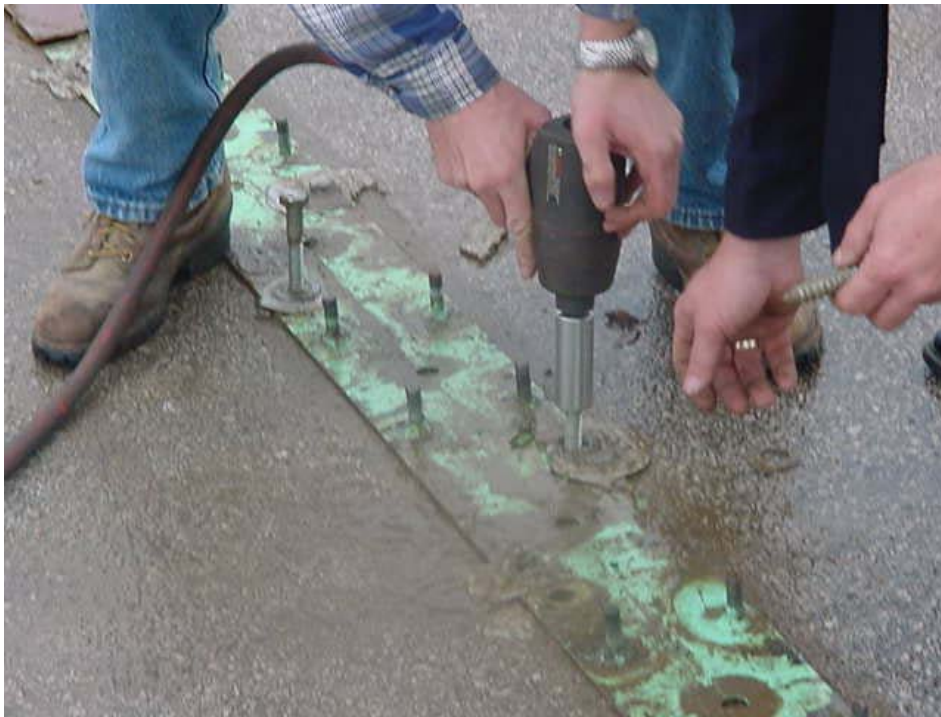
**Figure B3. Lag Bolt and Anchor Plate Removal.**

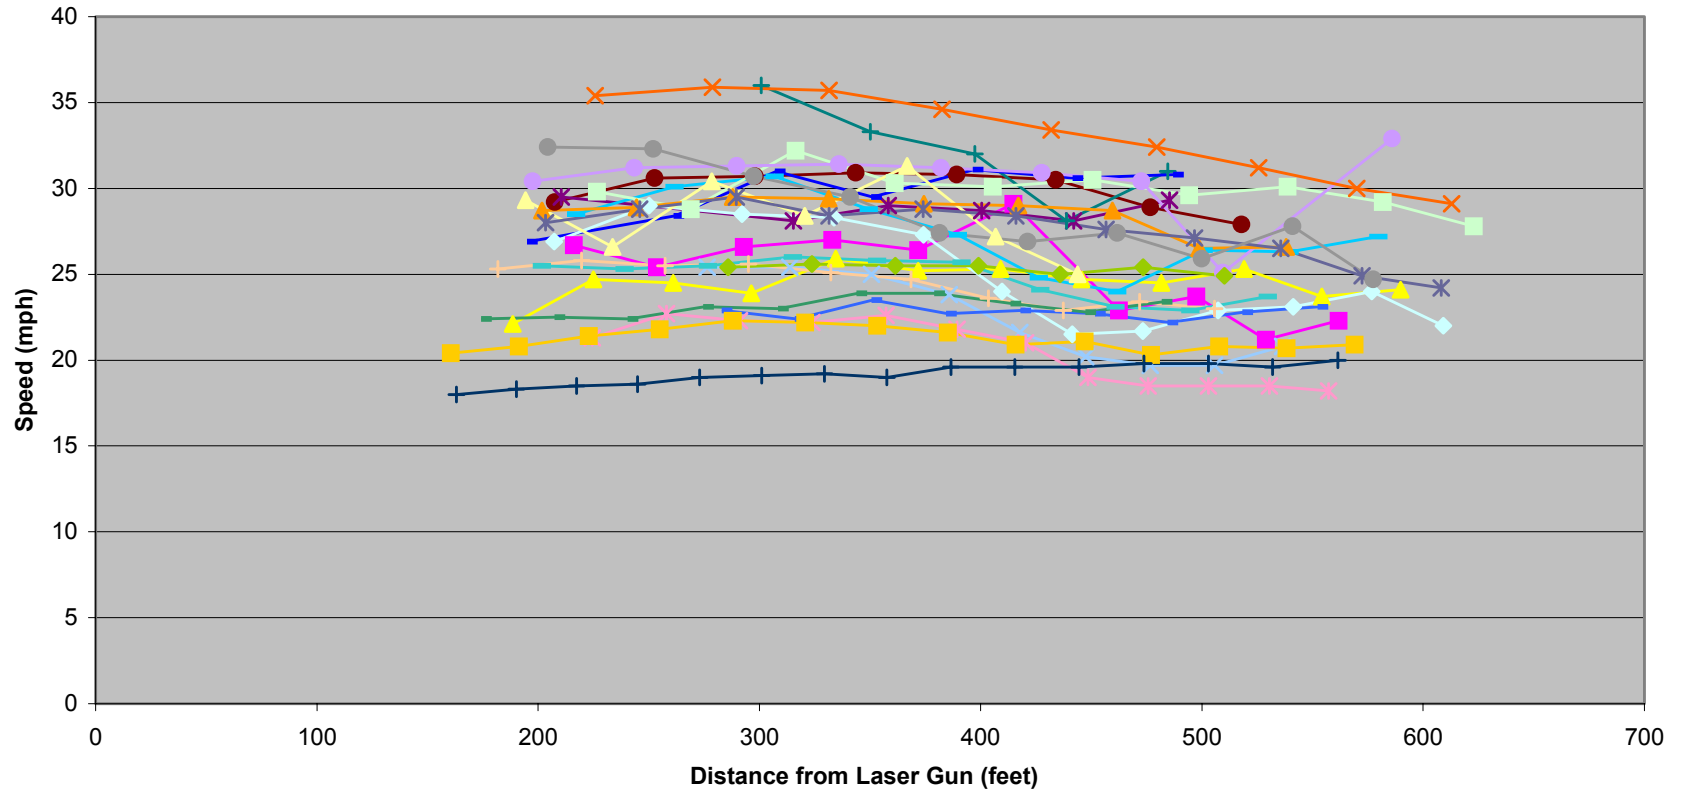
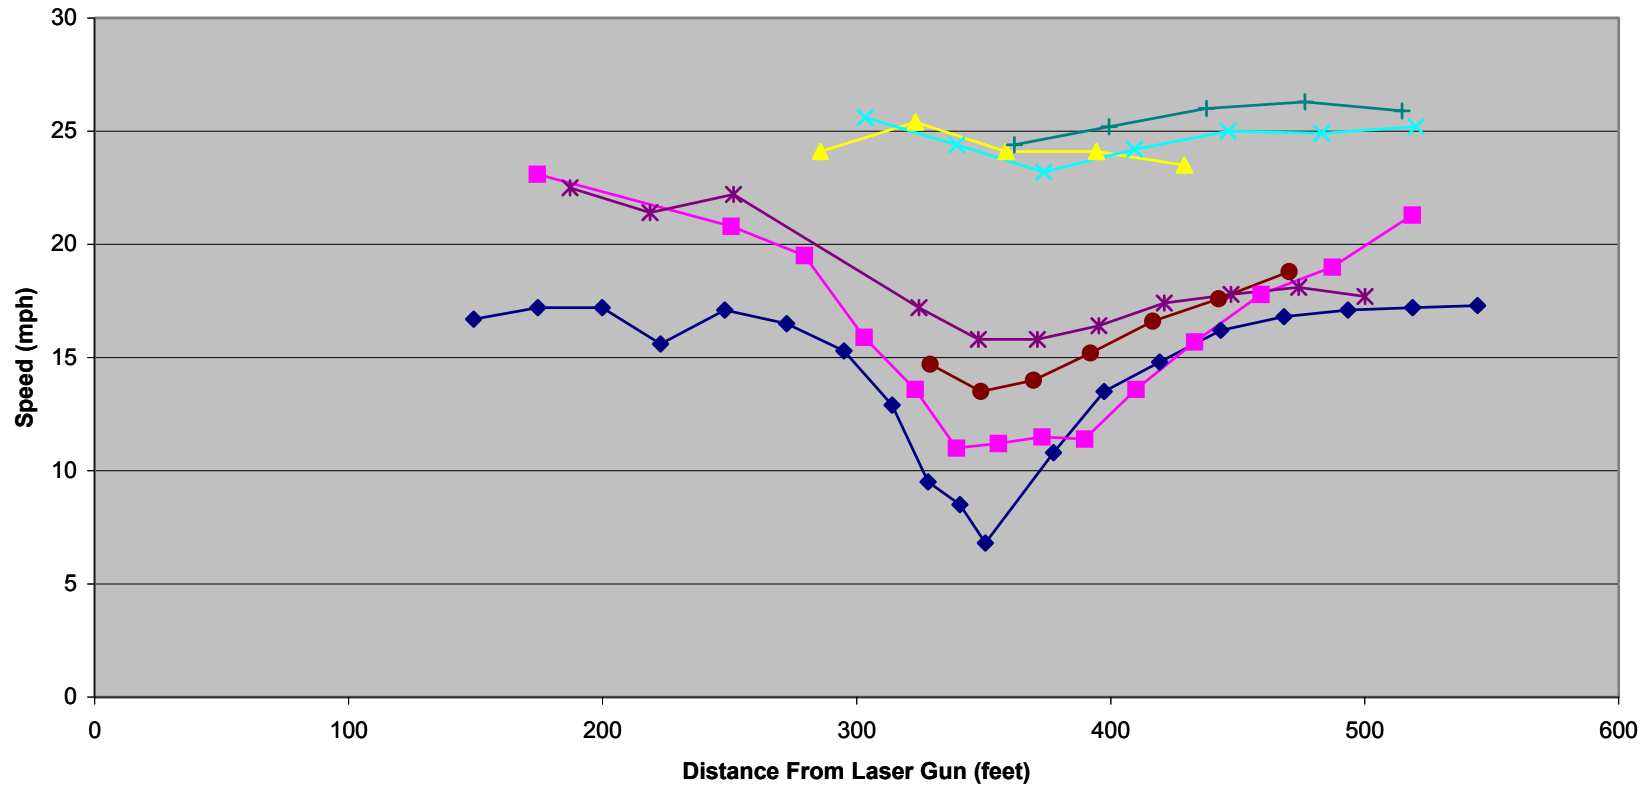
Figure D1: Roosevelt Drive Northbound “Before” Speed Profiles

Figure D2. Roosevelt Drive Northbound Temporary 25 mph Speed Hump Speed Profiles.

Figure D3. Roosevelt Drive Northbound Temporary 30 mph Speed Table Speed Profiles.

Figure D4: Roosevelt Drive Northbound "After" Speed Profiles

Speed profiles were plotted from the output of an executable program written in C, which calculated vehicle speed from the distance measurements collected using the laser gun. Speed profiles were plotted for each data collection period for each test site. Figures D1, D2, D3, and D4 show the profiles collected on Roosevelt Drive northbound in the “before”, while the temporary 25 mph speed hump was in place, while the temporary 30 mph speed table was in place, and “after” data collection periods respectively. Figures D5, D6, D7, and D8 show the profiles collected on Roosevelt Drive southbound in the “before”, while the temporary 25 mph speed hump was in place, while the temporary 30 mph speed table was in place, and “after” data collection periods respectively. Figures D9, D10, D11, and D12 show the profiles collected on Redwood Drive in the “before”, while the temporary 25 mph speed hump was in place, while the temporary 30 mph speed table was in place, and “after” data collection periods respectively. Figures D13, D14, D15, and D16 show the profiles collected on Canal Shore Drive in the “before”, while the temporary 25 mph speed hump was in place, while the temporary 30 mph speed table was in place, and “after” data collection periods respectively.

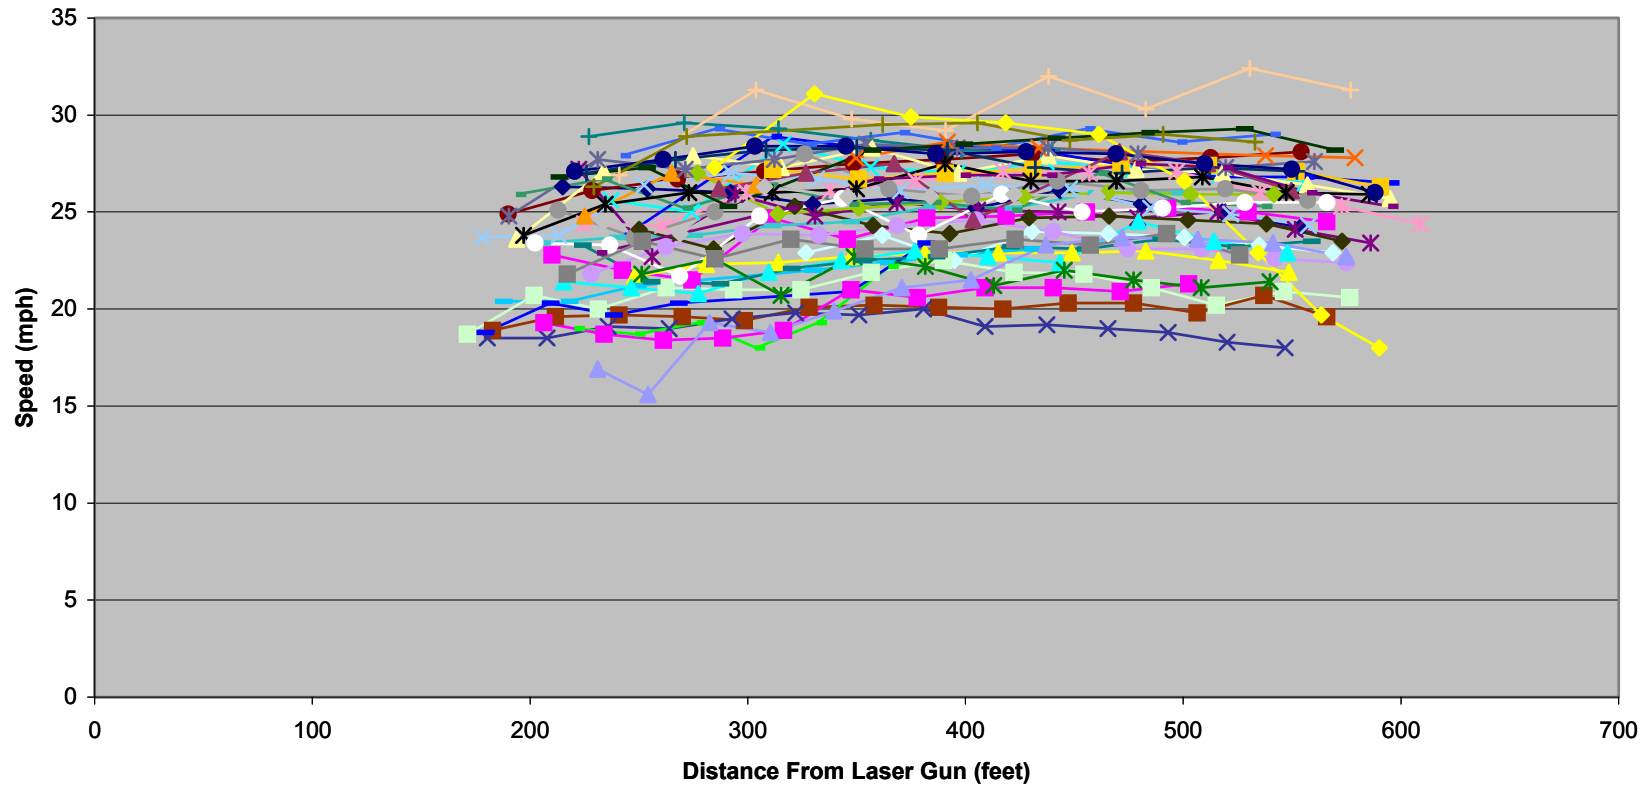
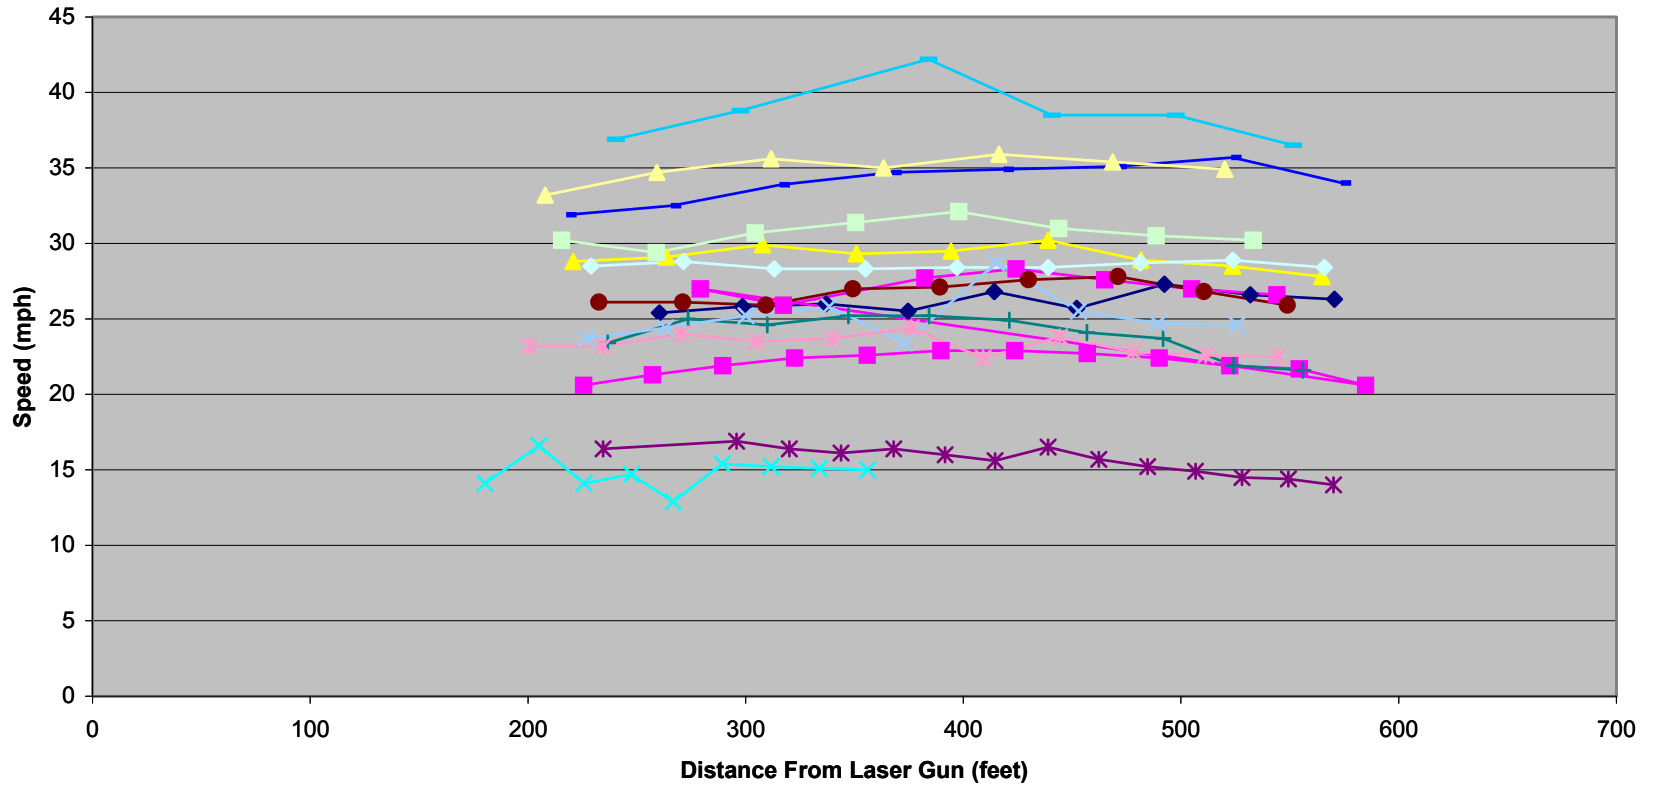
Figure D5: Roosevelt Drive Southbound “Before” Speed Profiles

Figure D6: Roosevelt Drive Southbound Temporary 25 mph Speed Hump Speed Profiles

Figure D7: Roosevelt Drive Southbound Temporary 30 mph Speed Table Speed Profiles

Figure D8: Roosevelt Drive Southbound "After" Speed Profiles

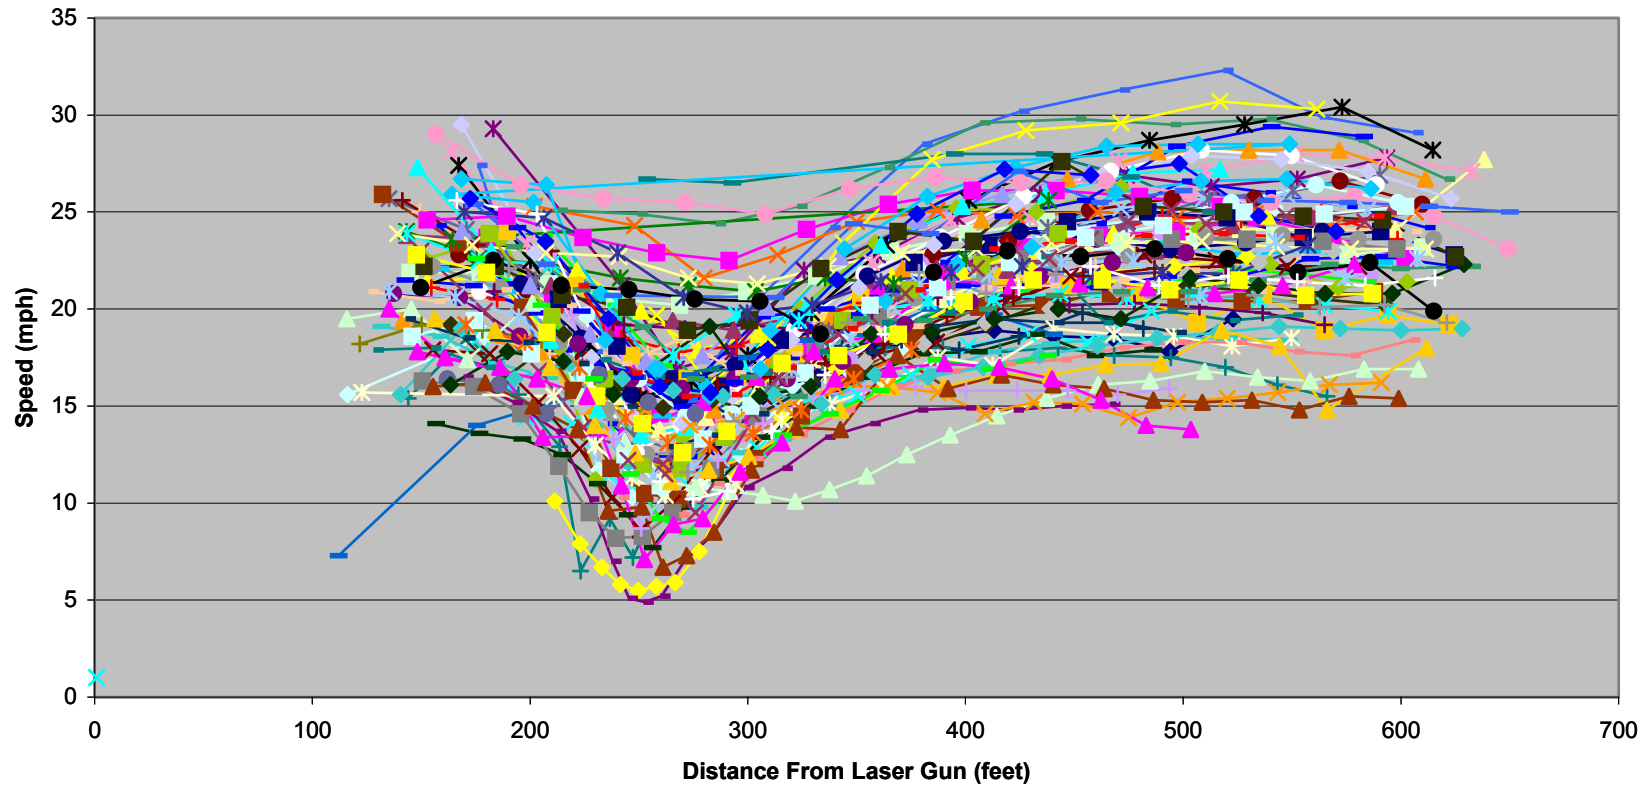
Figure D9: Redwood Drive “Before” Speed Profiles

Figure D10: Redwood Drive Temporary 25 mph Speed Hump Speed Profiles

Figure D11: Redwood Drive Temporary 30 mph Speed Table Speed Profiles

Figure D12: Redwood Drive "After" Speed Profiles

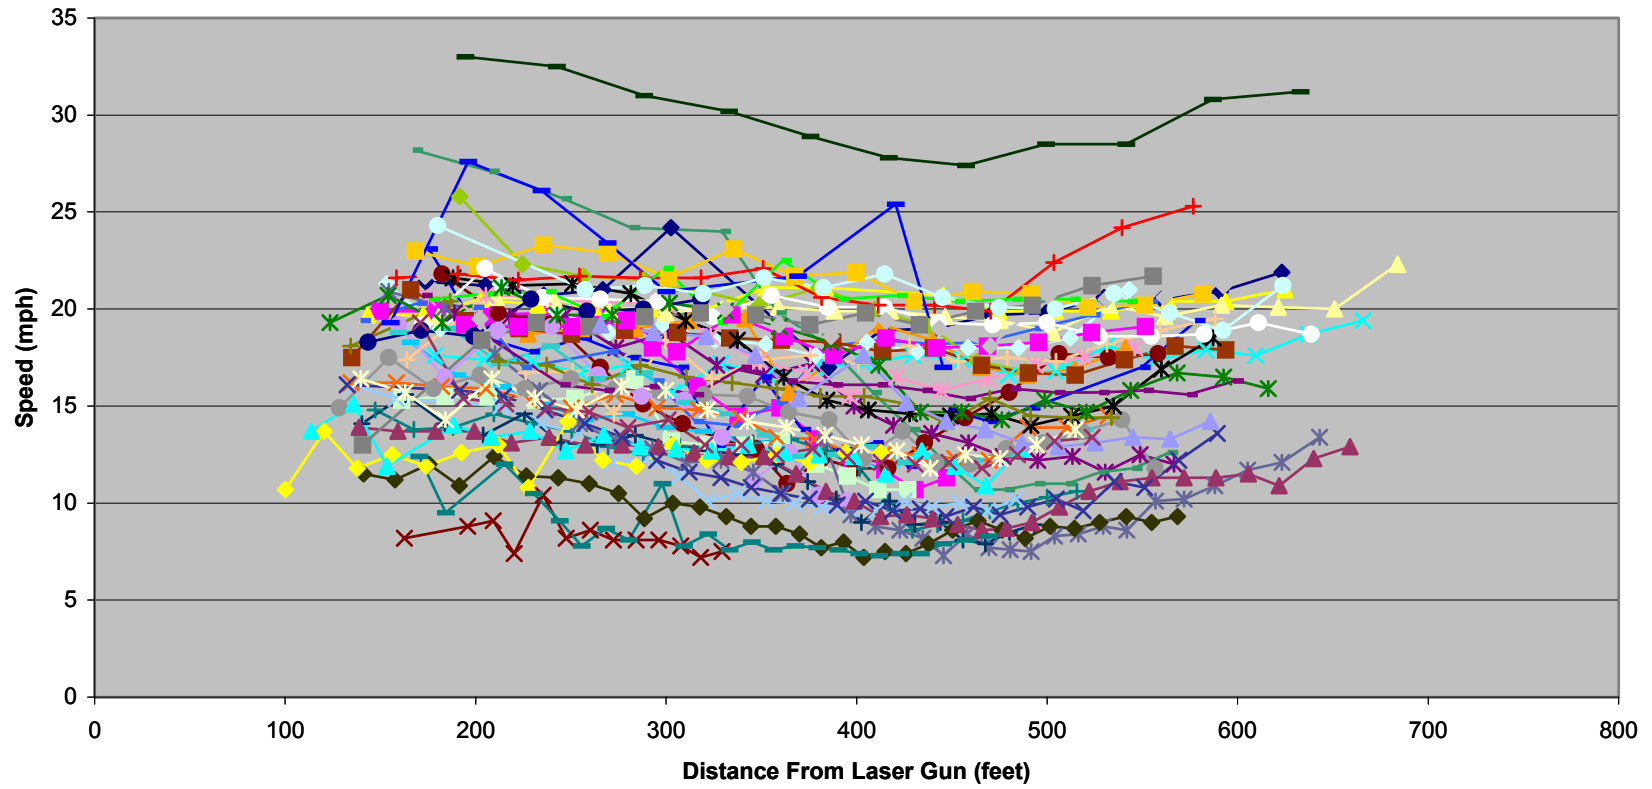
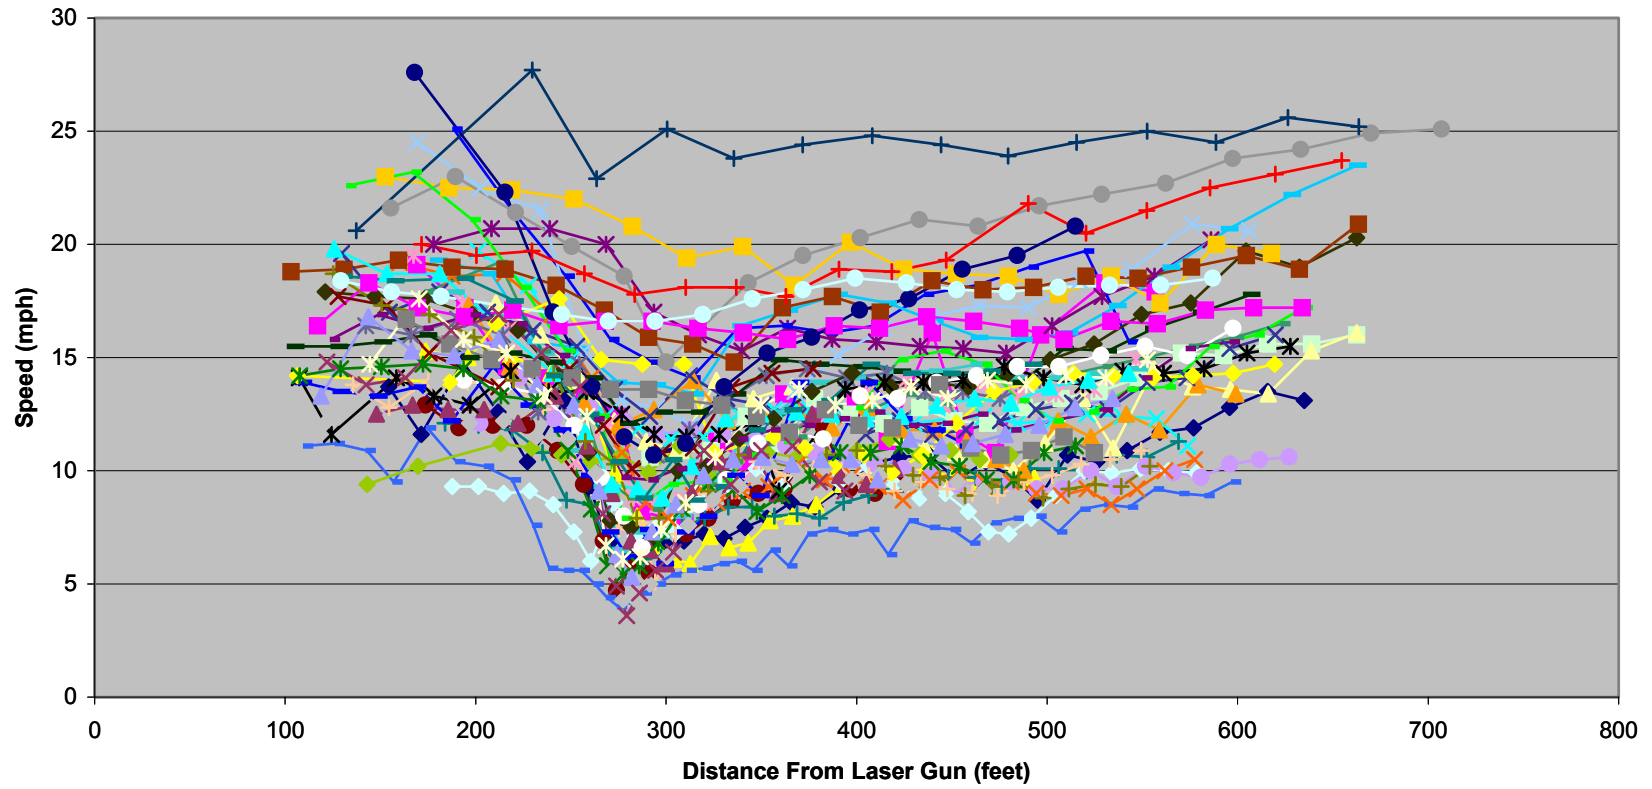
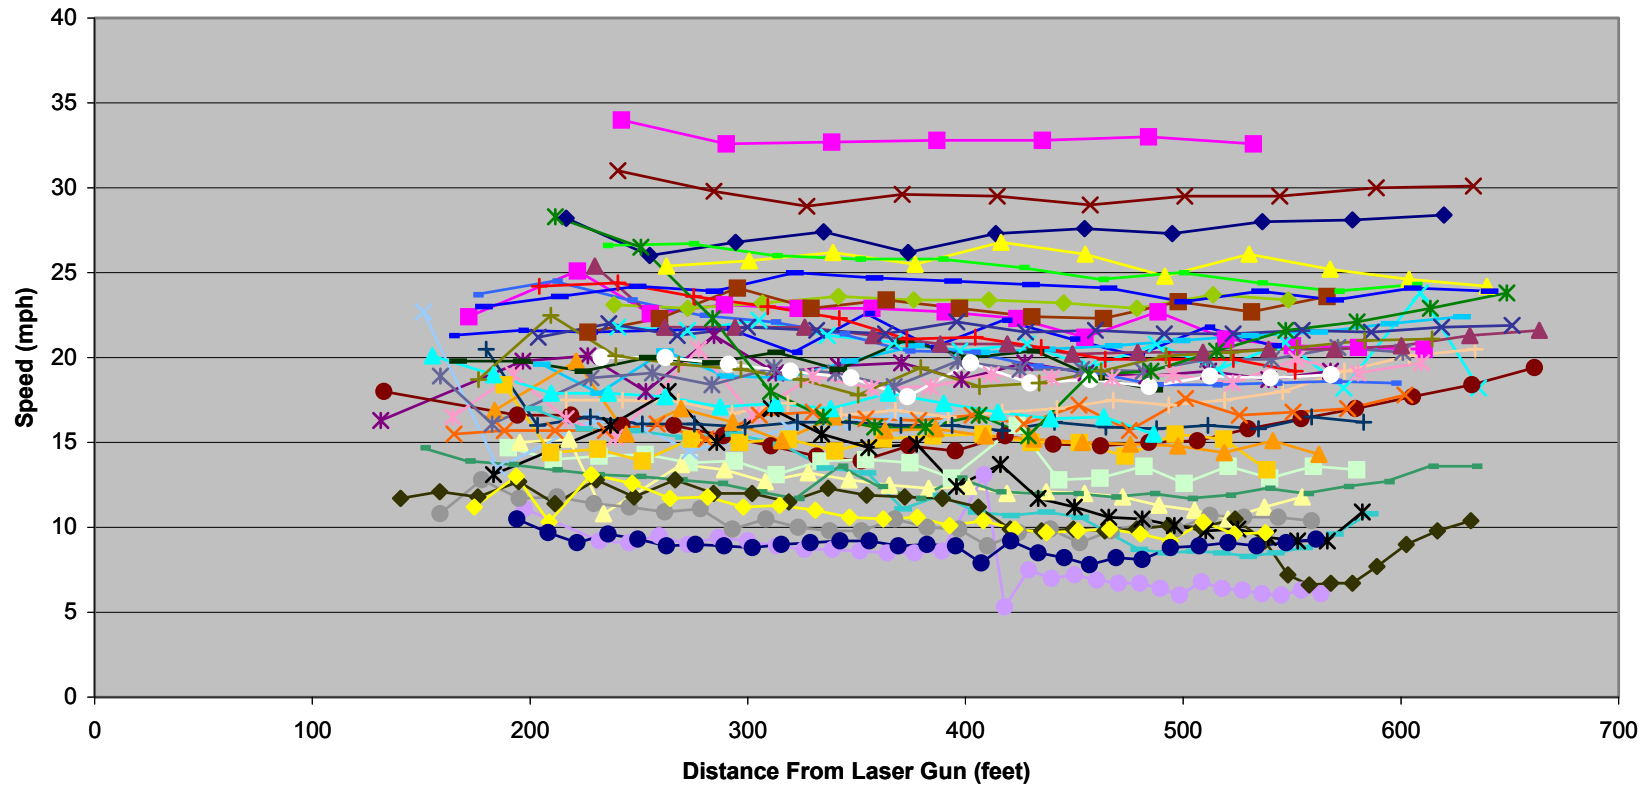
Figure D13: Canal Shore Drive “Before” Speed Profiles

Figure D14: Canal Shore Drive Temporary 25 mph Speed Hump Speed Profiles

Figure D15: Canal Shore Drive Temporary 30 mph Speed Table Speed Profiles

Figure D16: Canal Shore Drive “After” Speed Profiles
