Technical Memorandum 33-573

*The Mariner Mars 1971 Radio
Frequency Subsystem*

JET PROPULSION LABORATORY
CALIFORNIA INSTITUTE OF TECHNOLOGY
PASADENA, CALIFORNIA

December 1, 1972

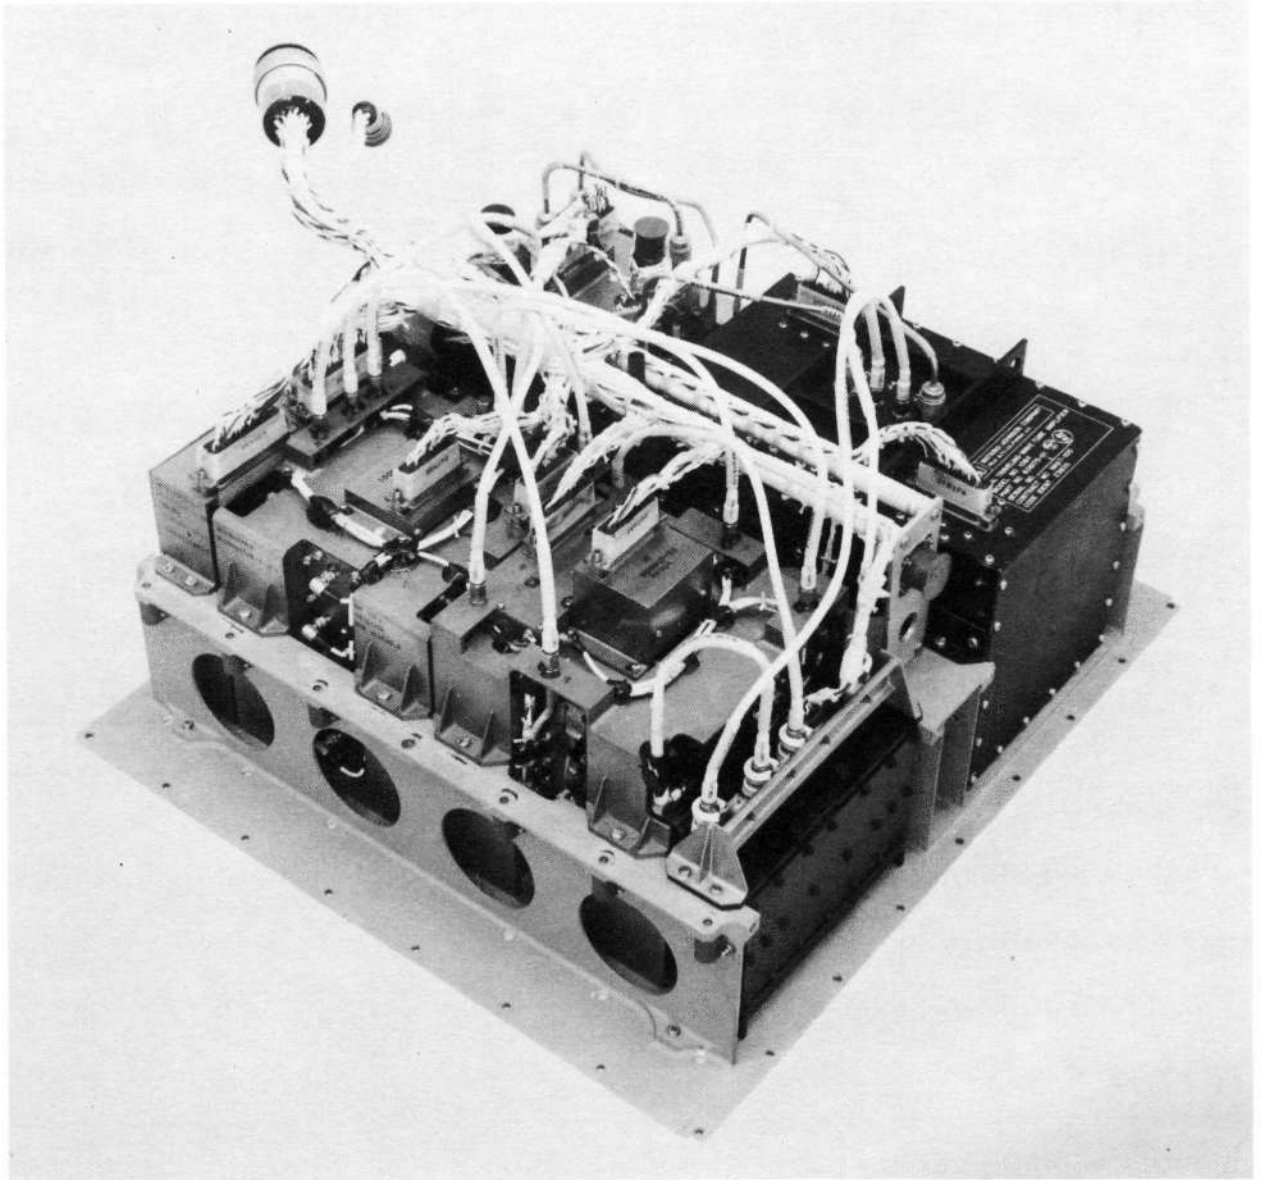
Fig. 1. MM'71 RFS

The Mariner Mars 1971 (MM'71) radio frequency subsystem (RFS) provides the communication link between the spacecraft and the ground-based Deep Space Instrumentation Facility (DSIF). The functions of the RFS, shown in Fig. 1, are to

- (1) Receive the S-band radio frequency signal transmitted from the DSIF.
- (2) Demodulate the S-band signal and provide the extracted composite command signal to the flight command subsystem.
- (3) Demodulate the ranging signal transmitted from the DSIF.
- (4) Transmit a modulated RF signal with a carrier which is phase-coherent with either the received carrier or with an internally generated frequency source.
- (5) Modulate the transmitted carrier with the composite telemetry signal from the flight telemetry subsystem.
- (6) Modulate the transmitted carrier with the receiver-detected ranging signal.

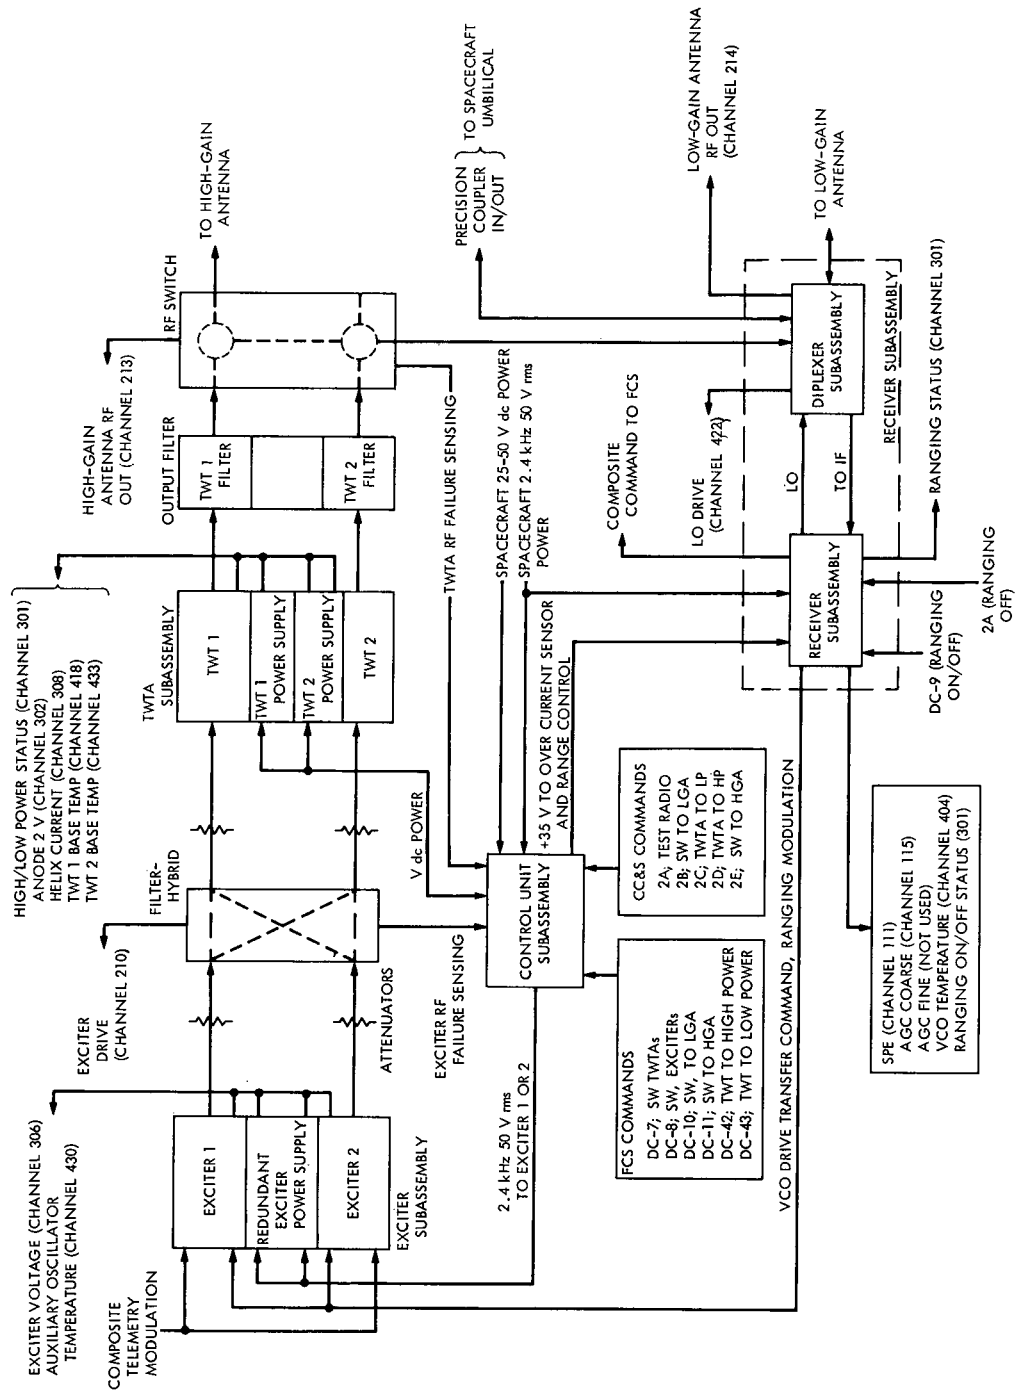
Fig. 2. Radio frequency subsystem block diagram

The RFS consists of the four subassemblies and the microwave components shown in Fig. 2. The major subassemblies are the receiver, the exciter, the traveling wave tube amplifier (TWTA), and the control unit subassemblies. The microwave components consist of the dual RF switch, the filter hybrid, the output filter, and the diplexer.

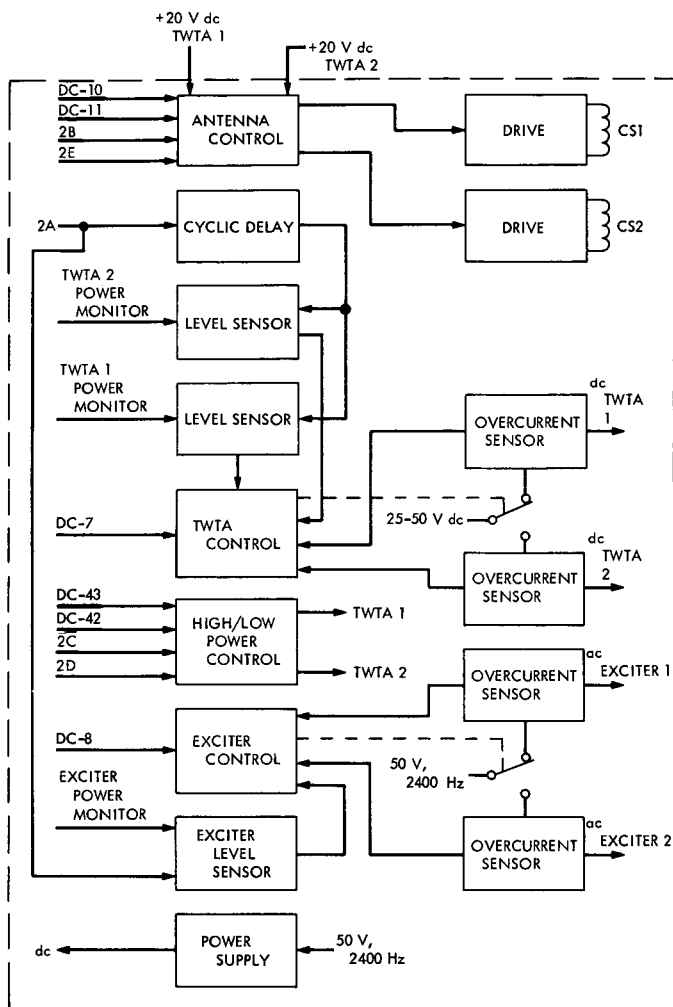
Fig. 6. Control unit block diagram

The control unit accepts direct commands from the FCS, the CC&S, and the failure-sensing circuits in the RFS. It selects the appropriate RFS operating mode. The functions of the control unit are to

- (1) Control the circulator switches to direct the output from either TWTA to the high-gain or low-gain antenna upon receipt of a suitable command from the FCS or CC&S.
- (2) Sense the TWTA and exciter power level and, if it is low, switch to the redundant unit upon receipt of the CC&S 2A cyclic command.
- (3) Sense overcurrent conditions in the TWTA and exciter power supplies and switch immediately to the redundant unit; switch to either redundant element upon receipt of a direct command from the FCS.
- (4) Select high or low power output from the TWTA upon receipt of a command from the FCS or the CC&S.
- (5) Sense overcurrent in the receiver power supply and remove its prime power if such a condition exists. The prime power is reapplied to the receiver upon receipt of each subsequent CC&S 2A cyclic command.
