**NASA TECHNICAL
MEMORANDUM**

NASA TM X- 68163

**WIND TUNNEL INVESTIGATION OF THE EFFECT
OF HIGH RELATIVE VELOCITIES ON THE
STRUCTURAL INTEGRITY OF BIRDS**

by Donald L. Bresnahan and Arthur H. Schultz
Lewis Research Center
Cleveland, Ohio
December, 1972

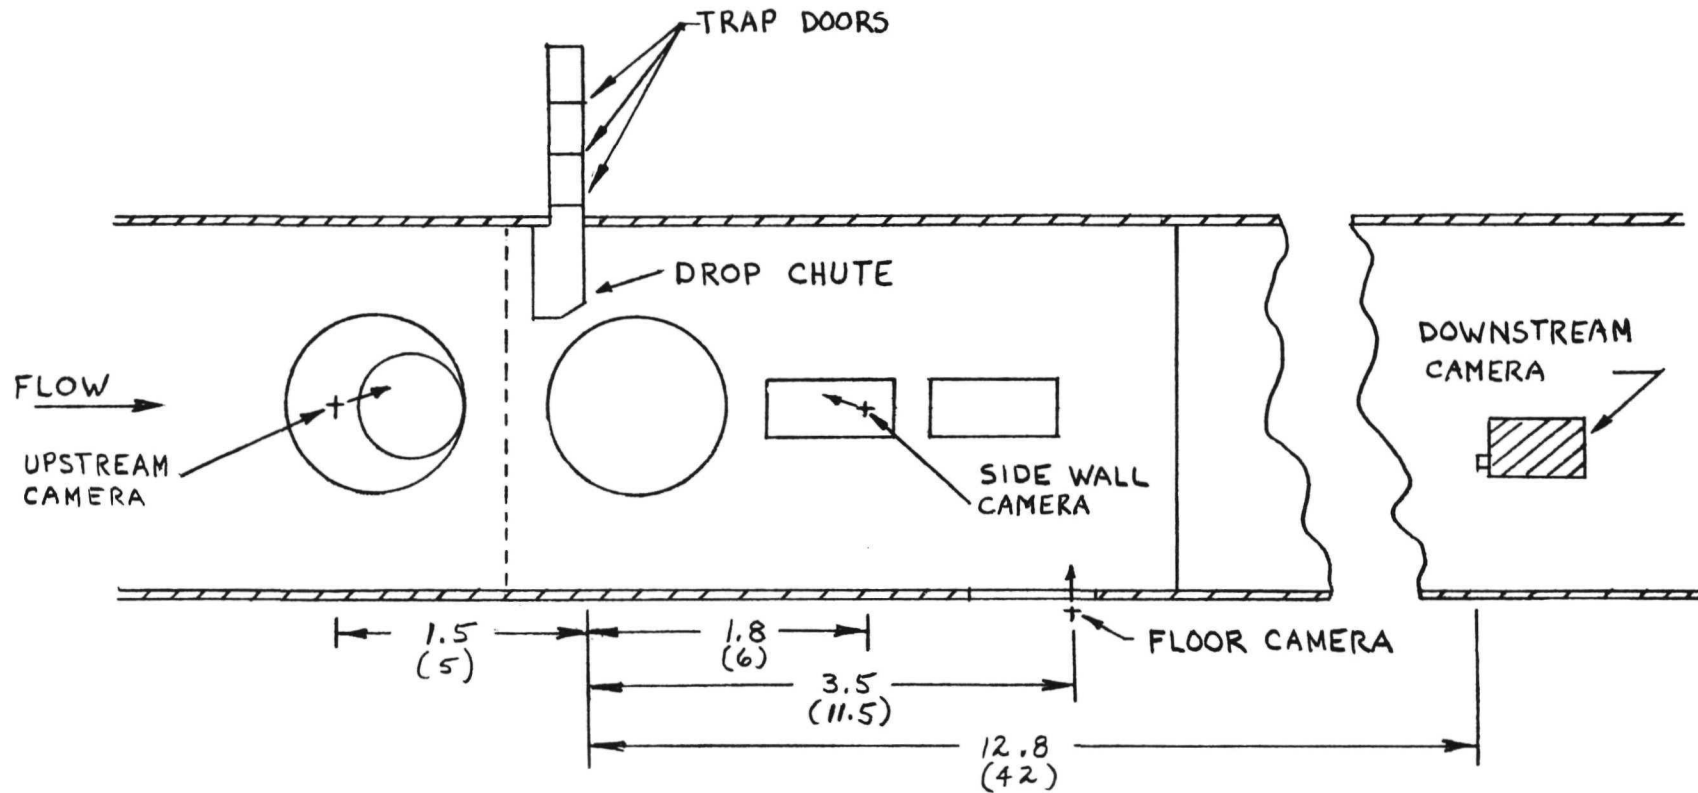
FIGURE 3. CAMERA LOCATION IN 8×6 FT SUPERSONIC WIND TUNNEL TEST SECTION (ALL DIMENSIONS IN METERS (FEET))

As the birds accelerated through the test section, they were photographed with color film by four high speed motion picture cameras at 2000 frames per second. The cameras were located as shown in figure 3, with the upstream, side wall, and floor cameras external to the test section and the downstream camera mounted inside on the tunnel wall downstream of the test section. The arrows indicate the direction the cameras were aimed. The color film supplement to this report does not include any footage from the floor camera.

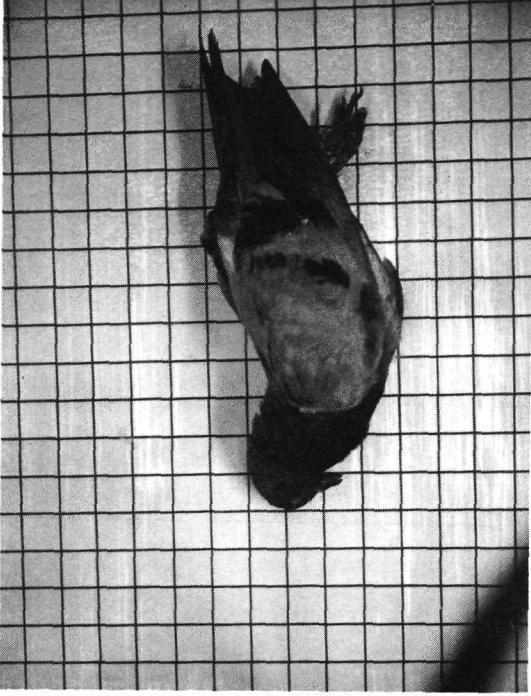
(a) Starling.

(b) Pigeon.

(c) Duck.

Figure 4. - Typical bird specimens, 2.54 cm (1.0-in.) grid.

Three species of birds were used (fig. 4): starlings, averaging 57 to 85 grams (2 to 3 oz); pigeons, averaging 284 to 340 grams (10 to 12 oz); and domestic ducks weighing approximately 1.96 kilograms (4 lb. 5 oz). Domestic ducks were used in this test because of difficulties in obtaining wild ducks. Table I lists the specimens tested at each Mach number. Three birds were dropped at free-stream Mach numbers of 0.2, 0.4, 0.6, and 0.8.
