NASA CR-72844

DEVELOPMENT OF THE ACTIVATED DIFFUSION BRAZING PROCESS
for
FABRICATION OF FINNED SHELL TO STRUT TURBINE BLADES

General Electric Company

Contract NAS3-12433

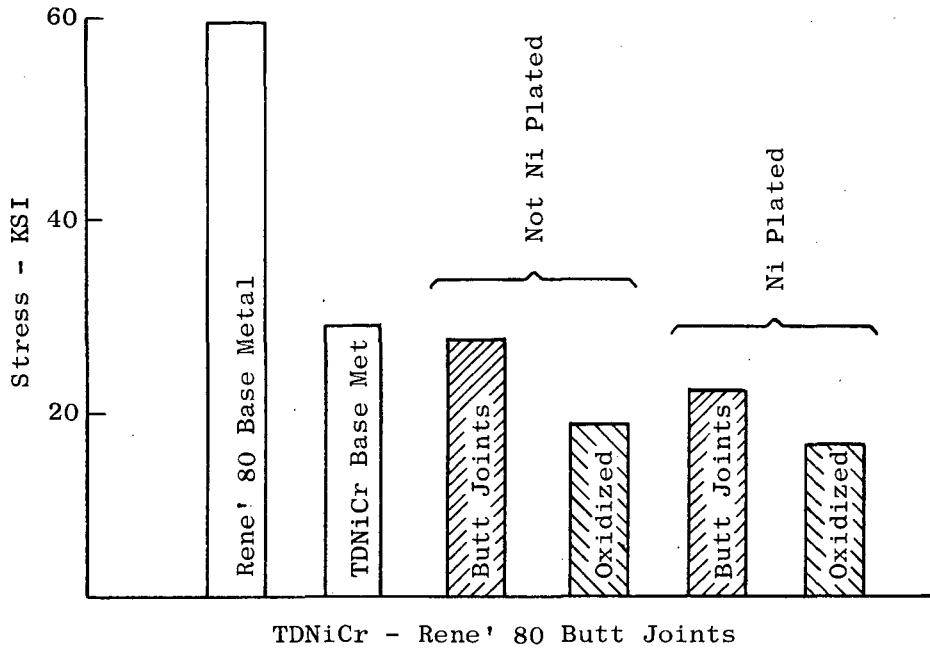
Figure 12. 1750°F (1228°K) Ultimate Strength of Activated Diffusion Brazed Butt Joints of TDNiCr to Rene' 80 Using B-1 Brazing Alloy.

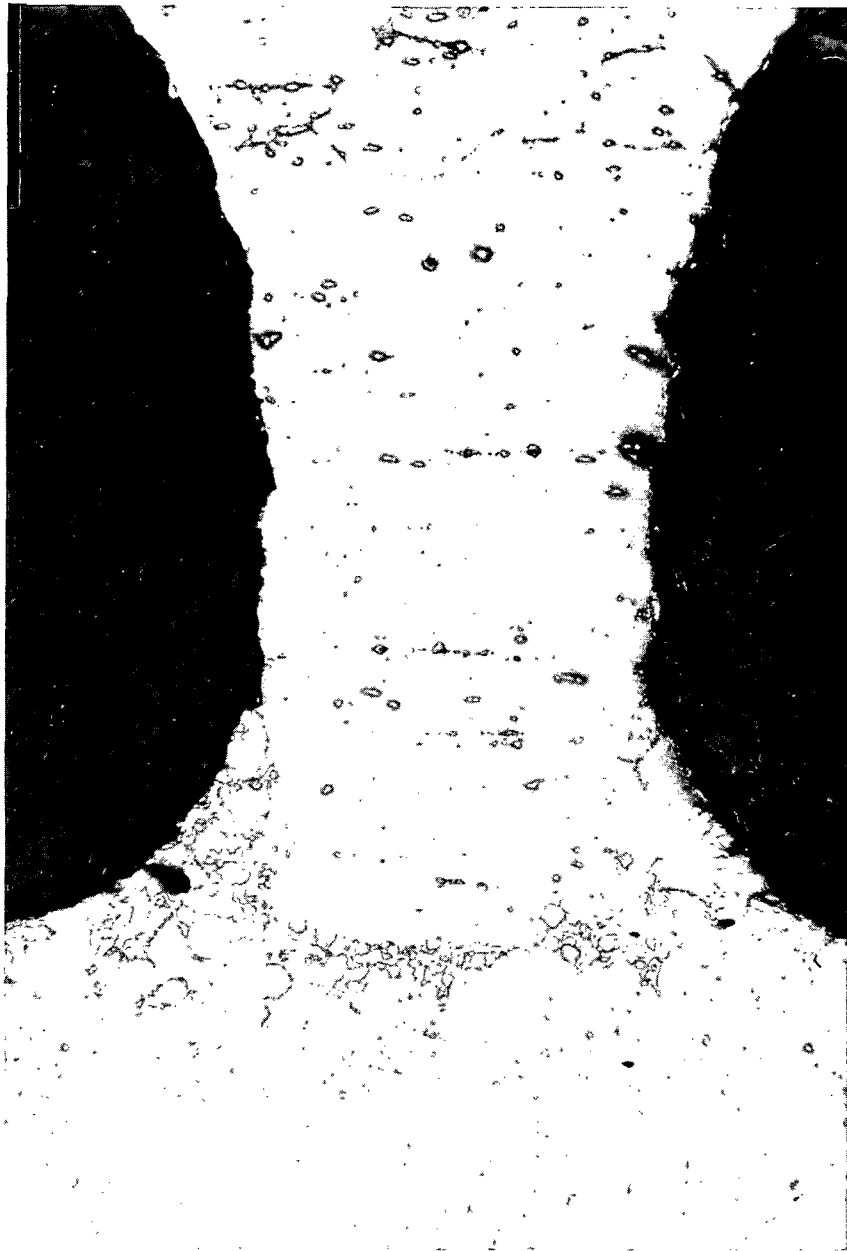
Figure 19. Typical Microstructure of Activated Diffusion Brazed U700 to Rene' 80 Using B-1 Brazing Alloy.

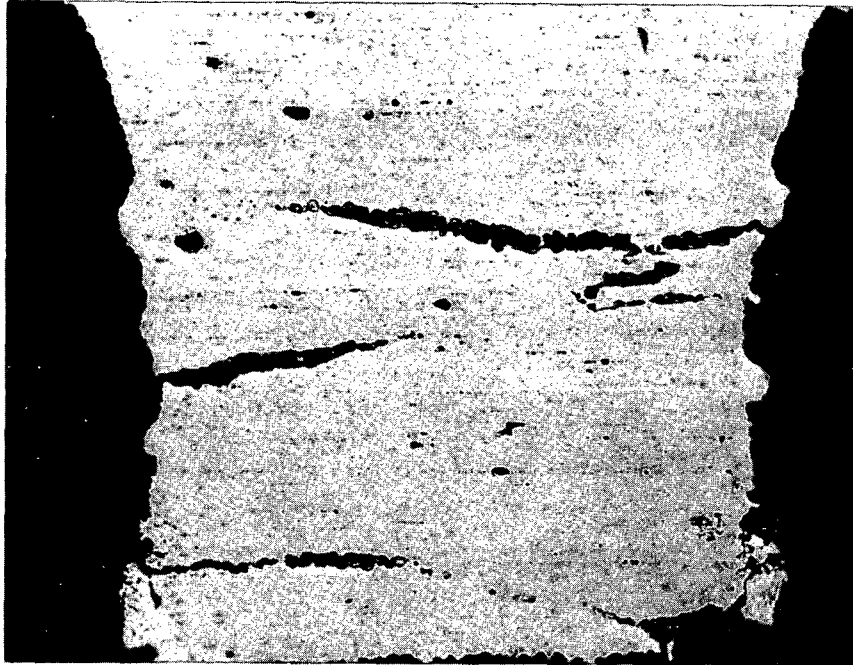
Figure 36. Stress-Induced Thermally Accelerated Cracking of a of a TDNiCr Fin. Note the Severe Oxidation in the Cracks.

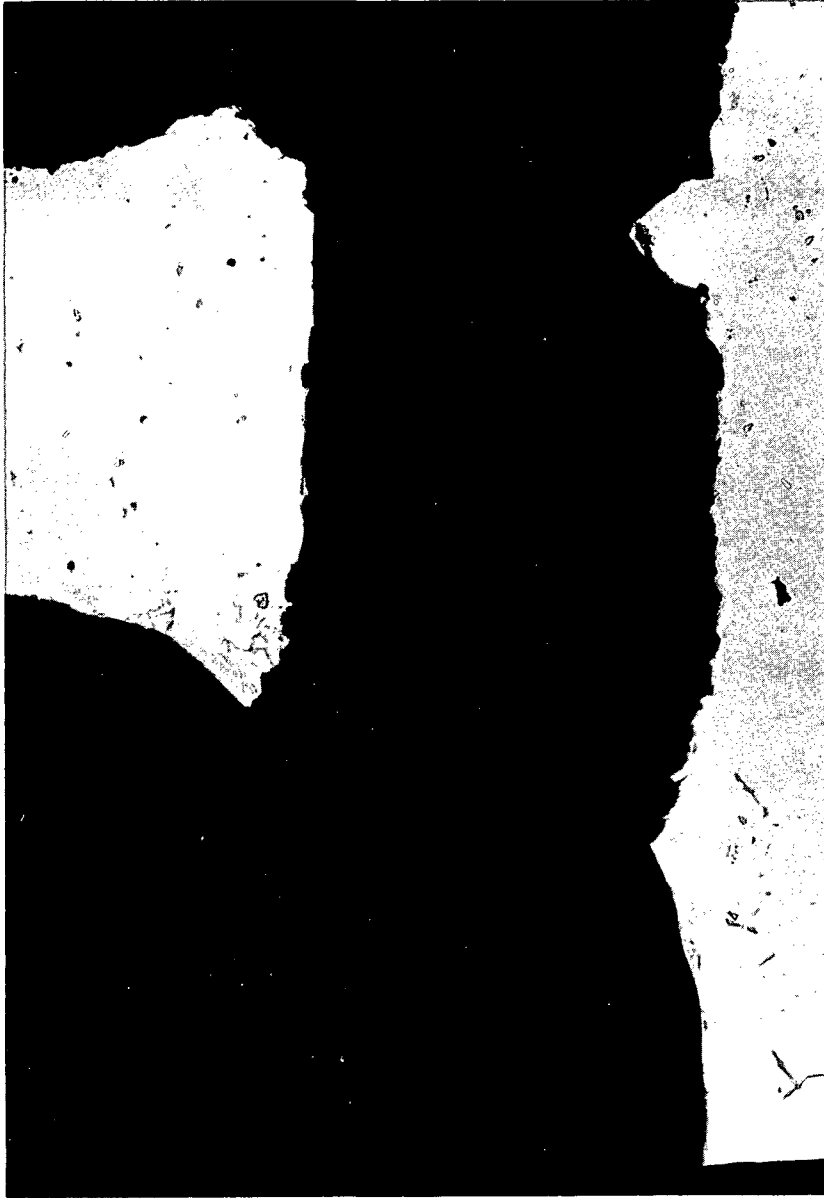
Figure 39. Typical Joint Failure of a U700 - Rene' 80 Short Transverse Finned Specimen.

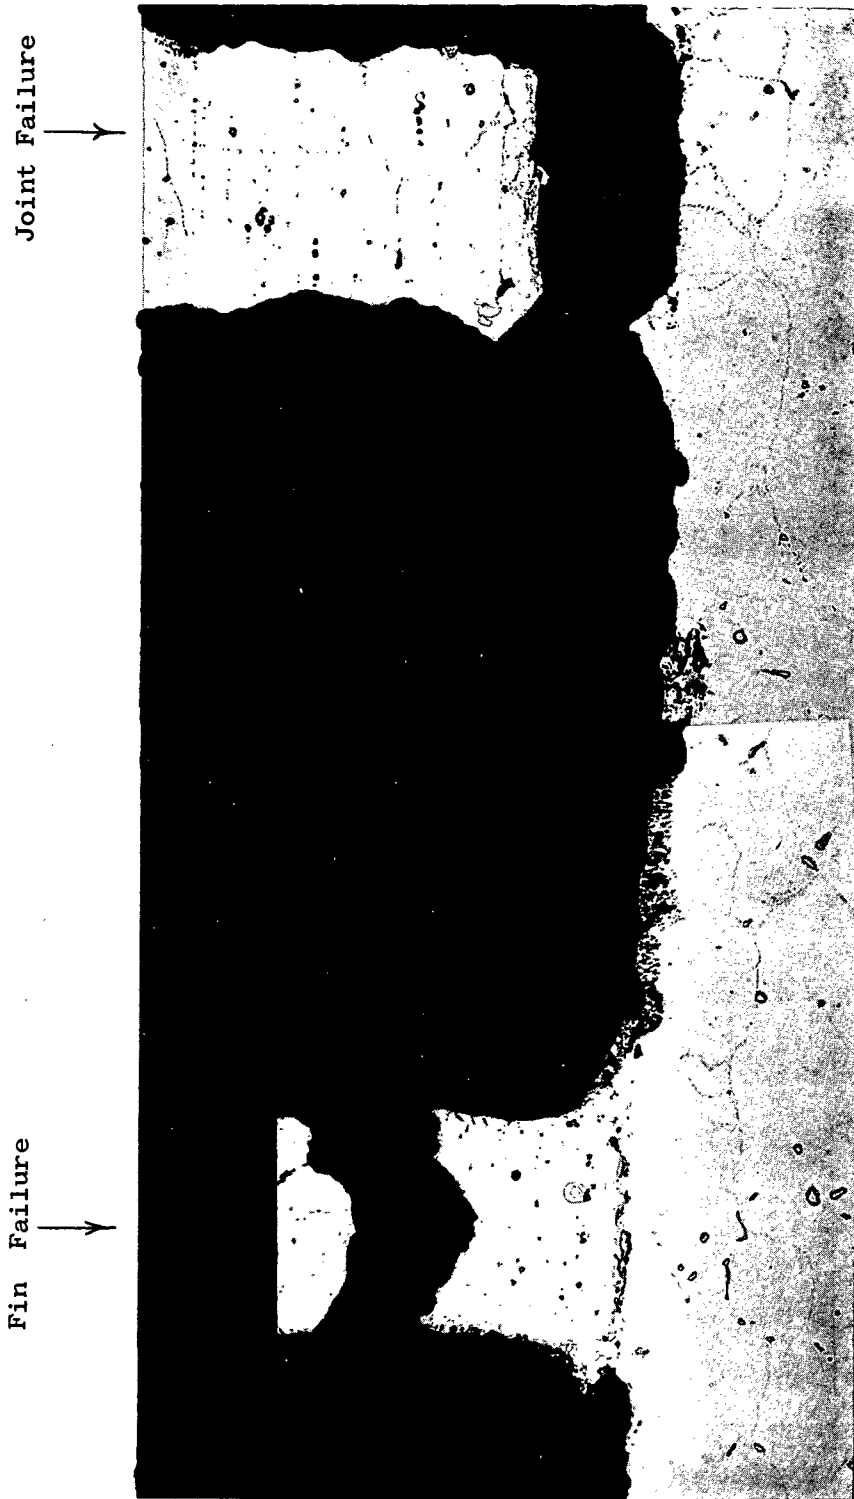
Figure 40. Combination Failure of U700 - Rene' 80 Short Transverse Finned Specimen.

Note that Some of the U700 Fins are
Still Joined to the Rene' 80 Clevis Block

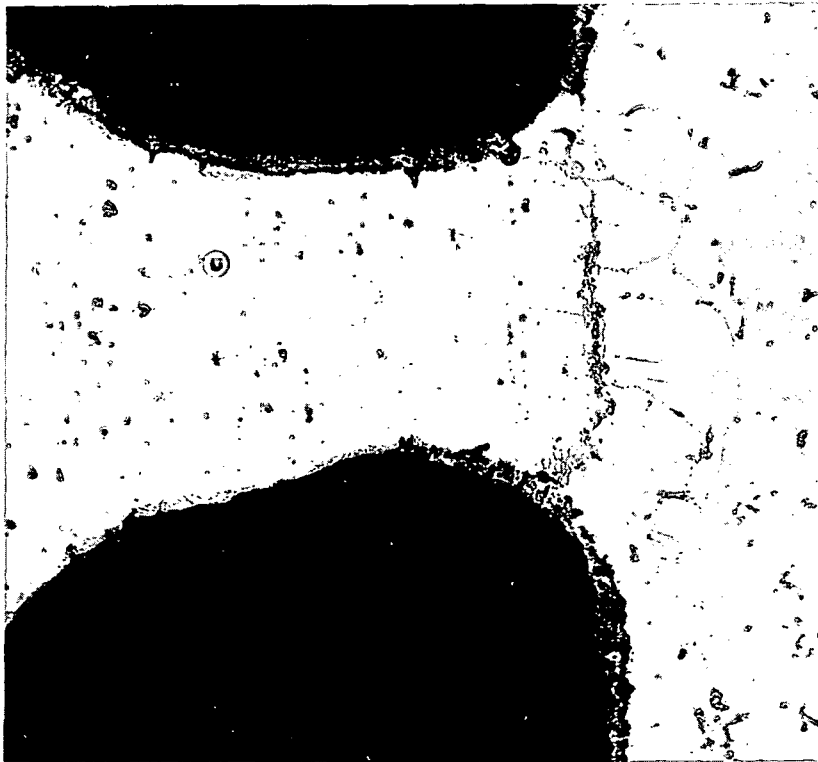
a. Uncoated.

b. Coated.
(Note the lack of oxidation)

Figure 43. Typical Oxidation due to Cyclic Exposure of a U700 - Rene' 80 Short Transverse Finned Specimen.

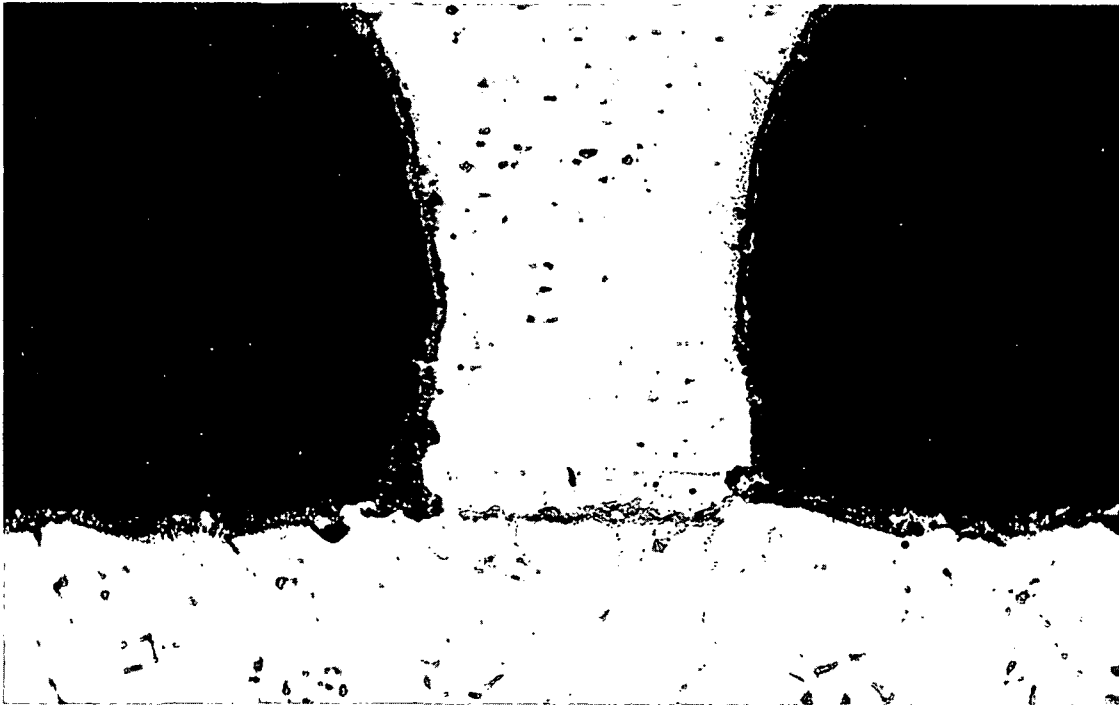
Figure 44. Gross Oxidation Occasionally Encountered in Cyclic Exposed U700 - Rene' 80 Short Transverse Finned Specimens.

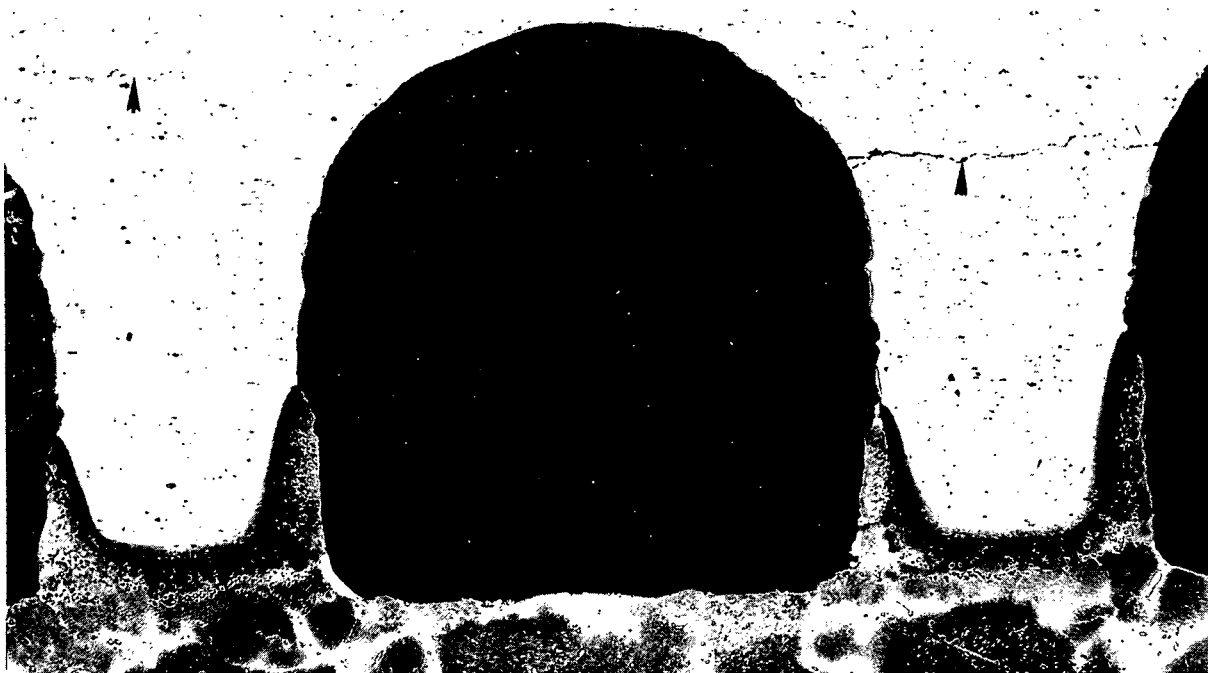
Crack Free, Showing Voids

Containing Cracks

Figure 62. Transverse Sections Through Finned TDNiCr Shell After Activated Diffusion Brazing Using B-1 Transfer Tape Alloy. Note Cracking Denoted by Arrows.
