# RESEARCH MEMORANDUM

OPERATION OF AN EXPERIMENTAL AIR-COOLED TURBOJET ENGINE

AT TURBINE-INLET TEMPERATURES FROM 2200° TO 2935° R

By Reeves P. Cochran, Robert P. Dengler, and Jack B. Esgar

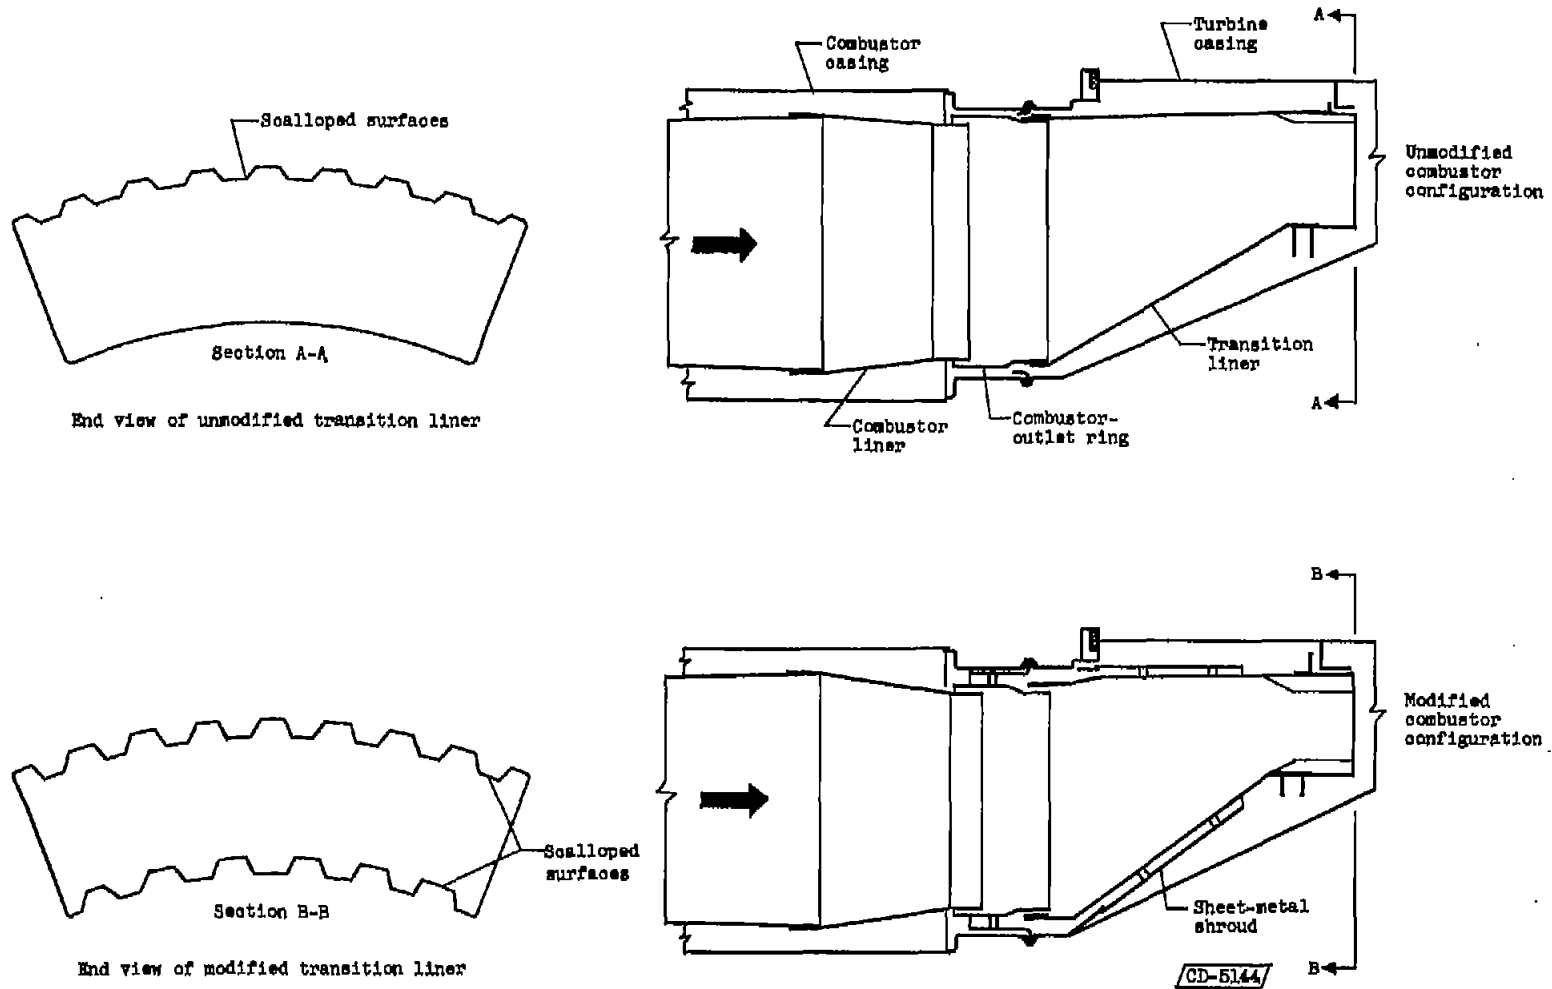
Figure 2. - Modified and unmodified production-model tubular combustors and transition liners.

(a) Cross-sectional drawings of combustors and liners.

cooling, production-model tubular combustors for this engine were modified as described in reference 9 to permit a larger flow of secondary (cooling) air around the inner and outer peripheries of the combustion chambers. Figure 2 gives a comparison of the production-type and the modified combustors. The support struts of the unmodified transition liner (fig. 2(b)) were removed in the modified version as a precautionary measure, that is, to prevent the possibility of these struts failing and damaging the turbine stator and rotor blades during operation at the proposed high turbine-inlet temperatures. The diameters of the aft end of the combustor liner, the combustor-outlet ring, and the forward end of the transition liner were reduced to increase the annular area between the liners and the combustor casings. A sheet metal shroud was built around the transition liner to direct the cooling-air over the outside surface of the liner. The scalloped surface on the outer radius of the aft end of the transition liner was more deeply drawn for added cooling-flow area, and scallops were also formed on the surface of the inner radius of the liner.

There were no thermocouples located on the turbine casing or on the modified combustor and transition liners (figs. 2 and 4), but the heat patterns observed on these parts during and at the conclusion of the investigation gave a good indication of the range of the wall temperatures. The forward portion of the turbine casing which encloses the transition liners (fig. 4) was protected from the hot gases by the large flow of cooling air around the modified combustion system. No heat pattern was observed here during operation. At the rear portion of the turbine casing where the adjustable stator blades were mounted, this cooling air was not

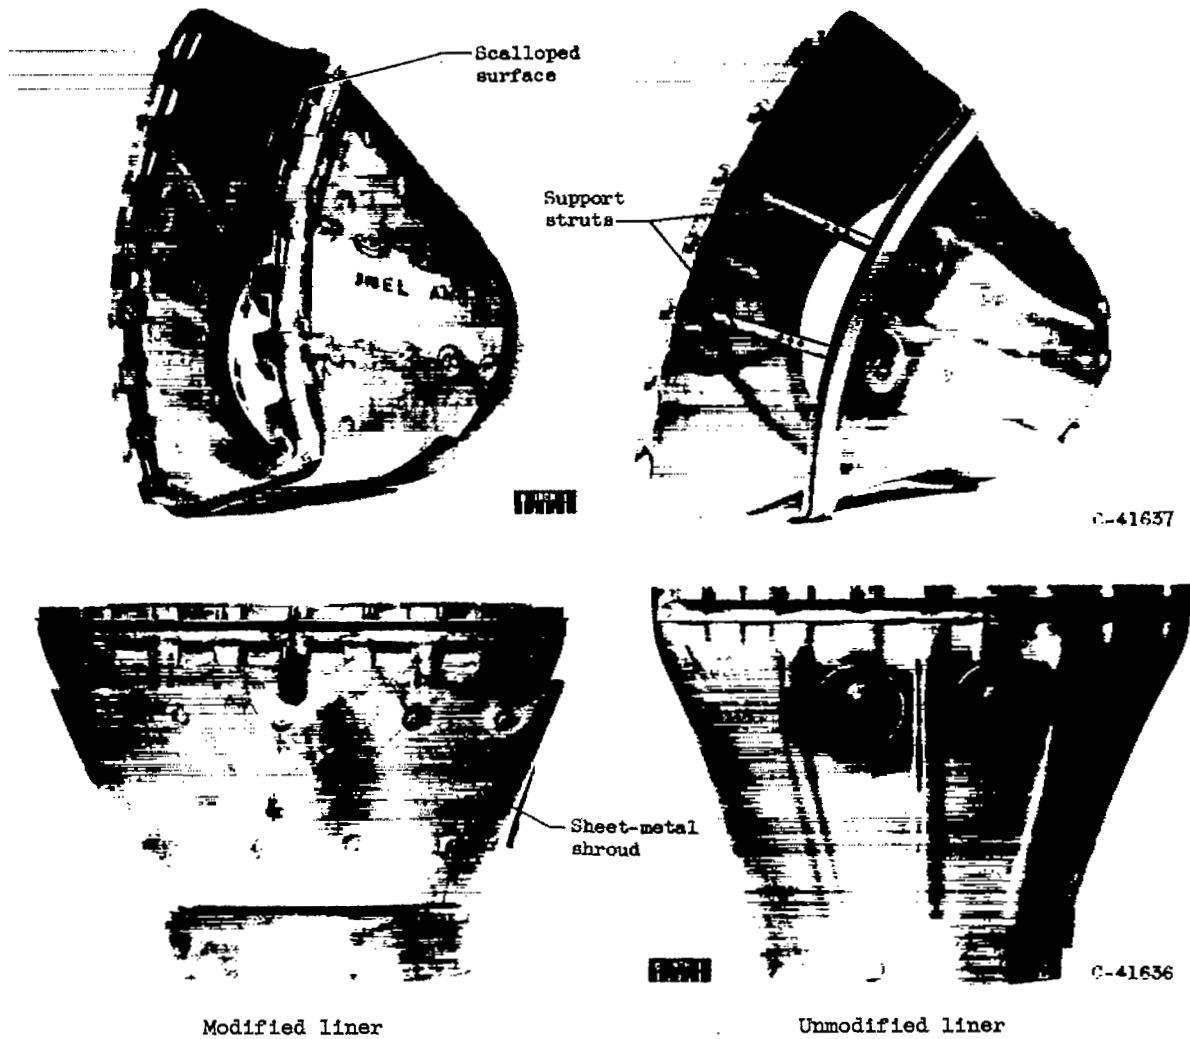
Figure 2. - Concluded. Modified and unmodified production-model tubular combustors and transition liners.

(b) Photographs of sheet metal transition liners.

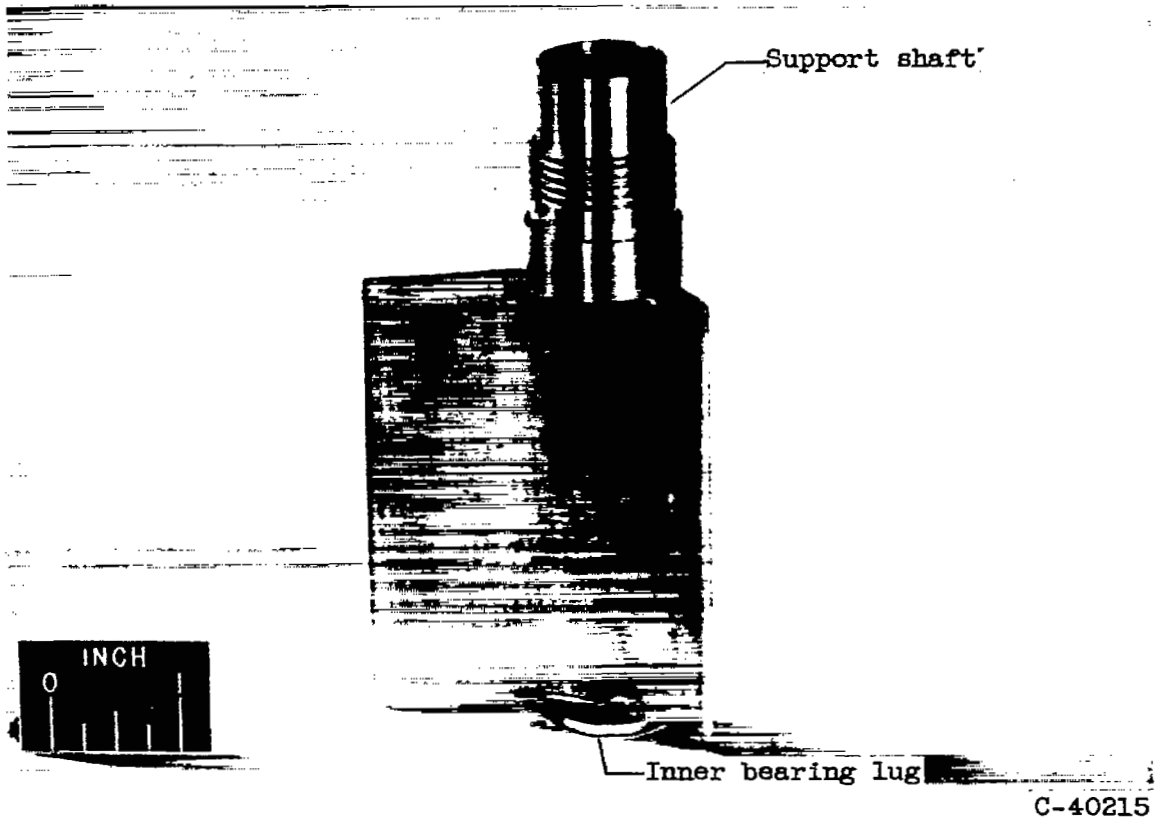
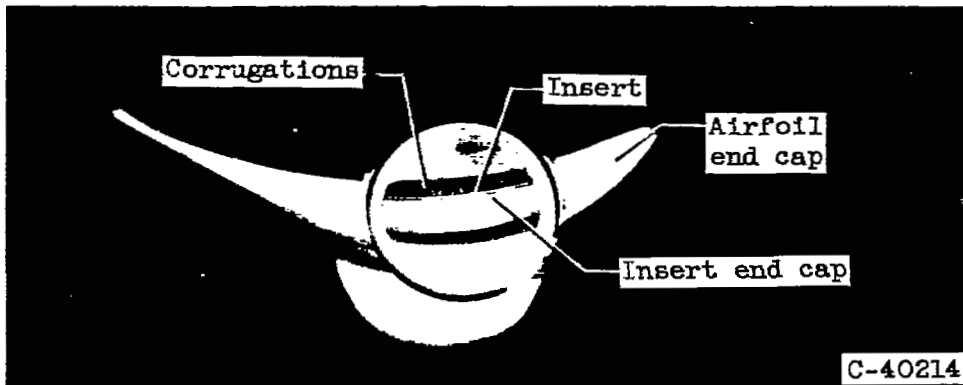
Figure 3. - Adjustable air-cooled corrugated-insert turbine stator blade.

End view of stator blade showing cooling-air entrance

The stator blades (fig. 3) were fabricated of a high-temperature alloy, N-155. The airfoil shell was formed in two halves of 0.020-inch-thick sheet stock. Corrugated heat-transfer surfaces (figs. 3 and 4) 0.010-inch thick with an amplitude of 0.070 inch and a pitch of 0.070 inch were fitted to the inside surfaces of both halves of the shell. A 0.010-inch-thick insert that extended from near the hub to near the tip of the blade (see fig. 4) was attached to the inner surface of the corrugations. This insert was capped at both ends; thus the cooling air was forced to flow over the corrugated heat-transfer surfaces in passing through the blade. The space between the end cap on the airfoil shell and the end cap of the insert at both the hub and tip of the stator blade (fig. 4) was intended to provide for the distribution of the cooling air over the entire chord length. The blade was assembled with a bearing lug at the root and a support shaft at the tip. All joints in this blade assembly were made with Microbraz except the leading- and trailing-edge joints which were heliarc welded.
