**NASA TN D-5807**

**STATIC AND DYNAMIC FATIGUE BEHAVIOR OF  
GLASS FILAMENT-WOUND PRESSURE VESSELS  
AT AMBIENT AND CRYOGENIC TEMPERATURES**

*by Morgan P. Hanson*

**NATIONAL AERONAUTICS AND SPACE ADMINISTRATION • WASHINGTON, D. C. • MAY 1970**

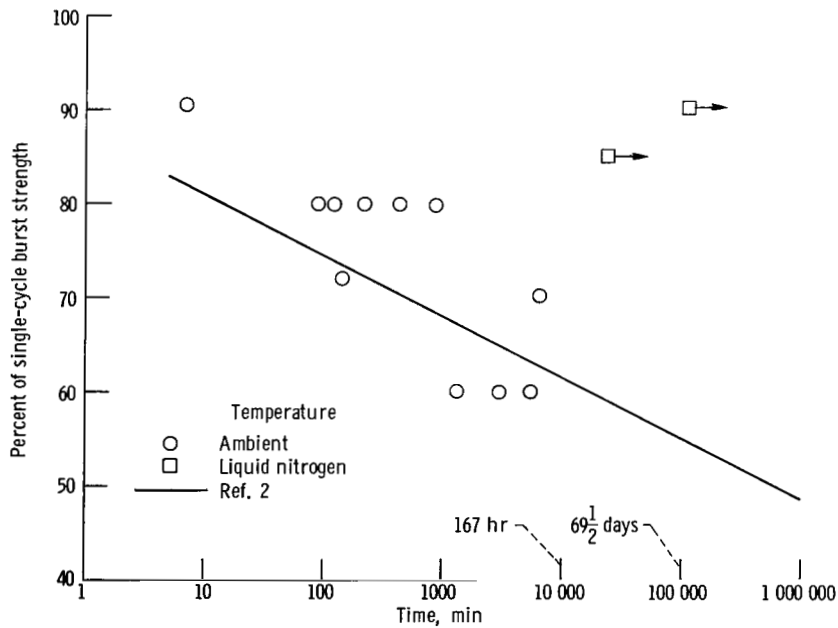
Figure 3. - Time to failure under sustained pressurization at various percents of single-cycle burst strength of aluminum-foil-lined FRP cylinders.

made ranging from 60 to 90 percent of the single-cycle burst strength. The results are compared with data from reference 2. Although scatter appears in the data of the present investigation, the general trend agrees favorably with the referenced results. Some of the scatter can be attributed to the variation in relative humidity and temperature that occurred during the testing period. At liquid nitrogen temperature where moisture is excluded, the only influencing physical factor should be the temperature because of the inertness of the nitrogen. In the two tests at liquid nitrogen temperature, no failures resulted in the FRP because of extended pressurization. Both tests were terminated because the test equipment malfunctioned. One cylinder sustained essentially constant pressurization at about 90 percent of the single-cycle burst strength for 88 days. The intent was to maintain a stable pressure in the liquid nitrogen environment. Maintaining this condition was difficult because of the problem in controlling the transfer of liquid nitrogen and pressurization with gaseous nitrogen. Figure 4 shows a continuous record of the temperature and percent of burst pressure of the cylinder pressurized at a nominal 90 percent of burst. After initial condensation of gaseous nitrogen and temperature stabilization, it was apparent that the system was not pressure tight, and, in one instance, a complete depressurization occurred. A preliminary pressure check of the cylinder at ambient temperature, however, disclosed no leaks in the cylinder. In two instances, the loss of liquid nitrogen caused the temperature to increase. Corrective

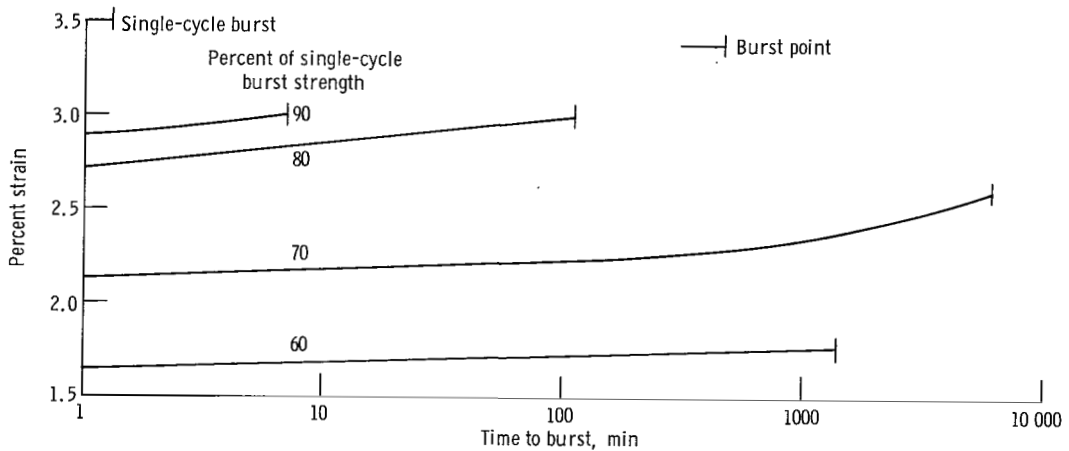
Figure 5. - Ambient temperature strain-time curves of aluminum-foil-lined FRP cylinders pressurized to various percents of single-cycle burst strength.

During the static loading of FRP cylinders at ambient temperature, hoop and longitudinal strains were recorded for a limited number of cylinders during the period of sustained pressurization. Although the cylinders were wound to have a balanced 1:1 ratio of hoop to longitudinal strain, the hoop strain was generally higher. The hoop strain as a function of time is shown in figure 5 for cylinders pressurized at various percents of

burst strength. The strain behavior is inconclusive because of variations in the results. However, it is interesting to observe that the static strain did not approach or exceed that of the short-time burst tests. Generally, it appears that no appreciable change in strain occurs above that of the initial strain. This has been observed in glass composites by other investigators (ref. 8).

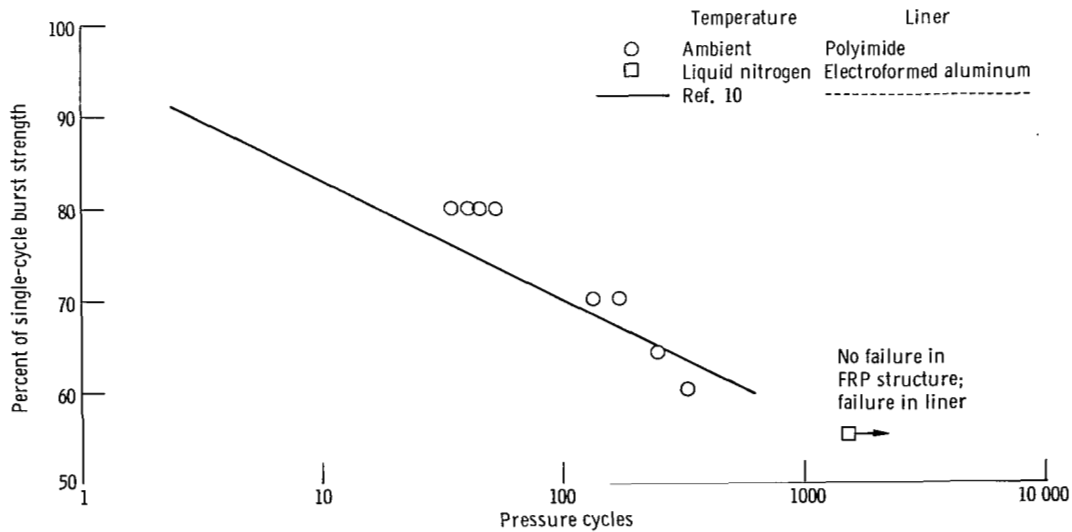
Figure 7. - Pressure cycles to failure at various percents of single-cycle burst strength of FRP cylinders with polyimide liners at ambient temperature and electroformed aluminum liners at liquid nitrogen temperature. Cyclic rate, 2 cycles per minute.

The results of cycling FRP cylinders at ambient and liquid nitrogen temperatures at various percents of the single-cycle burst strength are shown in figure 7. Polyimide-lined cylinders cycled to failure at ambient temperature show good agreement with pub-

lished data (ref. 10). In liquid nitrogen, the electroformed-aluminum-lined cylinder was cycled 1509 cycles at 55 percent of the liquid nitrogen burst pressure (approx 2.1 percent hoop strain) without failure to the FRP. However, extrapolation of the ambient temperature test results to the 55-percent level would predict failure in the FRP at ambient temperature.

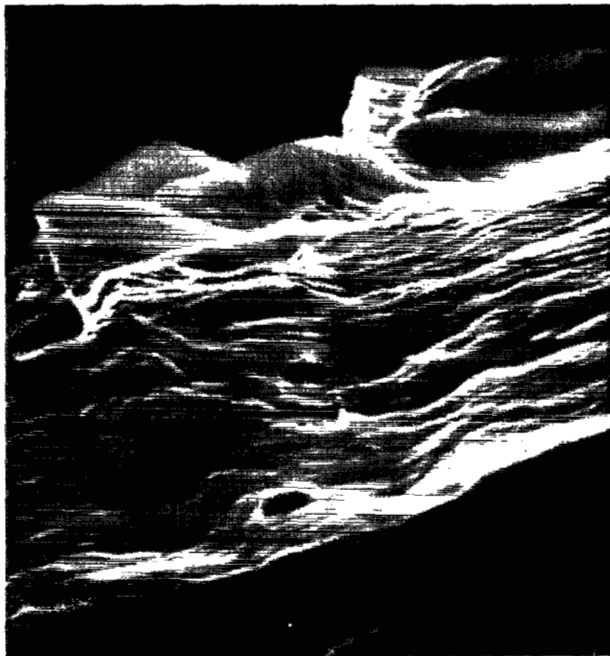
(b) Tensile fracture surface of electroformed aluminum liner material.  
X2000.

Figure 9(a) substantiates the conclusion that the liner failure resulted from fatigue. A scanning electron micrograph of the fatigue fracture surface reveals striations as a result of the crack propagation through the thickness of the liner. Surfaces of tensile fractures of electroformed aluminum (fig. 9(b)) and of wrought aluminum foil (fig. 9(c)) show different fracture phenomena.

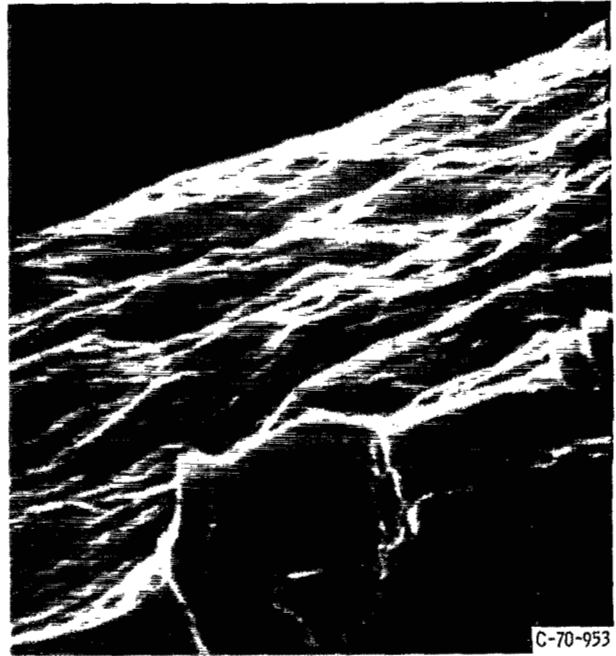
(c) Tensile fracture surface of wrought aluminum foil material.  
X2000.
