NASA TN D-5449

# SUMMARY OF XB-70 AIRPLANE COCKPIT ENVIRONMENTAL DATA

*by Kirk S. Irwin and William H. Andrews*

*Flight Research Center*

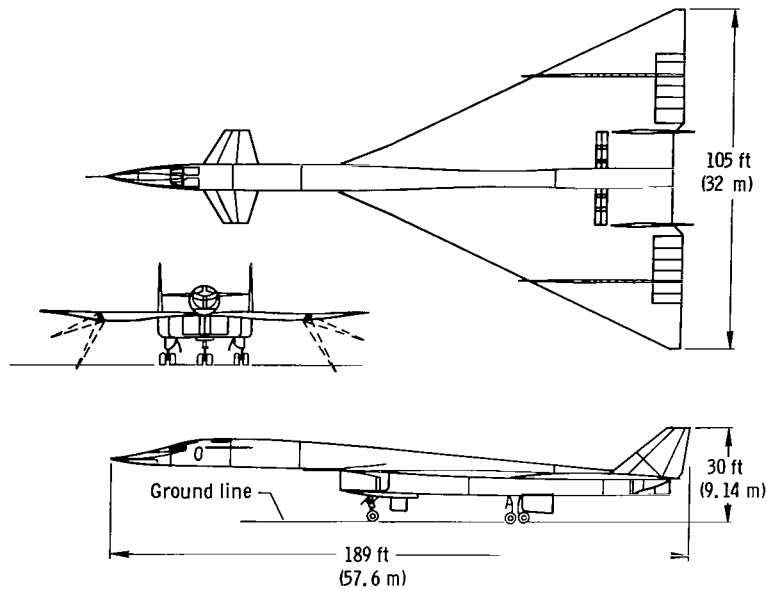
Figure 1.— Three views of the XB-70-1 airplane.

The XB-70 (fig. 1) is a two-place, high-altitude, supersonic airplane designed to fly at Mach 3 at altitudes above 70,000 feet (21,336 meters). It is characterized by a long forward fuselage with a canard surface equipped with flaps mounted aft of the crew compartment, a thin delta wing, twin movable vertical stabilizers, and dual two-dimensional, mixed-compression inlet ducts in the lower fuselage. Power is supplied by six General Electric YJ93-GE-3 afterburning turbojet engines, each in the 30,000-pound- (133,446-newton-) thrust class. Additional information on the airplane, including a table of physical characteristics, is presented in reference 3.

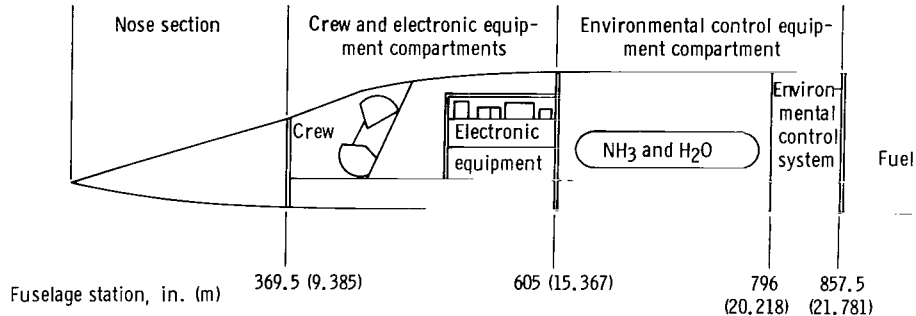
Figure 2.— Arrangement of XB-70 forward-fuselage compartment.

The forward fuselage (fig. 2) contains the nose section, the crew and electronic equipment compartments, and the environmental control equipment compartment. These areas are constructed of riveted titanium frames and skin with longerons of H-11 steel.

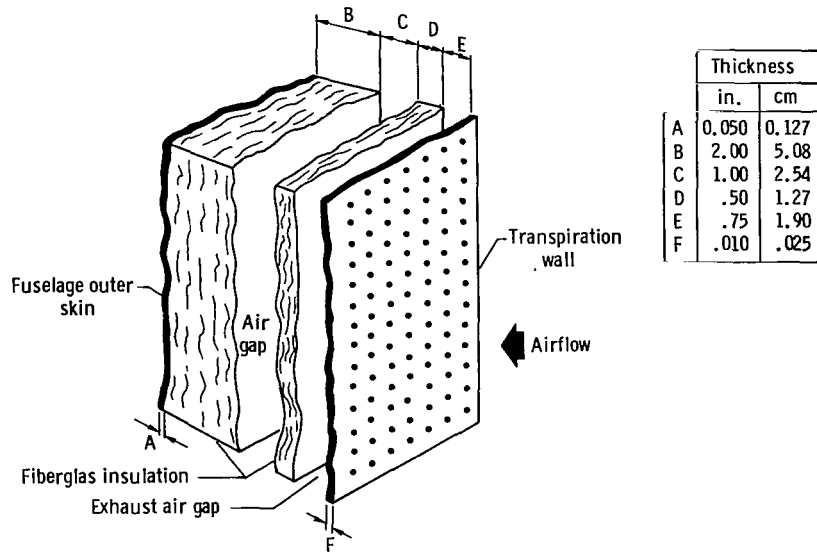
Figure 3.— Cross section of XB-70 crew-compartment transpiration wall.

The crew and electronic equipment compartments are environmentally controlled by means of a common air-recirculation system that provides air conditioning, ventilation, and pressurization, as described in reference 4. The recirculation air is cooled primarily by a Freon 11 vapor-cycle refrigeration system, supplemented by a ram-air-to-water heat exchanger and an emergency refrigerant heat exchanger. Engine extraction air is used for ventilation, pressurization, and heating. Cabin pressurization is normally controlled to an 8000-foot- (2438-meter-) altitude pressure level. The copilot can select a supply-air temperature between 42° F (5.6° C) and 105° F (40.6° C). Air that has been circulated through the cabin is exhausted into the return-air duct through a transpiration wall (fig. 3). Thin, perforated metal sheets are used to form the inner surface of the cabin walls. These sheets are separated from the airplane skin by two layers of aluminum-foil-covered insulative batts made of silicone-bonded

Fiberglas. In addition, there are two air spaces, one between the two layers of insulation and the other between the inner insulation layer and the perforated metal sheet. Cabin air flows through the perforations and along the inner air space to return-air manifolds. The transpiration wall and insulation provide thermal and acoustical protection for the crew and electronic equipment compartments. The nose section and the environmental control equipment compartment are not insulated or environmentally controlled.

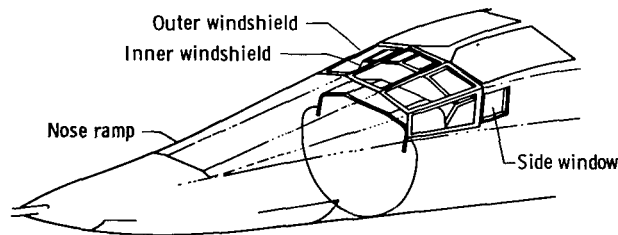
(a) Windshield arrangement.

Figure 4.— XB-70 windshield arrangement and variable nose-ramp positions.

The XB-70 has dual windshields (fig. 4(a)). The inner windshield forms the pressure bulkhead. The outer windshield and nose ramp are movable. With the nose ramp down as shown in figure 4(b), the crew has minimum acceptable visibility throughout the flight envelope. The nose-ramp-up position shown in figure 4(c) provides aerodynamic fairing to minimize drag and heating at high speeds and virtually eliminates forward

visibility. The space between the inner and the outer windshields is vented to the atmosphere. The outer windshield is composed of five tempered soda-lime glass panels, 3/8-inch (0.010-meter) thick and approximately 4 feet (1.22 meters) long. The five inner-windshield panels are laminated, with each panel consisting of a 1/8-inch- (0.003-meter-) thick silicone (type K) interlayer between two panels of 5/16-inch- (0.008-meter-) thick tempered soda-lime glass. There are two side windows, each composed of two 3/8-inch- (0.010-meter-) thick monolithic glass panels separated by a dead-air gap.

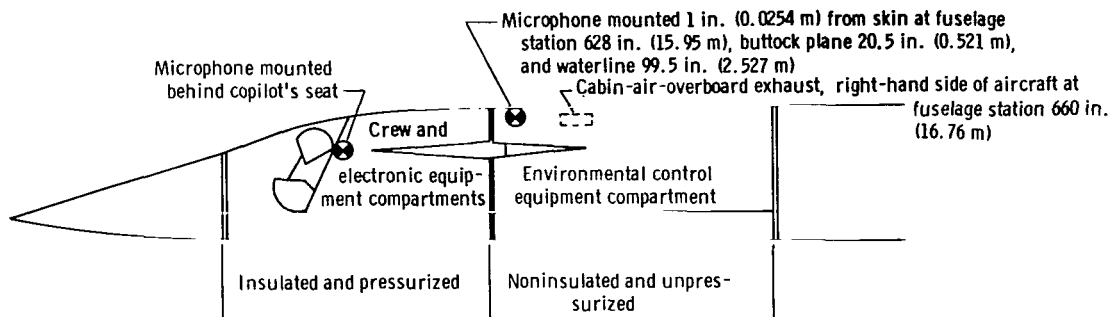
Figure 5.— Location of internal-noise microphones on XB-70-1.

Internal-noise microphones were installed in both XB-70 airplanes. Most of the data in this report were obtained from the XB-70-1, which had one Altec 21RB-150 microphone behind the copilot's seat in the cockpit and one Photocon M504 microphone in the environmental equipment compartment (fig. 5). The latter microphone was installed initially to investigate panel flutter and was, therefore, mounted very close to the outside skin. It was mounted within 1 inch (0.0254 meter) of a 0.050-inch- (0.00127-meter-) thick panel of 6AL4V titanium. The panel was nearly flat and measured about 9.25 inches (0.235 meter) by 46 inches (1.228 meters). The data from both microphones were recorded directly on a Parsons ATR 940 tape recorder at a tape speed of 7.5 inches per second (0.1905 meter/second).

On the XB-70-2 an Altec 21BR-150 type of microphone was mounted behind the copilot's seat, as in the XB-70-1. The data were recorded on an Ampex CP-100 tape recorder at a tape speed of 30 inches per second (0.7620 meter/second).

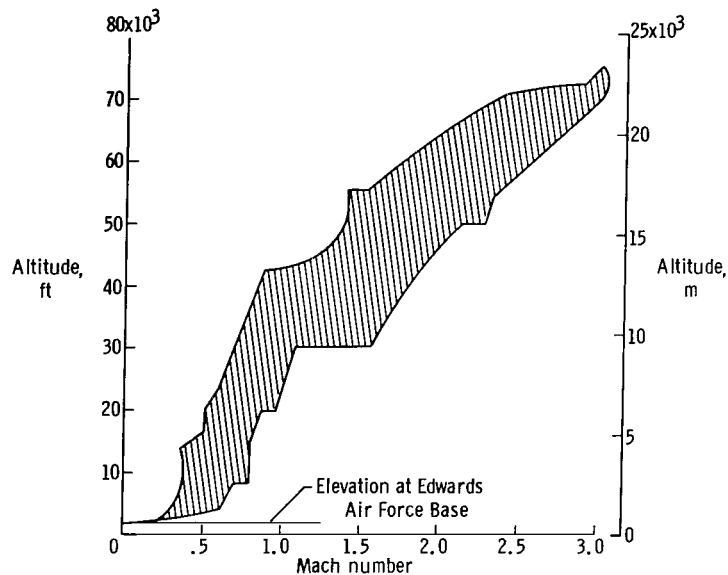
Figure 6.— Flight envelope covered during the airworthiness testing of the XB-70 airplanes.

The flight envelope covered during the airworthiness evaluation is shown in figure 6. The longest continuous time at Mach 3 was 32 minutes, accomplished with the XB-70-2 airplane.

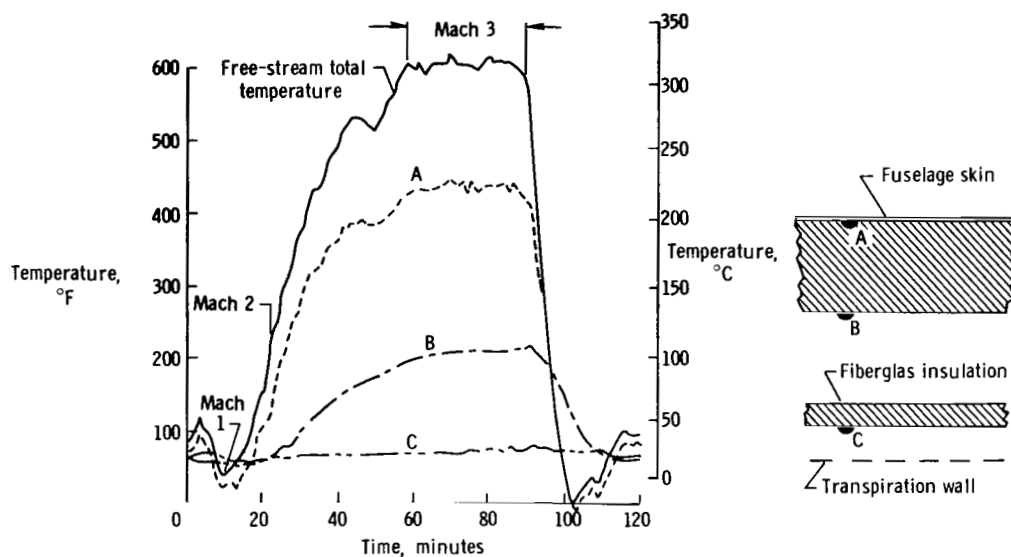
Figure 7.— Time histories of temperature at XB-70 crew-compartment wall for a flight with 32 minutes of Mach 3 cruise.

Cockpit wall.— Several areas of the cockpit transpiration wall were instrumented to evaluate heat transfer through the wall with and without "heat shorts" through structural frames. Time histories of three temperature measurements made on the left side of the fuselage about 5 feet (1.5 meters) aft of the pilot's seat are presented in figure 7 for a flight that achieved 32 minutes of sustained Mach 3 flight. A time history of free-stream total temperature is included for reference. The effectiveness of the transpiration-wall cooling system can be seen from the relative insensitivity of the inner temperature to variations in total temperature.

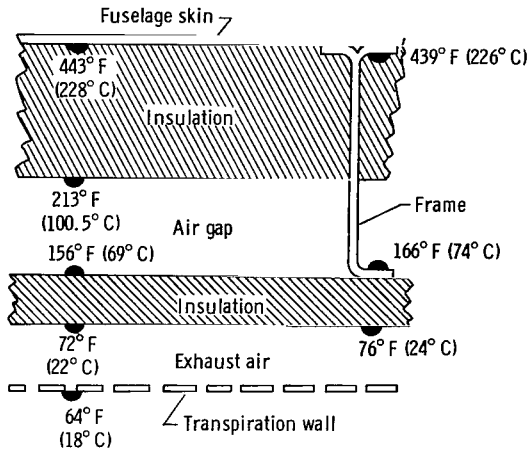
Figure 8.— Temperature at XB-70 crew compartment wall after 28 minutes of Mach 3 flight.

Figure 8 shows the temperature distribution through the same wall segment after 28 of the 32 minutes of flight at Mach 3. The instrumented cross section contained areas with and without structural frames. The outer thermocouples were inside the outer skin, and, hence, the temperatures they measured were somewhat lower than the actual skin temperature. Note that direct heat conduction through the metallic frame resulted in only a 10° F (5.6° C) higher temperature at the outer surface of the inner insulation than at the location at which there was no frame. The inner insulation further reduced that temperature difference to only 4° F (2.2° C); that is, 76° F (24° C) as compared to 72° F (22° C).

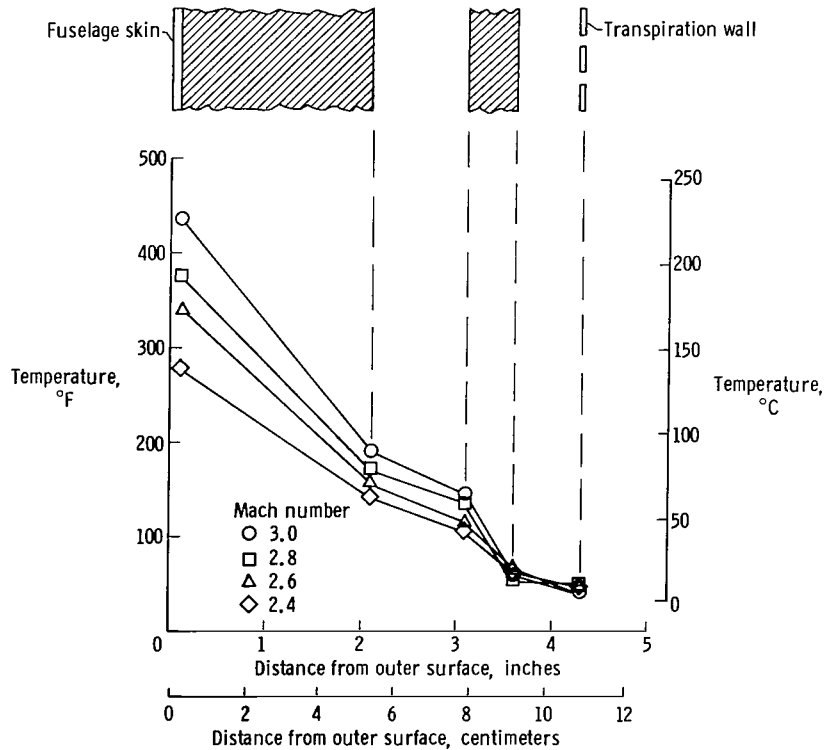
Figure 9.— Temperature gradients through XB-70 crew-compartment wall after 20 minutes of cruise at various Mach numbers.

Temperature gradients through the cockpit wall at various Mach numbers are shown in figure 9. For each test the Mach number was held constant for approximately 20 minutes. The gradients are proportional to the conduction heat-transfer rates through the material. Higher Mach numbers with correspondingly higher skin temperatures produced higher heat rates through the outer insulation layer. The heat-transfer rates through both air gaps appear to be essentially constant and independent of Mach

number. The inner temperatures are almost constant and appear to be dictated by the environmental control system rather than the external temperatures. The overall operating temperatures were considered to be within the acceptable crew comfort tolerances.

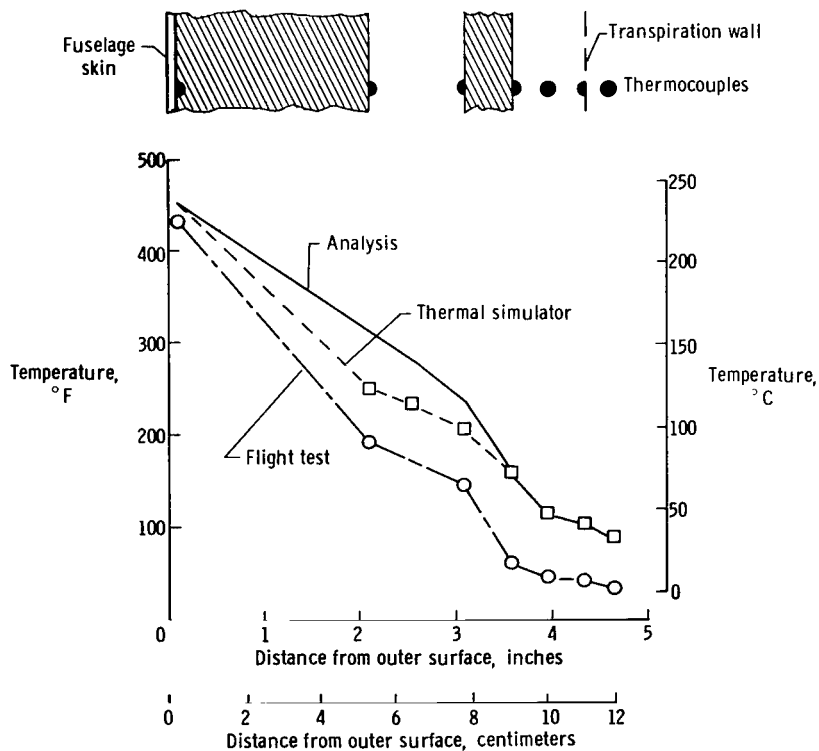
Figure 10. - Comparison of analysis, thermal simulator, and flight-test data for the temperature gradient through the XB-70 crew-compartment wall during Mach 3 cruise.

During the XB-70 design, the cockpit-wall temperatures were predicted on the basis of a passive network analog analysis (ref. 1). To confirm the design concept and check out the environmental control system, a thermal simulator was built and tested in an environmental chamber. The simulator was a full-scale mockup of the forward fuselage. Figure 10 compares the temperature gradients across a typical section of the cockpit wall for the analytical model, the thermal simulator, and the actual airplane. As indicated in reference 5, the primary reason for the disagreement between the analytical and thermal-simulator temperatures was air leakage in the air gap between insulation layers. Airflow through the "dead air gap" resulted in higher than estimated convective heat-transfer coefficients between the insulation layers. The flight-test data show even further disagreement. The outer-skin temperatures were lower because the airplane flew at higher altitudes than had been used in the design calculation. Also, the exterior paint was changed to a type with better radiation characteristics, which produced lower surface temperatures. Apparently, the airplane had more air-gap leakage than the simulator (ref. 5), with resultant lower internal temperatures. The air movement in the gap produced favorable temperature conditions, but only at the expense of environmental control system efficiency.

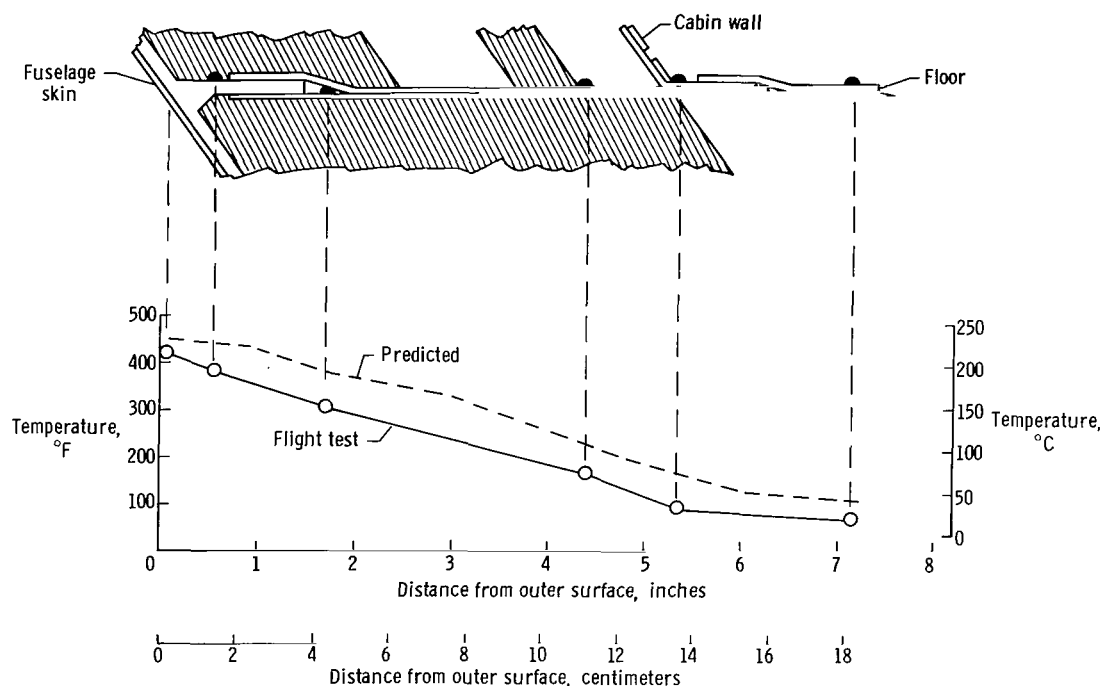
Figure 11.— Temperatures of crew-compartment floor predicted and measured on the XB-70 for Mach 3.

Cockpit floor.— To measure the heat transfer in the region of the cockpit floor, thermocouples were installed at various locations on the structure between the outer skin and the internal cabin wall. Figure 11 shows that after 32 minutes at Mach 3, the floor temperatures were lower than those predicted for the design mission. It is believed that the skin temperature was lower than predicted because the flight reached a higher altitude than that used in the design analysis. The inner-wall temperatures were lower than estimated because the flight-measured skin temperature was lower than that used for design estimates. Furthermore, the actual mission had less time at Mach 3 than the design mission, and the cockpit temperature was held at a much lower value than that used for prediction.

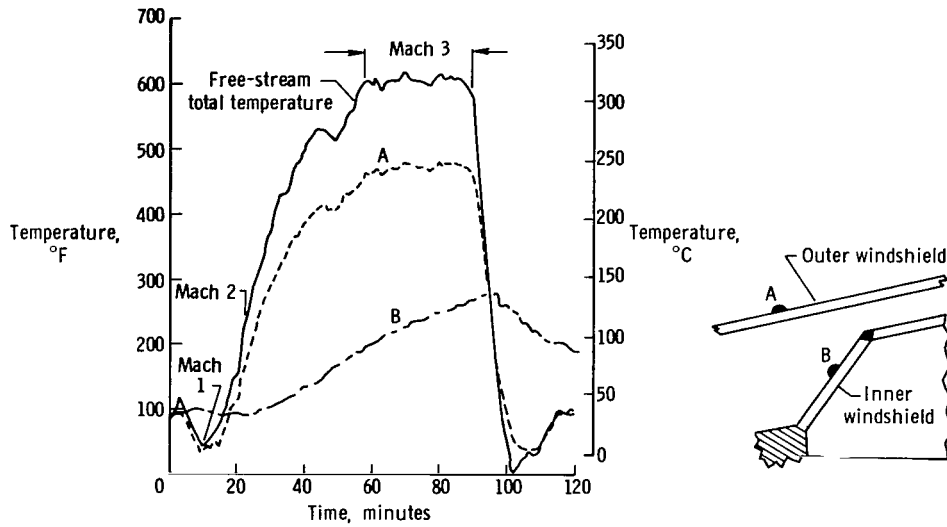
Figure 12.— Time histories of temperature on XB-70 windshields for a flight with 32 minutes of Mach 3 cruise.

Windshields.— Thermocouples were cemented to the outer and inner surfaces of the inner and outer windshields and imbedded in the silicone interlayer of the inner windshield to measure temperature levels and gradients. Figure 12 shows the temperature time histories of the outer surfaces of the inner and outer windshields for a flight with 32 minutes of Mach 3 cruise. Total temperature is plotted for reference. The surface temperature of the outer windshield responded rapidly to changes in total temperature, as would be expected. The surface temperature of the inner windshield was much less responsive, particularly at the lower temperatures. The fact that the inner-surface temperature dropped off soon after the outer-surface temperature decreased indicates that the primary source of heat transfer between the surfaces is radiation. Convective heat transfer would produce a greater lag.

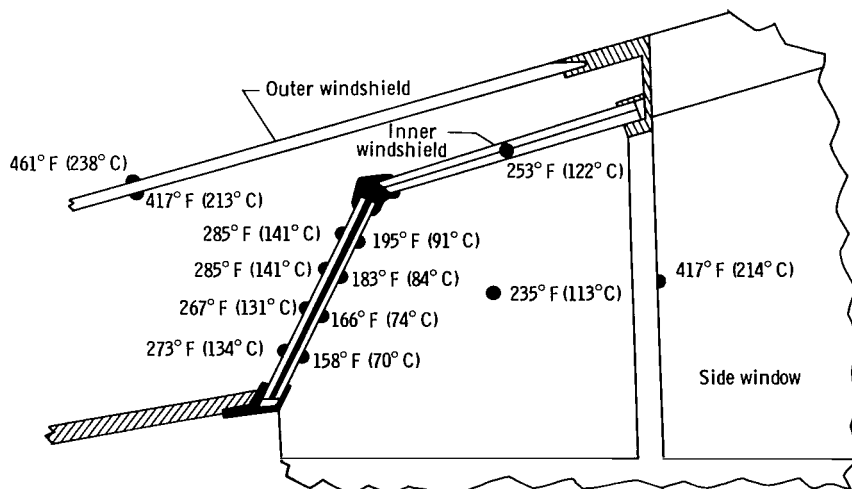
Figure 13.— Temperatures measured on the inner and outer windshields and the side window of the XB-70 after 32 minutes of cruise at Mach 3 with the nose ramp up.

Figure 13 shows the location of 13 of the thermocouples and the temperatures measured after 32 minutes of cruise at Mach 3 with the nose ramp up. The temperature of the outer surface of the outer windshield, 461° F (238° C), may be higher than expected because of the surface irregularity caused by the presence of the thermocouple itself. The temperature gradient from top to bottom of the inner windshield was caused primarily by the cooling air blown over the inner surface. The magnitudes of the inner-surface temperatures were strongly influenced by the cooling airflow rate selected by the crew. High flow rates produced lower temperatures but simultaneously

caused undesirable effects such as disturbing crew flight cards and procedures books. On all high-speed XB-70 flights the crew wore pressure suits and helmets with faceplates. The suit and helmet environment made the crew essentially unaware of any adverse thermal effects from the windshield. On the few occasions that the crew raised their faceplates during high Mach number flights, they reported noticeable thermal radiation from the windshield and termed it objectionable. The side-panel temperature of 235° F (113° C) was measured at the silicone interlayer of the inner windshield. The aft side-window panel temperature of 417° F (214° C) was measured on the outer surface.

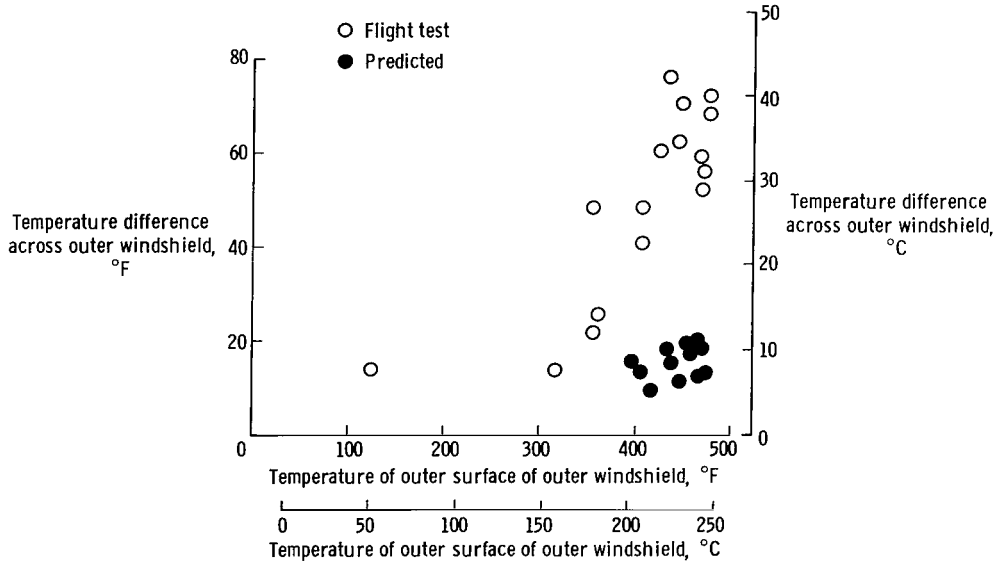
Figure 14.— Measured and predicted temperature differences across the outer windshield of the XB-70 as a function of the temperature of the outer surface of the outer windshield.

The only predicted data related to windshield temperatures that are applicable to the flight-test results are estimates of the temperature difference across the outer windshield. Figure 14 presents the temperature differences as a function of the outer-surface temperature for flight measurements and predictions from reference 1. The scatter in the prediction data is due to the use of different inside film coefficients and calculations with and without solar radiation. As shown, the measured temperature differences were much larger than predicted. Three possible explanations for this discrepancy are suggested in reference 5, as follows:

1. The local unevenness of the surface due to the presence of the thermocouple led to temperatures higher than true outer-surface temperatures.
2. The convective coefficients used in the analysis for the space between the two windshields were too low.
3. The windshield never reached steady-state conditions in flight test.

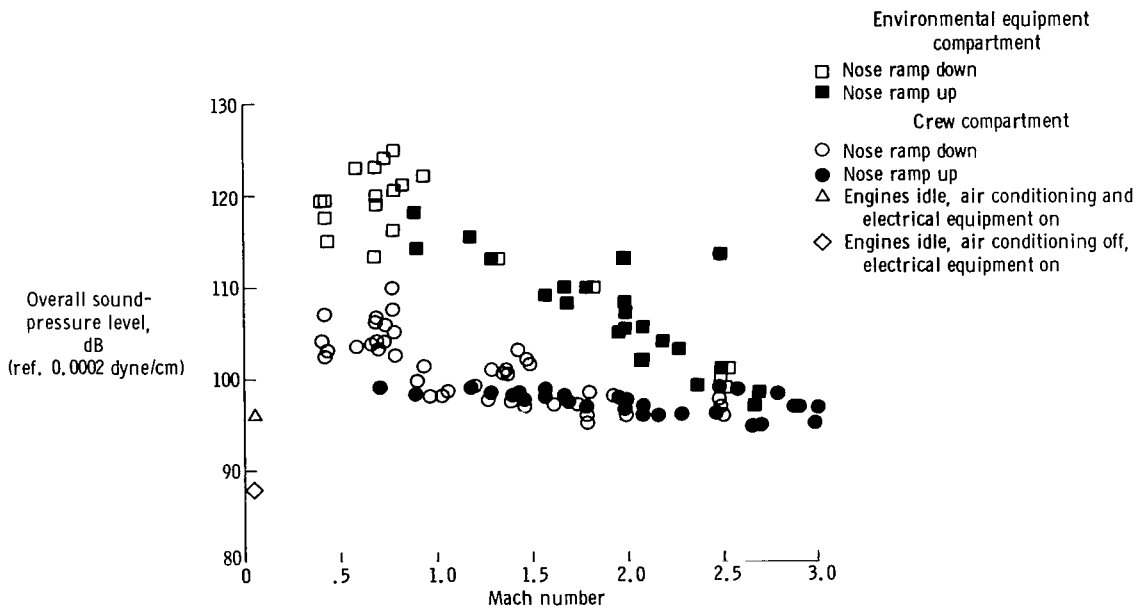
Figure 15.— Noise level of XB-70 crew and environmental equipment compartment as a function of Mach number.

Figure 15 is a plot of the overall sound-pressure-level measurements made on the XB-70-1 and the XB-70-2 under stabilized flight conditions. The sound-pressure level is plotted against Mach number to illustrate the trend of lower noise levels with

increasing Mach number. In general, the airplanes were at Mach 1 at about 32,000 feet (9754 meters) altitude, Mach 2 at 45,000 feet (13,716 meters) to 60,000 feet (18,288 meters) altitude, and Mach 3 at 70,000 feet (21,336 meters) altitude or above.

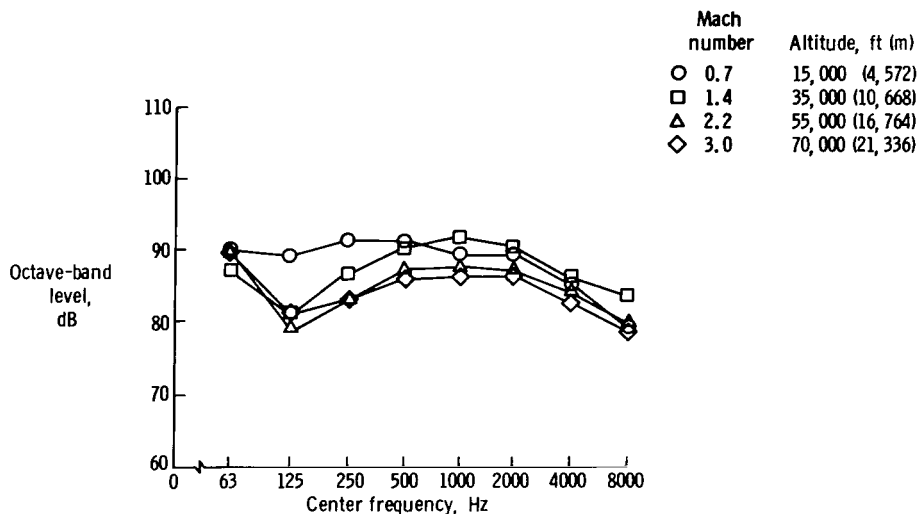
Figure 16.— XB-70 crew-compartment noise octave-band variations with Mach number for the nose-ramp-up configuration.

Octave-band plots of the cockpit noise for various Mach numbers are presented in figure 16 for the nose-ramp-up configuration. There was more low-frequency content in the noise spectrum at subsonic speeds than at supersonic speeds. This may be associated with the airframe vibration or buffet mentioned previously. Supersonically, the octave-band plots show similar trends, with a generally lower level at higher Mach numbers.

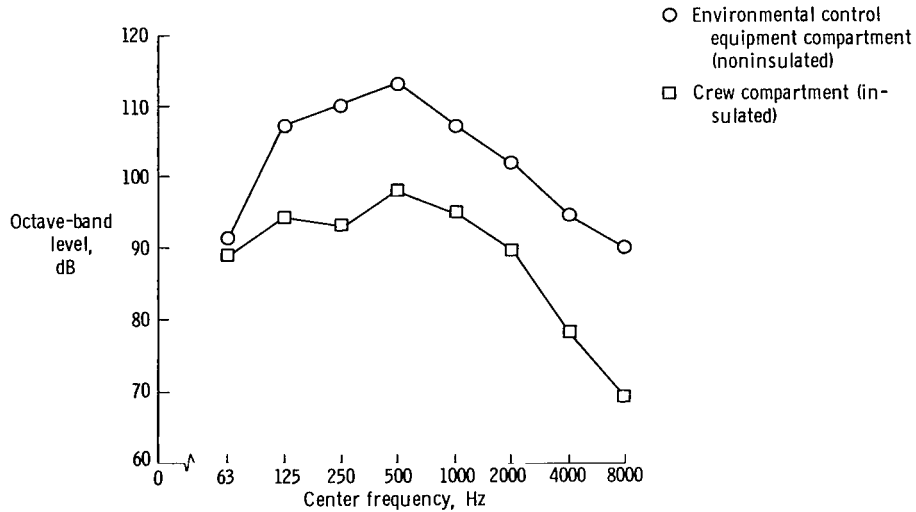
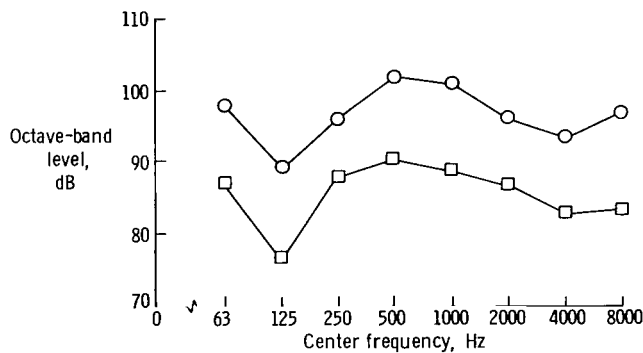
(a) Mach 0.8; altitude, 25,100 feet (7650 meters).

(b) Mach 1.8; altitude, 45,200 feet (13,777 meters).

Figure 17.— Octave-band characteristics of the noise in the XB-70 crew and environmental control equipment compartments with the nose ramp up at one subsonic and one supersonic flight condition.

Figure 17 compares the octave-band characteristics of the noise in the insulated cockpit with that in the noninsulated environmental equipment compartment. Both subsonically and supersonically the two areas had similar spectral characteristics, with the cockpit 10 decibels to 20 decibels quieter. At Mach 2.5 and above, the difference in levels between the two areas became very small, as noted earlier.

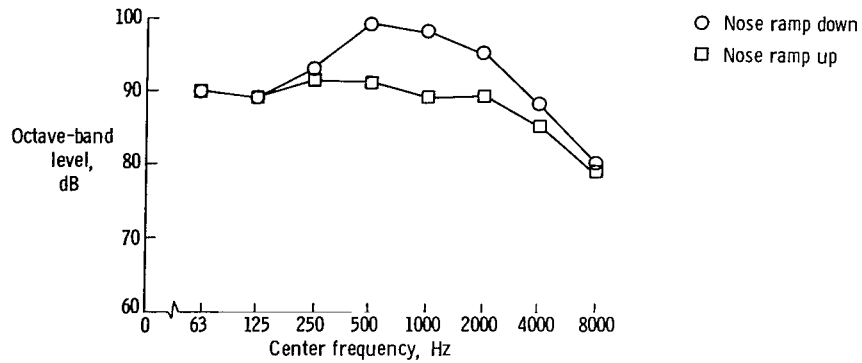
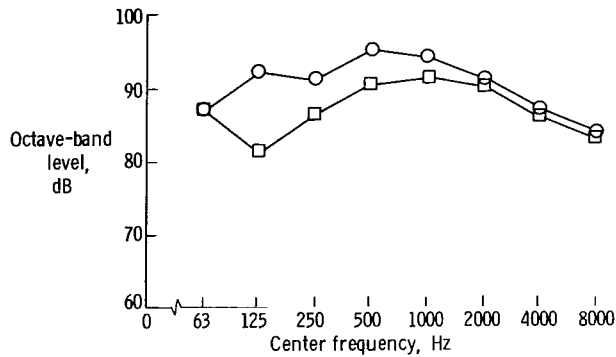
(a) Mach 0.7; altitude, 15,000 feet (4572 meters).

(b) Mach 1.4; altitude 35,000 feet (10,668 meters).

Figure 18.— Octave-band characteristics of the noise in the XB-70 crew compartment for the nose-ramp-up and nose-ramp-down configurations at one subsonic and one supersonic flight condition.

The influence of the nose-ramp position on the frequency content of the noise in the cockpit is illustrated in figure 18 for one subsonic and one supersonic flight condition. Raising the nose ramp reduced the high-frequency noise at subsonic speeds and reduced the low-frequency noise at supersonic speeds.

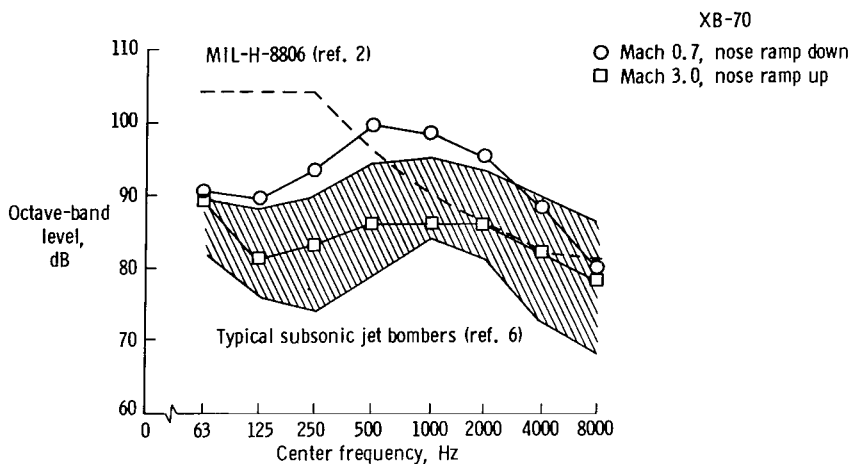
Figure 19.— Comparison of XB-70 crew-compartment noise octave-band characteristics with data for typical subsonic jet bombers and Military Specification MIL-H-8806.

Figure 19 shows that at the Mach 3 cruise condition with the nose ramp up, the XB-70 cockpit noise levels fell well within the band of data presented in reference 6 for

typical subsonic jet bombers. Also in this speed range, the noise levels appear to be within the requirements of reference 2 (MIL-H-8806), which governs the acceptable noise levels in the cockpit of military aircraft. The noise levels in the cockpit during cruise at Mach 0.7 with the nose ramp down exceeded this Military Specification by as much as 10 decibels at frequencies above 400 hertz and exceeded the sound levels measured on subsonic bombers in the frequency range to 3000 hertz. XB-70 crew members commented that the cockpit noise level did not differ appreciably from that of other large military turbojet aircraft they had flown.

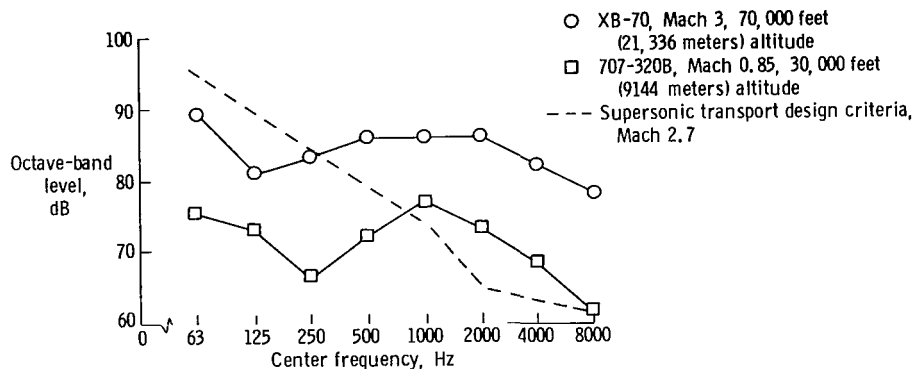
Figure 20.— Comparison of XB-70 crew-compartment noise octave-band characteristics at Mach 3 cruise with data for 707-320B airplane at typical cruise condition and with the proposed FAA supersonic transport cruise standard.

Figure 20 presents a comparison of the cockpit noise spectrum for the XB-70 cruising at Mach 3 at 70,000 feet (21,336 meters) altitude with the noise spectrum measured in a Boeing 707-320B cockpit at Mach 0.85 and 30,000 feet (9144 meters) altitude. Like most other military aircraft, the XB-70 exceeded the commercial-aircraft cockpit noise level by at least 10 decibels. Both the XB-70 and the 707 airplane exceeded the supersonic transport internal-noise-level design criteria in the frequency ranges above 300 hertz and 800 hertz, respectively.

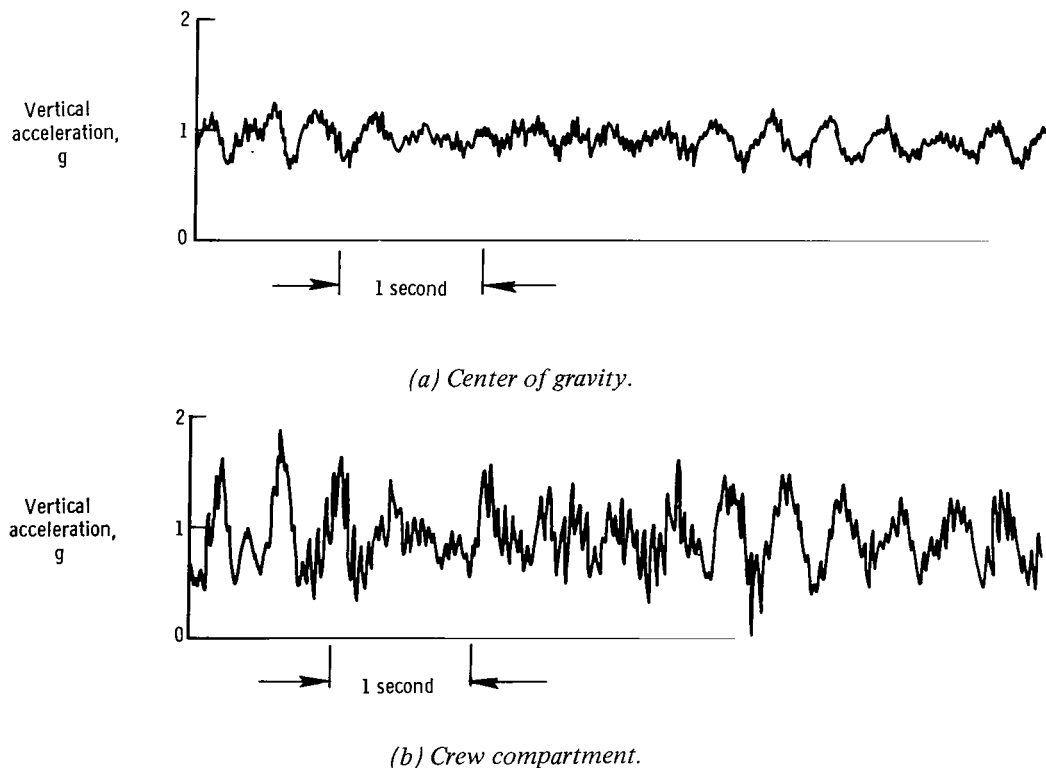
Figure 21.— Typical time history of vertical accelerations at XB-70 center of gravity and crew compartment during the takeoff roll.

The crew-compartment acceleration or vibration environment was usually more severe during the takeoff roll than at any other time in the flight. Typical traces of the crew-compartment and center-of-gravity normal accelerations are presented in figure 21. The greater response of the crew compartment to takeoff vibration is

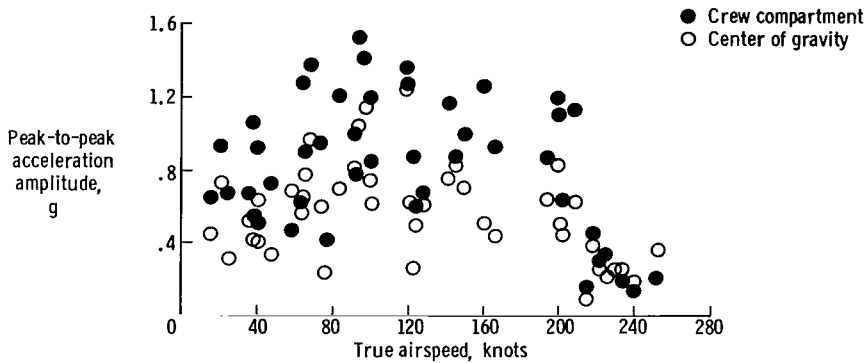
Figure 22. — Acceleration amplitudes of XB-70 crew compartment measured as a function of true airspeed during five typical takeoff rolls.

apparent. This is further emphasized in figure 22, a composite of data from five takeoffs, which shows the peak-to-peak acceleration amplitude experienced during the takeoff roll as a function of airspeed. Both crew-compartment acceleration and center-of-gravity data are presented. On the average, the crew-compartment acceleration was 0.32g greater peak-to-peak than the center-of-gravity acceleration. The maximum acceleration appears to be at 100 knots, possibly because of a structural dynamic characteristic of the airplane or the existence of a rough area on the runway which the airplane coincidentally crossed at about 100 knots. At lift-off, usually between 200 knots and 220 knots, the acceleration reduced to about  $\pm 0.1g$  (0.2g peak to peak).

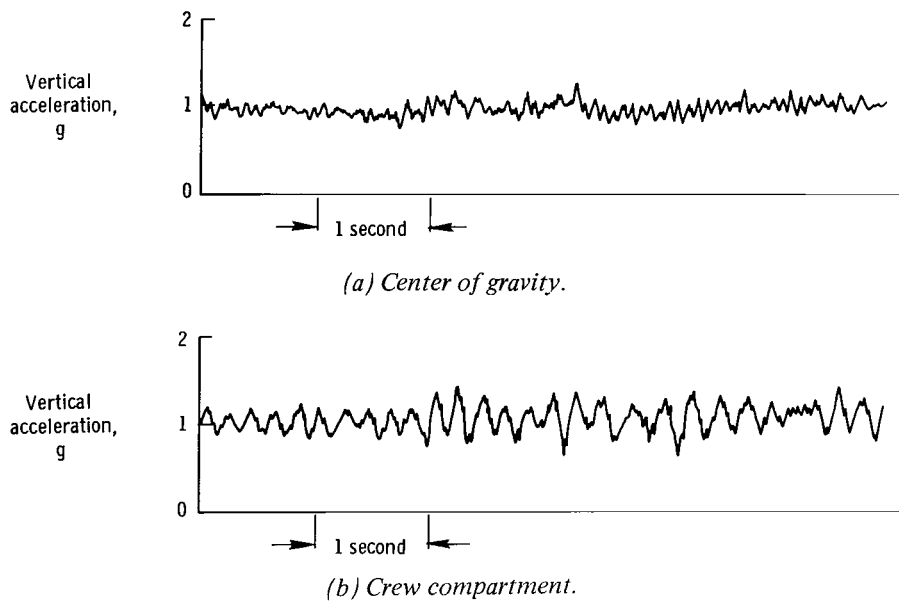
Figure 24.— Typical time history of vertical acceleration at XB-70 center of gravity and crew compartment during heavy turbulence. Mach 2.4; altitude, 55,000 feet (16,764 meters).

Reference 7 gives an account of the XB-70 encounters with turbulence during an accumulated 75,757 miles (121,919 kilometers) of flight above 40,000 feet (12,192 meters) altitude. Figure 24 presents time-history traces of the center-of-gravity and crew-compartment vertical accelerations during a portion of a turbulence encounter at Mach 2.4 and 55,000 feet (16,764 meters) altitude. The crew rated the turbulence as heavy.
