NASA TN D-4920

RADIOFREQUENCY TRANSMISSION
CHARACTERISTICS OF CANDIDATE
ABLATION MATERIALS FOR
PLANETARY-ENTRY-VEHICLE HEAT SHIELDS

*by Melvin C. Gilreath, Andrew J. Chapman,
and Douglas M. Hatcher*

*Langley Research Center
Langley Station, Hampton, Va.*

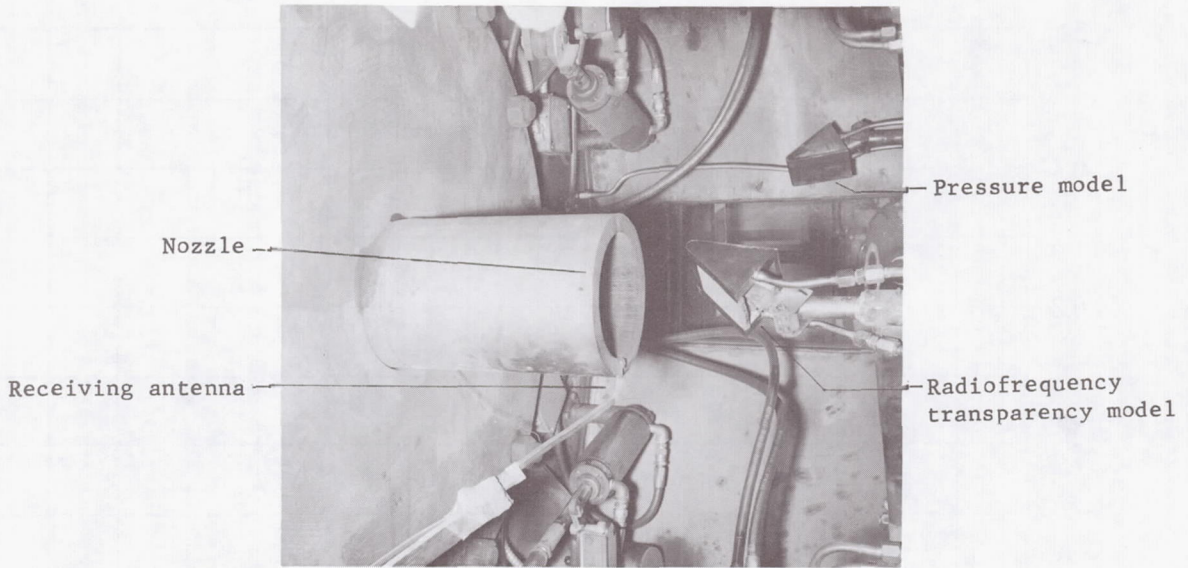
L-68-8516

(a) View looking upstream.

(b) View looking downstream.

Figure 4.- Photographs of 0.65-radian wedge model installed in tunnel.

Figure 4 shows the three models mounted in the tunnel in preparation for testing. Each model is mounted on a strut which moves radially to position the model into or out of the stream. The upper photograph of figure 4 shows the radiofrequency transparency model in position for testing. The horn antenna, which receives the signal transmitted through the ablator during tunnel operation, is aligned with the transmitting antenna behind the ablative panel. The lower photograph of figure 4 shows the radiofrequency transparency test model in the test position and the two calibration models in the stowed position.

The radiofrequency-transmission measurements in the arc tunnel were made by using the following procedure. With the model located in the test position, as shown in figures 4 and 9, and with the transmitting source operating, the recorder was adjusted to the desired calibration level before arc ignition. This calibration level does not include any transmission loss through the virgin material and is used only as a reference for determining the transmission loss during and after thermal degradation of the test specimen. After the desired calibration level was obtained, the arc-heater magnetic field was turned on without arc ignition to determine what effect this field would have on the received signal level. The only observed magnetic-field effects were small changes in the received-signal amplitude. After the calibration level and field effects were recorded, the test model was removed from the test position. The arc was ignited and the proper adjustments were made to provide the conditions indicated in table I. The calorimeter and pressure models were then inserted to measure the stream conditions. Upon completion of the stream measurements, the model was inserted and the thermal test began. The time for all low heat-transfer tests was 60 seconds except for one test of 49 seconds. The time for the high heat-transfer tests was 30 seconds for all specimens.

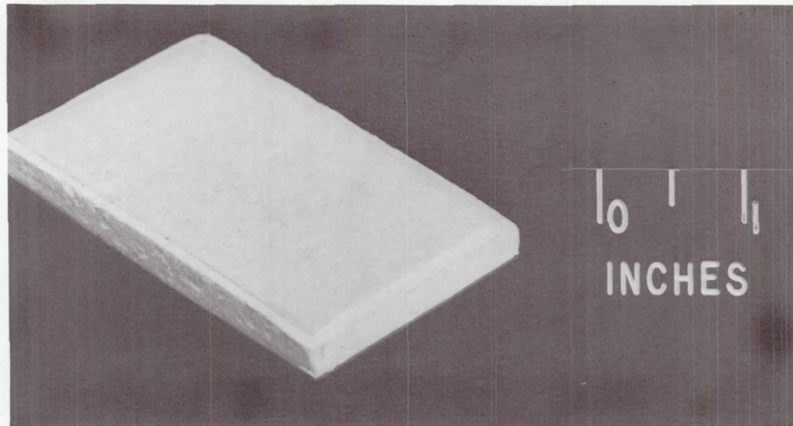
L-68-8519

(a) Avco foamed teflon.

Figure 12.- Photographs of test specimens before and after exposure to low-heat-transfer ($\alpha = 0$ rad) test condition in arc tunnel.

Photographs of all test specimens before and after arc-tunnel testing are presented in figures 12 and 13. Photographs of the low-heat-transfer test specimens are given in figure 12 and those for the high-heat-transfer test condition in figure 13. The top photograph of each figure shows the test material in its virgin condition and the remaining photographs are those of the different specimens after exposure to the arc-tunnel test. For example, figure 12(a) consists of three photographs. The top photograph is that of the virgin material, the middle photograph shows test specimen 1 after thermal exposure, and the bottom photograph shows test specimen 2 after thermal exposure. Some figures, such as figures 13(e) and 13(h), only have two photographs since only one specimen was measured for that particular test.
