Effect of NUCLEAR RADIATION on Materials at CRYOGENIC TEMPERATURES

**QUARTERLY
PROGRESS
REPORT
No. 15**

July 1964 through September 1964

**National Aeronautics/Space Administration
Contract NASw-114**

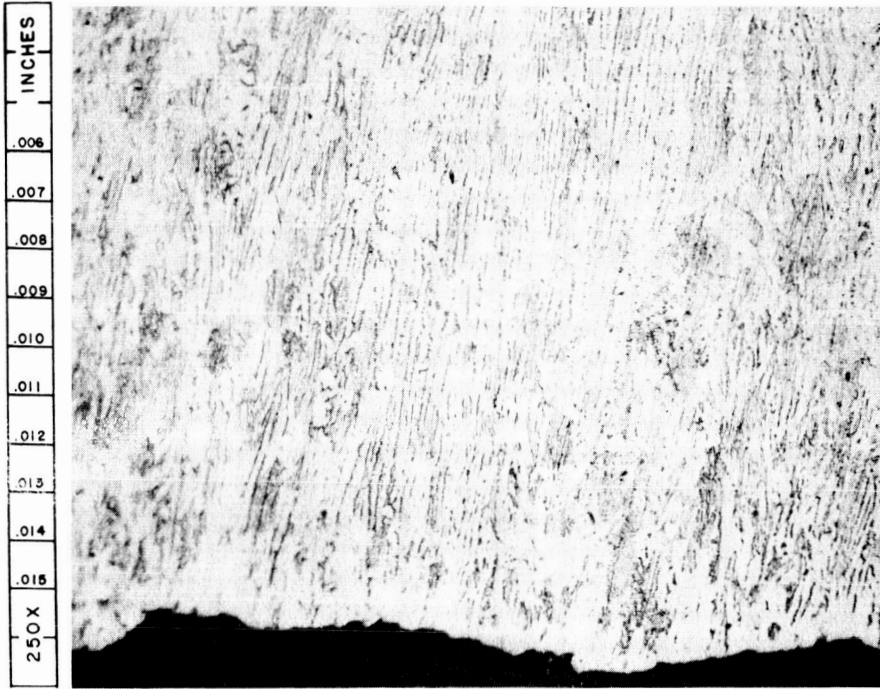
FIGURE 4 NECKED DOWN REGION OF TITANIUM
5% AL, 2.5% SN, STANDARD INTER-
STITIAL CONTENT, AFTER IRRADIATION
TO 1×10^{17} NVT AND FRACTURE AT
30° R, 250X

These photographs show that the break is more transgranular in the irradiated material, corresponding again to the large decrease in reduction in area. Close examination of the specimen shows there is also some apparent difference in the grain structure in the necked down region which does not appear in the photograph and it cannot be described as due to specific causes.

The same material, but with extra low interstitial content, showed some sizable differences in tensile properties due to irradiation with a larger effect on the elongation and less effect on the fracture stress than in the case of the standard interstitial content.

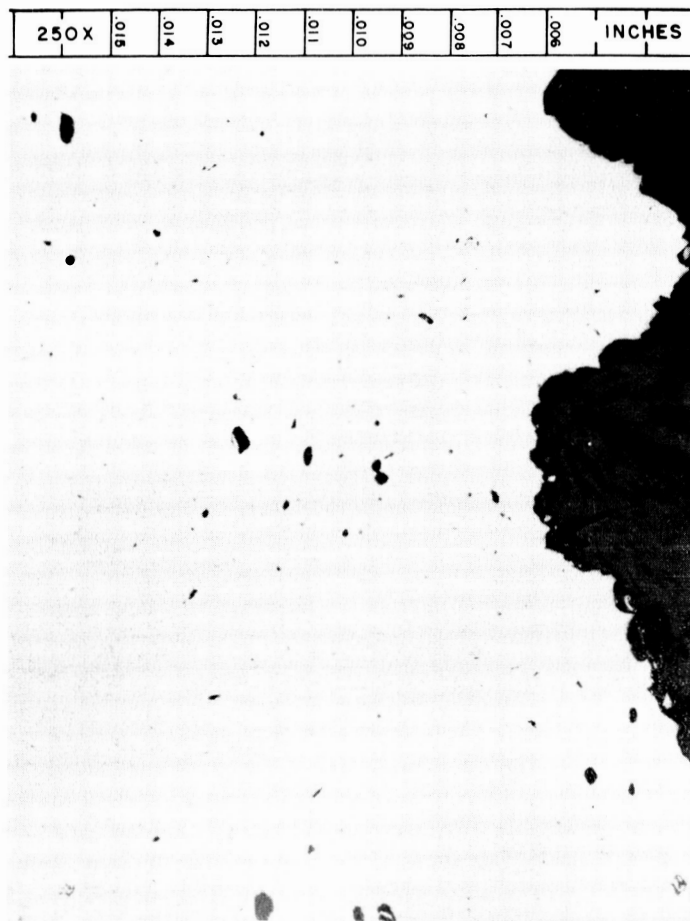
Figure 5 shows the necked down region of Titanium 5% Al, 2.5% Sn with extra low interstitials after irradiation and fracture at 30° R.

There is a large effect due to irradiation, appearing here that does not appear in the material with standard interstitial content. The necked down region shows large voids but less deformation of crystallites than in the standard interstitial material similarly irradiated and fractured. There is no apparent difference in the fracture. The voids seem to correspond to intergranular cracking brought on by unusual hardening of the crystallites.

FIGURE 5 NECKED DOWN REGION OF TITANIUM 5% AL, 2.5% SN, EXTRA LOW INTERSTITIAL CONTENT, AFTER IRRADIATION TO 1×10^{17} NVT AND FRACTURE AT 30° R, 250X
