RESEARCH ARTICLE

Quantification of structural changes of UHMWPE components in total joint replacements

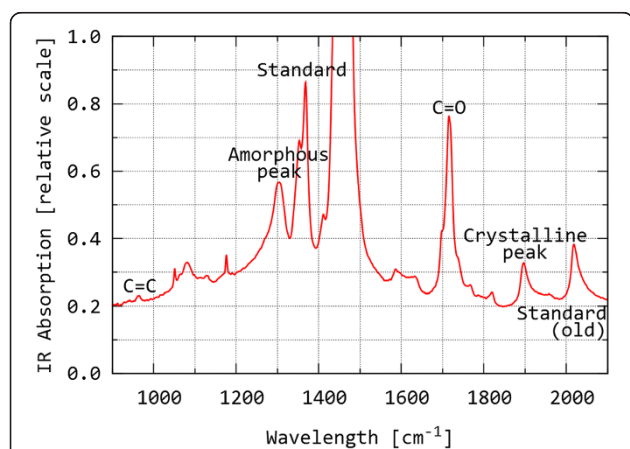
Figure 1 Part of IR spectrum from the 200 μm UHMWPE section with marked key peaks for calculation of the oxidation index (OI), trans-vinylene index (VI), and crystallinity index (CI).

of certain chemical groups within molecules of UHMWPE (see the orange marks in Figure 1). Using the area-under-peak ratios, it is possible to calculate: (i) the oxidation index (OI; ratio of the C=O band area at 1715 cm⁻¹ and the standard band at 1370 cm⁻¹), (ii) the trans-vinylene index (VI; ratio of the C=C band at 965 cm⁻¹ and the standard band at 1370 cm⁻¹) and (iii) crystallinity index (CI; ratio of the crystalline and amorphous bands at 1897 cm⁻¹ and 1303 cm⁻¹, respectively). The values of OI and CI are proportional to oxidation damage and weight fraction of the crystalline phase, while VI may be used to estimate the radiation dose used during UHMWPE modification and/or sterilization [10,11,18].

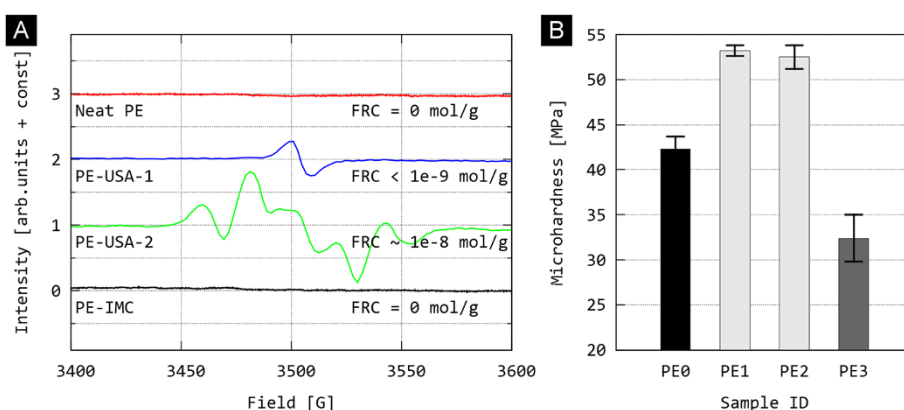
Figure 2 ESR spectra (A) and MH values (B) of new, unused UHMWPE components PE0-PE3 (see also Table 2).

from the surface inwards. It is worth noting that the rate of oxidative degradation strongly depends on the type of UHMWPE and may occur not only during its storage (shelf life), when the material is exposed to oxygen from air, but also during the period when the polymer component is in a human body (in vivo), when the material is exposed to body fluids containing dissolved oxygen and other oxidising compounds [23]. The following facts follow from the aforementioned data. It has been confirmed that virgin polyethylene (PE0), which has not been modified by radiation or sterilised and has been stored correctly, does not show any measurable oxidative damage (proportional to the OI value) and no cross-linking (proportional to the VI value) as well as no risk from the aspect of long term oxidative degradation (proportional to the FRC value). From the aspect of oxidative damage (OI), practically all modified materials (PE1, PE2, PE3) were of sufficient quality, although the best properties were found for the last sample (PE3). As far as for the aspect of cross-linking, which may be approximately estimated from the vinylene index (VI), we may roughly arrange the studied types according to the degree of cross-linking (which is presumed to be proportional to the resistance to wear) as follows: PE1 > PE3 > PE2 >>

PE0; it is worth noting that this is in perfect agreement with the data available from manufacturers, specified in the Experimental section. Concerning the aspect of free radical content, which represents a not-negligible risk of long-term in vivo oxidative degradation (i.e. the deterioration of mechanical properties after the implantation), the following series was obtained: PE0 = PE3 < PE1 < PE2.
