JACC April 1, 2014

POLYMER IODINATION FOR IMPROVED IN VITRO TRACKING OF BIODEGRADABLE STENT DEGRADATION: SERIAL MICROCT IMAGING FOR BIOREACTOR TESTING

Presentation Number: 1104-62

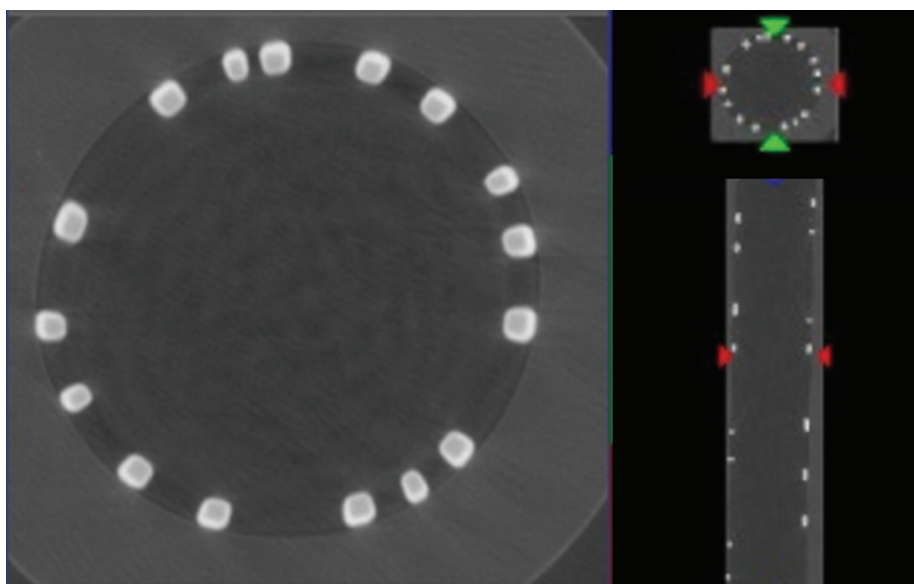
Results: X-ray attenuation of PLA was ~70% that of Mg. Iodinated PLA attenuation was ~130%, and was clearly visible against the background (see figure). Iodinated PLA on stents had even greater attenuation at 145% that of the Mg struts. Stent degradation was tracked with serial microCT imaging of polymer-coated stents.
