Case Report

Late perforation of Durata ICD lead – A case report

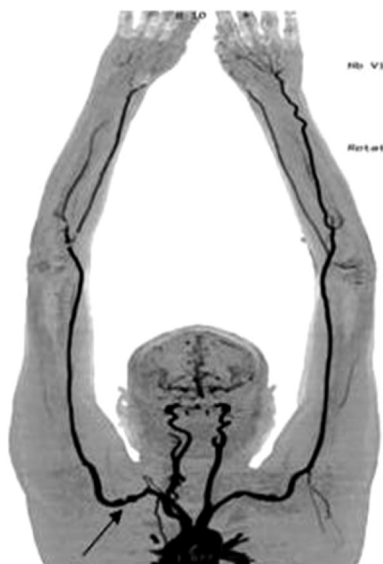
Fig. 1 – CT angiogram upper limb delineating outlet obstruction due to right cervical rib.

He underwent right cervical rib excision with right subclavian artery interposition graft. Post operative serial chest

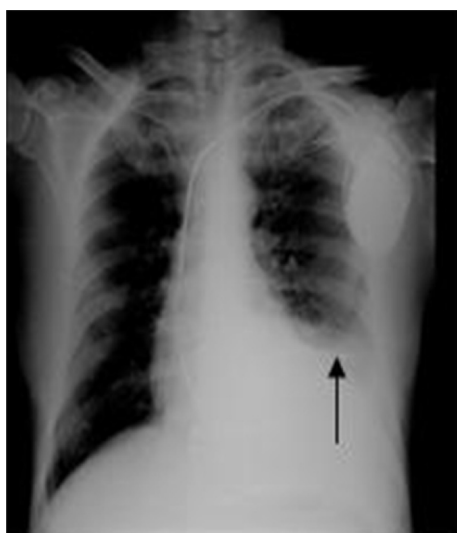
Fig. 2 – Pre op CXR—bilateral cervical rib, mild pleural effusion (Left).

In our patient, there was preoperative minimal left sided pleural effusion which increased post operatively. This favours that the perforation process must have started before the surgery. Pleural effusion may be caused by irritation of the pleura by the lead tip. So, the surgical procedure might not have any direct contribution to the complication. However our hypothesis is that use of anticoagulant preoperatively and subjecting the patient to different positions for investigation might have enhanced the process of perforation.

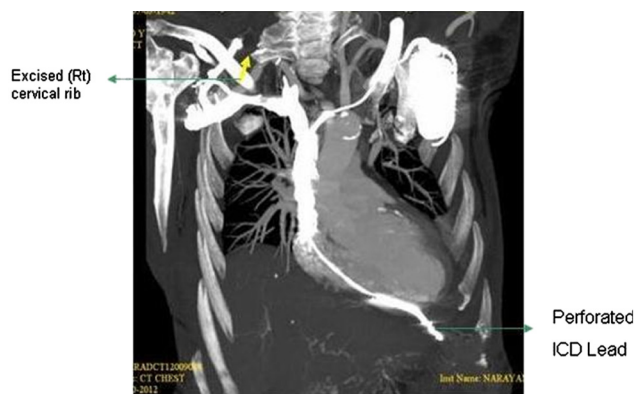
Fig. 3 – CT scan VR image, anterior oblique view confirming perforation of RV apex by ICD lead.

However pre-discharge ICD interrogation found loss of capture and intermittent sensing failure. Echocardiogram showed minimal pericardial effusion anterior to RV and endocardial lead in situ. Fluoroscopy image of ICD, when compared with implantation time showed displacement of lead tip. CT scan of the thorax (Fig. 3) showed perforation of ICD lead in to the pericardial space with small haematoma surrounding it and pleural effusion on left side. With surgical back up, repositioning of the ICD lead was done in hybrid lab by percutaneous transvenous approach with gentle traction

from the tract and screwing it to another site on the septum with acceptable parameters. There was no further increase in pericardial effusion or pleural effusion. He was discharged with these findings. His follow up visits showed gradual resolution of the pericardial and left pleural effusion and improvement in symptoms.
