“2014 ISSST”, 2014 International Symposium on Safety Science and Technology

## Study and prediction for the fire resistance of acid corroded intumescent coating

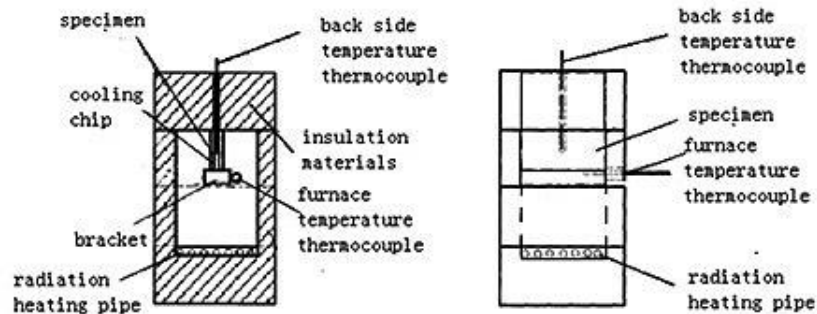
The fire resistance of the intumescent coatings of the acid treated samples was tested by a small-scale fireproof testing furnace [15]. Fig. 1 shows the sections of the furnace used. During testing, the uncoated sides of two specimens were attached at the lower end of the respective sides of a cooling chip, which was made of steel or heat-resistant alloy. Wire was used to combine the cooling chip and the two samples covering the sides of the cooling chip together. The cooling chip and the two samples were placed onto the bracket in the furnace vertically. One thermocouple was placed in the groove of the cooling chip to measure the back-side temperature of the specimens, and another thermocouple was placed in the furnace to monitor the temperature of the furnace. The time-temperature curve in the furnace is in accordance with the ISO 834 standard curve. The time when the back side temperature of the samples reaches 538 °C is defined as the fire-resistance time.

Fig. 1. Sections of the fire retardant coating testing furnace.

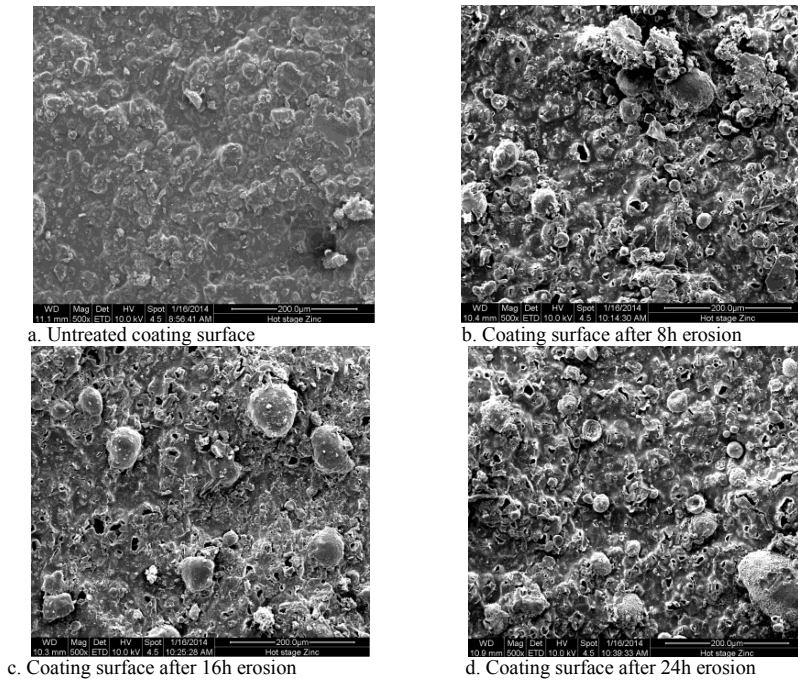
To investigate the changes of the surface morphology, the coating surface after different acid treatment times were observed using the SEM. Fig. 2 shows the surface morphology at a magnification of  $500\times$ . From the data shown in Fig. 3 indicate that the surface of the untreated coating is relatively smoother compared to the acid treated surfaces. The base resin covered and bonded the surface of the pigments and fillers continuously in the untreated coating. However, the corroded specimen surface was no longer flat and some particles appeared. After 24 h of corrosion, the particles became smaller and were fewer in number. In addition, some cracks and broken holes could be observed in the corroded samples surface.

Fig. 2. The surface morphology after different times of erosion.

Analysis of the data suggested that the particles in the coating surface were the fillers of the retardant system, mainly ammonium polyphosphate (APP), melamine (MEL) and pentaerythritol (PER). The APP is hydrolytic and produces ammonium ions ( $\text{NH}_4^+$ ) and pyrophosphate in a corrosive environment [16]. The process of the hydrolysis would be catalyzed by the action of the  $\text{NH}_4^+$  and  $\text{Cl}^-$  in the hydrochloric acid solution, leading to the production of ammonium chloride. The process of hydrochloric acid penetrating into the coating and the process of ammonium polyphosphate migrating to the surface occurred simultaneously. With increasing corrosion time, the consumption of the ammonium polyphosphate increased gradually, while the migration speed decreased. As a result, in the final period of long time erosion, the action was mainly between the hydrochloric acid and the APP in the coating surface, which caused the particles of APP to become smaller.

In the meantime, ammellid, ammeline and cyanuric acids are produced due to the action of MEL and hydrochloric acid. All the new products are water-soluble, which reduced the content of the MEL in the coating. PER also exhibits a degree of water-solubility, so as with the other two fillers, the migration to the surface and the consumption occur during the immersion process. In the immersion process, the hydrochloric acid and water would penetrate into the coating through the gap between the coating compositions; in addition, the coating fillers migrated to the surface, so that the coating swelled and became soft and the volume became larger. After the specimens were removed from the solution, during the period of the drying of the specimens, the absorbed water evaporates and the coating layer shrinks and becomes hard, eventually forming cracks. Broken holes would form after the drying process if spherical bubbles were produced during the coating swelling and softening. The coating surface is no longer continuous and integrated due to the presence of the cracks and holes, which affect the mechanical properties of the coating.

When the coating surface and char layer morphology were concerned, after the acid erosion, the thickness of the coating thinned, the surface became rough and had cracks and broken holes.

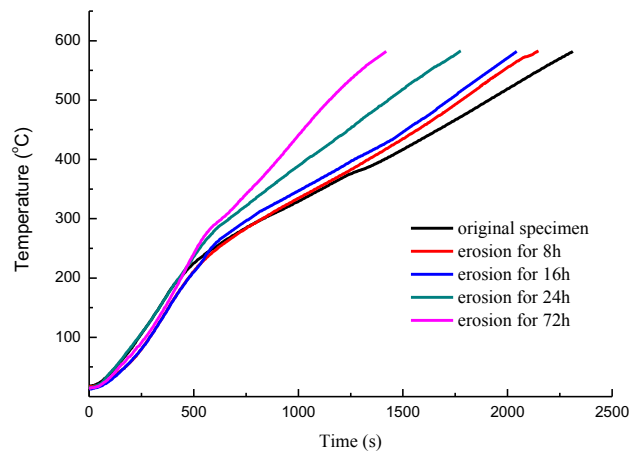
When the specimens met the prescribed corrosion time, they were moved from the hydrochloric acid solution and then dried under laboratory conditions. Before conducting the fire resistance test, the mixture layer of rosin and paraffin was removed. Fig. 3 shows the back side temperature of the samples with testing time. For different erosion time samples, the trends of the temperature rising was found to be similar in the early 400 seconds, but the behaviors became quite different in the later stage.

Fig. 3. The back side temperature of specimens vs. time.

The fire resistance performance of the intumescent coating is affected by the thickness and the morphology of the char layer. The thicker, more compact, and stronger is the char layer, the longer is the fire resistance time. As a result, to investigate the alteration of the fire property of the coating due to acid corrosion, in addition to testing the fire resistance time, the thickness and the morphology of the char layer must be measured. Table 2 presents the fire resistance time and char thickness of the coating after different times of acid erosion.

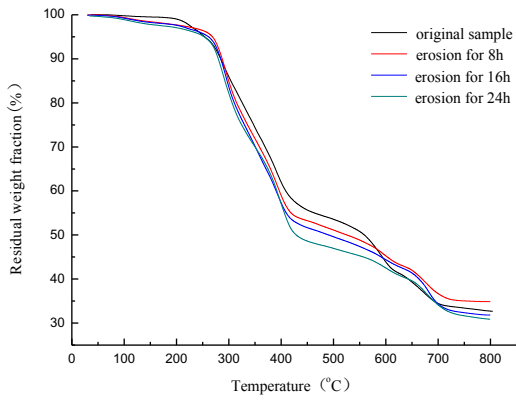
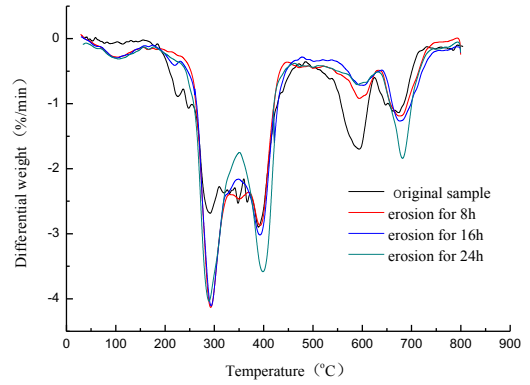
For the fire retardant coating, studied in this paper, has nearly dozens of effective components, the thermal decomposition process of the coating is very complex. As can be seen from its TG/DTG figure (Fig. 4), there were six stages in the decomposition process, which fully reflected the variety of physical and chemical changes in the heating process. In the weightlessness stages of 206–242 °C and 242–272 °C, the decomposition occurred mainly in the APP, MEL, PER and chlorinated paraffin, and little amount of water, ammonia, methane and hydrogen chloride gas were released. The top weight loss rate temperature was 226 °C and 248 °C respectively, and the cumulative weight loss of the two stages was 5.06%. In the range of 272–380 °C, the main chemical reaction was between the APP and PER, in which much of water, ammonia gas were produced. What is more, in this stage, the MEL, base resin and chlorinated paraffin decomposed too. Therefore, besides the relatively big trough at 291 °C, there were four small troughs in the period of 300–380 °C. The whole weight loss of the stage was 23%. The further decomposition and oxidation of base resin and chlorinated paraffin, in addition with the further reaction between the decomposition products of APP and PER, were occurred in the stage of 380–556 °C. The top weight loss rate temperature was 389°C, and the cumulative weight loss of the stage was 17.9%. In the stage of 556–641 °C, the phosphate, generated in the former stage, decomposed continually. The top weight loss rate temperature was 593 °C, and the weight loss was 12.9%. In the last stage of 641–804 °C, the C element contained in resin and PER was oxidized to CO<sub>2</sub>, and the top weight loss rate was at 674 °C, the weight loss was 8.61%

Fig. 4 shows the TG/DTG curves of samples with different erosion time. For the TG curves, looked from the

whole, the corrosion time had little effect on the thermal decomposition processes of the coatings. Especially lower than 400 °C, there were little difference between the curves. Although there were slightly differences in the stage of 400–600 °C, the overall trends were consistent. But for DTG curves, the corroded coating samples were quite different from the untreated one in trough number and size. In order to facilitate the analysis of changes at various stages, the DTG curve were divided into three temperature stages, which were low temperature stage (30–260 °C), medium temperature stage (260–420 °C) and the high temperature stage (420–800 °C), as shown in Fig. 5, 6 and 7. The following for each temperature section is analyzed. The comparing analysis for each of the stage was conducted in the following sections.

a. TG curves

b. DTG curves

Fig. 4. TG/DTG curves of samples for different erosion time.

To sum up, with the acid erosion time increasing, the DTG curves changed significantly, which including: in the low temperature stage, the adsorbed water evaporated, and the loss weight was not obvious when the temperature was higher than 200 °C, and the curve was relatively flat. In the medium temperature stage, the number of the weight loss troughs decreased; the shape of the troughs simplified; and the top weight loss rate increased. In the high temperature stage, the troughs near 593 °C flattened gradually, and the top weight loss rate became smaller, while the top weight loss rate became larger around 674 °C. Thus by compared with the DTG curves of experimental samples, the resistant performance of the unknown coating samples can be roughly predicted.

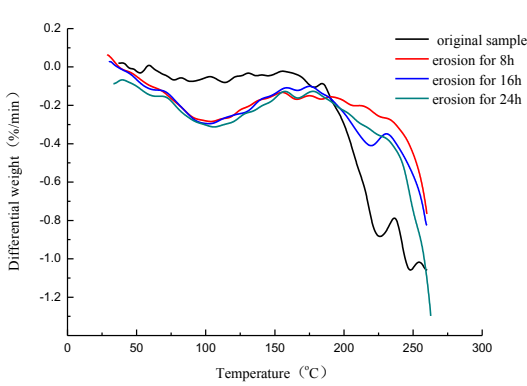
In the low temperature stage, there were two main differences between the corroded samples and the original sample. One was that, before 175 °C, there was an obvious weight loss trough, and the peak temperature was about 100 °C. This difference was caused by the adsorbed moisture of the coating during immersion in the acid solution. The other difference was that, between 175–260 °C, the untreated sample had two fast weight loss trough, while the weight loss rate of the corroded ones in this stage was slow, and the trough was not clear or even without trough. This change illustrated that, after the erosion of the acid, the APP, PER and MEL were lost in certain amount.

Fig. 5. The DTG curves in the low temperature stage.

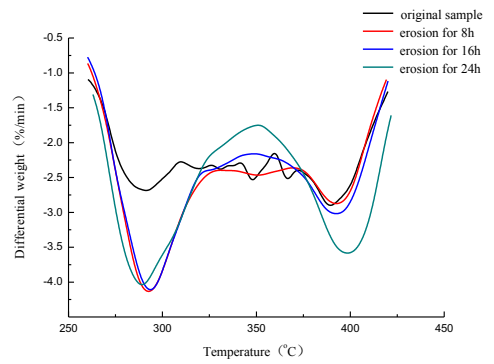
In the medium temperature stage, the coatings, with different corrosion degree, varied in the number and size of weight loss trough. The virgin sample had four weight loss troughs because of its complex reaction process. The sample, corroded for 8h, contained three weight loss troughs, and the middle trough was not obvious. There were only two troughs in the DTG curves of samples corroded for 16h and 24 h. This demonstrated that in this stage, with the immersion time prolonged, the reaction between each component simplified, and had the trend of single component decomposed. The four top weight loss rates were between -2.5–-2.9 %/min; the two obvious top weight loss rates of the sample for 8h erosion were -4.1 %/min and -2.9%/min respectively; the two top weight loss rates of the sample for 16 h erosion were -4.1 %/min and -3.0 %/min respectively; and the two for 24 h erosion were -4.0 %/min and -3.6 %/min respectively. At this stage, due to the loss of the fire retardant system during the corrosion, the reaction process was relatively simple and concentrated. Besides the decomposition of the residual APP, PER, MEL and their reaction products with acid (corresponding to the trough at 290 °C), the main reaction materials were acrylic resin and chlorinated paraffin (corresponding to the trough at 390 °C). Because of the loss the APP, PER and MEL, the relative content of acrylic resin and chlorinated paraffin increased, and the rate of weight loss had an increasing tendency. The phenomenon that with the erosion time prolonged the top weight loss increased, also showed that the relative content of the resin and chlorinated paraffin increased.

Fig. 6. The DTG curves in the medium temperature stage.

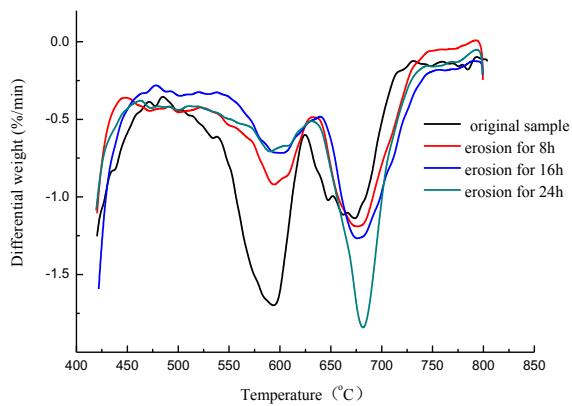
In the high temperature stage, the weight loss rate trough number was consistent for different corrosion degree of coatings, that all samples had two obvious weight loss rate troughs. However, the corresponding value of the troughs changed regularly with the erosion time prolonged. The weight loss rate trough value (absolute value) around 593 °C became smaller with the erosion time increasing, but became larger near 674 °C. The top weight loss rate of the untreated sample around 593 °C was -1.7 %/min, while the top weight loss rates of the samples were -0.92%/min, -0.71 %/min and -0.72 %/min respectively for the erosion time of 8 h, 16 h, 24 h. The top weight loss rates of the samples were -1.14 %/min, -1.19 %/min, -1.27 %/min and -1.84%/min respectively for the original, 8h, 16h, 24h acid erosion specimens. The weight loss trough at 593 °C was generated by the decomposition of the phosphate, which produced by the reaction of APP and PER in the former stage. With the erosion time increasing, the contents of the APP and PER were decreased; the produced phosphate decreased correspondingly, and resulted in the lower top weight loss rate in this temperature. The oxidization of the C element contained in resin and PER to CO<sub>2</sub> generated the trough at 674 °C. After the acid erosion, some active components lost, and the relative content of the base resin increased, which led the higher top weight loss rate at this temperature.

Fig. 7. The DTG curves in the high temperature stage.
