EJVES Extra 4, 65–66 (2002)

## SHORT REPORT

# A Case of latrogenic External Iliac Vein Injury During Revision Total Hip Arthroplasty

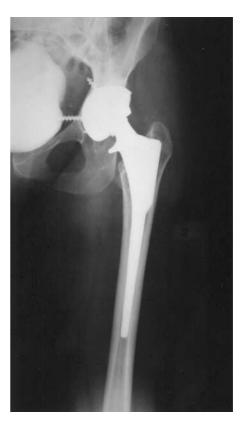
Fig. 1. Initial X-ray showing very prominent acetabular screw protruding into pelvis.

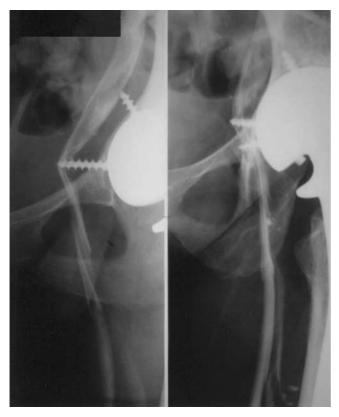
Examination 1 month post-operatively revealed a swollen mottled leg. A venogram showed patent deep veins, but tenting and partial obstruction of the external iliac vein by an acetabular screw, which had been placed in the antero-inferior quadrant of the acetabulum (Fig. 2). The vein was explored extraperitonealy and repaired with a vein patch. The screw was cut short. The remnants of the screw were covered with the iliacus muscle, and a PTFE patch sutured between the superior pubic ramus and iliacus

Fig. 2. Venogram showing external iliac vein being tented by screw.
