6th International Building Physics Conference, IBPC 2015

"Retrofit of an historical building toward NZEB"

1. The case study

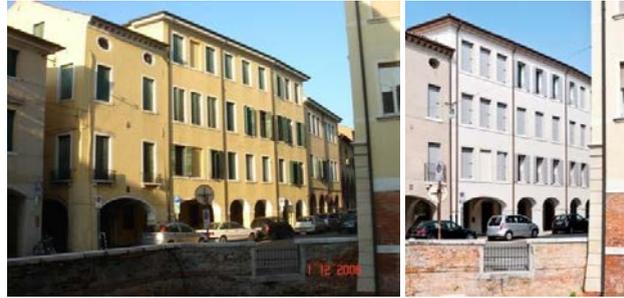
Fig. 1 General view of the building a) before and b) after the intervention.

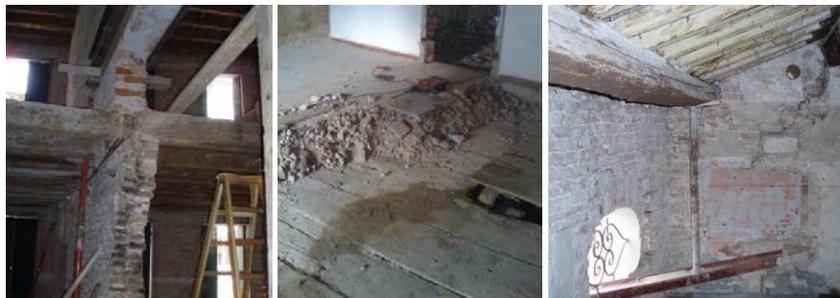
Fig. 2 Building envelope before renovation: a) crooked walls; b) demolished partition walls left and used as a substrate; c) beam support in the perimeter wall.

At the beginning of construction phase the structure revealed a quite ruined state of conservation: walls are crooked and presented different solutions, moisture affected wooden elements in the floors and in the roof. There was a heritage architectural restriction about the external envelope. Specific goals of renovation project were:

Building envelope before renovation presented a traditional construction system, based on bearing masonry with covered solid bricks. The floor had a wooden structure, while the ground floor leaned directly on soil. The roof is made of hollow tiles sheets with a wooden structure and a lightweight ceiling slab (Fig. 2).

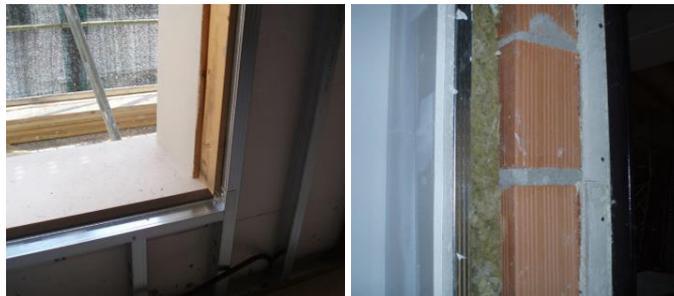
Fig. 3 Insulation on a) internal and b) external walls.

In the external walls the insulation is placed on the inner part (Fig. 3) and this solution meet the requirements of the Superintendence of Veneto Region, preserving the existing materials and the external architectural identity of the building. Specifically, two types of insulating are used: an expanded polystyrene (EPS) foam, placed directly on masonry, and a rigid mineral wool panel with a plasterboard cover. Roof was replaced with a new wooden structure and it was insulated with wood fiber and water tight covering. All existing windows are replaced with a low-energy double layer ones within wooden frames.

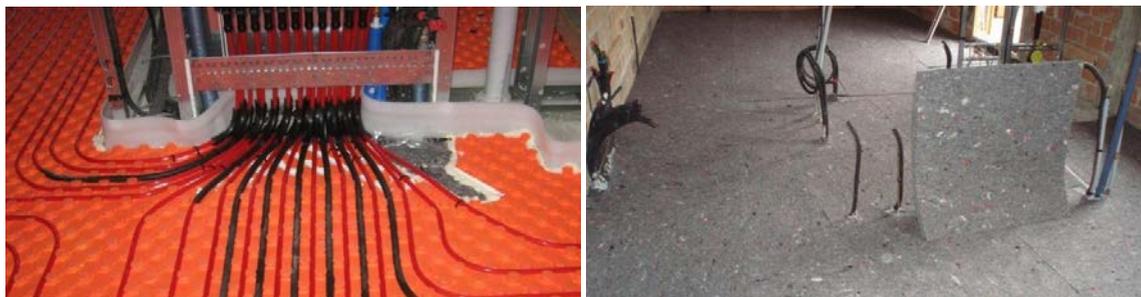
Fig. 4 Radiant system: a) collectors and b) TNT underflooring above system.

About technical systems, the HVAC generation system is a water to water centralized heat pump/chiller. The underlying well is the hot/cold water source and internal comfort is achieved exploiting a radiant system (Fig. 4) installed in the floor together with a dehumidification system for the summer period.

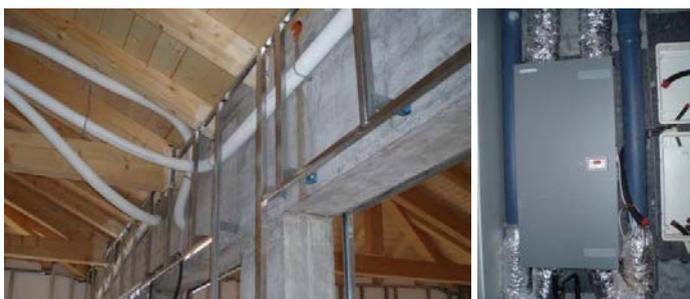
Fig. 5 Mechanical ventilation system.

For heating and cooling the system adopted is a 32 kW heat pump with a distribution by radiant floor system; another heat pump (20 kW) is installed for domestic hot water requirement (DHW); mechanical ventilation (Fig. 5) is provided by a system with heat recovery box (95% efficiency).
