The Malaysian International Tribology Conference 2013, MITC2013

## Comparison between up-milling and down-milling operations on tool wear in milling Inconel 718

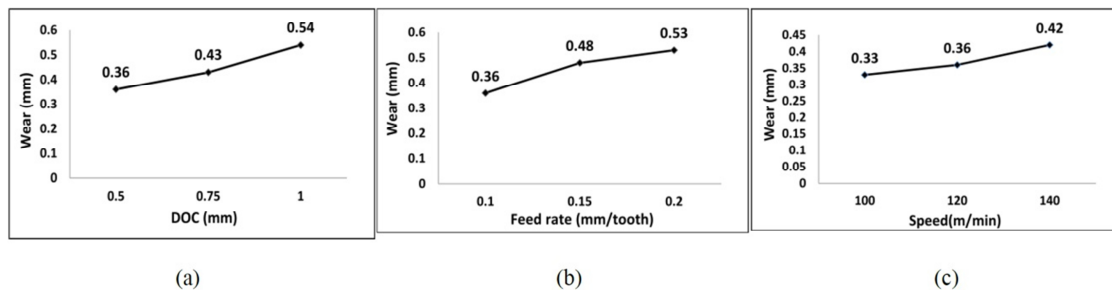
Fig. 1. Maximum wear in single cutting pass when (a)DOC are set at 0.5, 0.75 and 1 mm while feed rate and speed are constant at 0.1 mm/tooth and 120 m/min, (b) feed rate are set at 0.1, 0.15 and 0.2 mm/ tooth while DOC and speed are constant at 0.5 mm and 120 m/min, (c) speed are set at 100, 120 and 140 m/min while DOC and feed rate are constant at 0.5 mm and 0.1 mm/tooth.

Fig. 1(a) (b) and (c) show the effect of cutting parameters on the flank wear. The effect of DOC on tool wear by keeping feed rate and speed constant is shown in Fig.1(a). From Fig. 1(a), it is clearly shown that DOC is directly proportional to the tool wear. In single cutting pass measurement, the tool wear increases as the DOC increases. The same finding was obtained by Ali and Salama [13] through their experiment on austenitic stainless steel where they found that as the DOC increases, chip width will also increases and the center of pressure of the chip tend to moves away from the cutting edge, which initiated the crack to occur. At DOC 1 mm, the tool wear meet the maximum flank wear ( $V_{b_{max}}$ ) which is 0.5 mm as per ISO-8688 in only one pass.

Fig. 1(b) indicates the effect of feed rate on the tool wear by keeping the DOC and speed constant. From the result obtained, feed rate also give a direct proportional relation to the tool wear, where increasing the feed rate will accelerate the tool wear. For feed rate of 0.2 mm/tooth, tool is already worn-out in a single cutting pass with the wear reading of 0.53 mm. This phenomenon is due to BUE formed on flank face that changes the geometry of the tool [14]. The result as in Fig. 2(a) was obtained from the experiment and it shows BUE occurred near the DOC line because of higher stress acting on the cutting edge.

From Fig. 1(c), the effect of cutting speed is clearly shown that the flank wear is increased with increase of cutting speed. The experiment was done with a constant DOC; 0.5 mm and feed rate; 0.1 mm/tooth. The result also concluded that as the cutting speed is increased, abrasive and adherence of workpiece on the flank face can be clearly seen as illustrated in Fig. 2(b). In general, this phenomenon is mainly due to the generation of high contact pressure and temperature between workpiece and tool, where most of the wear mechanism of carbide tool is abrasive and adhesive wear [14]. In term of chip morphology, up-milling operation tends to generate a segmented chip with a typical saw-tooth shape as shown in Fig. 2(c). This phenomenon showed that the local rate of heat build-up in the material is large enough that thermal softening overwhelms the effect of strain hardening. The segmented chip will result an increase in tool wear and degradation of workpiece surface finish [15].

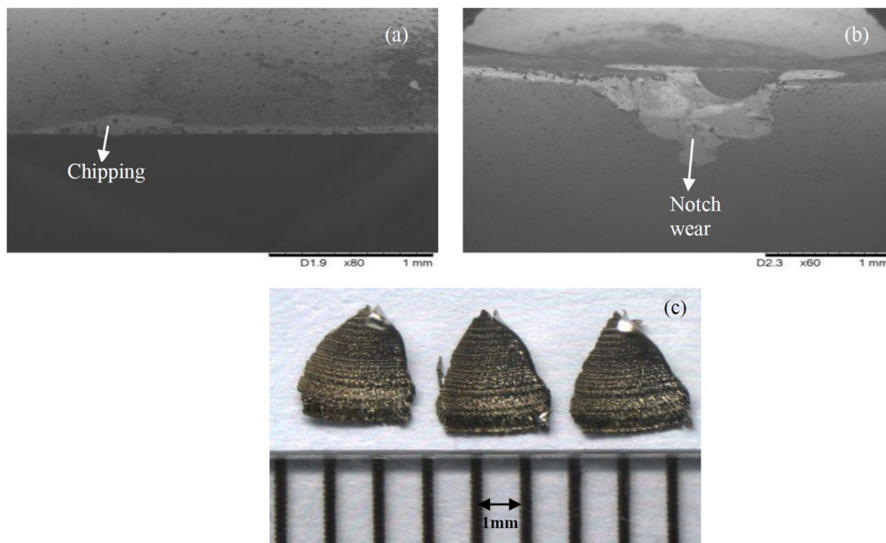
Fig. 3. Tool wear patterns observed (a) Chipping (b) Notch wear (c) Discontinuous serrated chip.

As compared to up-milling operation, down-milling process will tend to scoop the metal starting at the top of DOC and goes all the way to the bottom. In this method, chips are generally bigger (approximate two times bigger than up-milling) because of the high force during contact and it can produce a better surface finish as compared to up-milling operation. However, the high impact force can cause chipping (Fig. 3a) due to the harden layer on the surface and this will promoting the formation of notch wear (Fig. 3b). Localized of notch wear can lead to tool fracture and will be considered as a catastrophic failure. Besides that, the chip morphology during down-milling was also different than with up-milling. Whereby, in down-milling the chip produced was a discontinuous serrated chip as shown in Fig. 3(c). This type of chip will reduce the tool wear and produce better quality of workpiece surface finish.

The difference in cutting results during down-milling that due to change of DOC, feed rate and speed over cutting time can be seen in Fig. 4(a), (b) and (c). Overall, all the parameters show the improvements in tool wear when the same parameters used in up-milling are applied in down-milling operation. From the results in Fig. 4(a), the progress of flank wear increases steadily at the initial stage before unevenly progressed after around four minutes of cutting times. This is due to chipping and further more will lead to notch wear that caused by the repetitive load [5].

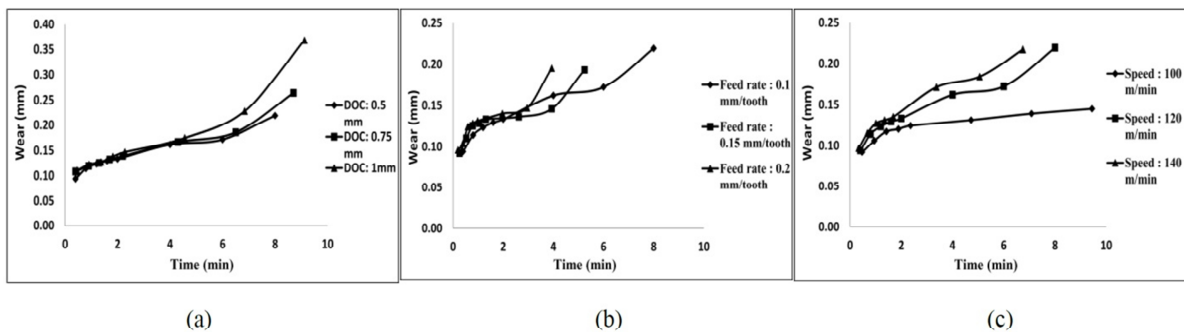
The effect of feed rate during down-milling is observed in Fig. 4(b). In general, the progress of the wear has three stages: initial, steady-state and worn-out regions. All the feed rate values started with the increasing of flank wear until they reached almost 1 minute before they gone through steady state region for a certain period of time. For  $f_z=0.2$  mm/tooth, it takes 3 minutes, while for  $f_z=0.15$  mm/tooth and  $f_z=0.1$  mm/tooth both respectively take 4 minutes and 8 minutes before the wear drastically increase, leaving the steady state region. As in up-milling, flank wear increases when the feed rate is increased due to BUE formed at flank face and increase the normal contact stress at the tool-chip interface and in the tool-chip contact area. The chipping of the cutting edge will take place and leads to tool breakage when the level of normal contact stress reaches the breaking feed of the tool [16].

Fig. 4(c) shows the influence of different cutting speed on tool wear under down-milling operation. It can be observed that tool wear is very sensitive to cutting speed. When the speed is low (100 m/min), the tool wear on the flank face is slowly increasing compared to the progress of wear during high speed (140 m/min). This was most likely due to increase of the cutting temperature which resulted in a loss of material strength and increase of its plasticity [17]. In other words, tool tips become easier to get wear where abrasive wear marks and workpiece material adhesion were still prevalent in all test performed.
