Transportation Research Procedia 14 (2016) 1930 – 1939

6th Transport Research Arena April 18-21, 2016

A new methodology for assessment of railway infrastructure condition

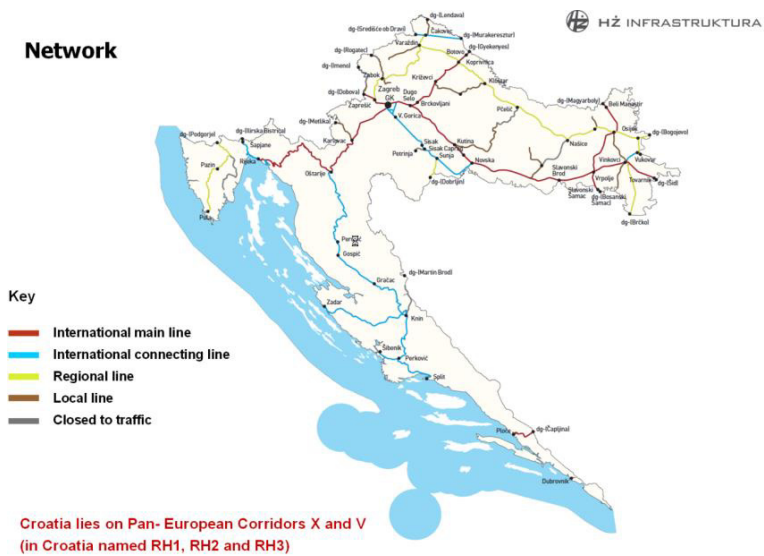
Fig. 1. Railway network in Croatia.

Safe and efficient transport infrastructure is a fundamental requirement to facilitate and encourage the movement of goods and people throughout the European Union. There is approximately 215,400 km of rail lines in the EU which represent a significant asset. Many of the rail networks in Eastern Europe and in parts of Western Europe were developed more than 150 years ago. These networks were not built to conform to modern standards and suffer from low levels of investment and in some cases poor maintenance strategies. In the current economic climate it is vital that we maintain and develop our transport network and optimize the use of all resources. The Croatian railway network has 2604 km of railway lines. The majority of the railway infrastructure in Croatia is over one hundred years old. In common with many other EU member states, a lack of investment in maintenance and renewal projects in over the last 30 years has resulted in generally poor track conditions. As a result traffic speeds are often restricted with some important operating with speeds limited up to only 20 km/h. Main railway international and national lines are shown in Fig. 1.

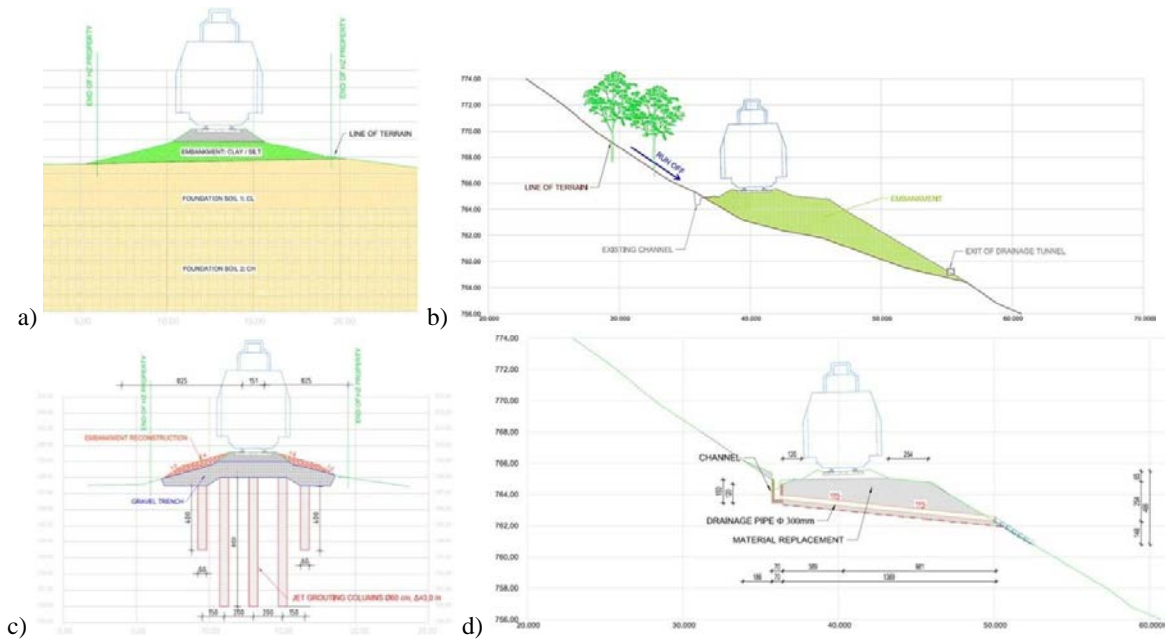
Fig. 3. Examples of typical problems a) cross section of the embankment with soft soil, and b) instability problem due to the lack of drainage system, c) remediation measure for the case a); d) remediation measure for the case b).

The Croatian rail network crosses areas where near surface soils consist of soft clay and loose sand which are relatively poor founding soils. Typical problems associated with these soils relate to their low bearing capacity and tendency for the accumulation of long-term settlements. With a move to increase train speeds these problems can accelerate. Typical problems associated with weak sub-soil or poor drainage and remediation measures are considered in Figure 3.

Another case study is the rehabilitation of the instability of embankments in km 588 + 000 to km 588 + 110, 202 track M 202 (FCE-2, 2014). At this location investigation works included also the implementation of geodesic survey, geotechnical drilling, laboratory testing and geophysical methods of GPR recording and seismic refraction. The results of testing are presented in Figure 8. Based on the investigation works it was shown that a major cause of instability was poorly maintained or absent drainage. The flow of water from the slope located above the track (Fig. 3b and Fig. 8) caused the retention of water in the embankment, primarily because of an inadequate drainage system. In order to improve the current situation, 22 drainage canals were designed where drainage pipes will be installed and will collect water from the embankment body and from a new concrete channel that will be located at the bottom of the upper slope (Fig. 3d). This improved design will greatly increase the safety of the embankment and improve its performance.

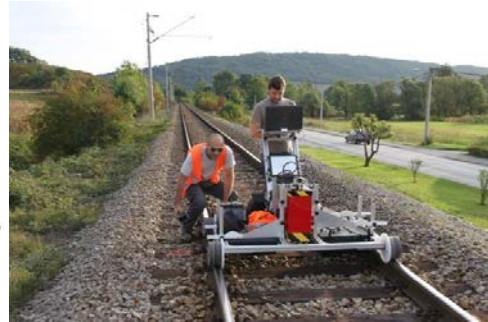
Fig. 6. Multichannel GPR system installed on the special vehicle.

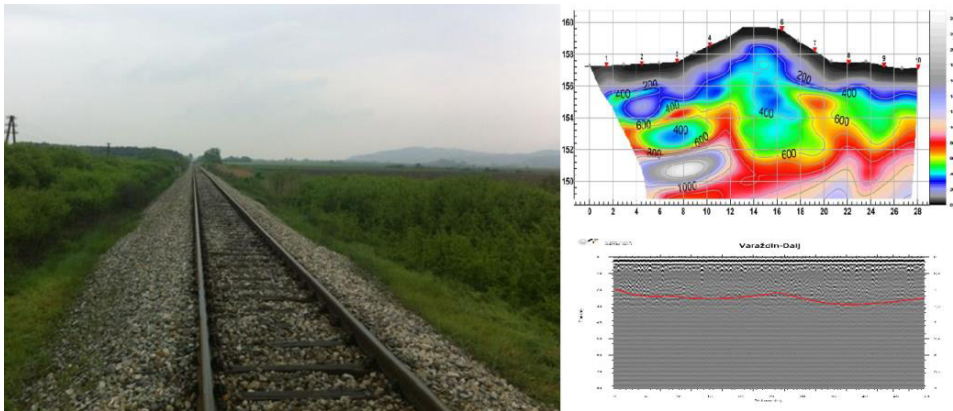
Fig. 7. Unstable embankment at km 132+200 till km 133+000, railway track R202 in Croatia, with belonging refraction profile and GPR profiles recorder during the assessment stage.

During 2014, two rehabilitation projects have been designed and performed for the improvement of embankments stability at railway tracks in Croatia (FCE – 1 2014, FCE – 2 2014). The investigation works comprised of geodesic survey, geotechnical boreholes, laboratory testing and non-destructive geophysical, GPR and seismic refraction measurements. In Figures 7 and 8 the results of seismic refraction and GPR measurements are presented for both locations.

Investigation works carried out at track R202 have established that the railway embankment is located on soft soil, with the seismic refraction survey identifying soils of very low stiffness in the area directly beneath the embankment. A remediation method consisting of the installation of 0.6 m diameter, 4 to 8 m long jet grouted piles see Fig. 3c. was adopted. It is also proposed to strengthen the embankment body by execution of gravel trenches on the longitudinal distance of 3 meters (above the jet grouted piles). Finally the slopes of the embankment will be reduced to between 1:4 and 1:2.
