MATERIALS INTERACTIONS
BETWEEN THE
THERMOELECTRIC CONVERTER
AND THE
5-kwe REACTOR SYSTEM

AEC Research and Development Report

P. B. FERRY

**CONTRACT: AT(04-3)-701
ISSUED: JUNE 30, 1973**

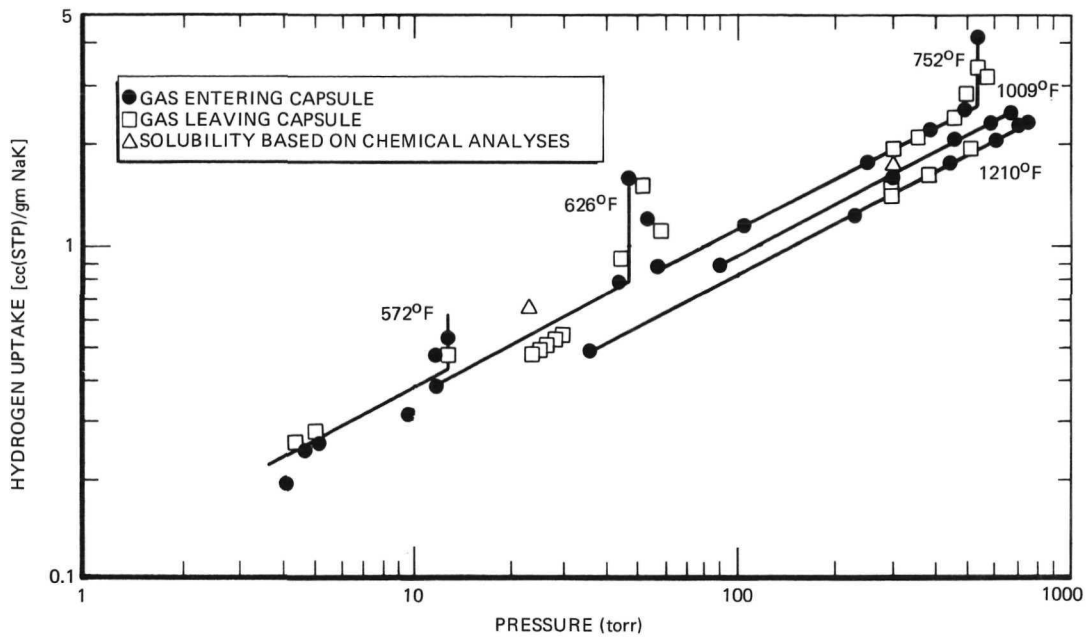
Figure 5. NaK-Hydrogen System⁽⁷⁾

appears to be the proper form. (7, 8) In both equations, C is in wppm of hydrogen in NaK, and P is in atmospheres of hydrogen. The chief differences to be noted between the two are the pressure dependence (square root at high pressures, and linear at low pressures) and the magnitude and sign of the temperature dependence. While the two forms appear to be significantly different, the two relationships are not inconsistent when plotted in their respective regions of high and low pressure.

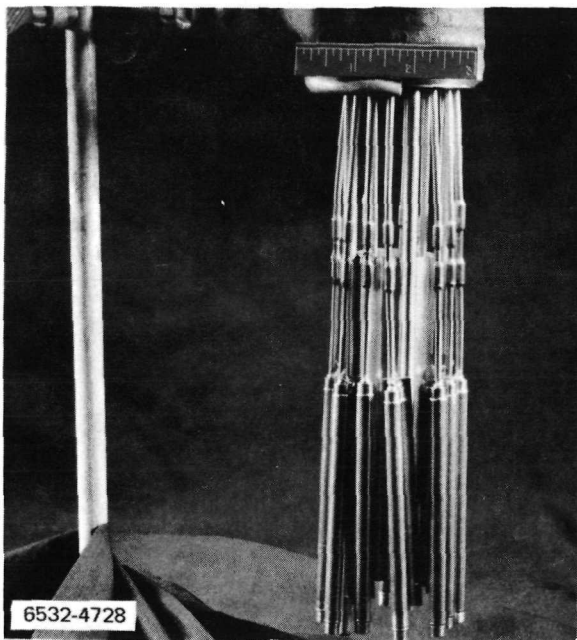
Figure 22. Configuration of Test Specimens

a. Overall View of Test Assembly

b. Steel Test Specimens and Ta - 10 W Tube and Strips

c. Attachment of Strips to Pressurization Tubes

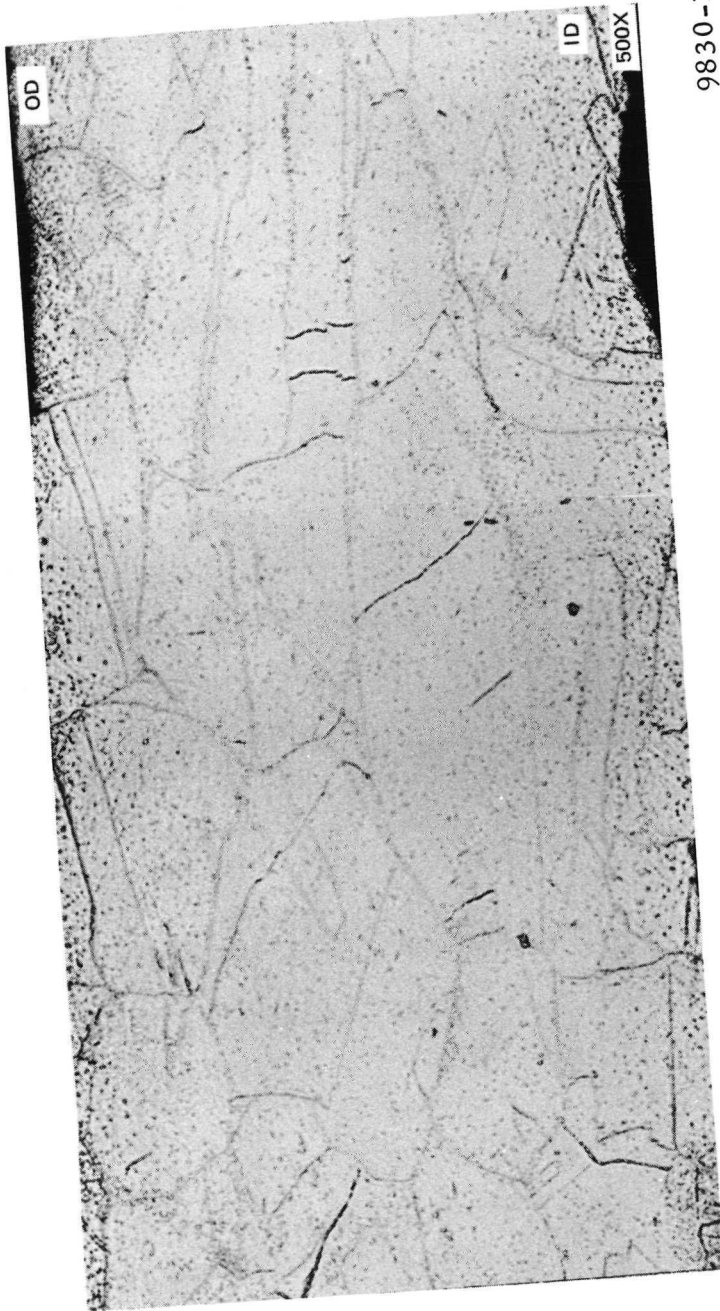
Figure 24. Microstructure of AISI Type 316 Stainless Steel Biaxial Stress-Rupture Specimens
(Sheet 1 of 4)

Figure 24 shows the structure of the stainless steel prior to exposure at 1200°F to NaK containing samples of Ta - 10 W. The uniform grain size (ASTM micrograin size 5 to 5-1/2), single-phase structure, typical of annealed stainless steel cladding, is evident. The metallographic examination indicates that there was no metallic corrosion or deposition as a result of the exposure, and the carbide precipitation appears to be relatively uniform and not significantly dependent upon stress. However, the very-high-strained regions (~50% local reduction) of the two high-stressed samples do appear to exhibit more precipitates than those at the remaining test conditions. It is more likely due to

a. As Received

b. Exposed to Test Environment Unstressed

d. 19 ksi Hoop Stress, 10.5% Diametral Strain,
Not Ruptured

c. 18 ksi Hoop Stress, 8% Diametral Strain,
Not Ruptured

- e. 20 ksi Hoop Stress, 17% Diametral Strain, 2246-hr Rupture Time

f. 22 ksi Hoop Stress, 13% Diametral Strain, 1344-hr Rupture Time
