GE-SSO-70SD4286
FEBRUARY 1, 1971

FINAL REPORT

DESIGN AND DEVELOPMENT OF
A THIRTY WATT PER POUND 250
SQUARE FOOT ROLL-UP SOLAR ARRAY

VOLUME I PROGRAM SUMMARY

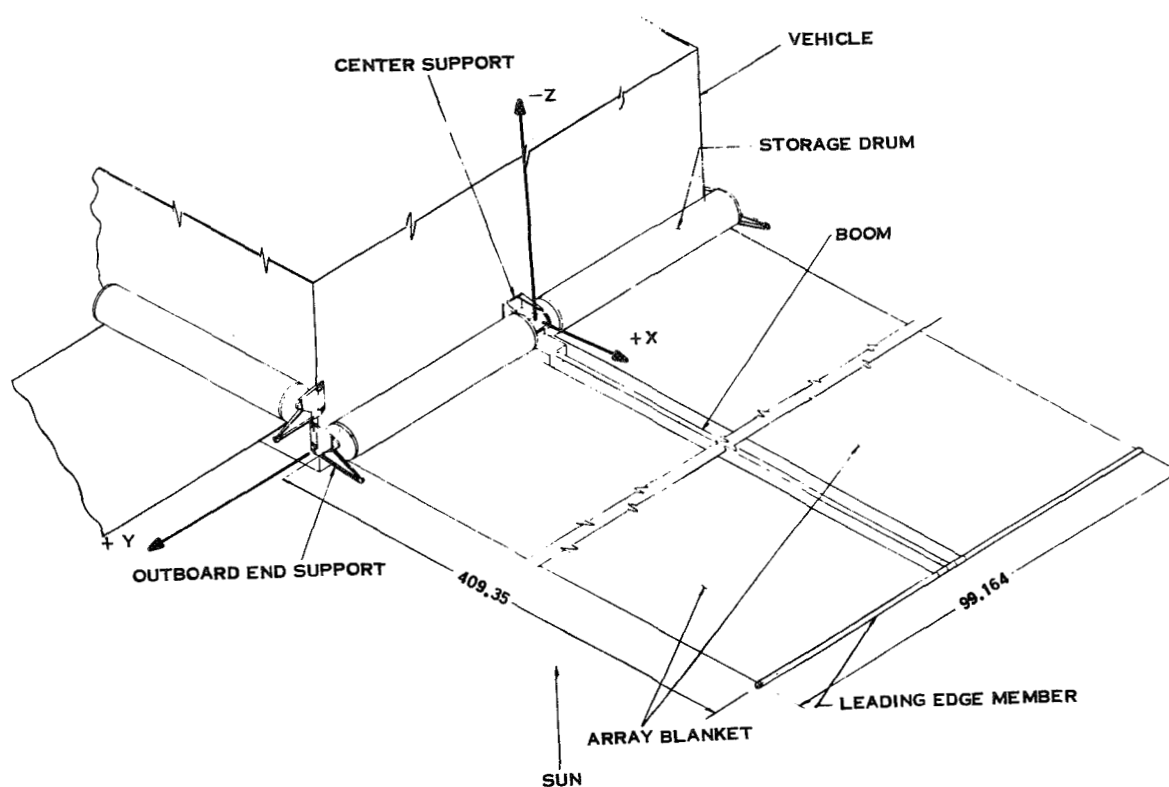
Figure 1-1. Rollup Solar Array Configuration (Coordinate System Shown)

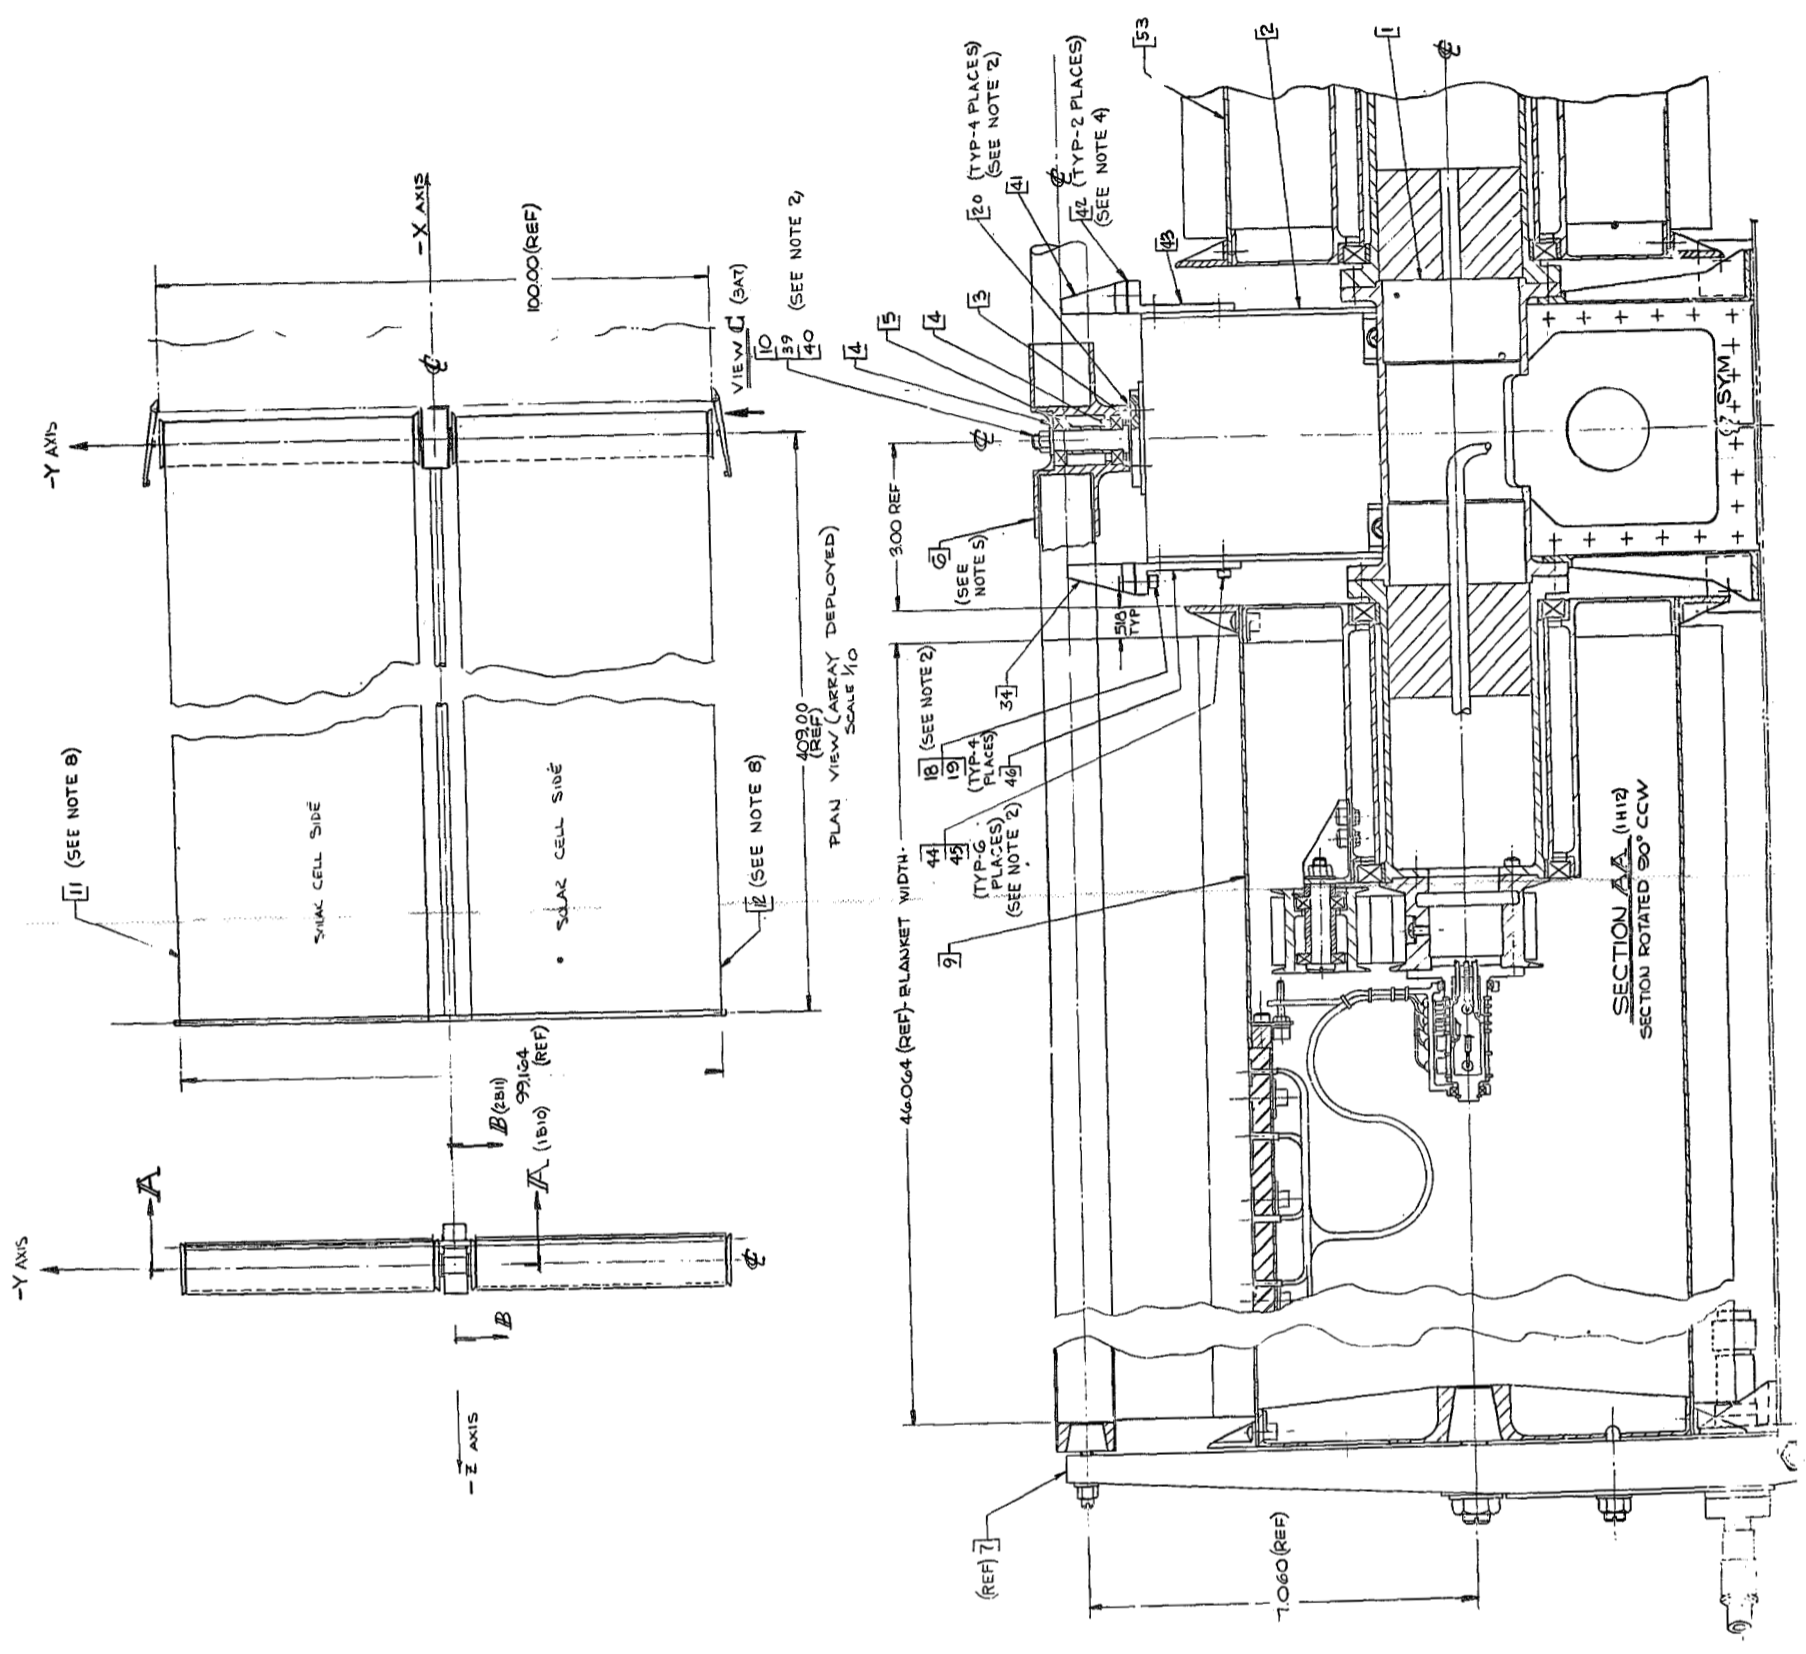
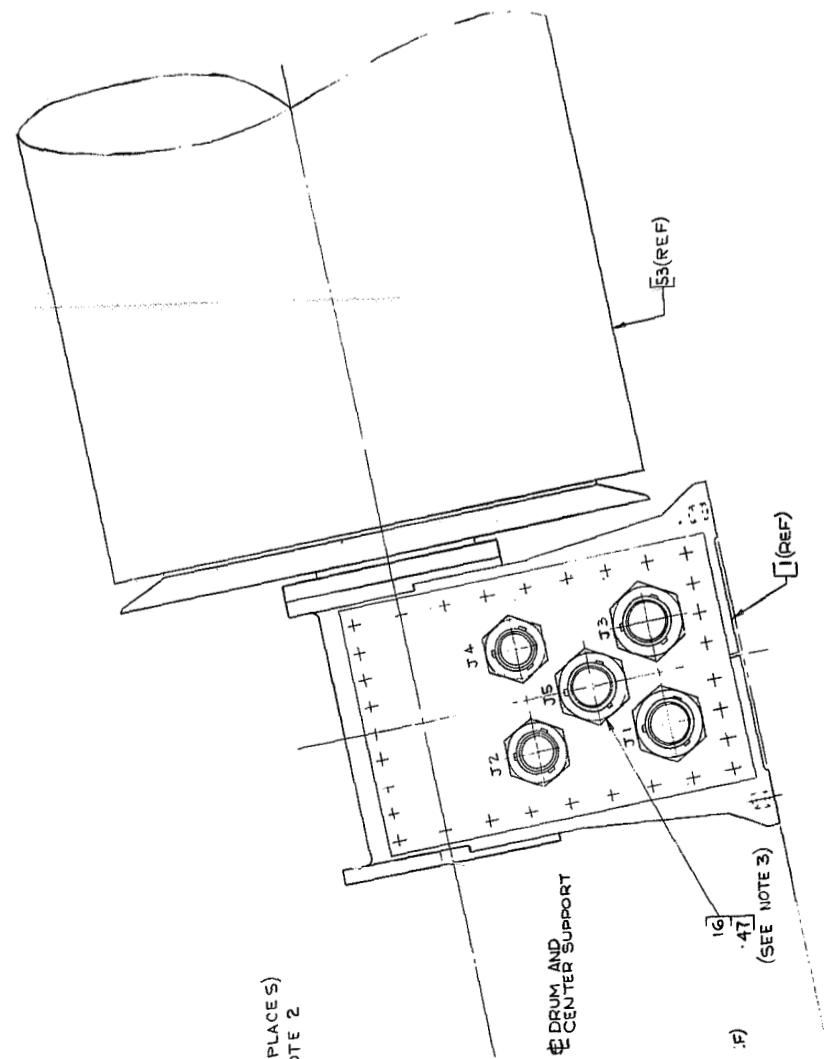
Figure 3.1-1 RA250 Assembly 3-3/4

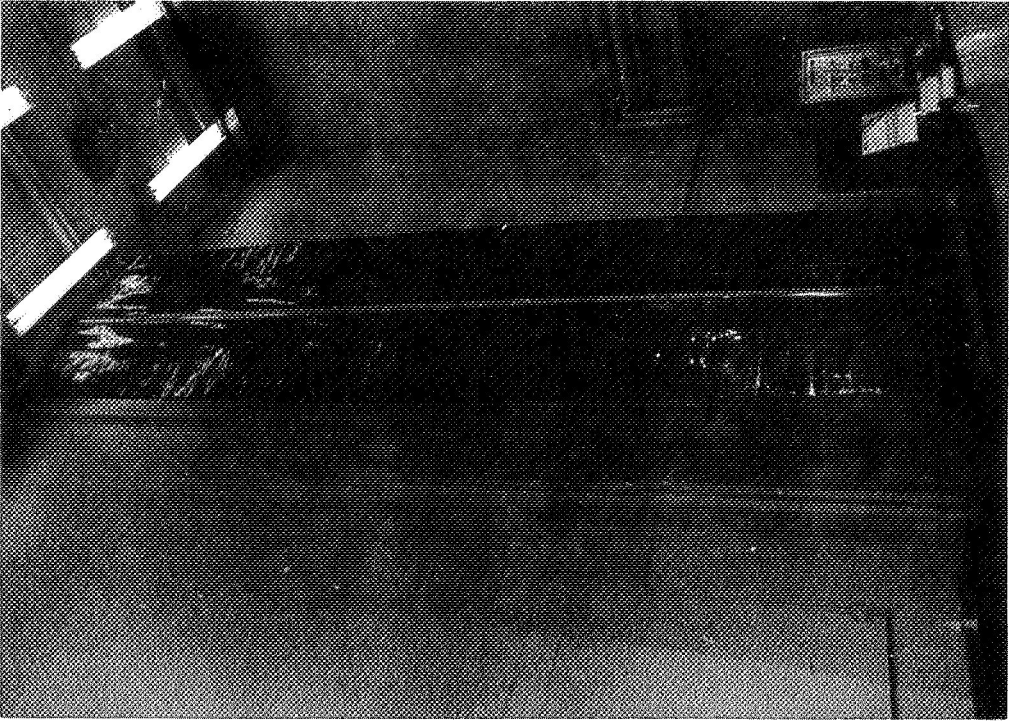
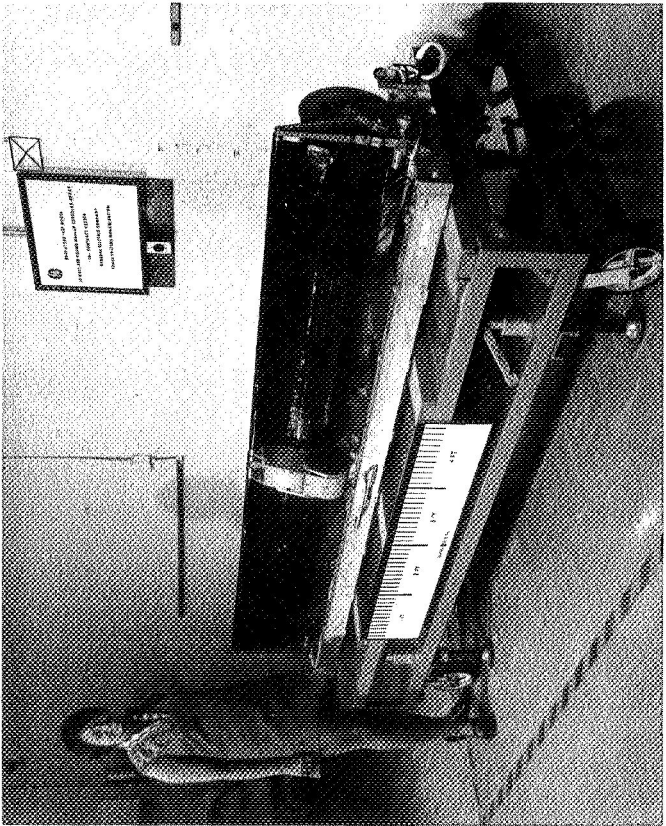
(b) Fully Deployed(VF70228D)

(a) Stowed (VF70409B)

Figure 3.1-2. RA250 Prototype Test Model

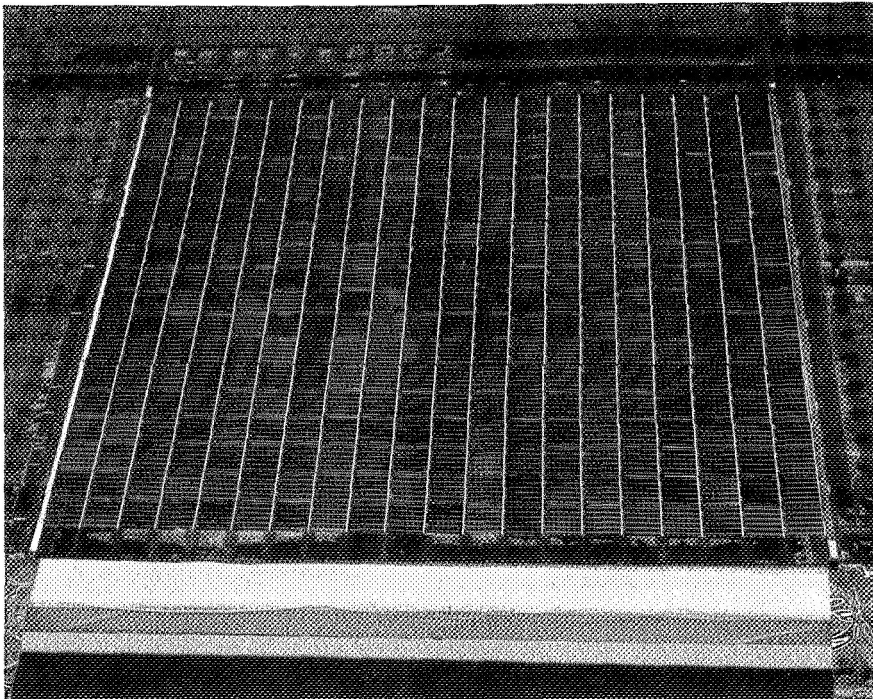
Figure 3.1-6 EOS Module Mounted on -Y Blanket Assembly

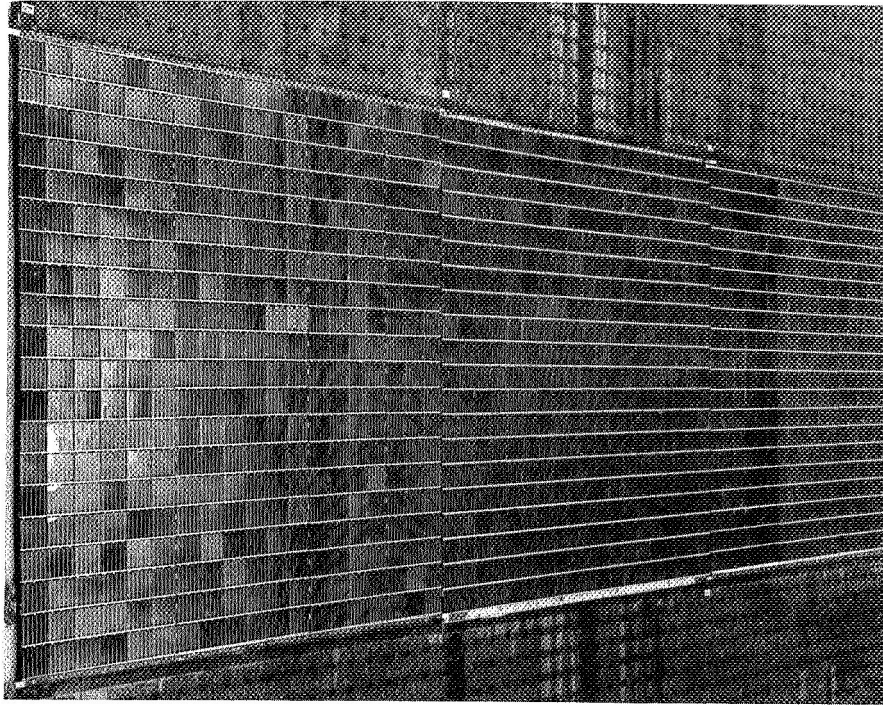
Figure 3.1-7 Heliotek (near) GE No. 2 (middle) and Boeing (far) Modules Mounted on -Y Blanket Assembly (VF 70127C)

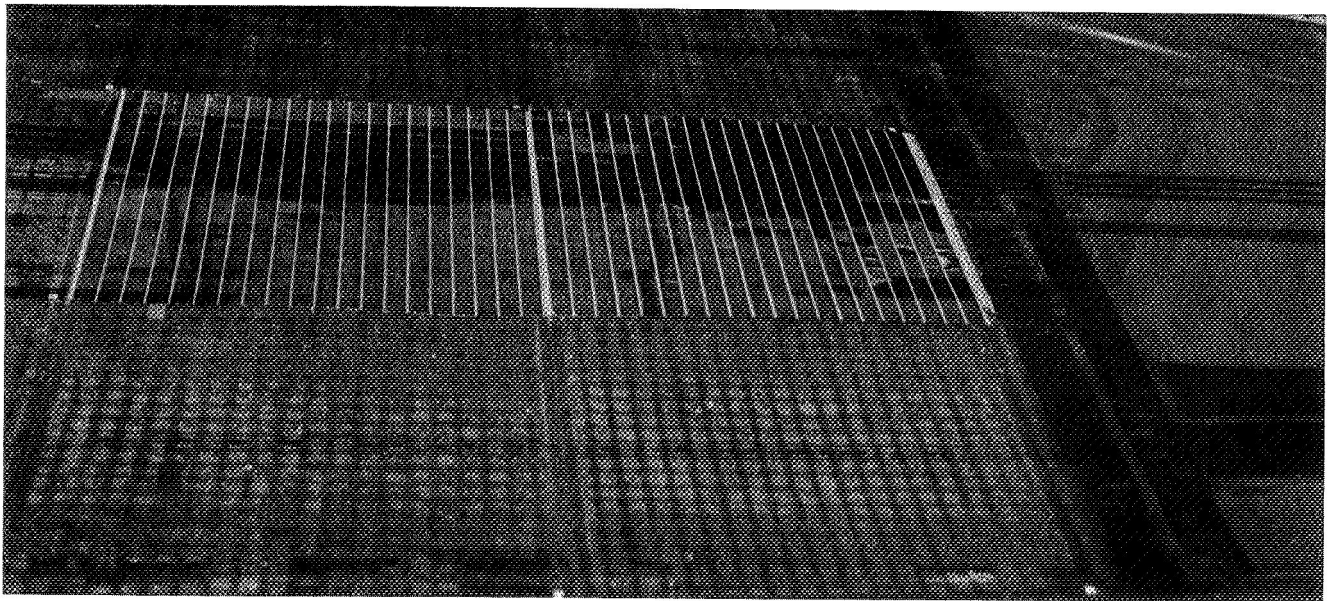
Figure 3.1-8 GE No. 1 (left) and Centralab No. 1 (right) Modules Mounted on -Y Blanket Assembly (VF70127C)

connecting two modules in the series direction. The two main bus strips at the drum end of the blanket are visible through the substrate.

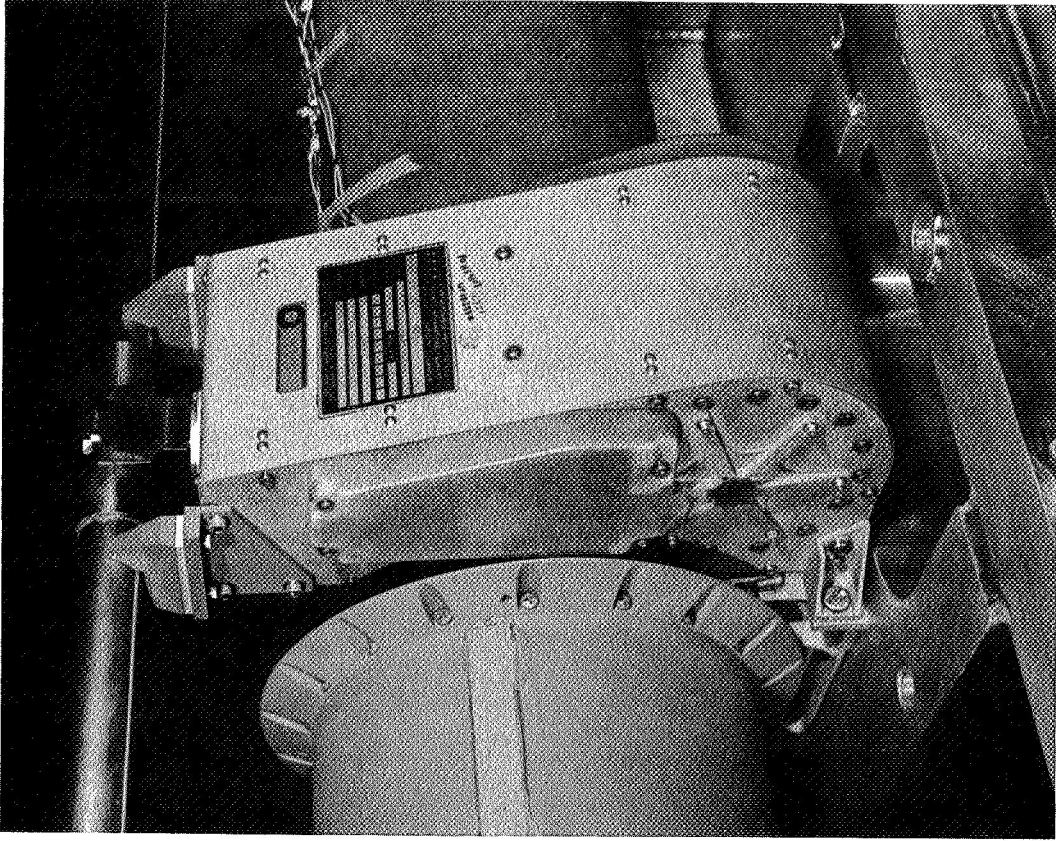
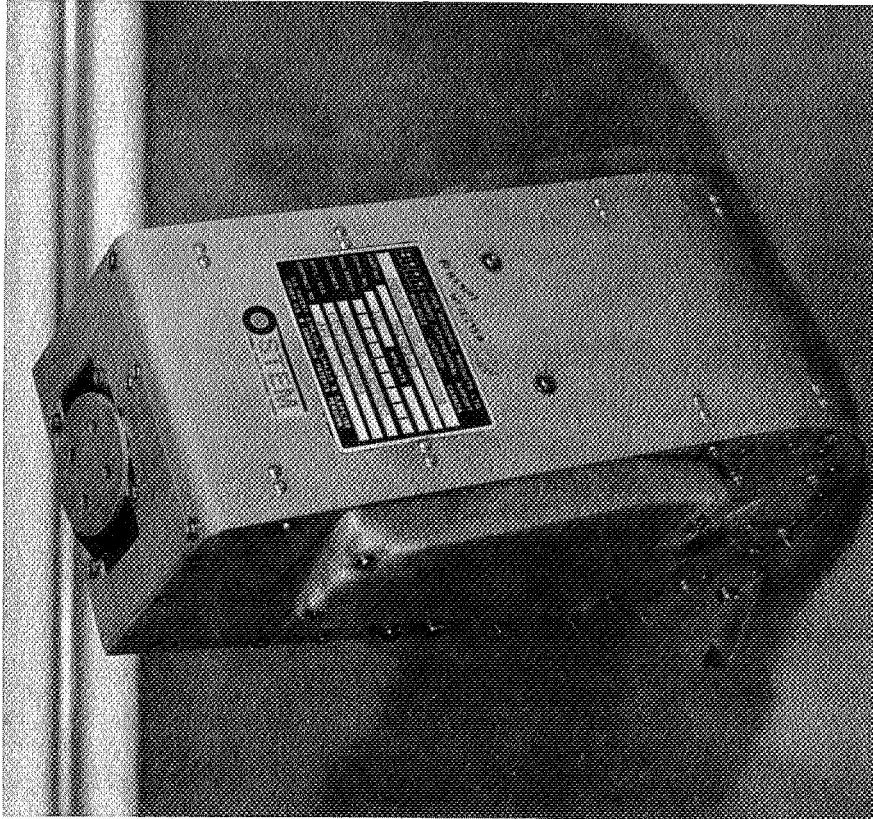
(b) Mounted on Center Support
(VF70136C)

(a) Bi-Stem Component
(VF70136D)

Figure 3.1-9 Solar Panel Actuator

The solar panel actuator is a BI-STEM deployable boom designed and developed by SPAR Aerospace Products, Ltd. Figure 3.1-9 shows this component isolated and mounted on the center support structure between the drums. The boom element of the BI-STEM unit, the component which provides the actuation force for deployment and forms the primary structure in the deployed configuration, has a nominal diameter of 1.34 inches. It is made up of two 301 stainless steel strips, wide and 0.007 inch thick, which are prestressed to form an overlapped tube in the deployed position. The BI-STEM principle is shown schematically in Figure 3.1-10. The boom is silver-plated on its outside surfaces to reduce the temperature gradients in the boom when one side is exposed to solar radiation and the other side is in the shadow. Properties of the boom element (as supplied by the vendor) are given in Table 3.1-2.

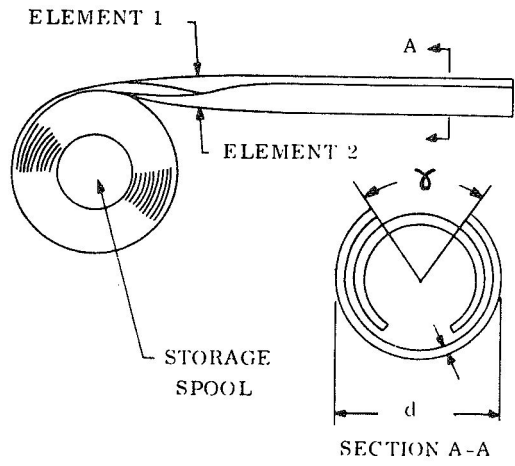
Figure 3.1-10 The BI-STEM Principle

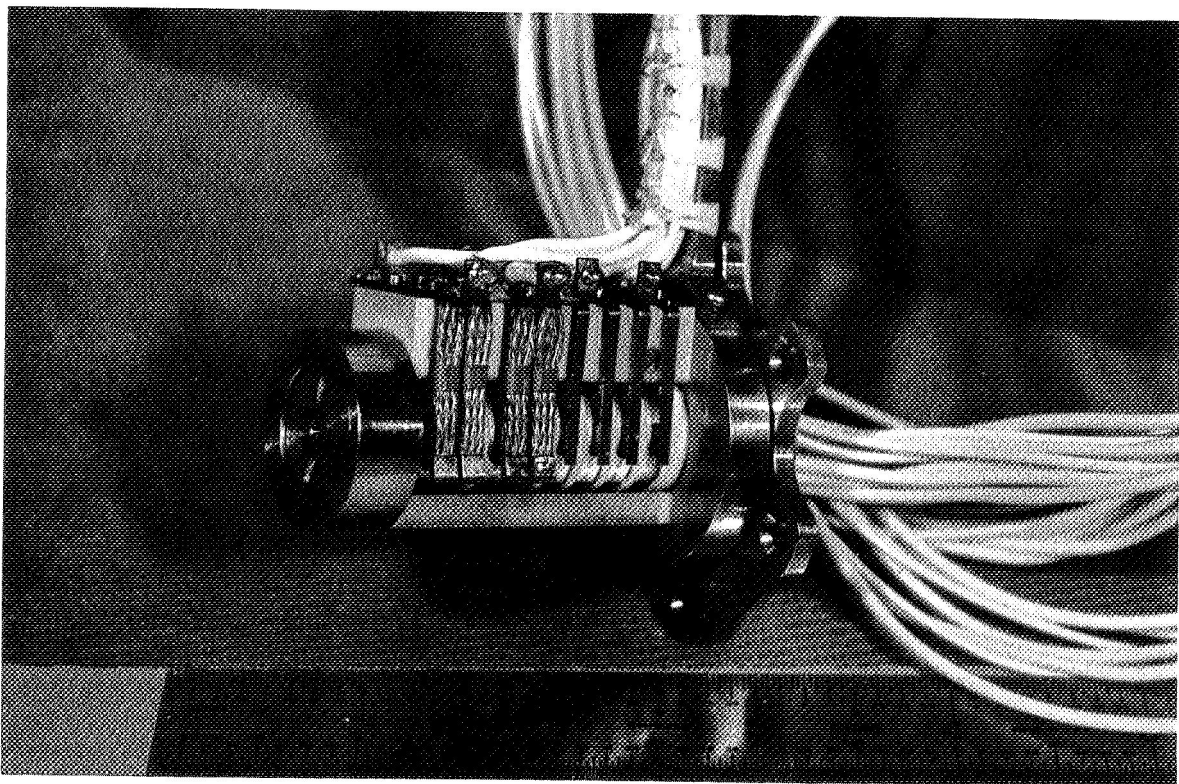
Figure 3.1-11 Slip Ring Assembly (VF70731)

• Power rings per assembly	2
• Signal rings per assembly	4
• Structural material	303 stainless steel
• Ring material	Coin silver
• Ring diameter	0.60 in.
• Brushes per signal ring	2
• Brushes per power ring	4
• Brush material	Silver/copper/niobium diselenide/ graphite
• Brush spring material	Ney Paliney 7
• Rated current per ring	15.0 amp dc
Power	1.0 amp dc
Signal	
• Brush contact force	
Power	0.33 lb + 10%
Signal	0.12 lb + 10%
• Starting torque	
Air	0.7 in. -lb
Vacuum	0.4 in. -lb
• Signal ring static contact resistance	0.065 ohm
• Power ring static contact resistance	0.020
• Rated current density/ring	
Power	188 amp/in. ²
Signal	83 amp/in. ²
• Anticipated power loss/assembly	6 watts
• Weight/assembly	0.617 lb

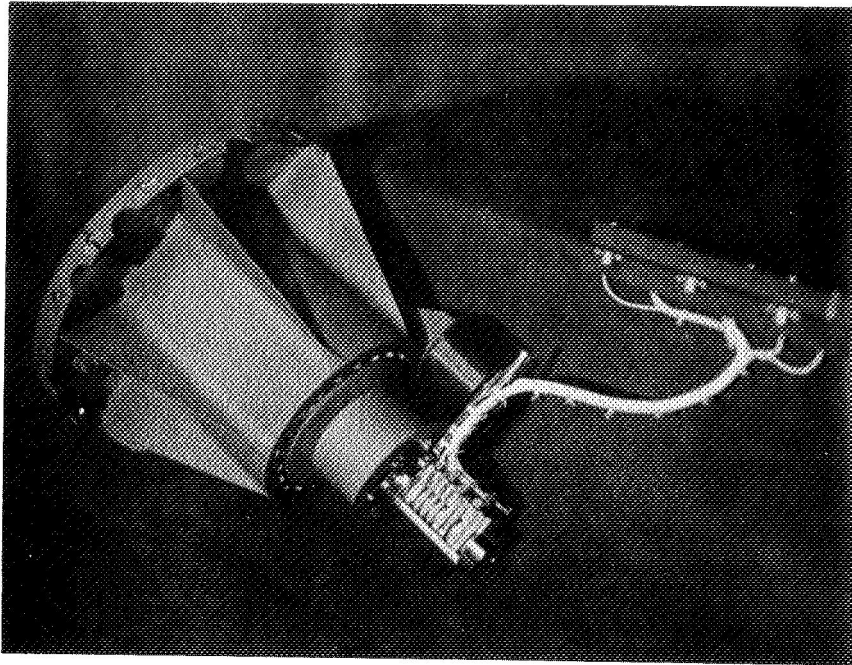
Figure 3.1-12 Inboard End Cap Assembly

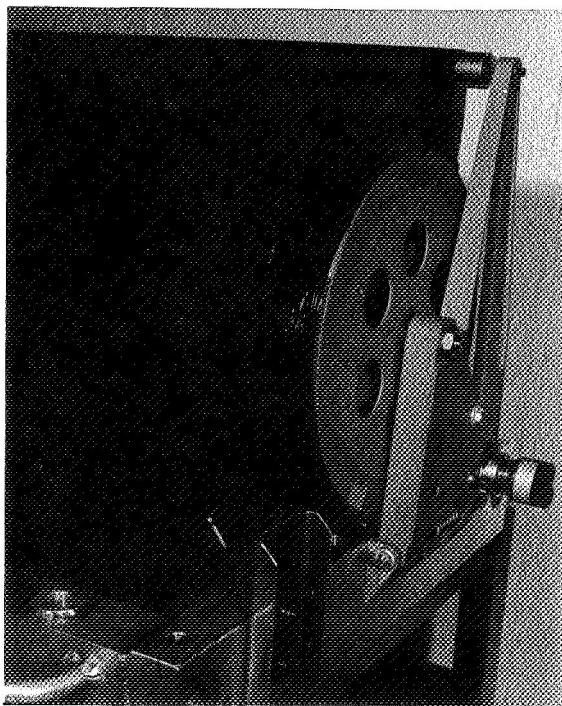
Figure 3.1-13 Outboard End Support (VF70157C)

the LEM functions to restrain the outer blanket wrap and to cage the BI-STEM boom element. The ends of the LEM are supported by the outboard end supports and the center section is supported from the actuator housing by two saddle-type brackets. With the exception of the stainless steel boom post, bearings, and associated spacers all parts are made from beryllium. The LEM is made up from two 50.1-inch-long cylinders fabricated from 0.020-inch beryllium sheet bonded with Epon 934. The two cylinders are inserted into a center fitting and bonded in place. This fitting also houses two instrument bearings which mate with the stainless steel boom post. These bearings decouple the array blanket from the BI-STEM boom for rotation about the boom axis. No bearing inserts are required because the surrounding material is steel and beryllium whose coefficients of thermal expansion are nearly the same.

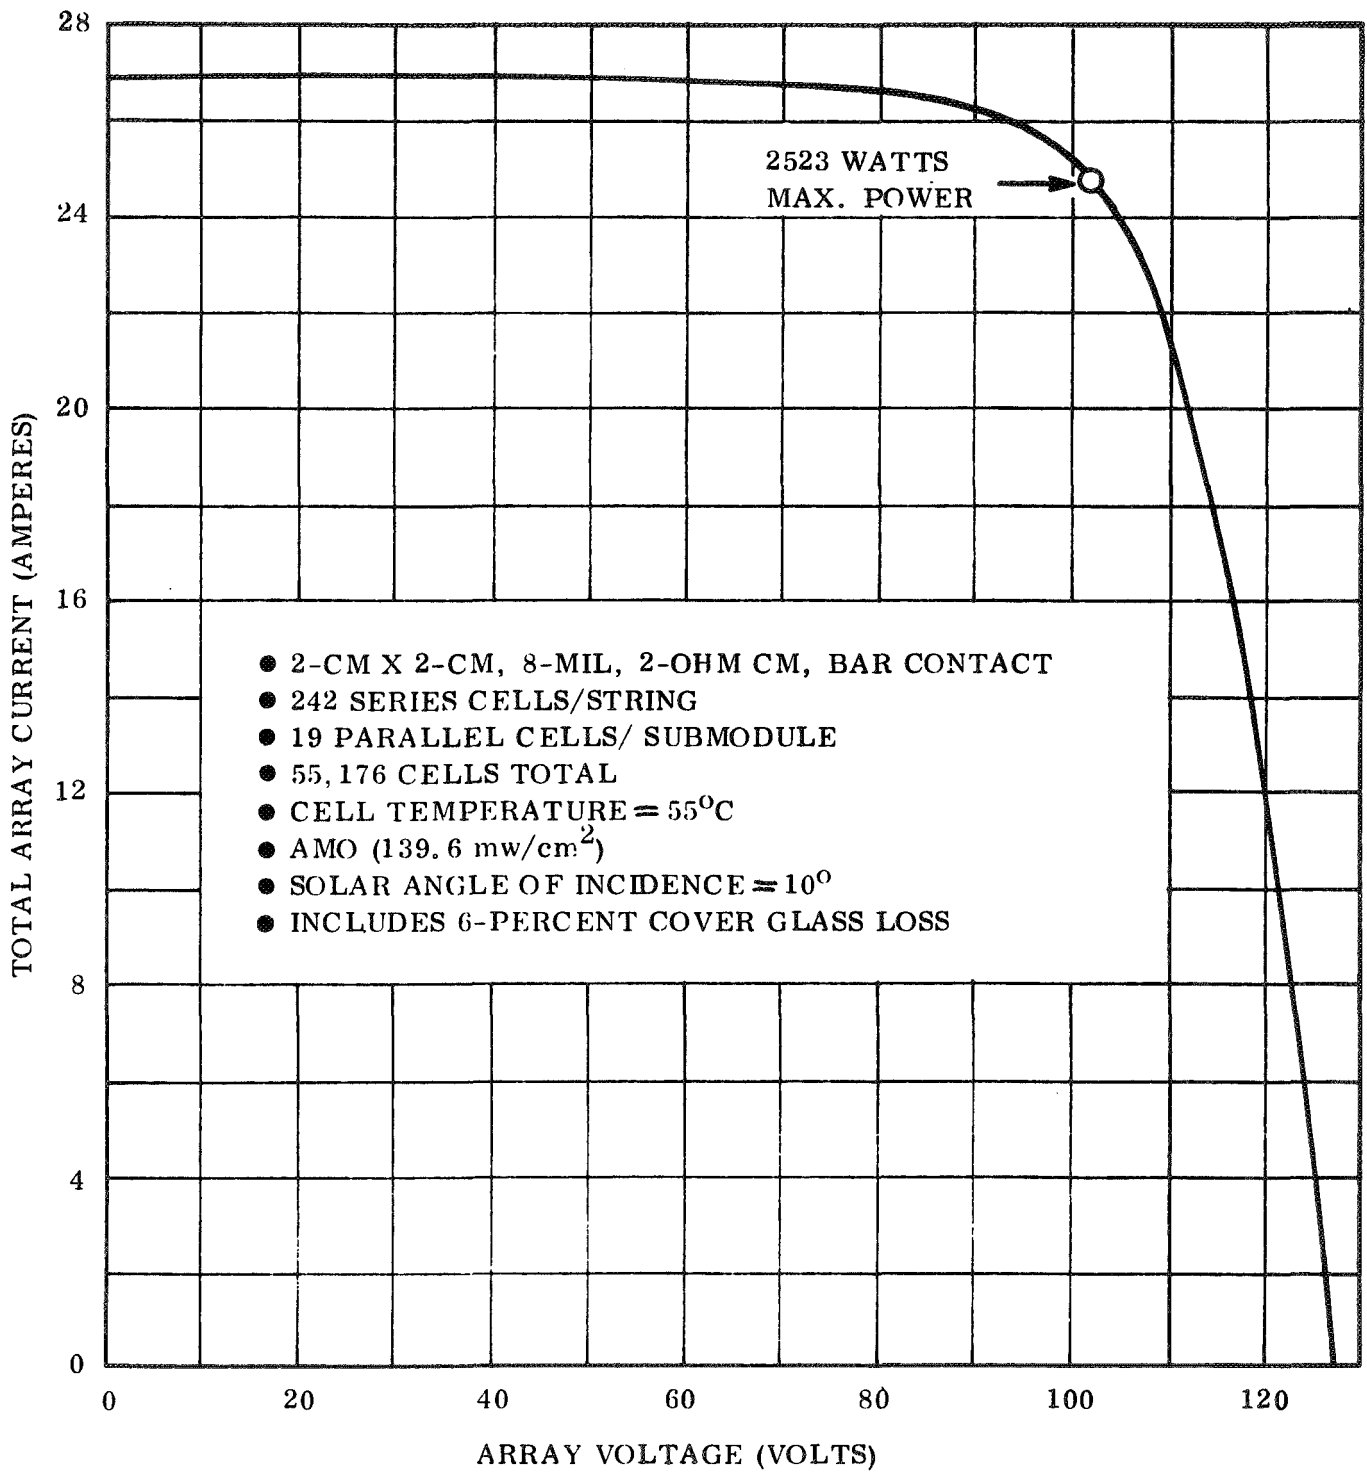
Figure 3.2-1. Nominal Subsolar Array I-V Curve

The effect of this combined series resistance is to reduce the maximum power by 51 watts at a 55°C operating temperature. The effective series resistance of the slip rings and associated harnessing within the drum and center support was

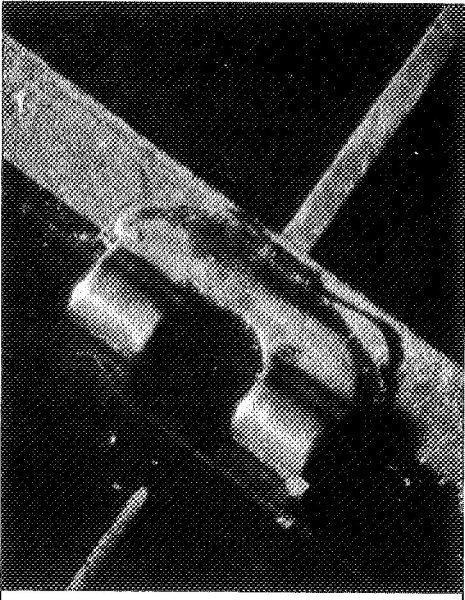
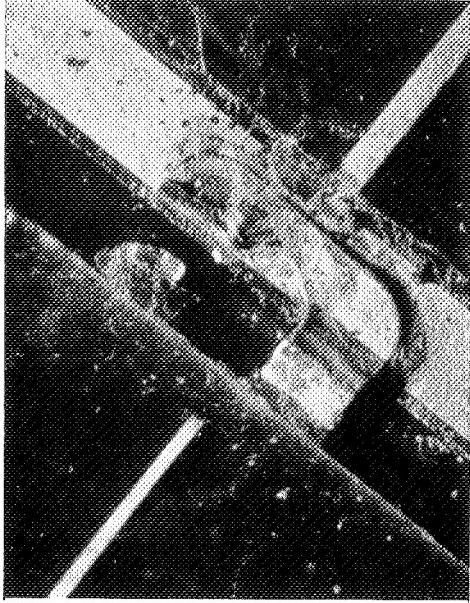
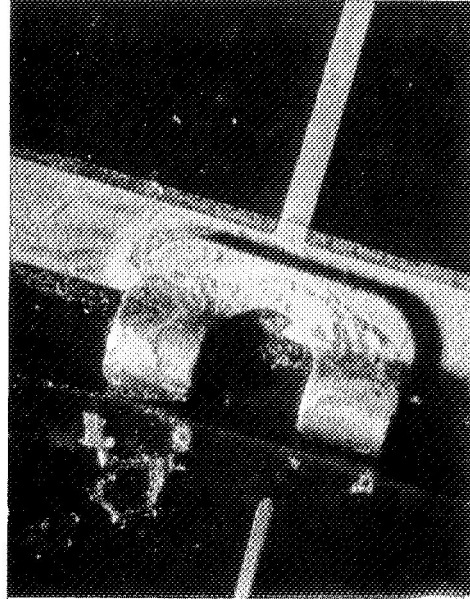
(a) Silicon Flake-out

(b) Silicon Flake-out and Splintering

(c) Fractured Interconnect Foot

(d) Lifted Interconnect Foot

Figure 3.2-2. Damage in J6 Module

Module J6 suffered extensive interconnect damage which was reflected by a 29.5 percent reduction in the maximum power. This damage occurred as a result of the thermal vacuum test series. Figure 3.2-2 shows examples of the various type of damage which occurred within this module. The majority of this damage occurred within the area of the module which was affected by the localized overheating during the stowed high temperature thermal vacuum test. The temperature in this area was high enough to melt the solder and cause the top contact feet to lift as shown in Figure 3.2-2 (d). The damaged pictured in figure 3.2-2 (a) and (b) is a silicon flake-out at the foot which is indicative of a low temperature failure mechanism. It is possible that the fractured conductor in (c) was caused by snagging on a cushioning button on the adjacent wrap.

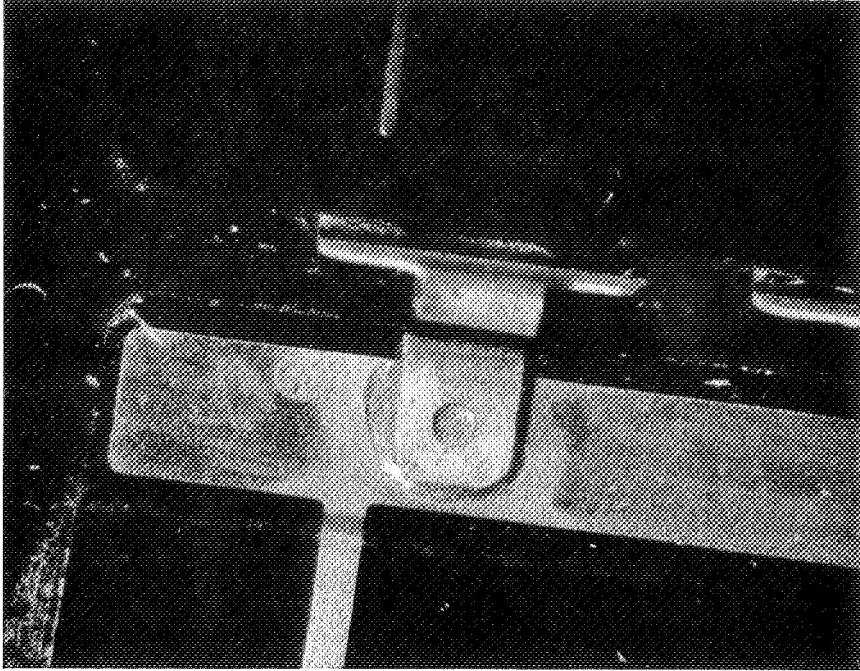
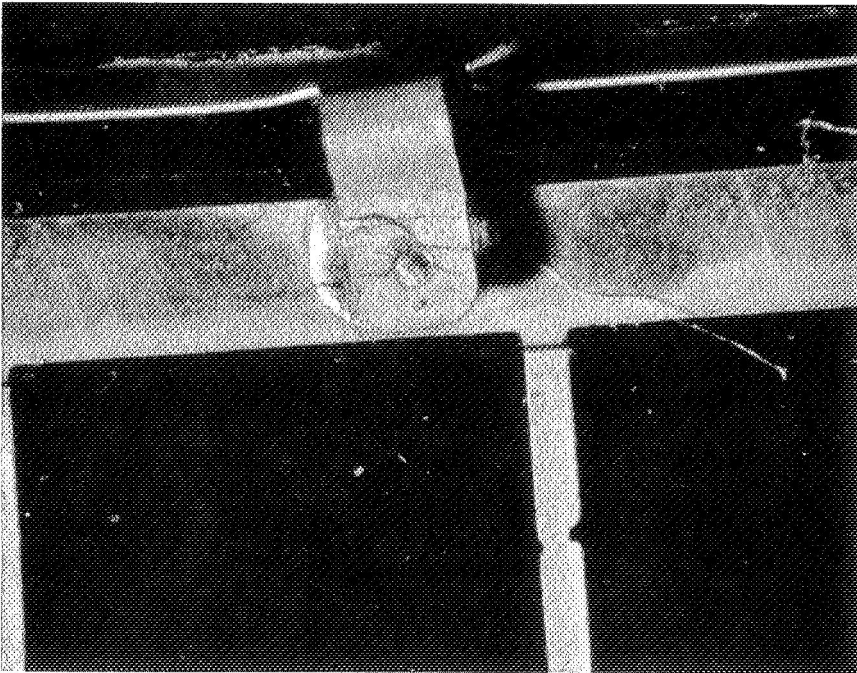
(a) Fractured Interconnect Foot

(b) Lifted Interconnect Foot

Figure 3.2-3. Damage in H1 Module

Some interconnect damage on the H1 module was observed after the stowed vibration test. Figure 3.2-3 shows examples of the types of failure. The lifted feet

occurred adjacent to a cell which was not securely bonded to the substrate. The fractured conductor pictured in (a) was at the edge of the module.

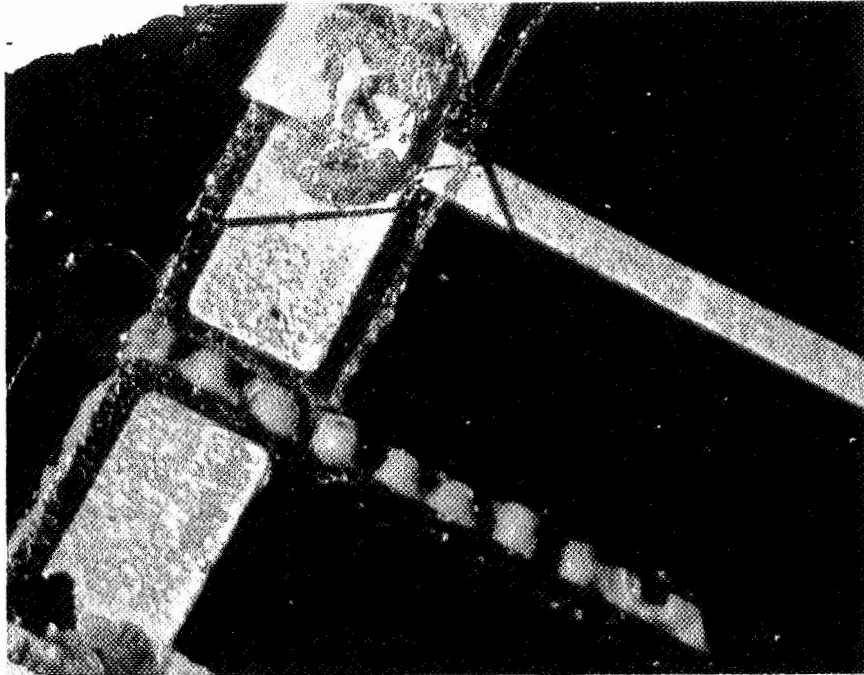
Figure 3.2-4. Fractured Cell at Foot in G7 Module

One example of an interconnect related failure was also observed in the G7 Module following the stowed vibration test. This fracture of the cell around a top connection is pictured in Figure 3.2-4.

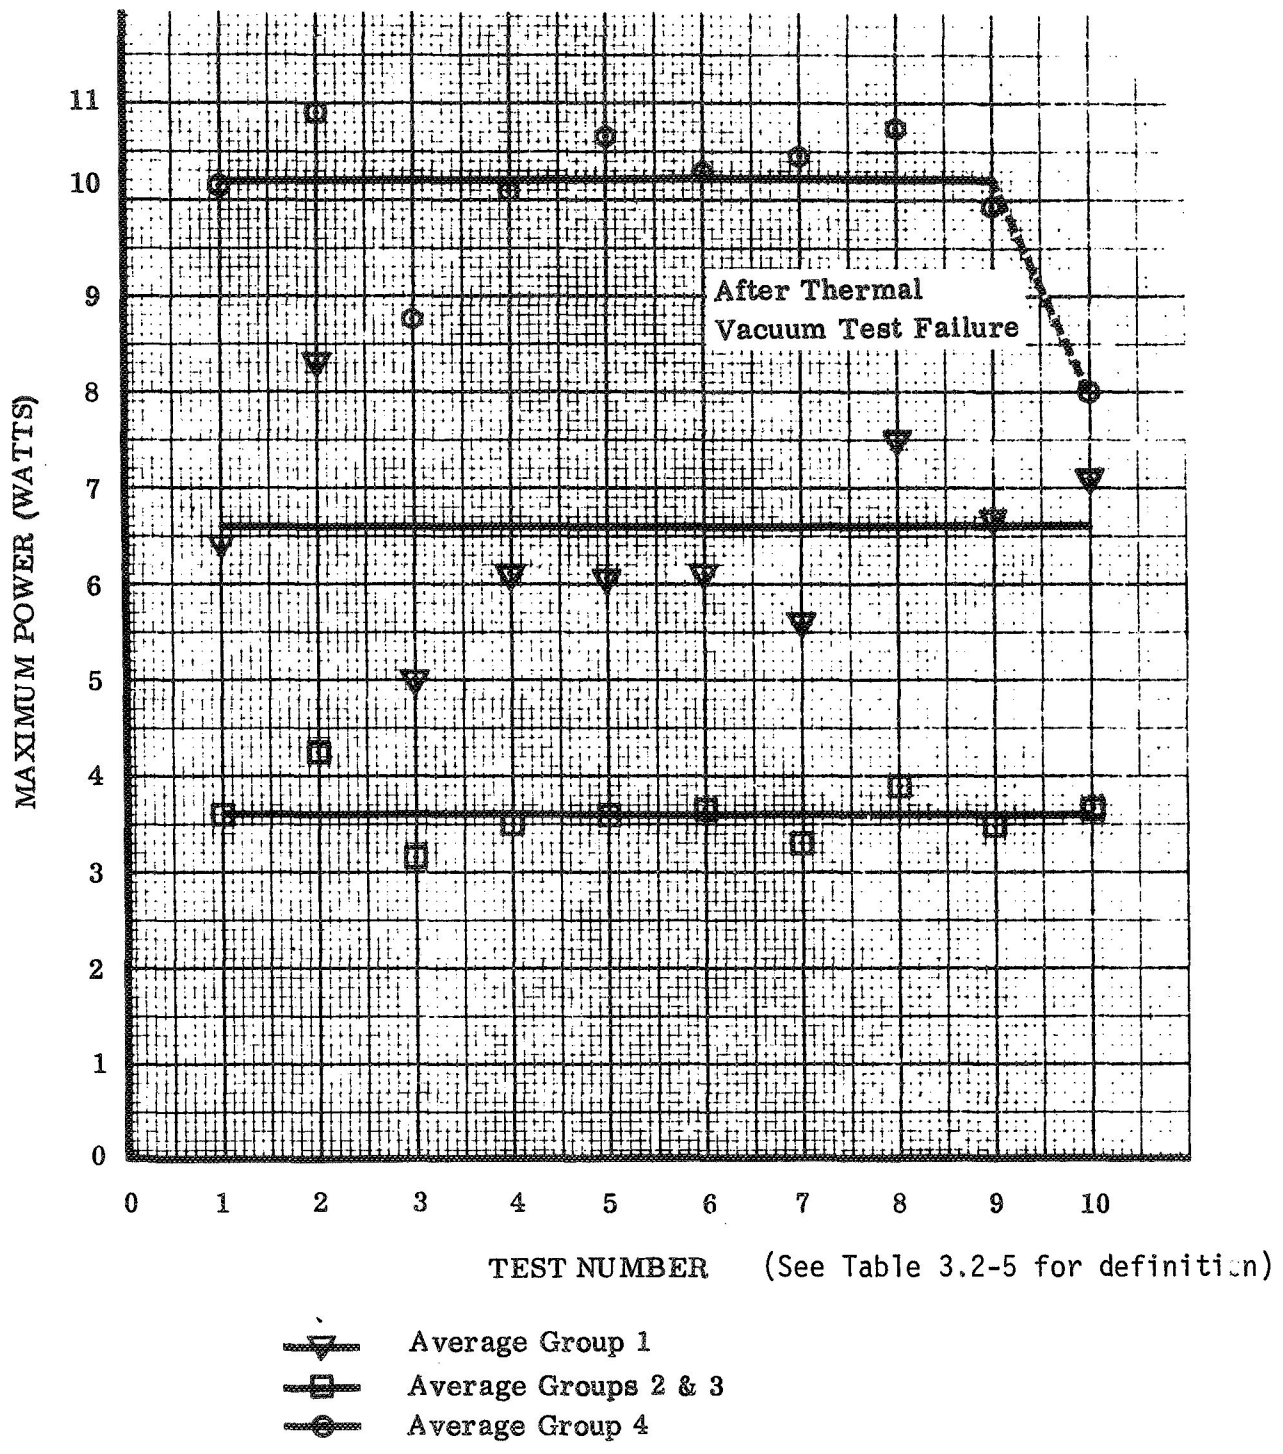
Figure 3.2-5. Electrical Performance (From Ryan Solar Array Program Report)

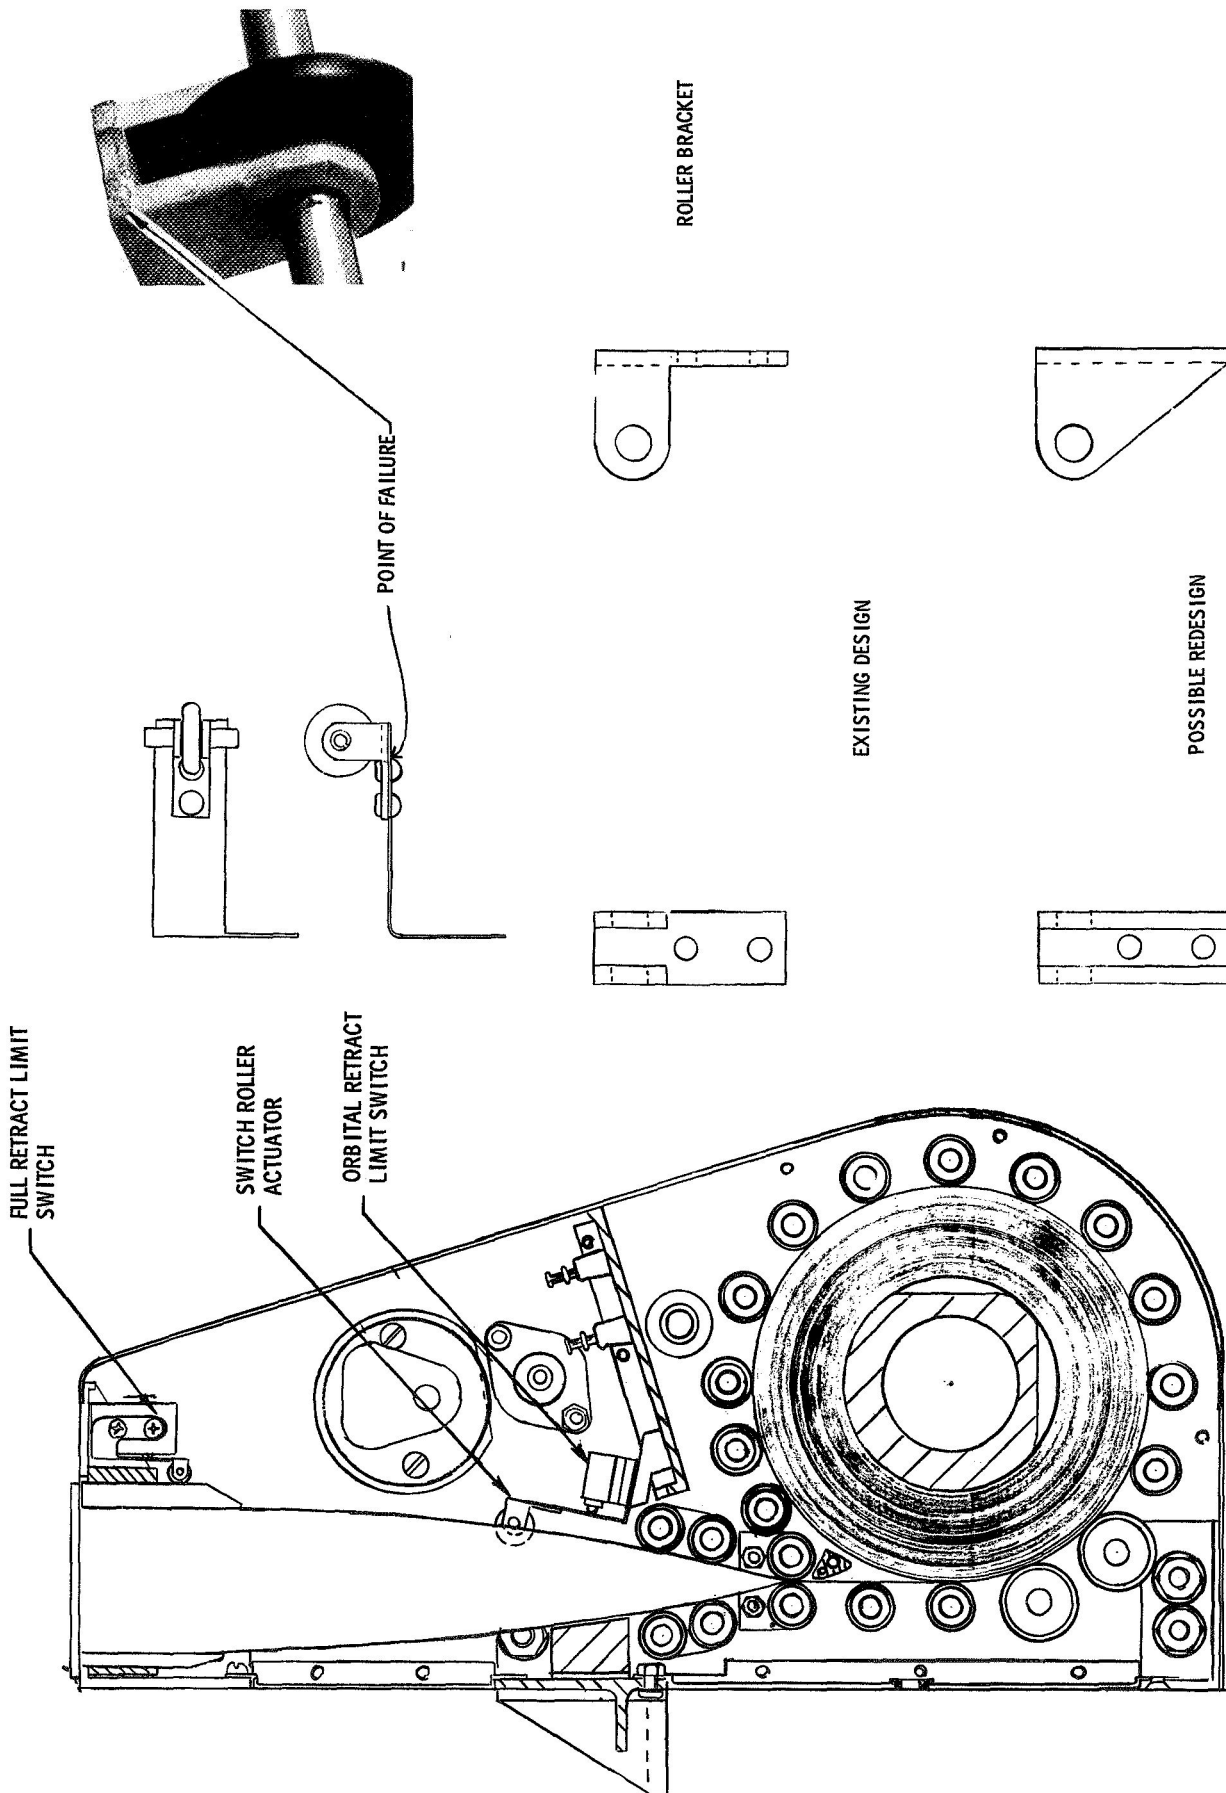
Figure 3.2-6 BI-STEM Limit Switch Actuator Problem

At the conclusion of the testing program none of these switches was operable. The full retract limit switch mounting bracket was out of adjustment as it became loose during the course of the testing program. Since its function was not vital to the actuation of the BI-STEM no effort was made to repair or adjust this switch. The orbital retract limit switch roller actuator broke off during an ambient deploy/retract of the BI-STEM on March 20, 1970. Figure 3.2-6 shows the location of this switch in the BI-STEM actuator housing. The roller which falls in the slot in the rod element is attached to a AZ31B-H24 magnesium bracket with a spring pin as shown in the detail sketch. This bracket is, in turn, riveted to a 302 stainless steel leaf spring which deflects to depress the microswitch button. The point of fracture was at the root of the bracket at the outermost rivet hole. The most probable cause of this failure is fatigue damage due to an inadequate section moment of inertia to accommodate the cyclic bending loads imposed during the component vibration test. The stress concentration at the rivet hole was probably a major contributing factor. A possible redesign of this roller bracket is shown on Figure 3.2-6 to illustrate that an adequate fix is not complicated. On June 5, 1970 an identical failure of the roller bracket on the full extend limit switch was discovered while attempting to deploy the BI-STEM following the Z axis stowed vibration test. This switch is located adjacent to the orbital retract limit switch and is actuated in exactly the same manner.
